Refurbishment & Demolition Asbestos Survey

Location: *No. 1 & 2 Moore Street.
Dublin 1*

Client: *Dublin Central GP Ltd*

Survey Date: *October 8th, 2020*

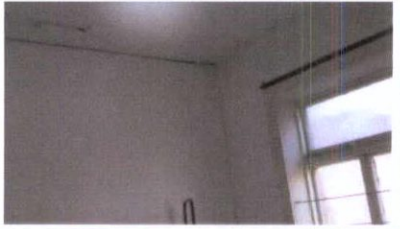
10	No. 1 & 2 Moore St.	No. 2 2 nd floor		Roof not accessible		Presumed to contain asbestos felts						Investigation prior to work likely to cause disturbance.

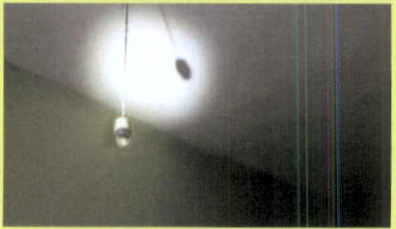
14	No. 3 Moore Street	1 st floor		AH ductwork with MMMF insulation		No visible asbestos containing materials identified.
