## Executive Summary

A Refurbishment and Demolition Asbestos Survey was carried out of the above property. Below is a summary of the survey.

**Site Full Name:**  
No. 4 Moore Street  
Parnell Street  
Dublin 1

**Report Author:**  
About Safety Limited  
24 Oceancrest  
Arklow  
Co. Wicklow

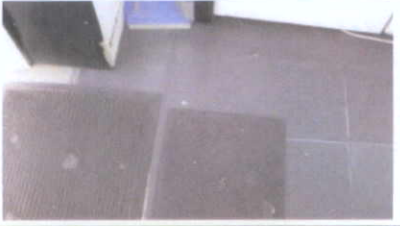
Ref No.	Building or Area of Site	Location or Functional Space	Sample No.	Material Description, surface treatment and condition	Extent	Asbestos identified (presumed, strongly presumed or identified)	Product type	Condition	Surface treatment	Asbestos type	Material assessment score	Recommendations	Photo
1	No. 4 Moore Street	Ground floor CE Fones outlet		Ceramic tiles to front of shop		NAD

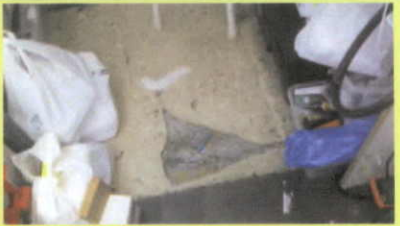
2	No. 4 Moore Street	Ground floor CE Fones outlet		Under existing lino at back of shop		Presumed to contain VFT and adhesive						Investigation and sampling prior to work likely to cause disturbance.

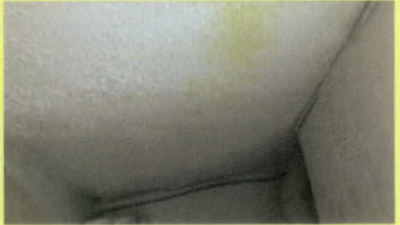
3	No. 4 Moore Street	Ground floor CE Fones outlet		Textured paint to back of shop		Presumed to contain asbestos						Investigation and sampling prior to work likely to cause disturbance.

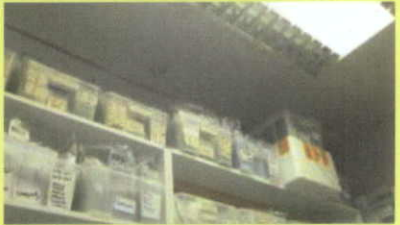
4	No. 4 Moore Street	Ground floor CE Fones outlet		Textured paint to back of shop		Presumed to contain asbestos						Investigation and sampling prior to work likely to cause disturbance.
