Refurbishment & Demolition Asbestos Survey

Location: *No. 10-12 Moore Street
Dublin 1*

Client: *Dublin Central GP Ltd*

Survey Date: *October 8th, 2020*

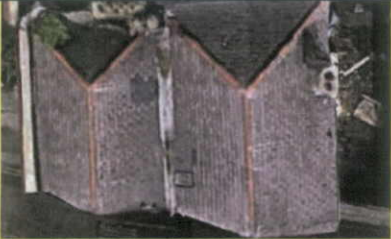
Ref No.	Building or Area of Site	Location or Functional Space	Sample No.	Material Description, surface treatment and condition	Extent	Asbestos identified (presumed, strongly presumed or identified)	Product type	Condition	Surface treatment	Asbestos type	Material assessment score	Recommendations	Photo
1	No.s 10-12 Moore Street	Roof of No. 10		Misc. repaired areas in the valley of natural quarry slates.		Presumed asbestos						Investigation by a competent contractor prior to work likely to cause disturbance.
