Refurbishment & Demolition Asbestos Survey

Location: *No. 20-21 Moore Street
Dublin 1*

Client: *Dublin Central GP Ltd*

Survey Date: *October, 2020*

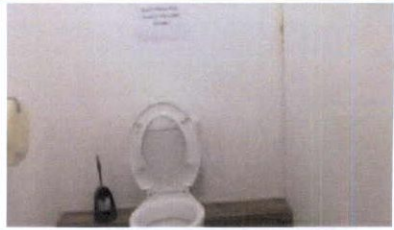
Ref No.	Building or Area of Site	Location or Functional Space	Sample No.	Material Description, surface treatment and condition	Extent	Asbestos identified (presumed, strongly presumed or identified)	Product type	Condition	Surface treatment	Asbestos type	Material assessment score	Recommendations	Photo
5	22-23 Moore Street	Street Oriental Pantry				No visible asbestos containing materials identified.

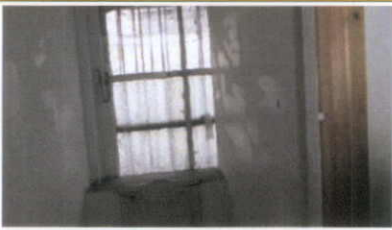
12	No. 20/21 Moore Street	1 st floor	2029209 2029210	Adhesive to VFT under raised floor in big room	60 SM approx.	Chrysotile	1	0	0	1	2	Removal and disposal as asbestos waste by a competent contractor prior to work likely to cause disturbance.

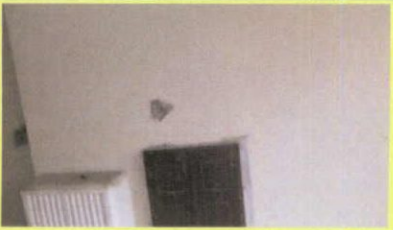
Ref No.	Building or Area of Site	Location or Functional Space	Sample No.	Material Description, surface treatment and condition	Extent	Asbestos identified (presumed, strongly presumed or identified)	Product type	Condition	Surface treatment	Asbestos type	Material assessment score	Recommendations	Photo
21	No. 20/21 Moore Street	1 st floor		Integral areas of the storage heater and the wall mounted safe		Presumed to contain asbestos						Dismantling and investigation by a competent contractor prior to work likely to cause disturbance.
