APPENDIX 14.1 CONSTRUCTION & DEMOLITION WASTE MANAGEMENT PLAN

**CONSTRUCTION &
DEMOLITION WASTE
MANAGEMENT PLAN FOR
A PROPOSED RESIDENTIAL
DEVELOPMENT**

**MASTERPLAN, SITE 3, SITE 4
AND SITE 5.**

CB/20/11784WMR01

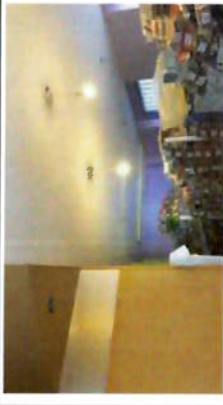
Ref No.	Building or Area of Site	Location or Functional Space	Sample No.	Material Description, surface treatment and condition	Extent	Asbestos identified (presumed, strongly presumed or identified)	Product type	Condition	Surface treatment	Asbestos type	Material assessment score	Recommendations	Photo
5	No. 1 & 2 Moore St.	No. 2 1 st floor Store rooms				No visible asbestos containing materials identified.

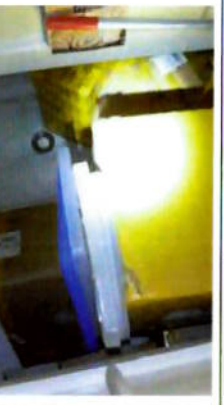
7	No. 1 & 2 Moore St.	No. 2 1 st floor WC				No visible asbestos containing materials identified.

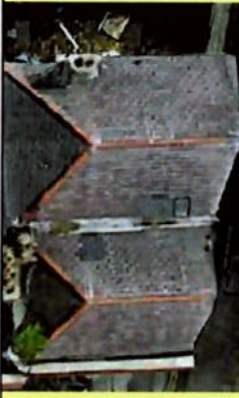
Ref No.	Building or Area of Site	Location or Functional Space	Sample No.	Material Description, surface treatment and condition	Extent	Asbestos identified (presumed, strongly presumed or identified)	Product type	Condition	Surface treatment	Asbestos type	Material assessment score	Recommendations	Photo
1	No.s 10-12 Moore Street	Roof of No. 10		Misc. repaired areas in the valley of natural quarry slates.		Presumed asbestos						Investigation by a competent contractor prior to work likely to cause disturbance.

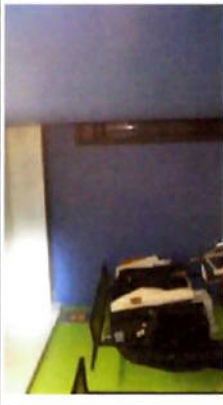
Ref No.	Building or Area of Site	Location or Functional Space	Sample No.	Material Description, surface treatment and condition	Extent	Asbestos identified (presumed, strongly presumed or identified)	Product type	Condition	Surface treatment	Asbestos type	Material assessment score	Recommendations	Photo
13	22-23 Moore Street	1 st floor Gymnasium Changing rooms				No visible asbestos containing materials identified.

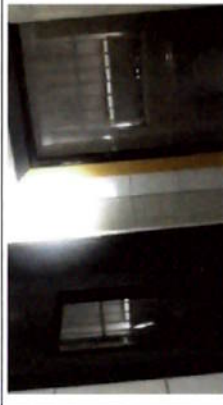
14	22-23 Moore Street	1 st floor Gymnasium WC's				No visible asbestos containing materials identified.

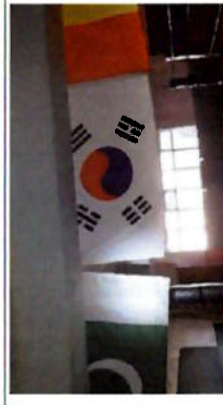
15	22-23 Moore Street	2 nd floor Gymnasium				No visible asbestos containing materials identified.

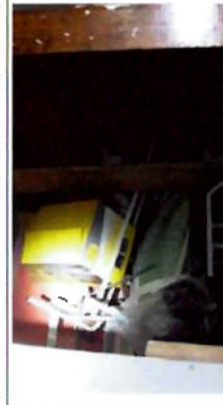
16	22-23 Moore Street	2 nd floor Gymnasium Store room				No visible asbestos containing materials identified.

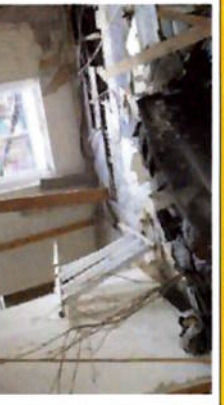
15	No. 20/21 Moore Street	1 st floor				No visible asbestos containing materials identified

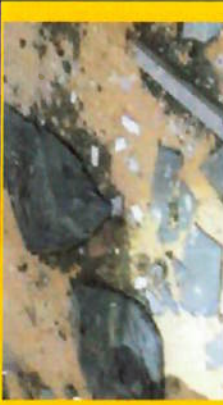
Ref No.	Building or Area of Site	Location or Functional Space	Sample No.	Material Description, surface treatment and condition	Extent	Asbestos identified (presumed, strongly presumed or identified)	Product type	Condition	Surface treatment	Asbestos type	Material assessment score	Recommendations	Photo
17	No. 20/21 Moore Street	2 nd floor	2029213	Roof slate debris on floor		Chrysotile	1	2	1	1	5	Removal and disposal as asbestos waste by a competent contractor prior to work likely to cause disturbance.

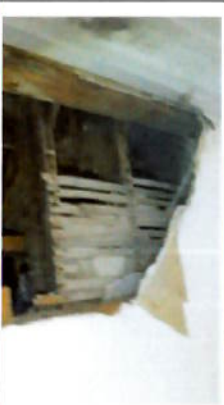
19	No. 20/21 Moore Street	2 nd floor Ceiling s		Original lat and plaster ceilings.		No visible asbestos containing materials identified

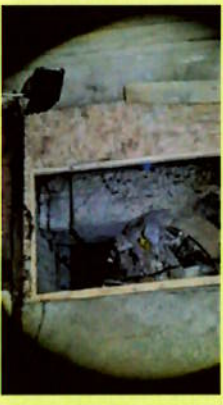
Ref No.	Building	Location or Functional Space	Sample No.	Material Description, surface treatment and condition	Extent	Asbestos identified (presumed, strongly presumed or identified)	Product type	Condition	Surface treatment	Asbestos type	Material assessment score	Recommendations	Photo
25	6 Moore Street	Basement back room		Inaccessible		Presumed to contain asbestos						Investigation by a competent contractor prior to works likely to cause disturbance

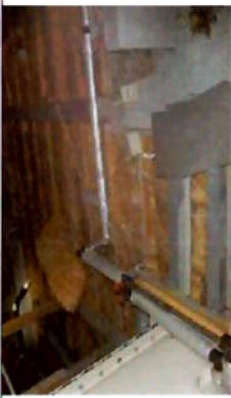
2	No. 24/25 Moore Street	Attic floor	202950	Slates on attic floor		NAD

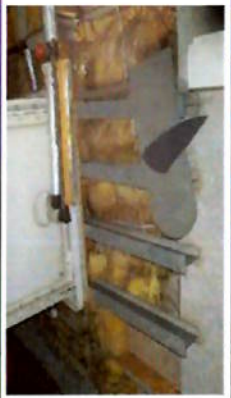
3	No. 24/25 Moore Street	Attic		MMMF insulation between joists		No visible asbestos containing materials identified.
