### **Refurbishment & Demolition Asbestos Survey**

**Location:** *No. 1 & 2 Moore Street.  
Dublin 1*

**Client:** *Dublin Central GP Ltd*

**Survey Date:** *October 8<sup>th</sup>, 2020*

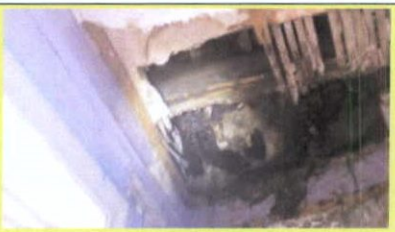
10	No. 1 & 2 Moore St.	No. 2 2 <sup>nd</sup> floor		Roof not accessible		Presumed to contain asbestos felts						Investigation prior to work likely to cause disturbance.

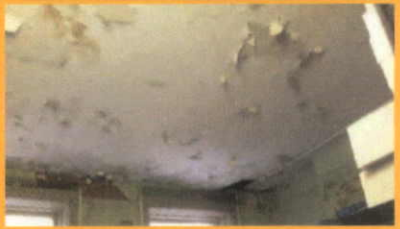
10	No. 3 Moore Street	1 <sup>st</sup> floor Store rooms	2028441	Textured paint to back of stairway		Chrysotile						Removal and disposal as asbestos waste by a specialist asbestos contractor prior to work likely to cause disturbance.

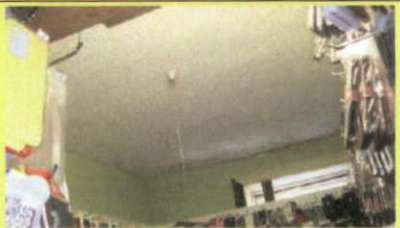
11	No. 3 Moore Street	1 <sup>st</sup> floor Store rooms		Textured paint		Strongly presumed asbestos						Investigation and sampling when the premises is vacant.

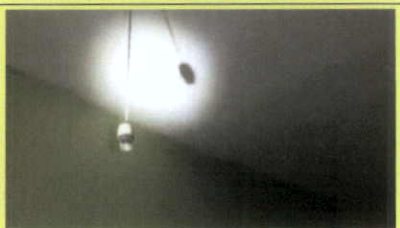
12	No. 3 Moore Street	1 <sup>st</sup> floor Store rooms		Textured paint		Strongly presumed asbestos						Investigation and sampling when the premises is vacant.
