Refurbishment & Demolition Asbestos Survey

Location: *No. 5 Moore Street.
Dublin 1*

Client: *Dublin Central GP Ltd*

Survey Date: *October 8th, 2020*

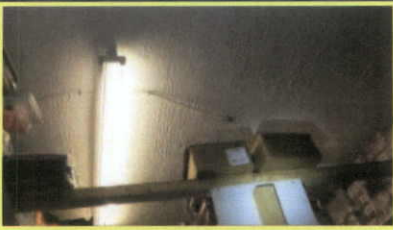
10	No. 4 Moore Street	2 nd floor CE Fones outlet Storeooms		Textured paint to ceiling		Presumed to contain asbestos						Investigation and sampling prior to work likely to cause disturbance.

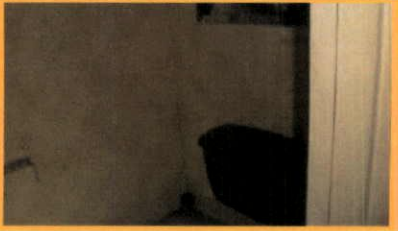
6	No. 5 Moore Street	1 st floor Rooms				No visible asbestos containing materials identified

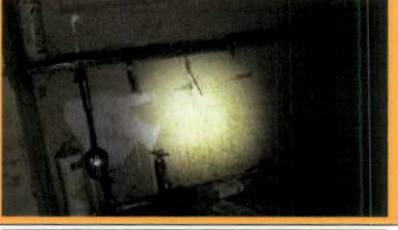
8	No. 5 Moore Street	2 nd floor Stairway		Plasterboard linings around door		No visible asbestos containing materials identified
