Executive Summary

Site Full Name:
No. 10-12 Moore Street
Dublin 1

ASBESTOS BULK IDENTIFICATION REPORT

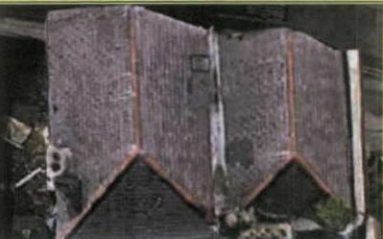
2	No.s 10-12 Moore Street	Roofs to No. 11 and 12		Felts to all flat		Presumed asbestos						Investigation by a competent contractor prior to work likely to cause disturbance.

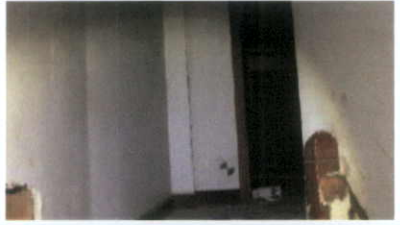
26	No.s 10-12 Moore Street	No. 10 1 st floor				No visible asbestos containing materials identified.
