Refurbishment & Demolition Asbestos Survey

Location: *6 Moore Street
Dublin*

Client: *Dublin Central GP Ltd*

Survey Date: *14th October 2020*

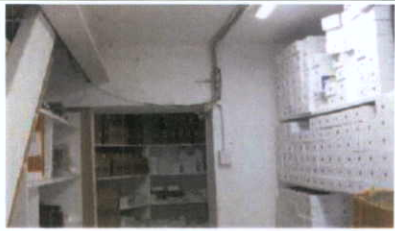
| Ref No. | Building | Location or Functional Space | Sample No. | Material Description, surface treatment and condition | Extent | Asbestos identified (presumed, strongly presumed or identified) | Product type | Condition | Surface treatment | Asbestos type | Material assessment score | Recommendations | Photo |
|---|---|---|---|---|---|---|---|---|---|---|---|---|---|
| 3 | No. 6 Moore Street | Basement store rooms | | | | No visible asbestos containing materials identified. | | | | | | | |

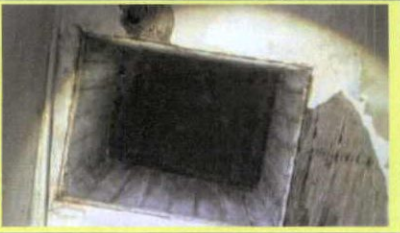
| Ref No. | Building or Area of Site | Location or Functional Space | Sample No. | Material Description, surface treatment and condition | Extent | Asbestos identified (presumed, strongly presumed or identified) | Product type | Condition | Surface treatment | Asbestos type | Material assessment score | Recommendations | Photo |
|---|---|---|---|---|---|---|---|---|---|---|---|---|---|
| 13 | No. 7 Moore Street | 2 nd floor Roof hatch | | No access to flat roof. | | Presumed to contain asbestos roofing felts. | | | | | | Investigation by a competent contractor prior to work likely to cause disturbance. | |
