## CONSTRUCTION & DEMOLITION WASTE MANAGEMENT PLAN

**CONSTRUCTION &  
DEMOLITION WASTE  
MANAGEMENT PLAN FOR  
A PROPOSED RESIDENTIAL  
DEVELOPMENT**

**MASTERPLAN, SITE 3, SITE 4  
AND SITE 5.**

CB/20/11784WMR01

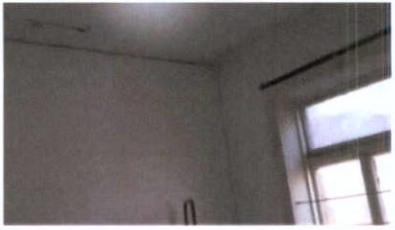
| Ref No. | Building or Area of Site | Location or Functional Space | Sample No. | Material Description, surface treatment and condition | Extent | Asbestos identified (presumed, strongly presumed or identified) | Product type | Condition | Surface treatment | Asbestos type | Material assessment score | Recommendations | Photo |
|---|---|---|---|---|---|---|---|---|---|---|---|---|---|
| 9 | No. 1 & 2 Moore St. | No. 2 2 <sup>nd</sup> floor Back rooms | | | | No visible asbestos containing materials identified. | | | | | | | |

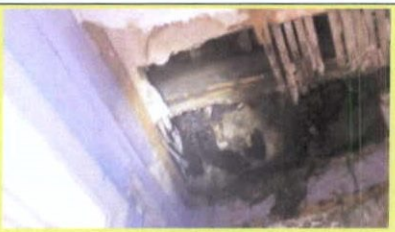
| Ref No. | Building or Area of Site | Location or Functional Space | Sample No. | Material Description, surface treatment and condition | Extent | Asbestos identified (presumed, strongly presumed or identified) | Product type | Condition | Surface treatment | Asbestos type | Material assessment score | Recommendations | Photo |
|---|---|---|---|---|---|---|---|---|---|---|---|---|---|
| 10 | No. 1 & 2 Moore St. | No. 2 2 <sup>nd</sup> floor | | Roof not accessible | | Presumed to contain asbestos felts | | | | | | Investigation prior to work likely to cause disturbance. | |

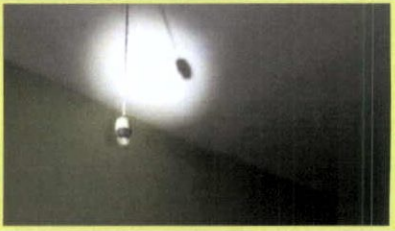
| Ref No. | Building or Area of Site | Location or Functional Space | Sample No. | Material Description, surface treatment and condition | Extent | Asbestos identified (presumed, strongly presumed or identified) | Product type | Condition | Surface treatment | Asbestos type | Material assessment score | Recommendations | Photo |
|---|---|---|---|---|---|---|---|---|---|---|---|---|---|
| 13 | No. 3 Moore Street | 1 <sup>st</sup> floor Store rooms | | Textured paint | | Strongly presumed asbestos | | | | | | Investigation and sampling when the premises is vacant. | |

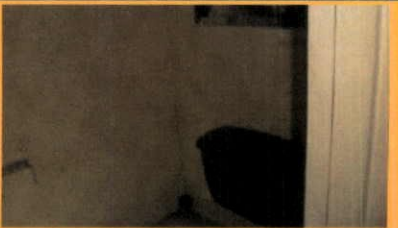
| Ref No. | Building or Area of Site | Location or Functional Space | Sample No. | Material Description, surface treatment and condition | Extent | Asbestos identified (presumed, strongly presumed or identified) | Product type | Condition | Surface treatment | Asbestos type | Material assessment score | Recommendations | Photo |
|---|---|---|---|---|---|---|---|---|---|---|---|---|---|
| 5 | No. 5 Moore Street | 1 <sup>st</sup> floor | | Bakelite cistern | 1 | Amosite | 1 | 0 | 1 | 2 | 4 | Removal and disposal as asbestos waste by a competent contractor prior to work likely to cause disturbance. | |

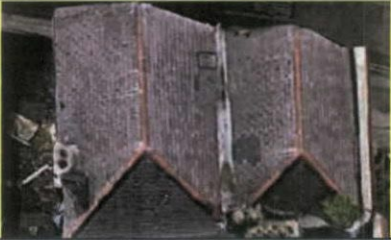
| Ref No. | Building or Area of Site | Location or Functional Space | Sample No. | Material Description , surface treatment and condition | Extent | Asbestos identified (presumed, strongly presumed or identified) | Product type | Condition | Surface treatment | Asbestos type | Material assessment score | Recommendations | Photo |
|---|---|---|---|---|---|---|---|---|---|---|---|---|---|
| 1 | No.s 10-12 Moore Street | Roof of No. 10 | | Misc. repaired areas in the valley of natural quarry slates. | | Presumed asbestos | | | | | | Investigation by a competent contractor prior to work likely to cause disturbance. | |

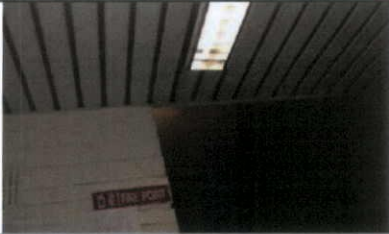
| Ref No. | Building or Area of Site | Location or Functional Space | Sample No. | Material Description, surface treatment and condition | Extent | Asbestos identified (presumed, strongly presumed or identified) | Product type | Condition | Surface treatment | Asbestos type | Material assessment score | Recommendations | Photo |
|---|---|---|---|---|---|---|---|---|---|---|---|---|---|
| 9 | No. 24/25 Moore Street | Ground floor Hallway | | | | No visible asbestos containing materials identified. | | | | | | | |

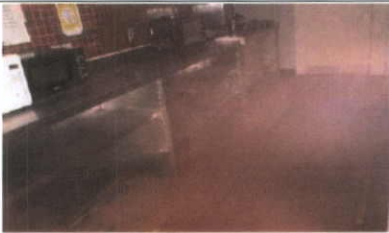
| Ref No. | Building or Area of Site | Location or Functional Space | Sample No. | Material Description, surface treatment and condition | Extent | Asbestos identified (presumed, strongly presumed or identified) | Product type | Condition | Surface treatment | Asbestos type | Material assessment score | Recommendations | Photo |
|---|---|---|---|---|---|---|---|---|---|---|---|---|---|
| 11 | No. 24/25 Moore Street | 1 <sup>st</sup> floor Canteen Kitchen | | | | No visible asbestos containing materials identified. | | | | | | | |

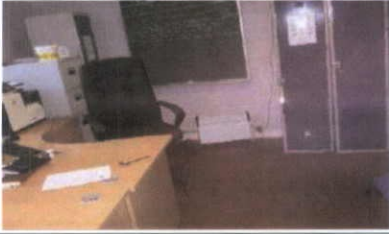
| Ref No. | Building or Area of Site | Location or Functional Space | Sample No. | Material Description, surface treatment and condition | Extent | Asbestos identified (presumed, strongly presumed or identified) | Product type | Condition | Surface treatment | Asbestos type | Material assessment score | Recommendations | Photo |
|---|---|---|---|---|---|---|---|---|---|---|---|---|---|
| 12 | No. 24/25 Moore Street | 1 <sup>st</sup> floor Office | | | | No visible asbestos containing materials identified. | | | | | | | |
