Title: **Proposed Strategic Housing Development At Ballymany
Combined Stage 1&2 Road Safety Audit**

Client: **Briargate Developments Newbridge Limited/Muir
Associates**

Date: **May 2021**

Report reference: **1035R01**

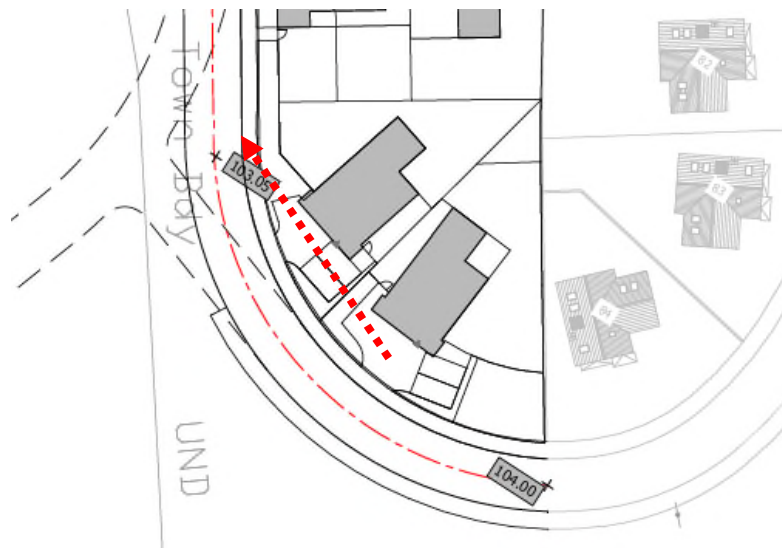
Drawing D1920-MAL-00-XX-C-002 Rev B, Visibility from driveway, most southern unit.

The most southerly unit is located on a sharp bend of the main access road. There is a risk that drivers exiting this premises may not have adequate visibility to approaching southbound vehicles. This could result in collisions.

It is recommended that suitable visibility be provided.

3.2	YES	YES	Note: An appropriate visibility splay for the Plots in question will be demonstrated as a part of the planning application drawings.	Yes
3.3	YES	YES

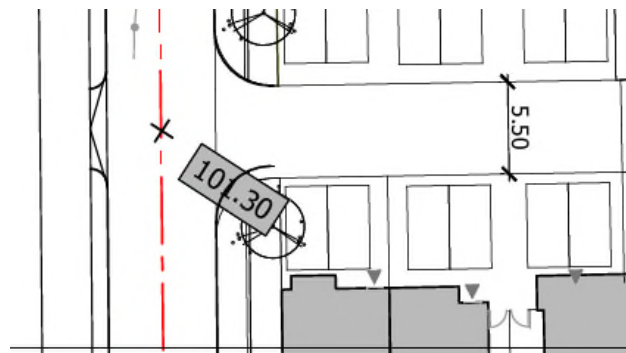
Drawing D1920-MAL-00-XX-C-002 Rev B, 003 Rev A, 004 Rev A & 005 Rev A, Trees within visibility splays.

Throughout the proposed development trees are shown at the internal junctions. There is a risk that these trees could obscure inter-visibility between drivers and pedestrians. This could lead to collisions.

Ensure trees do not block visibility splays.

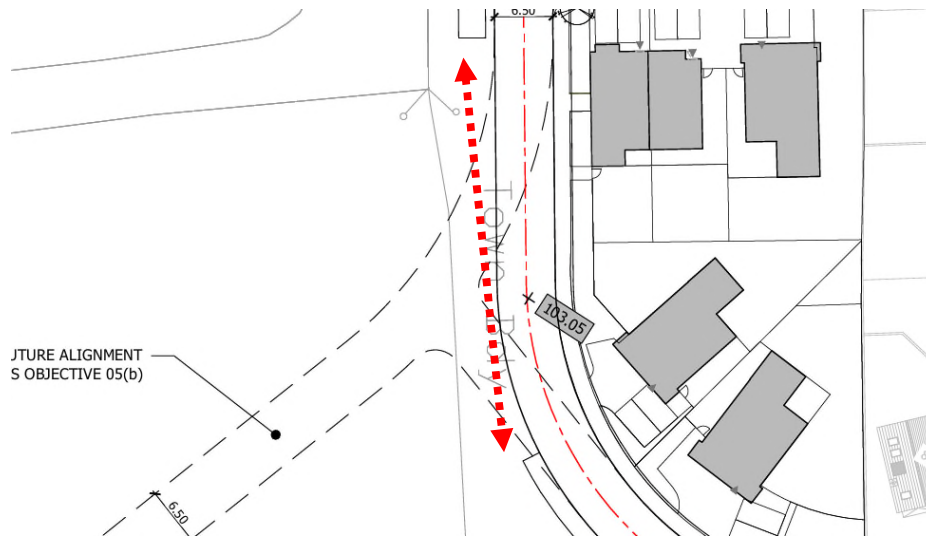
Drawing D1920-MAL-00-XX-C-005 Rev B, Discontinuity in footpath provision.

There is a discontinuity in the footway provision on the main access road where the future alignment of roads objective 05(b) is to be located. In the intervening period the discontinuity could lead to pedestrians crossing the carriageway at the severe bend where drivers may not have full visibility to them or a desire line along the reserved alignment junction may be formed on an unsuitable surface leading to slips, trips and falls.

It is recommended that a continuous footway be provided until the future alignment is constructed.

3.4	YES	NO	A raised pedestrian crossing will be provided at the end of the highlighted footpath area in order to provided for a safe pedestrian crossing location.	Yes

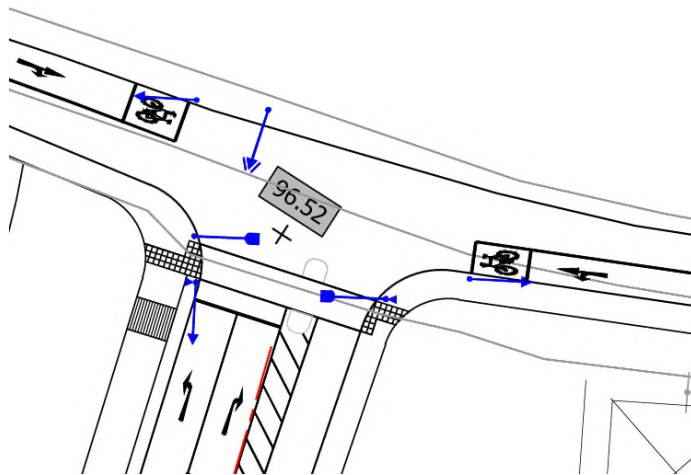
Drawing D1920-MAL-00-XX-C-005 Rev B, Standhouse Road Junction.

It is unclear if the proposed vulnerable user facility on the western side of the main access road is a shared use pedestrian cycle facility and if it is to be for one or two-way cycling. Without adequate width and adequate access facilities there may be collisions between cyclists and pedestrians.

It is recommended that if the facility is to be for two-way cycling that the proposed signalised pedestrian crossing be upgraded to a toucan crossing, if not, then a southbound cycle facility should also be provided.

conflicts between cyclists and other road users.	
3.6	YES	YES	Note: The facility on the western side of the Link Road is a two-way cycle track and a toucan crossing will be provided as a part of the Stanhouse Road junction design in line with the audit recommendations.	Yes
3.7	YES	YES		
3.8	YES	YES		
3.9	YES	YES

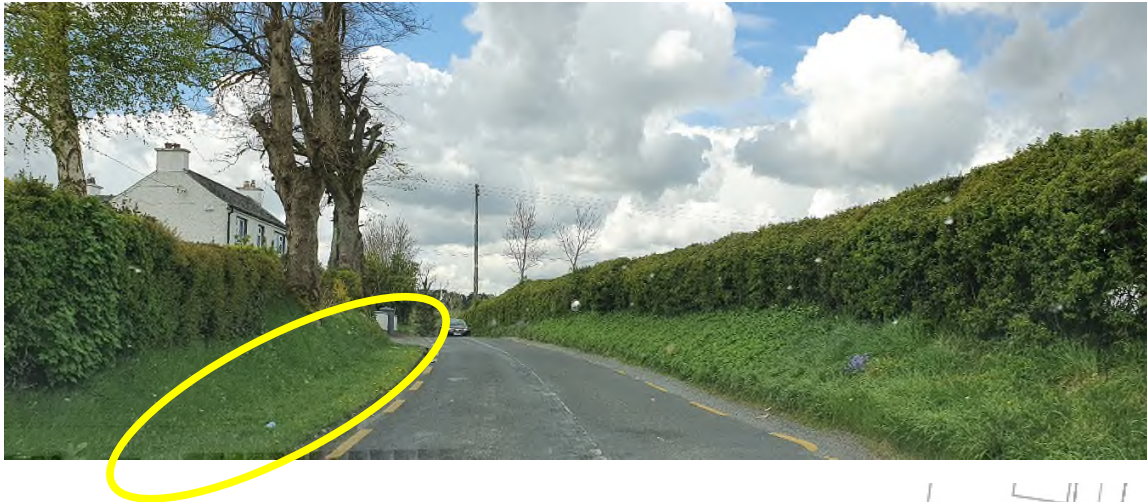
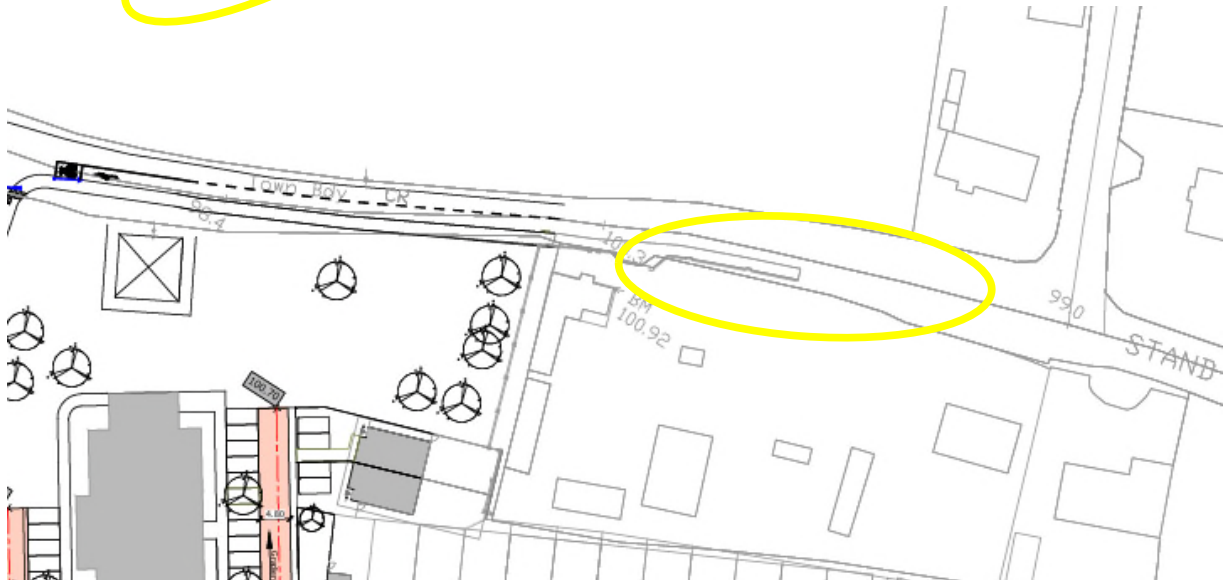
Drawing D1920-MAL-00-XX-C-005 Rev B, Standhouse Road Footpath.

There is a discontinuity in the footway provision along Strandhouse Road between the development and Scoil Mhuire junior school. This could result in school children not being able to safely get to school on foot from the proposed development.

It is recommended that the footpath be made continuous through this section.

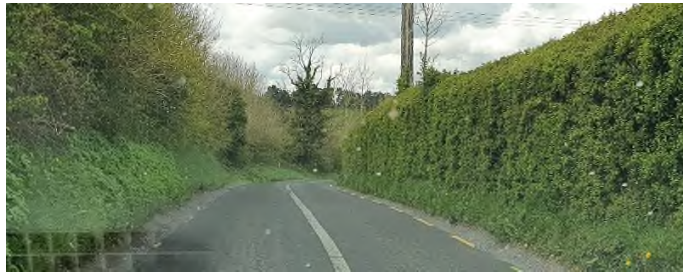
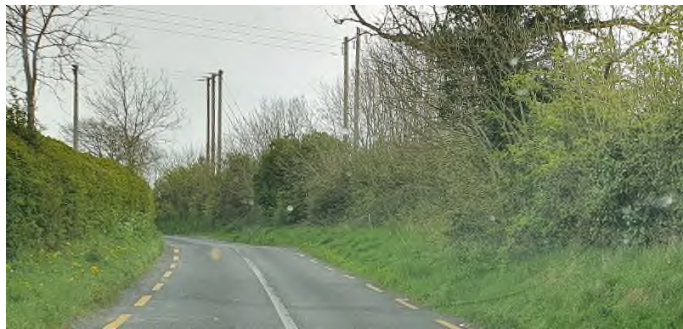
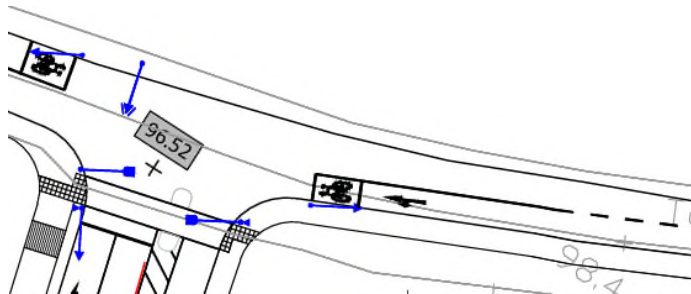
Drawing D1920-MAL-00-XX-C-005 Rev B, Standhouse Road Carriageway Width.

The existing carriageway width at Strandhouse Road is narrow and passing vehicles use the narrow verge to gain extra space when passing. With the introduction of the footpath in the southern verge the effective width of the carriageway will be reduced and this could result in side-swipe collisions.

It is recommended that the Strandhouse road carriageway width be sufficient to allow queuing and passing of vehicles.

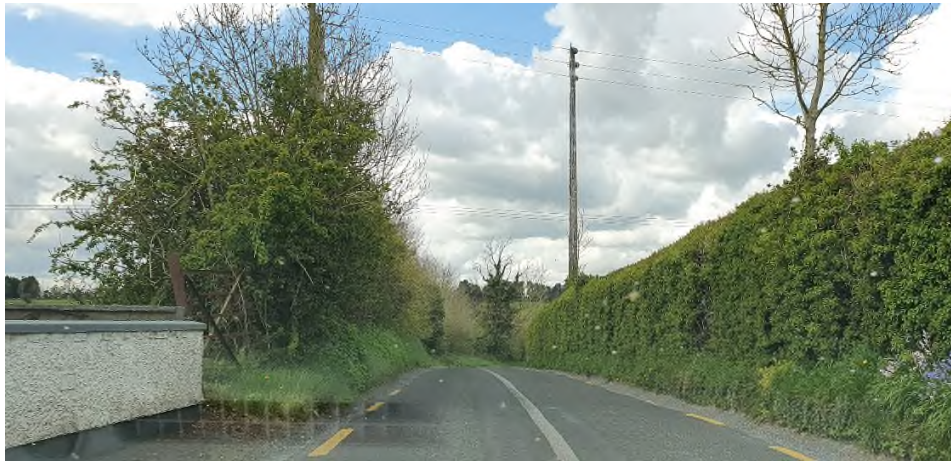
Drawing D1920-MAL-00-XX-C-005 Rev B, Strandhouse Road Vertical Alignment.

There is a steep decline in the vertical alignment of Strandhouse Road on the westbound approach to the proposed signalised junction. In wet or icy conditions drivers may not be able to stop if there is queue at the lights which could lead to rear-end collisions.

It is recommended that the vertical alignment be checked for stopping sight distance compliance with design standards and that high friction surfacing or a surface course with aggregate of high polished stone value and aggregate abrasion value be provided on approach to the signals.
