20023-01-001

Proposed Residential Development at R510, Raheen, Limerick

ROAD SAFETY AUDIT STAGE 1/2

March 2020

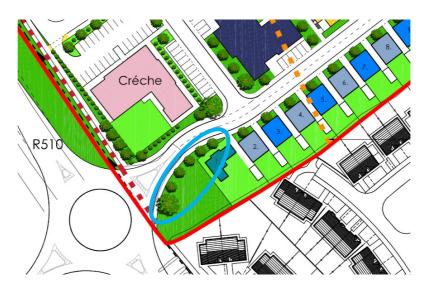
2.1 **Problem**

Stopping sight distance for drivers of vehicles on the approach to the proposed roundabout from the development may be restricted by the proposed vegetation on the southern side of the proposed access road. A lack of adequate stopping sight distance at the proposed access may contribute to a rear end collision at the roundabout exit.

Omit the vegetation so as to provide adequate stopping sight distance on approach to the proposed roundabout.

2.1	yes	no	Proposed hedging to be low level (<0.9m height). Tree to be set back clear of approach sight line.	485
2.2	yes	yes		
2.3	yes	yes	Shared surface is proposed to encourage a low speed zone. Ramps at the entrance and contrasting colour tarmac proposed. Yield lines to be introduced, see attached 18112-C13-C Footpath along main thru road running west-east.

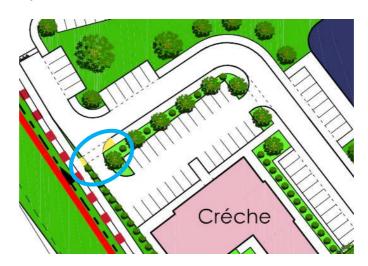
2.2 **Problem**

There is an uncontrolled pedestrian crossing located at the exit from the crèche. However, it is unclear whether adequate inter-visibility is provided between drivers of vehicles approaching the pedestrian crossings and pedestrians stopped waiting to cross. Planting shown to be provided could obstruct visibility.

Provide adequate inter-visibility between drivers of vehicles approaching the pedestrian crossings and pedestrians stopped waiting to cross at the pedestrian crossing. Ensure that planting is set back sufficiently behind the visibility splays.

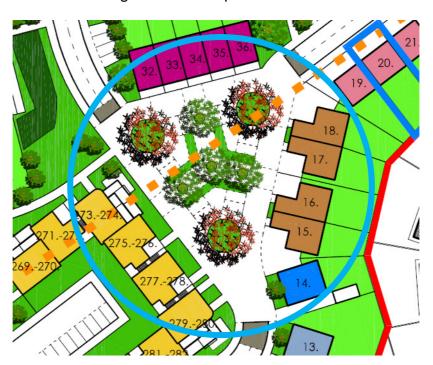
2.3 **Problem**

A shared surface is proposed along the access road from houses 14-18, 32-36 & 274-280. This access road acts as a through route with a number of houses accessing onto it and as a result will generate a significant amount of vehicular movement along this section of road. A shared surface may not be suitable in this area. In addition, it is unclear whether adequate inter-visibility is provided between drivers of approaching vehicles and drivers of vehicles exiting the car parking spaces provided in the centre of the shared area. Planting shown to be provided could obstruct visibility.

Provide a separate footpath along this section of the access road to ensure the safety of pedestrians is catered for. Ensure that planting is set back sufficiently to ensure adequate inter-visibility between drivers of approaching vehicles and drivers of vehicles exiting the car parking spaces.

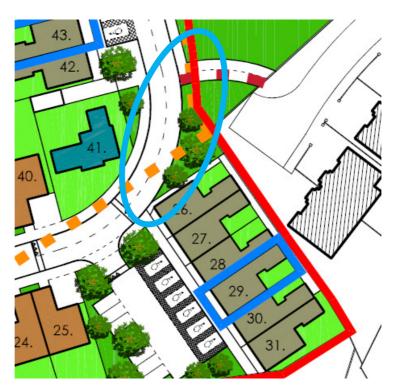
2.5 **Problem**

It is proposed to provide a footpath connection to the existing housing estate located to the northeast of the proposed development. However, no direct footpath connection is provided for a pedestrian travelling along the southern side of the main spine road and from houses 26-31 to access the proposed footpath. This may lead to pedestrians stepping out onto the carriageway where they would be at an increased risk of being struck by a passing vehicle.

Provide a footpath connection to cater for the desired route for pedestrians accessing the proposed footpath connection into the existing housing estate.

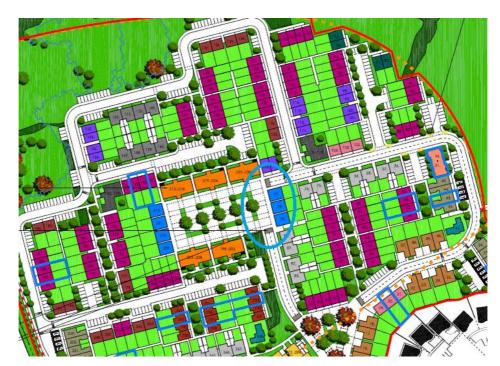
2.6 **Problem**

The most direct route from the proposed development access to houses at the northern end of the development is via an area of shared surface at the apartment blocks. This will result in a significant amount of vehicular

movement along this section of the shared surface. A shared surface may not be suitable along this section of the access road.

Either provide a separate footpath along this section of the shared road to ensure the safety of pedestrians is catered for or revise the layout to prevent vehicles from travelling through this area.

2.5	yes	yes		_
2.6	yes	yes	Shared surface is proposed to encourage a low speed zone. Ramps at the entrance and contrasting colour tarmac proposed. The road width on approach to shared area to be reduced to 5.5m to encourage low approach speed. Pedestrian footpath provided through this section.

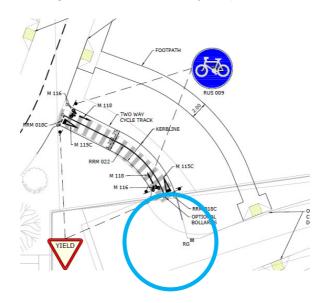
2.7 **Problem**

It is proposed to provide a cycle path connection to the existing housing estate located to the northeast of the proposed development. However, a cyclist is required to transverse a grass verge from the existing housing estate access road to gain access to the cycle path.

Extend the cycle path to provide a direct link to the existing housing estate access road.

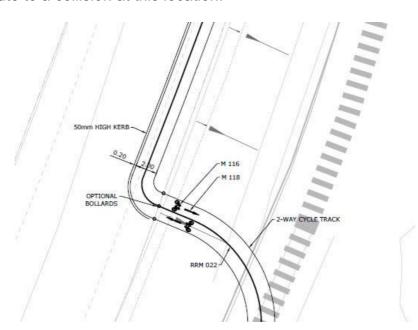
2.9 **Problem**

It is unclear from the drawings provided how it is intended to tie-in the proposed two-way cycle facility into the existing cycle network at the northern end of the scheme. A lack of an appropriate connection may contribute to a collision at this location.

Temporarily connect the proposed cycle facility into the existing hardshoulder on the R510. In the long term the local authority should consider extending the two-way cycle facility north to connect to the existing cycle network at the junction of the R510 with the N69/N18 interchange.

2.7	yes	yes		_
2.8	yes	yes		_
2,9	no	no	The proposed connection is in accordance with the discussions with LCCC. Proposal is to provide a two-way cycleway along the hard shoulder of the	YES

R510 that will connect to existing of infrastructure at the roundabout to north. The cycleway is to be separ from vehicular traffic by a 50mm his kerb. Expansion of the lanes to include a footpath is problematic due to the intersection with the CIE rail line at other land ownership issues. However, the re-routing into part of the site is long term proposal to provide more amenity on the cycle lane and fully break from the traffic.	the ated gh lude e nd ever s a

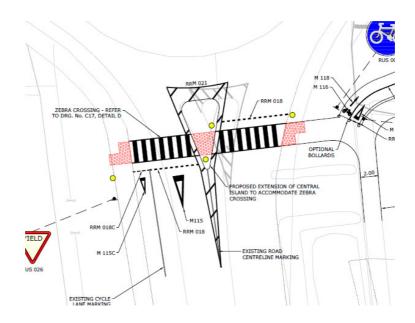
2.10 Problem

The proposed cycle layout on the southern arm of the roundabout at the development access may not safely cater for cyclists wishing to access or exit the proposed development. A lack of an appropriate cycle access to and from the development may contribute to a collision at this location.

Provide appropriate cycle connections between the cycle facility within the proposed development and the existing northbound cycle lane and south hardshoulder on the R510.

2.10	yes	yes	Two way cycleway through the site proposed for north and south bour traffic. Northbound cyclists can eith around the roundabout or dismount access footpath and zebra crossin dropped kerb, Southbound cyclists now provided with a link to the exist hard shoulder to the south of the roundabout.	ner go et and g via are

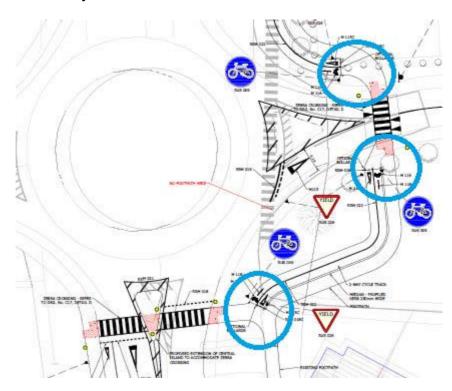
2.11 Problem

There are a number of conflict points between pedestrians and cyclists at the proposed zebra crossings. A lack of adequate guidance may contribute to a pedestrian/cycle collision at these locations.

Provide appropriate corduroy paving on the pedestrian and cycle approaches to the conflict points to reduce the risk of a pedestrian/cycle collision.
