**Arboricultural Report
Trees at Proposed Site at
Balscadden
Howth
Co Dublin**

March 2022

**The Tree File Ltd
Consulting Arborists
Ashgrove House
26 Foxrock Court
Dublin 18
D18 R2K1
086-3819011**

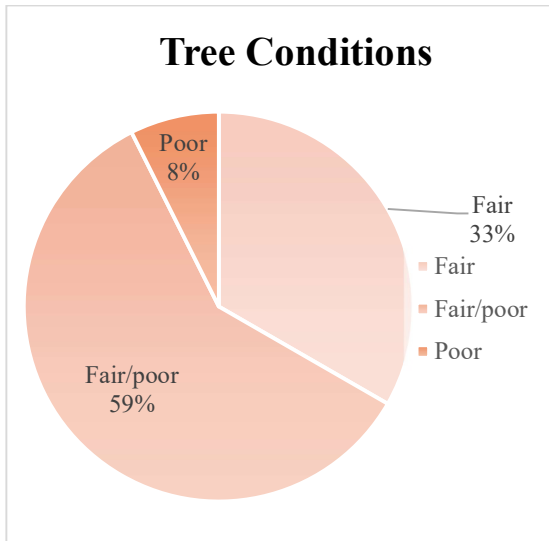
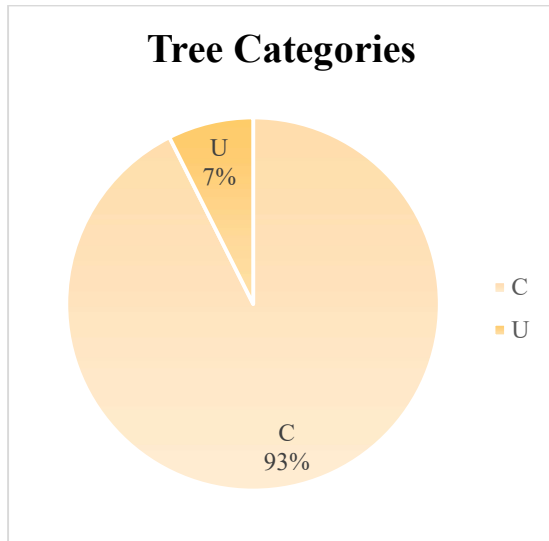
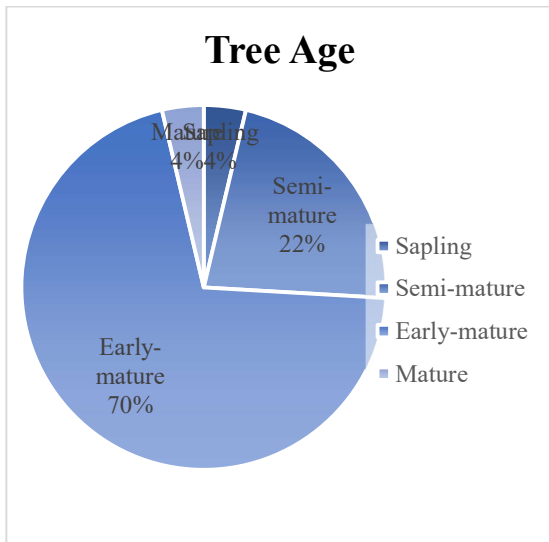
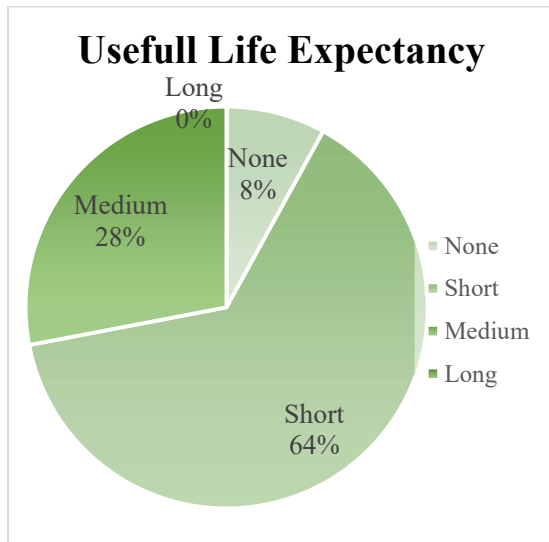
4.8 Figs 1 to 5 provide a graphic representation of the tree survey findings. Notwithstanding young age, the tree qualities are low, with 66% being in the fair/poor or poor category. This appears borne out in fig 2 that show 93% of trees in category “C” and the remainder as unsustainable category “U”. This is again corroborated in the useful life expectancy graph, at fig 4 that is dominated by short-term at 64%. The typically small size and limited visual impact if the trees is well explained by the typically young ages as shown in fig 3.

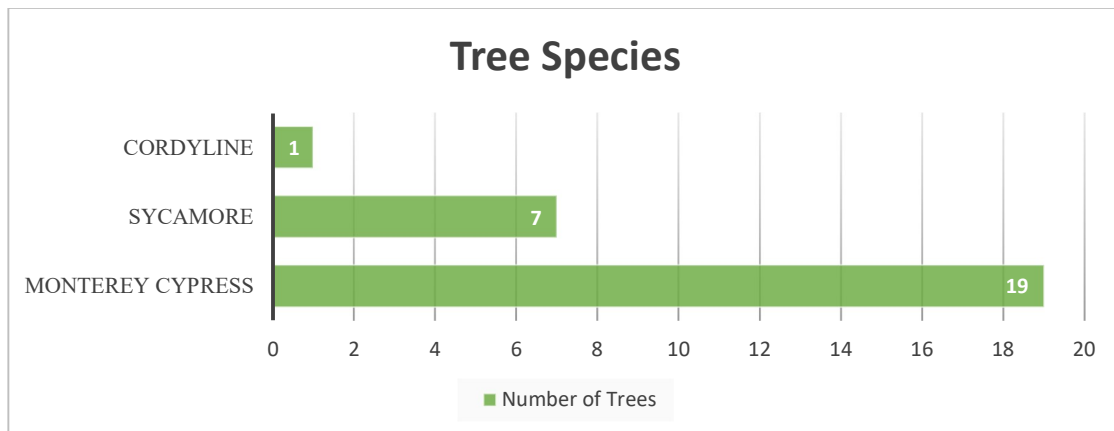
4.9 Fig 5 illustrates a particularly low diversity of tree species, dominated by Monterey Cypress. This illustrates an artificially planted tree population.

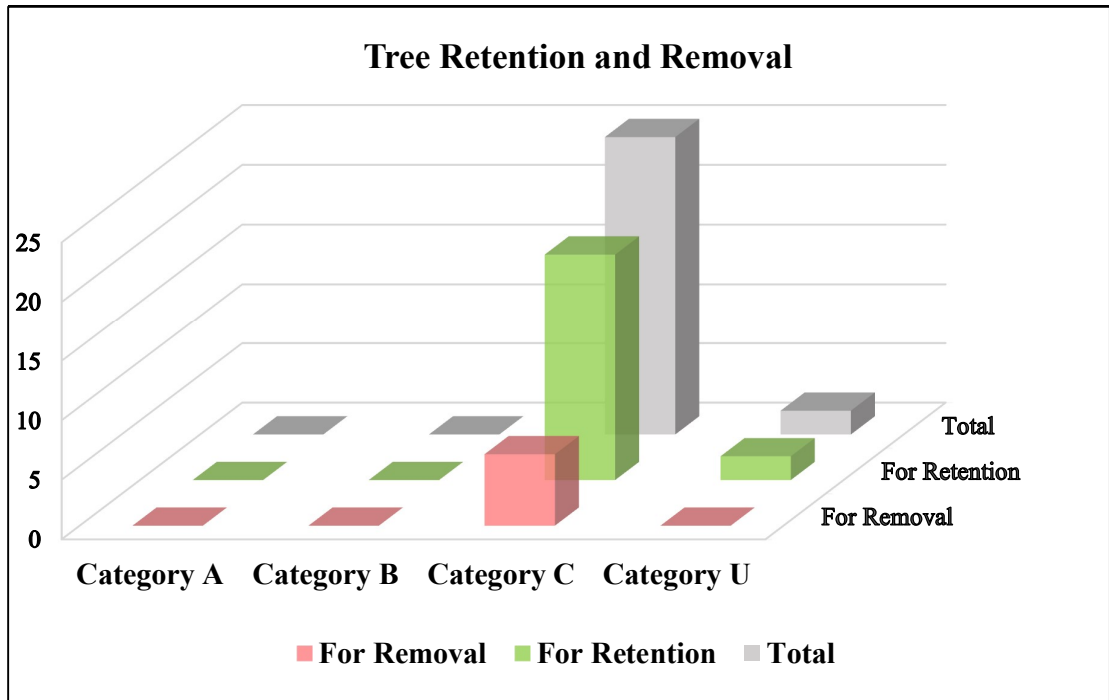
Fig 5 Graphic Representation of Tree Loss/Retention Scenario

12.2 While most poor-quality category “U” trees would be removed regardless of development, note is made that the only two “U” category trees recorded as adjoining the site, are positioned outside of the “red line” area and thus beyond the jurisdiction of the developer.
