**Title: QUALITY AUDIT  
INCLUDING ROAD SAFETY AUDIT (Stage 1)  
For;  
Proposed Residential Development and Road Upgrade,  
Boherboy, Saggart, Co. Dublin.**

**Client: Pinnacle Consulting Engineers.**

**Date: September 2021**

**Report reference: 1151R01**

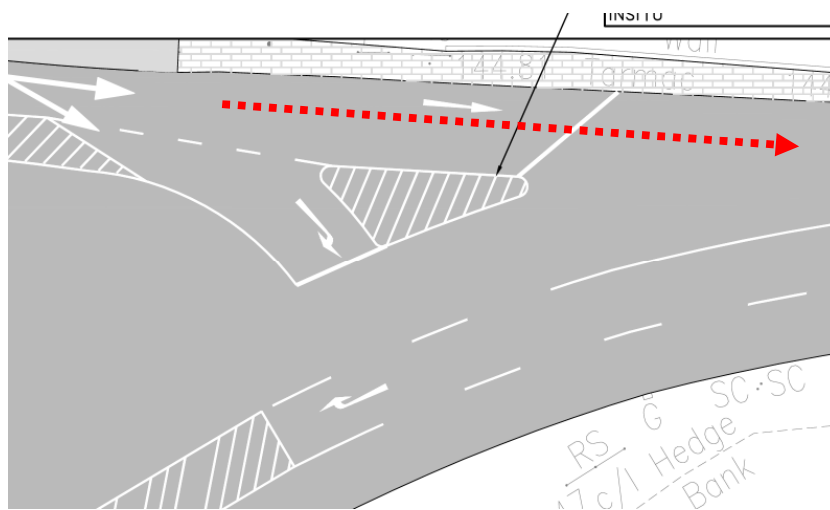
Drawing p200107X-PIN-XX-Dr-D-0011-SI Rev P01

There is a risk of overshoot of the stop line at the N81 junction for eastbound drivers on Boherboy Road. This could lead to rear end or side-impact collisions with eastbound traffic on the N81. In addition the proposed straight ahead arrow may suggest drivers have priority to proceed.

It is recommended that a buildout be provided at the existing footpath into which some signage or other feature be provided to alert drivers that it is not a through route and which will force drivers to approach the N81 at a less acute angle. The straight ahead arrow should be removed.

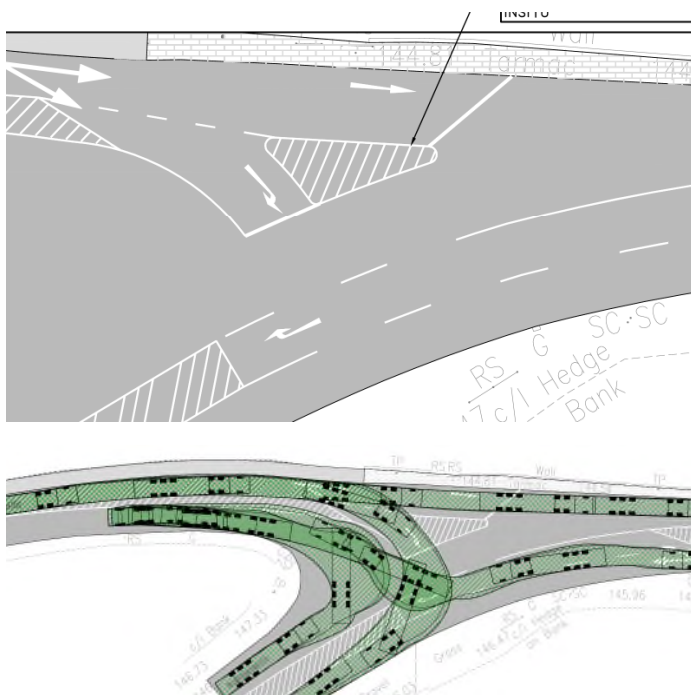
Drawing p200107X-PIN-XX-Dr-D-0011 & 0014-SI Rev P01

It is proposed to provide a hatched area between the right turning and ahead lanes at the N81 junction. There is a risk that the road markings will become faded over time due to the tyre forces from the turning movements of vehicles. This will lead to a junction without adequate definition which would result in drivers taking the incorrect position and causing side-swipe collisions.

It is recommended that a solid island be provided in lieu of the hatched area.

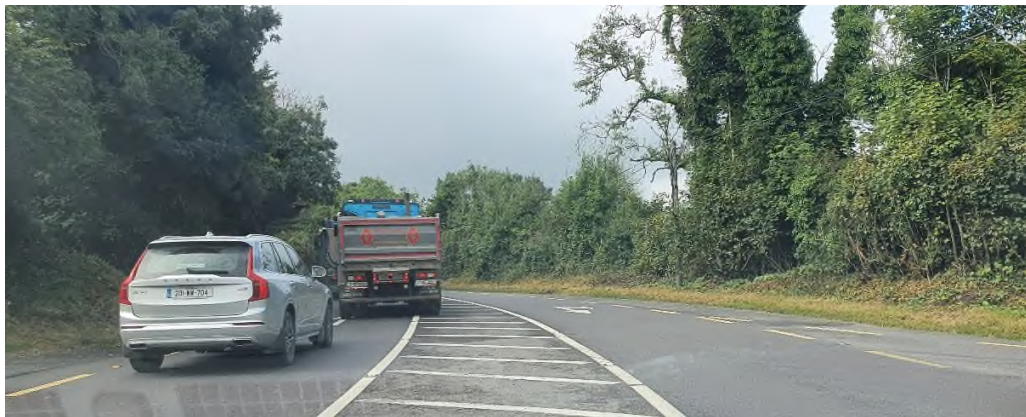
Drawing p200107X-PIN-XX-Dr-D-0011-SI Rev P01

Due to the tight radius horizontal bend on the N81 at the junction with Boherboy Road a driver in the right turning lane has limited forward visibility to oncoming eastbound traffic on the N81 if there are other vehicles travelling westbound. This lack of visibility could lead to side-impact collisions.

It is recommended that a gateway/transition type feature be provided at the 60/80km/hr transition on the N81 to ensure vehicle speeds at the junction are at or below the speed limit of 60km/hr.

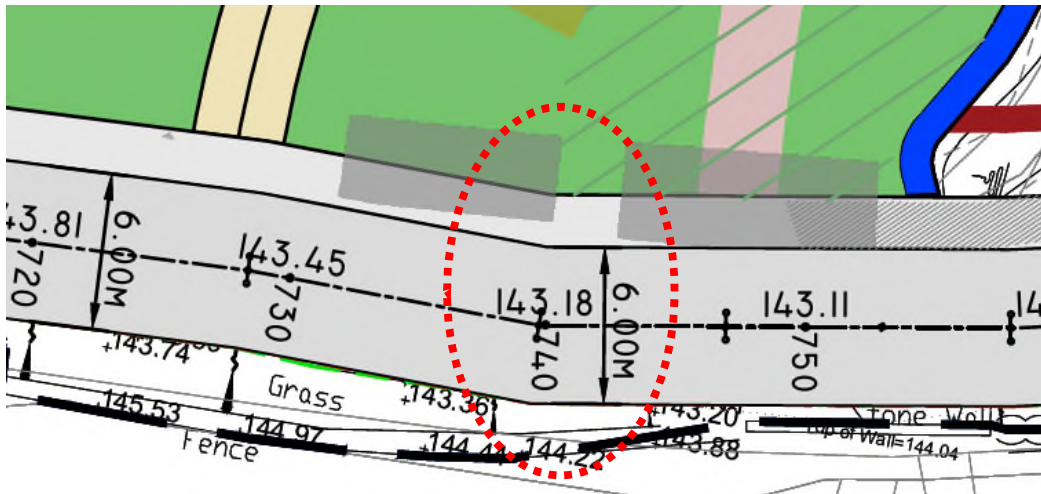
Drawing p200107X-PIN-XX-Dr-D-0011-SI Rev P01, Boherboy Road, Chainage 740

There is a 'kink' in the horizontal alignment of Boherboy Road at chainage 740. This could lead to overrun of the centre line and side-swipe collisions.

Ensure there is a smooth horizontal alignment with a series of curves of suitable radii be provided without straight sections joining.

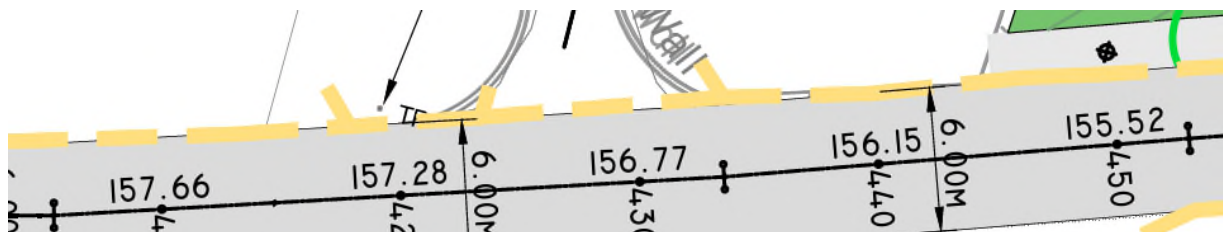
Drawing p200107X-PIN-XX-Dr-D-0011-SI Rev P01, Boherboy Road, Chainage 70 to chainage 440.

There is a discontinuity in the footway provision on Boherboy Road between chainage 70 and Chainage 440 due to land ownership constraints. The road is being realigned and widened to have a constant cross sectional width of 6m. There is a risk that the proposed development will lead to an increased usage of Boherboy Road by pedestrians wishing to travel to Saggart village, leading to a higher likelihood of a collision with vehicular traffic. It is proposed to provide a raised rib line along the section without a footway. There is a risk that the raised rib line will not be provided due to the noise effects on local residents.

It is recommended that the carriageway be marked narrower than 6m and that the verge be provided flat and level with the carriageway so that pedestrians will have refuge. In areas of wider road bed, vegetation should be cleared to provide additional refuge.

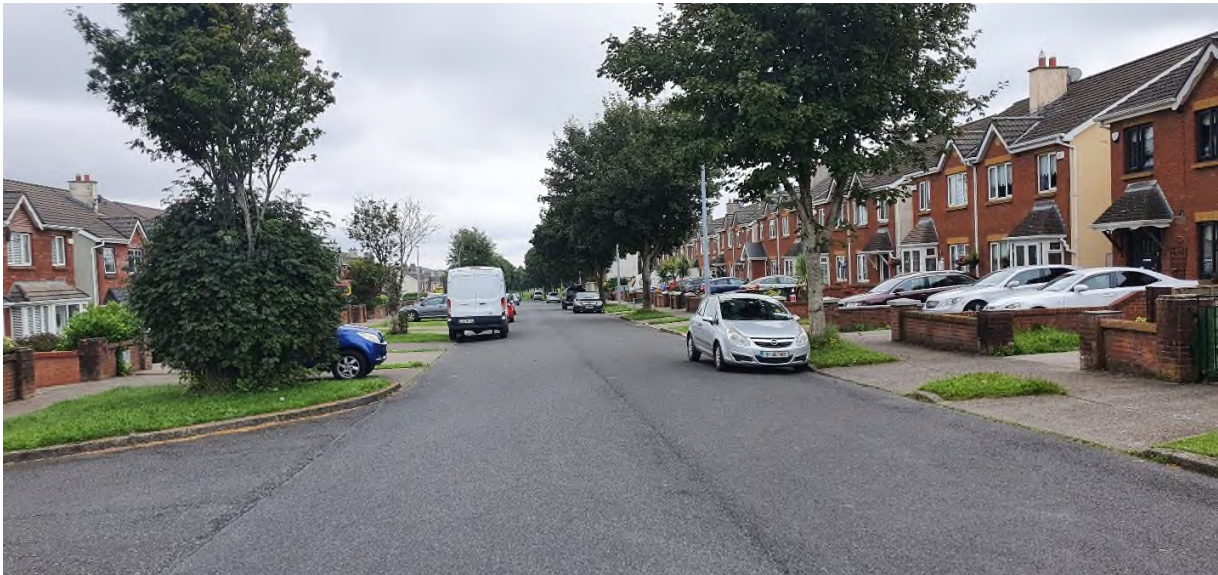
Drawing p200107X-PIN-XX-Dr-D-0013-SI Rev P01, Corbally Heath & Carriagmore Green.

It was observed during the site visit that there is extensive on-street parking on Corbally Heath & Carriagmore Green to which the proposed development will be linked for vehicular traffic. Whilst the on-street parking provides traffic calming effects in the current scenario this may result in driver frustration and side-impact collisions as these routes become more intensely used when the development is fully occupied.

It is recommended that an assessment of the amount of on-street parking be undertaken along with the current under usage of on-curtilage parking to establish if the problem as described above will manifest itself.

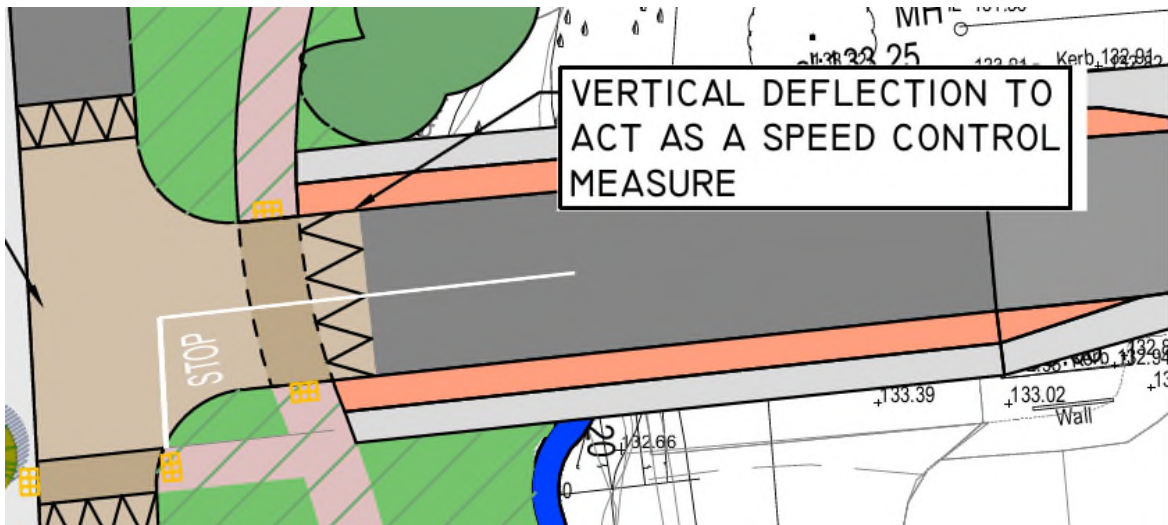
Drawing p200107X-PIN-XX-Dr-D-0032-SI Rev P01, Corbally Heath

It is proposed to provide a shorth length of cycle track at the connection to Corbally Heath. There are no dedicated cycle facilities either side of this short section. This could lead to cyclists weaving into and out of traffic and sharing space with pedestrians that are not wide enough for both users.

It is recommended that the short section of cycle track be omitted.

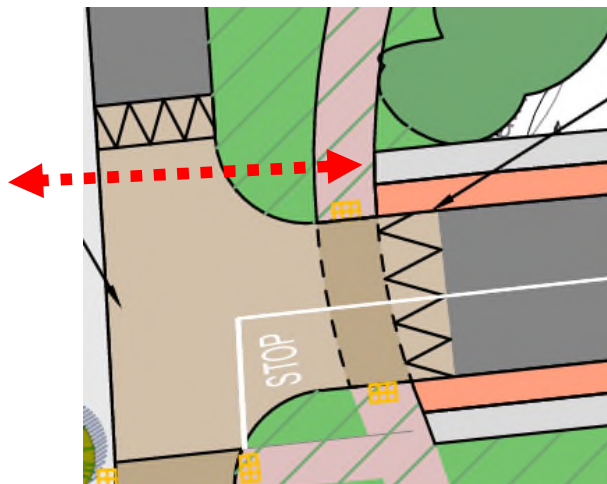
Drawing p200107X-PIN-XX-Dr-D-0032-SI Rev P01, Corbally Heath

There will be a pedestrian desire line from the footpath on the northern side of Corbally Heath to the footpath on the opposite side of the internal development road.

It is recommended that a pedestrian crossing similar to the south side of the junction be provided.

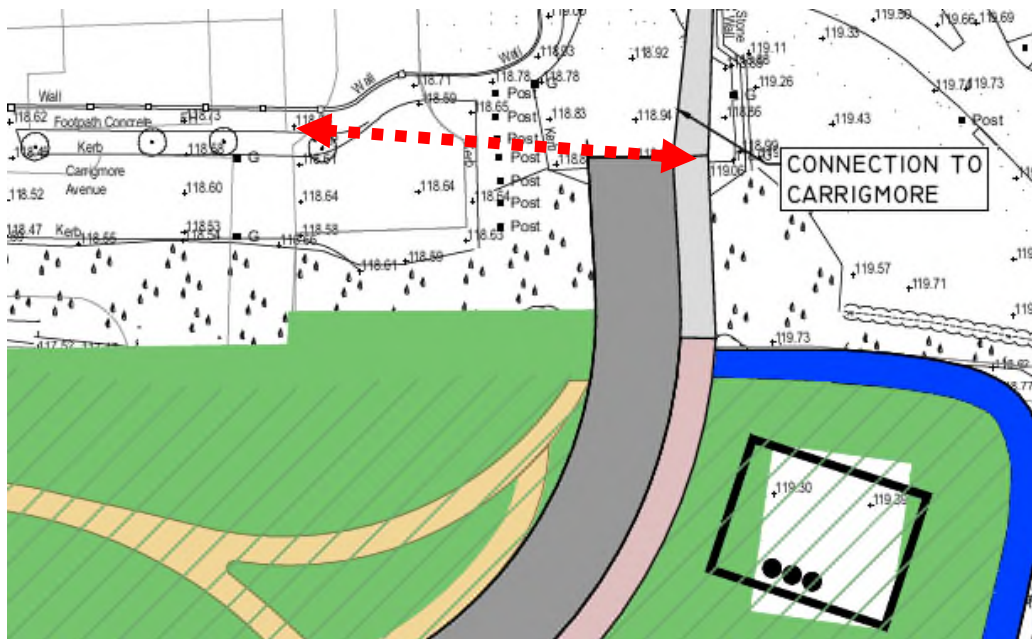
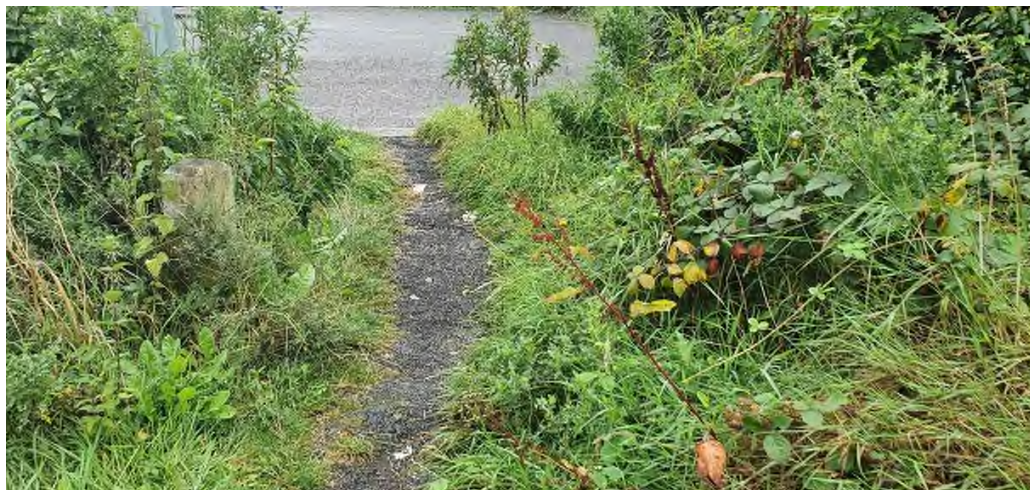
Drawing p200107X-PIN-XX-Dr-D-0033-SI Rev P01, Carraigmore.

There is an existing pedestrian desire line from Carraigmore Green to Carraigmore Avenue. The demand will increase when the proposed development is fully occupied and this pedestrian desire line should be facilitated as an alternative pedestrian route to Saggart village rather than Boherboy Road.

It is recommended a pedestrian link to Carraigmore Avenue be provided.

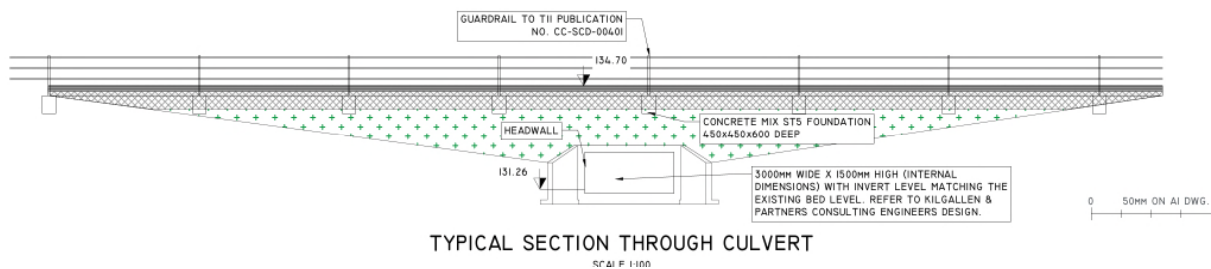
Drawing p200107X-PIN-XX-Dr-D-0034-SI Rev P01, Culvert protection.

A railing in accordance with TII Standard Detail CC-SCD-00400 has been referred to on the drawing as containment at the bridge structures. It is unclear if this will provide adequate containment to errant vehicles.

It is recommended a risk assessment be carried out to ensure sufficient containment is being provided at the bridges/culverts.
