Appendix 14.1

Scheme Walkover Summary

Appendix A14.1: Scheme Walkover Summary

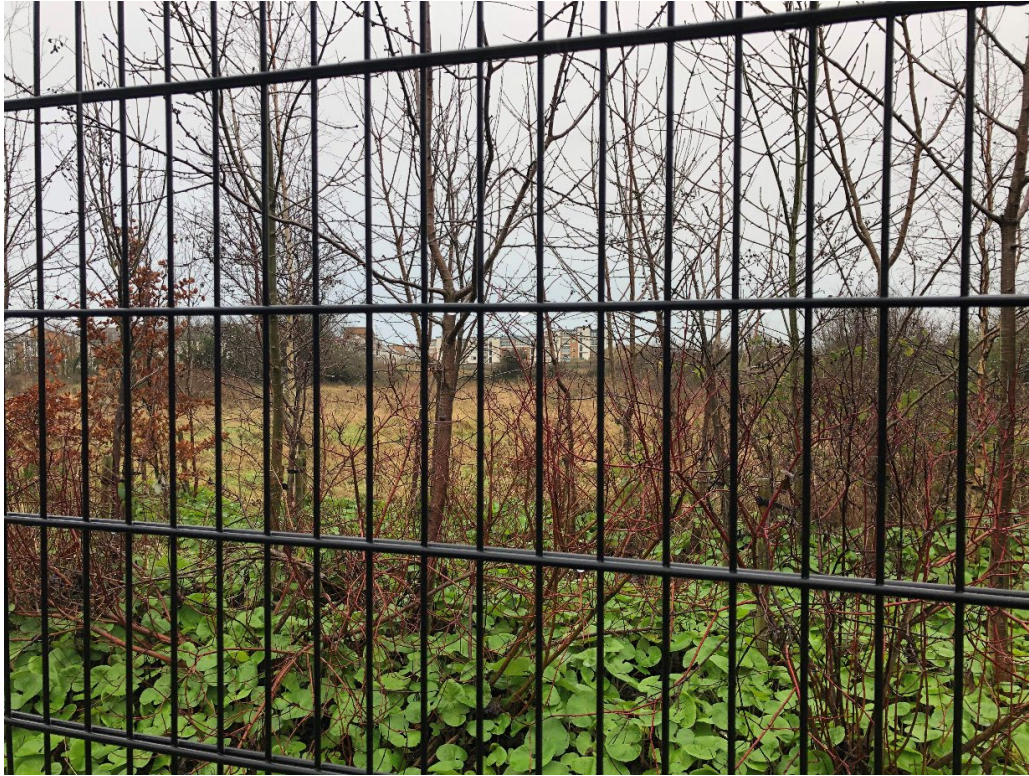
Photo ID	Caption	Date Taken	Coordinates
Clongriffin_image05	Overgrown area with bunds of potential made ground	14/01/2020	721177, 740715 (ITM)

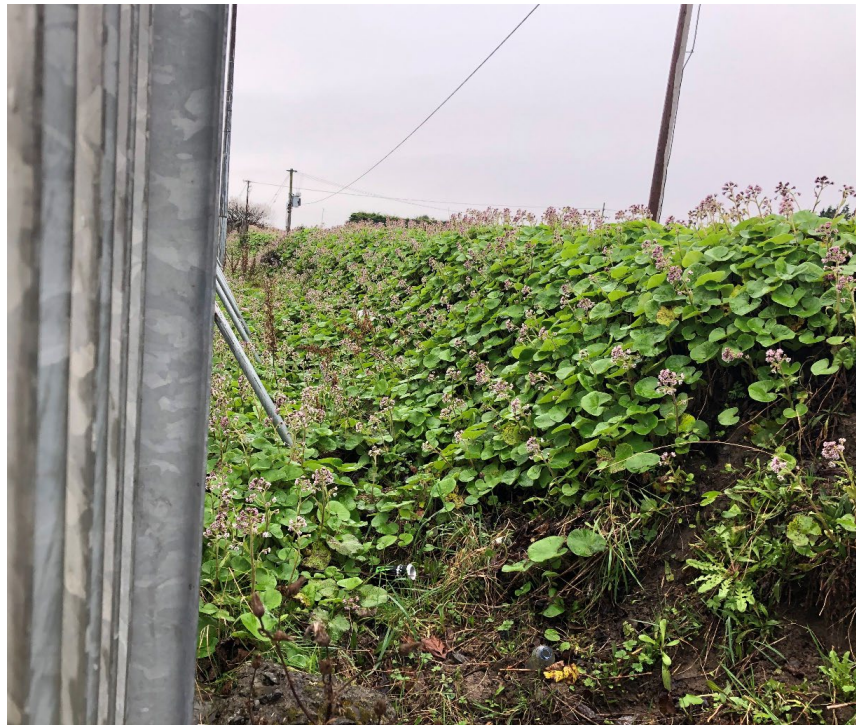
Photo ID	Caption	Date Taken	Coordinates
Clongriffin_image06	Image of raised verge along Malahide Road	14/01/2020	721079, 740717 (ITM)

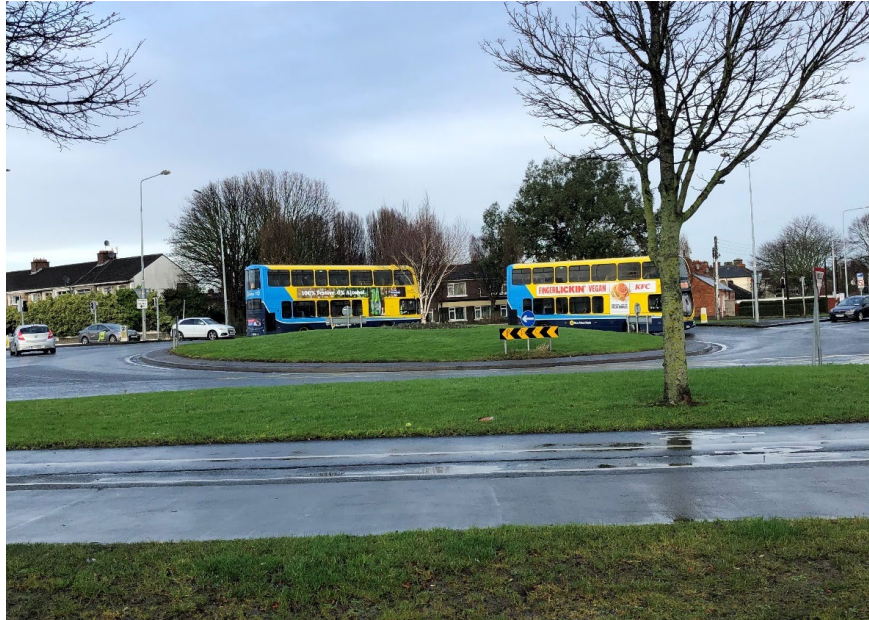
Artane Roundabout	Sheet 13 & 14	There is a notable level change at the roundabout. There will be earthworks required to achieve the proposed road levels.	This may pose an issue for the earthworks balance and waste assessment.	Clongriffin_image10
Old River	Sheet 13 & 14	Old river south of Artane Roundabout, which can be seen on the 25inch Historic Map at present day Mornington Grove. This is associated with a strip of alluvial deposits, so it may impact road design. However, no evidence of this old river was encountered during the site walkover.	This may pose an issue for the earthworks balance due to the requirement to excavate soft ground and creating a pathway to groundwater.	N/A
Donnycarney Bridge	Sheet 17	The proposed scheme passes over the Donnycarney bridge at this location which allows access over the culverted River Wad. In addition, there is a petrol station close to Donnycarney Bridge which may also be a potential source of contamination.	This may pose an issue for the earthworks balance and waste assessment and mobilising contaminants into the groundwater.	Clongriffin_image19 and Clongriffin_image20.

Photo ID	Caption	Date Taken	Coordinates
Clongriffin_image10	Image of raised verge along Malahide Road and surrounding the Roundabout; also note raised mound on roundabout	14/01/2020	719432, 738473 (ITM)

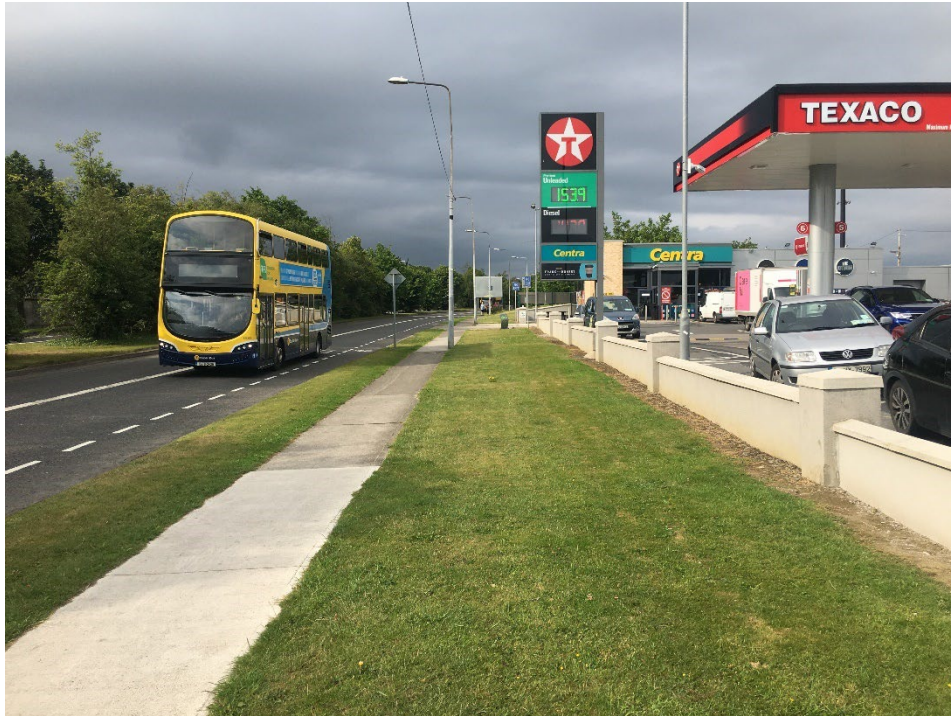
Alternative cycle route	Sheets 20 & 21	This route is considered an alternative to the current cycle route outlined in the drawings.	This may pose an issue for the earthworks balance and waste assessment.	Clongriffin_image21
Petrol stations	Sheet 09, 14 & 17	Two petrol stations are located along the Malahide Road and a third located near Donnycarney. A disused petrol station is also located opposite Belcamp Lane. Historic activities at petrol stations may have resulted in oil leaks into the surrounding soils and groundwater in the past.	This may pose an issue for the earthworks balance and waste assessment and mobilizing contaminants into the groundwater.	Clongriffin_image16, 17 and 18

Photo ID	Caption	Date Taken	Coordinates
Clongriffin_image16	Image of Texaco Service Station on Malahide Road.	09/07/2021	720492, 739951 (ITM)

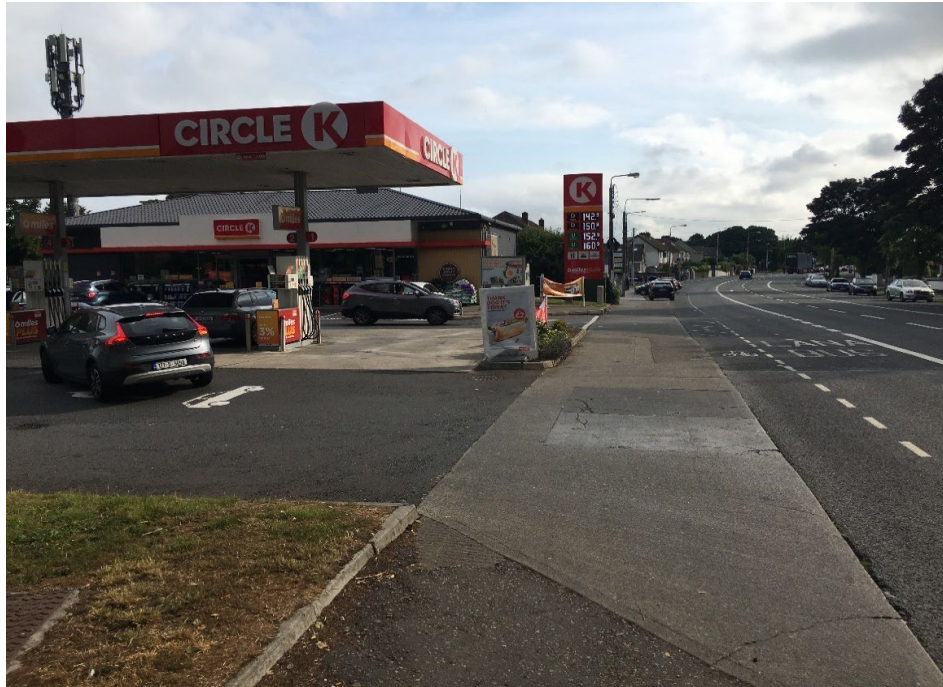
Photo ID	Caption	Date Taken	Coordinates
Clongriffin_image17	Image of Circle K Artane Service Station on Malahide Road	09/07/2021	719210, 738352 (ITM)

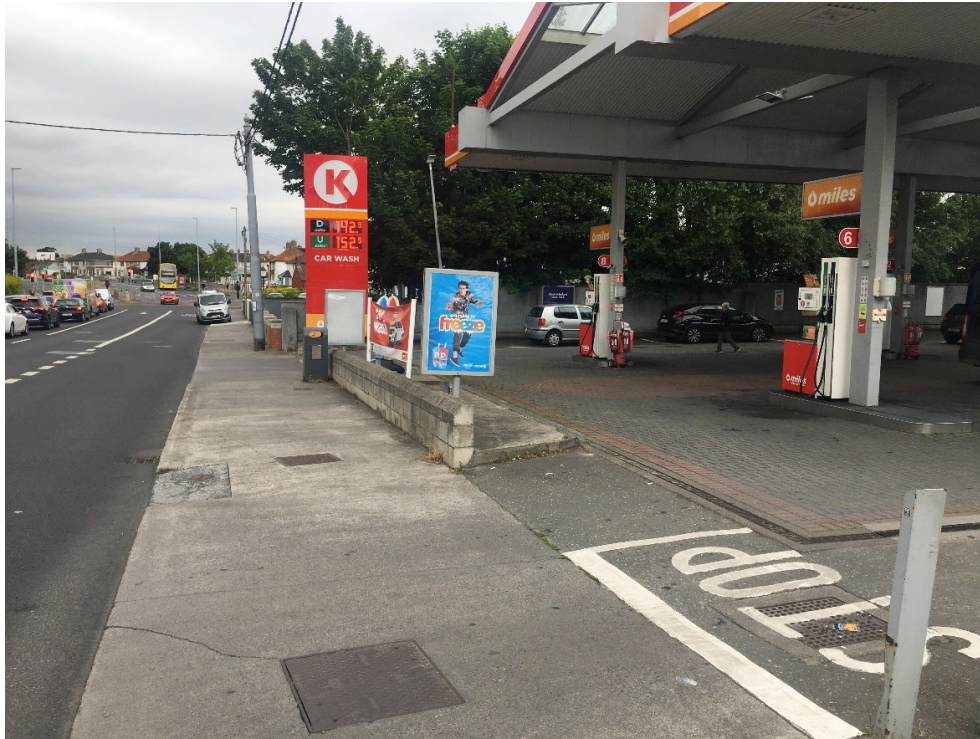
Photo ID	Caption	Date Taken	Coordinates
Clongriffin_Image18	Image of Circle K Maypark Service Station at Donnycarney.	09/07/2021	718565, 737699 (ITM)

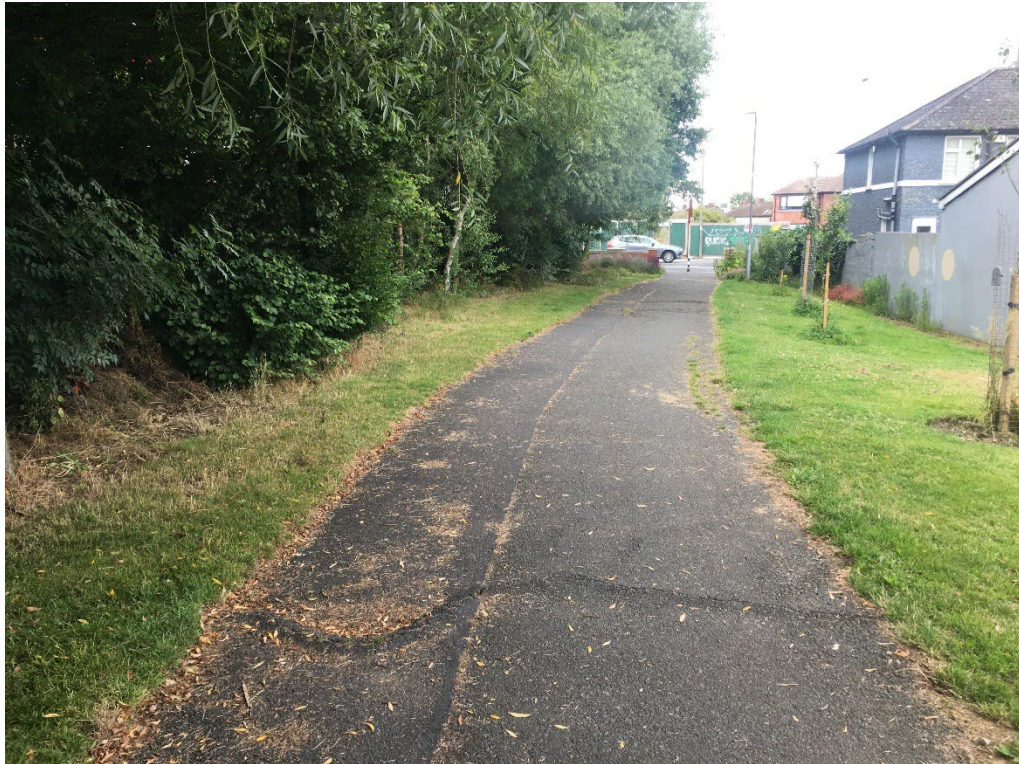
Photo ID	Caption	Date Taken	Coordinates
Clongriffin_Image19	Image of the location of the culverted River Wad at Donnycarney Bridge.	09/07/2021	718544, 737691 (ITM)

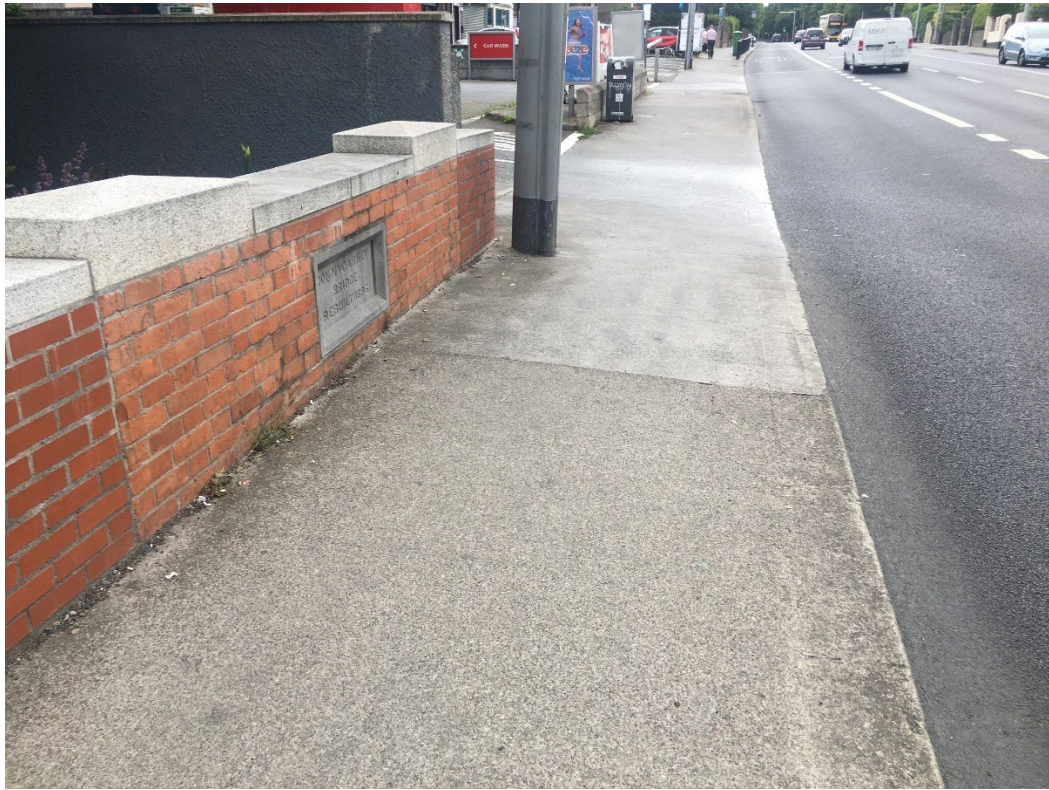
Photo ID	Caption	Date Taken	Coordinates
Clongriffin_Image20	Image of Donnycarney Bridge.	09/07/2021	718564, 737678 (ITM)

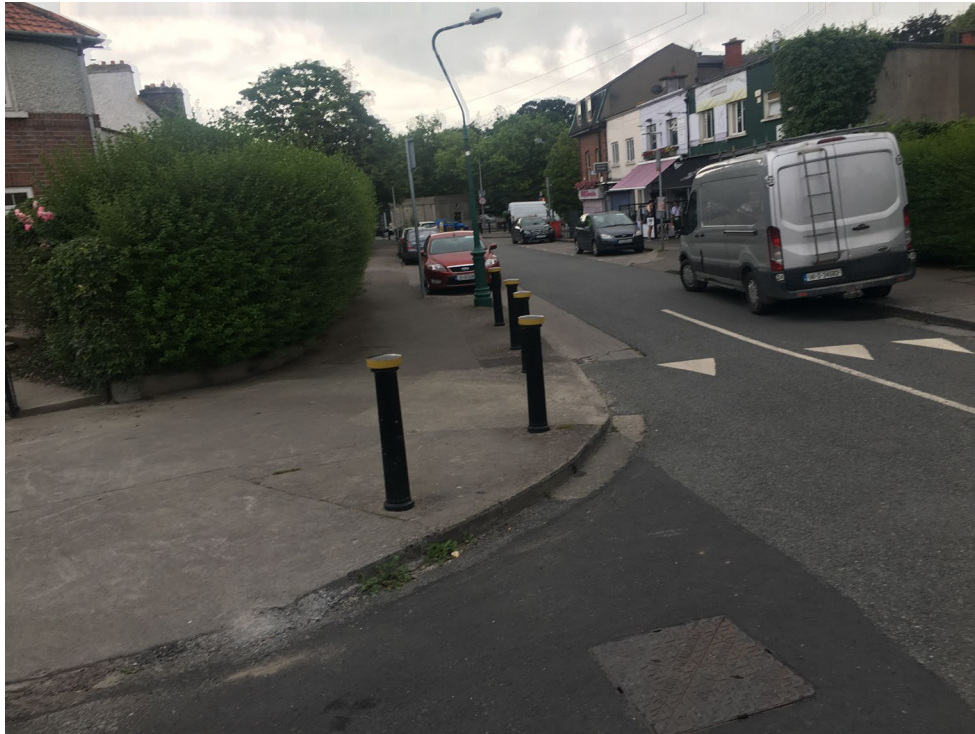
Photo ID	Caption	Date Taken	Coordinates
Clongriffin_Image21	Image of the proposed alternative cycle road near St. Aidan's Park	09/07/2021	717769, 736445 (ITM)
