ASBESTOS R&D SURVEY REPORT

LIMERICK TRANSPORT,
PARK RD, RHEBOGUE,
LIMERICK,
IRELAND

R&D ASBESTOS SURVEY REPORT

Reference: REPORT-230119MG-V1					
Issue		Prepared by	Reviewed by	Verified by	
V1	5 th February 2019

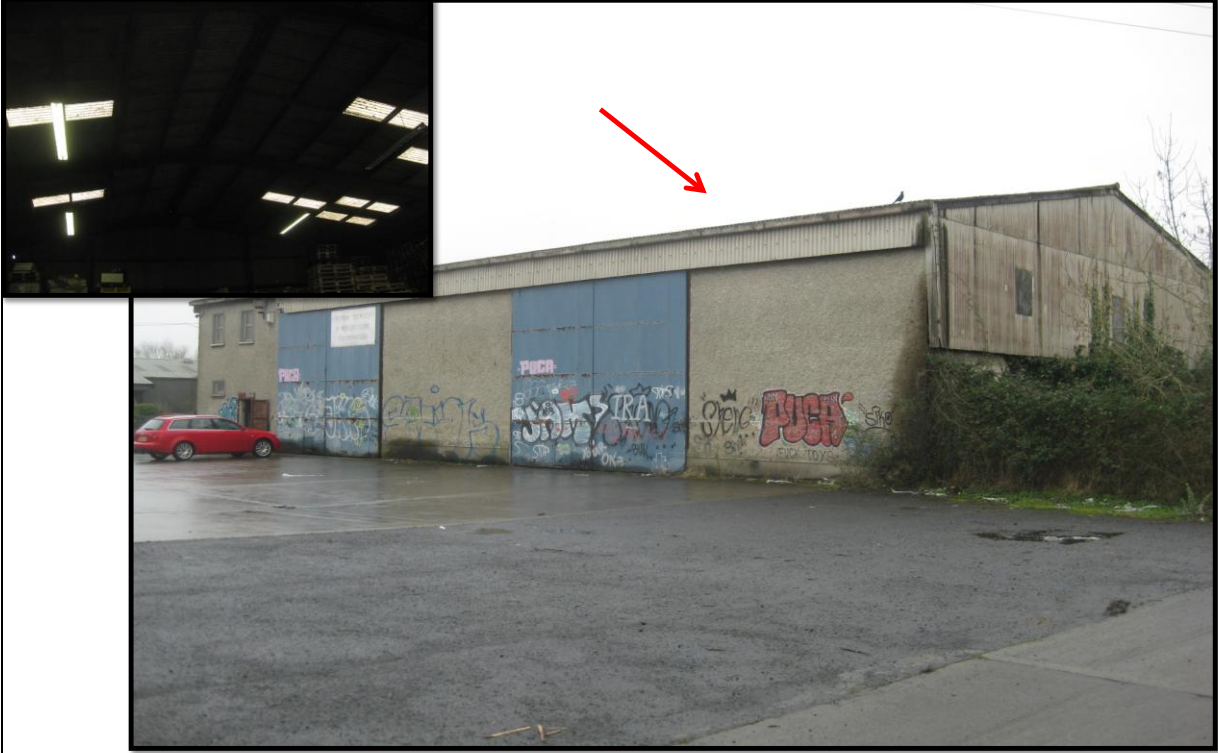
2019 R&D Survey Number	1	Reference number	230119MG01
Inspection / Sample	Sample	Inspection Cross Reference / Visual I.D.	Not Applicable

Notes	Big 6 single skin roof sheeting - Fixed to metal purlins with J bolts - Consider all of the ridge tiles and edge flashing panels as being asbestos cement and remove as ACM - 26 fibreglass skylight panels on the roof.

Building	Limerick Transport	Condition	Low Damage	1
Floor Level	Roof	Surface Treatment	Enclosed lagging, encapsulated AIB, Cement, Paper, Textiles, Gaskets, Seals	1
Location	Main Apex roof	Material Friability	Low	1
Feature	Grey Corrugated Panels	Asbestos Type	Chrysotile (White)	1
Material Type	Cement	Accessibility	Medium	
Extent	700 sq. m.	Position	External	
Recommendation	Remove using Competent contractor	Assessment Score	4	
		Assessment Band	Very Low Risk

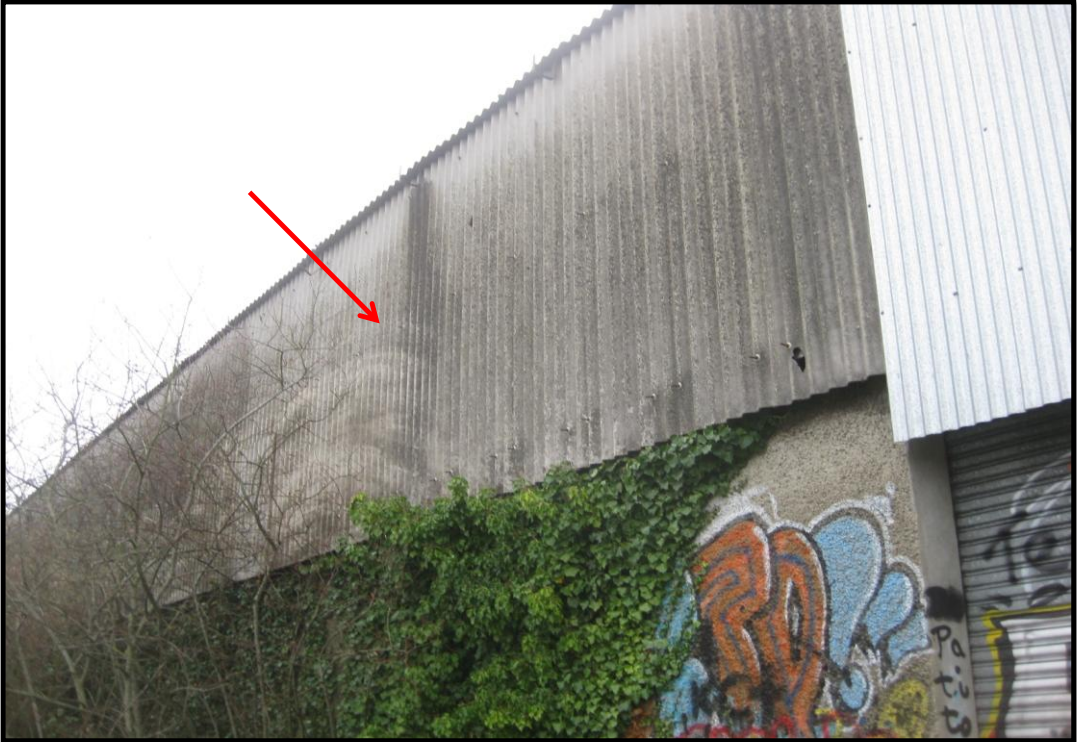
2019 R&D Survey Number	3	Reference number	230119MG03
Inspection / Sample	Inspection	Inspection Cross Reference / Visual I.D.	230119MG02

Notes	Corrugated Big 6 panels covering upper section of rear wall - some damage and section at one corner has been replaced with metal corrugated sheeting. Consider all of the edge flashing panels as being asbestos cement and remove as ACM Fixed to metal purlins with J bolts

Building	Limerick Transport	Condition	Low Damage	1
Floor Level	External	Surface Treatment	Enclosed lagging, encapsulated AIB, Cement, Paper, Textiles, Gaskets, Seals	1
Location	Rear wall High Level	Material Friability	Low	1
Feature	Grey Corrugated Panels	Asbestos Type	Strongly Presumed Chrysotile (White)	1
Material Type	Cement	Accessibility	High	
Extent	110 sq. m.	Position	External	
Recommendation	Remove using Competent contractor	Assessment Score	4	
		Assessment Band	Very Low Risk

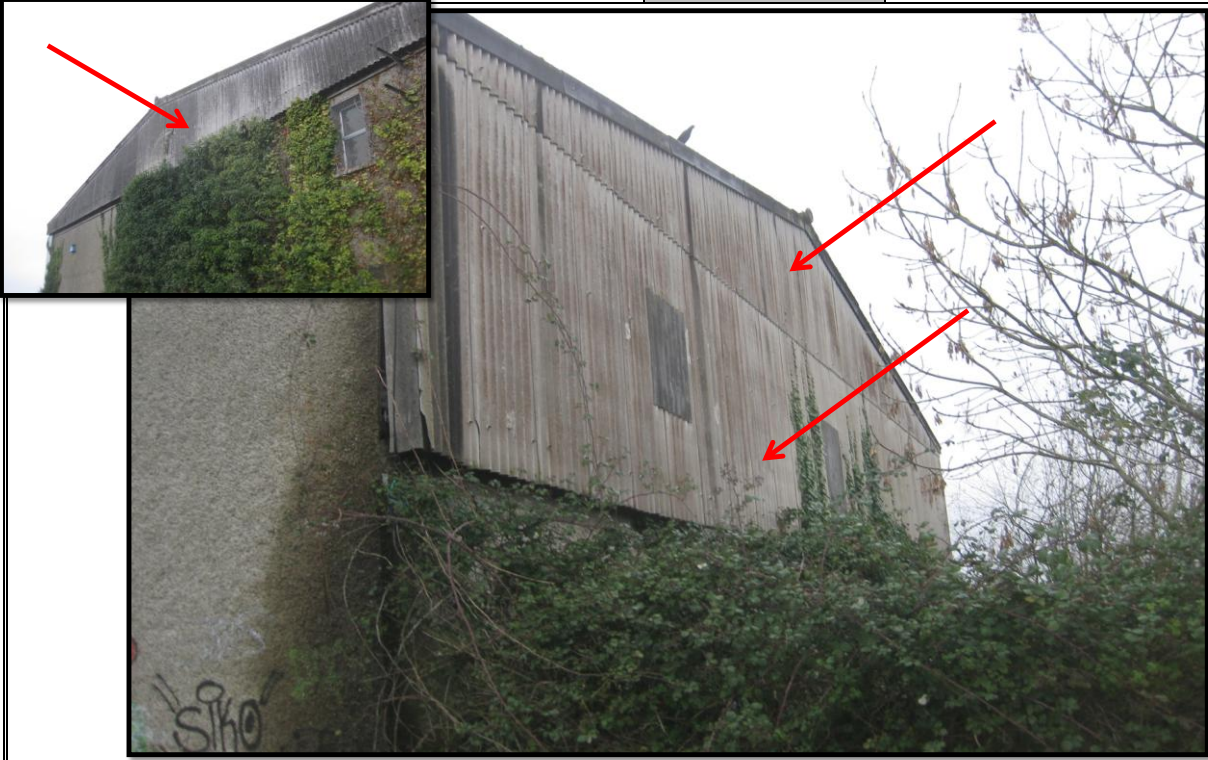
2019 R&D Survey Number	4	Reference number	230119MG04
Inspection / Sample	Inspection	Inspection Cross Reference / Visual I.D.	230119MG02

Notes	Corrugated Big 6 panels covering upper section of rear wall and roof gable on RHS with the LHS only having the roof gable covered with corrugated sheeting. Consider all of the edge flashing panels as being asbestos cement and remove as ACM - Fixed to metal purlins with J bolts

Building	Limerick Transport	Condition	Low Damage	1
Floor Level	External	Surface Treatment	Enclosed lagging, encapsulated AIB, Cement, Paper, Textiles, Gaskets, Seals	1
Location	Gable end walls	Material Friability	Low	1
Feature	Grey Corrugated Panels	Asbestos Type	Strongly Presumed Chrysotile (White)	1
Material Type	Cement	Accessibility	Medium	
Extent	80 sq. m.	Position	External	
Recommendation	Remove using Competent contractor	Assessment Score	4	
		Assessment Band	Very Low Risk

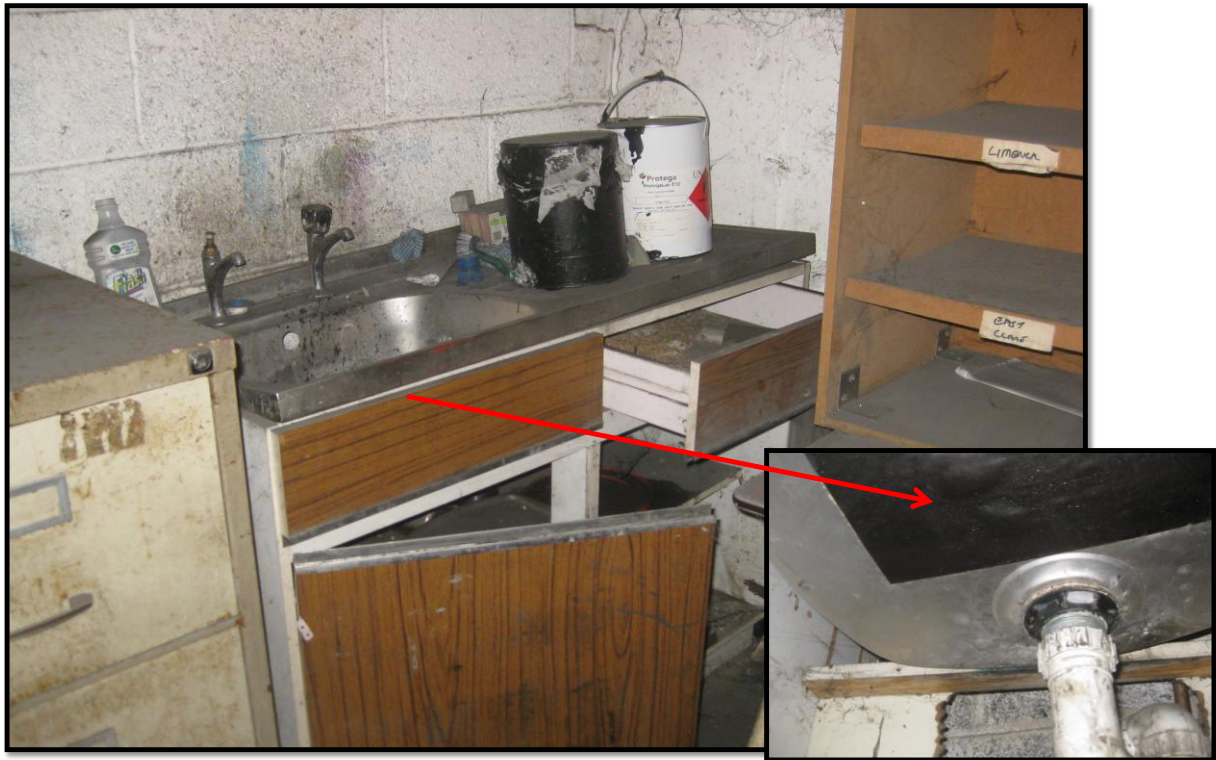
2019 R&D Survey Number	6	Reference number	230119MG06
Inspection / Sample	Sample	Inspection Cross Reference / Visual I.D.	Not Applicable

Notes	Bitumen acoustic pads on underside of stainless steel sink unit.
-------	--

Building	Limerick Transport	Condition	Low Damage	1
Floor Level	Ground	Surface Treatment	Composite materials, reinforced plastics, resins, vinyl tiles, Bitumen.	0
Location	Kitchen	Material Friability	Low	1
Feature	Sink unit acoustic pads	Asbestos Type	N.A.D.I.S	0
Material Type	Bitumen	Accessibility	High	
Extent	2 No.	Position	Internal	
Recommendation	No asbestos detected no further action required	Assessment Score	0	
		Assessment Band	E

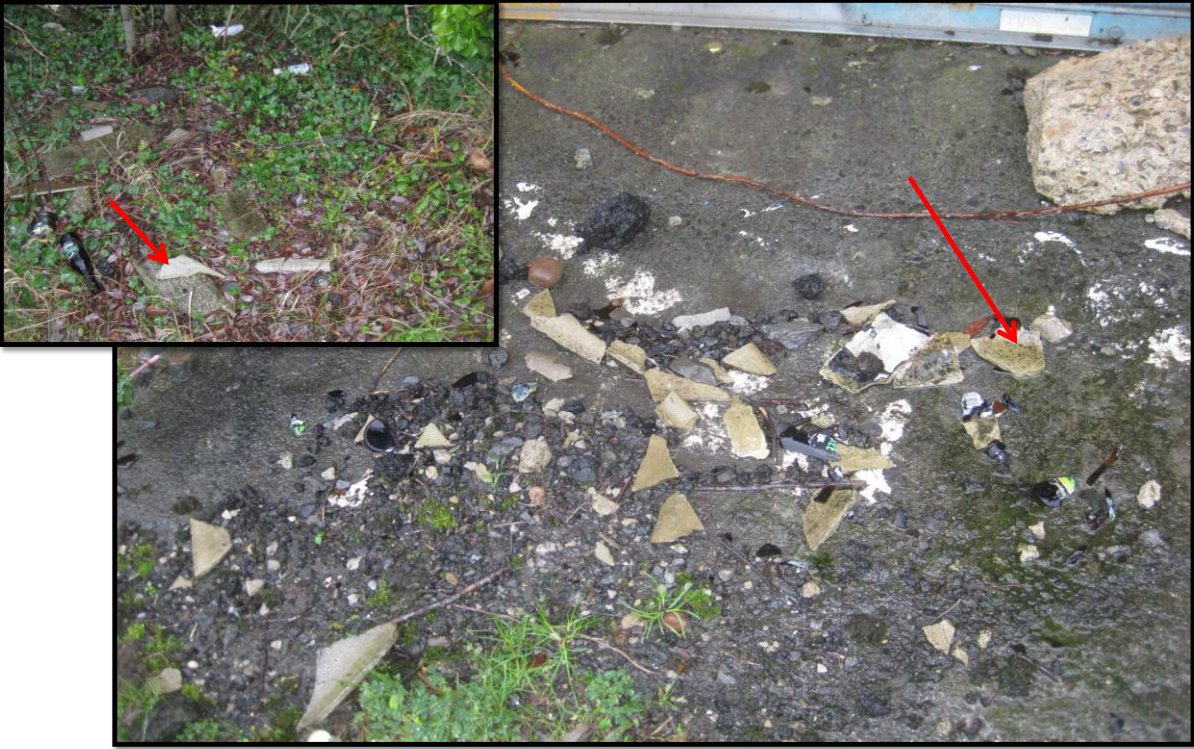
2019 R&D Survey Number	8	Reference number	230119MG08
Inspection / Sample	Inspection	Inspection Cross Reference / Visual I.D.	230119MG02

Notes	On the ground at the rear wall of the building grey fragments identified these are visually similar to big 6 sheeting and box guttering - Heavy vegetation along the length of the wall and RHS gable end prevented full examination of area but damage to sheeting is visible and supports for guttering are in place.

Building	Limerick Transport	Condition	High Damage	3
Floor Level	External	Surface Treatment	Enclosed lagging, encapsulated AIB, Cement, Paper, Textiles, Gaskets, Seals	1
Location	Ground at rear wall	Material Friability	Low	1
Feature	Cement Fragments	Asbestos Type	Strongly Presumed Chrysotile (White)	1
Material Type	Cement	Accessibility	High	
Extent	<25 sq. m.	Position	External	
Recommendation	Remove using Competent contractor	Assessment Score	6	
		Assessment Band	Low Risk

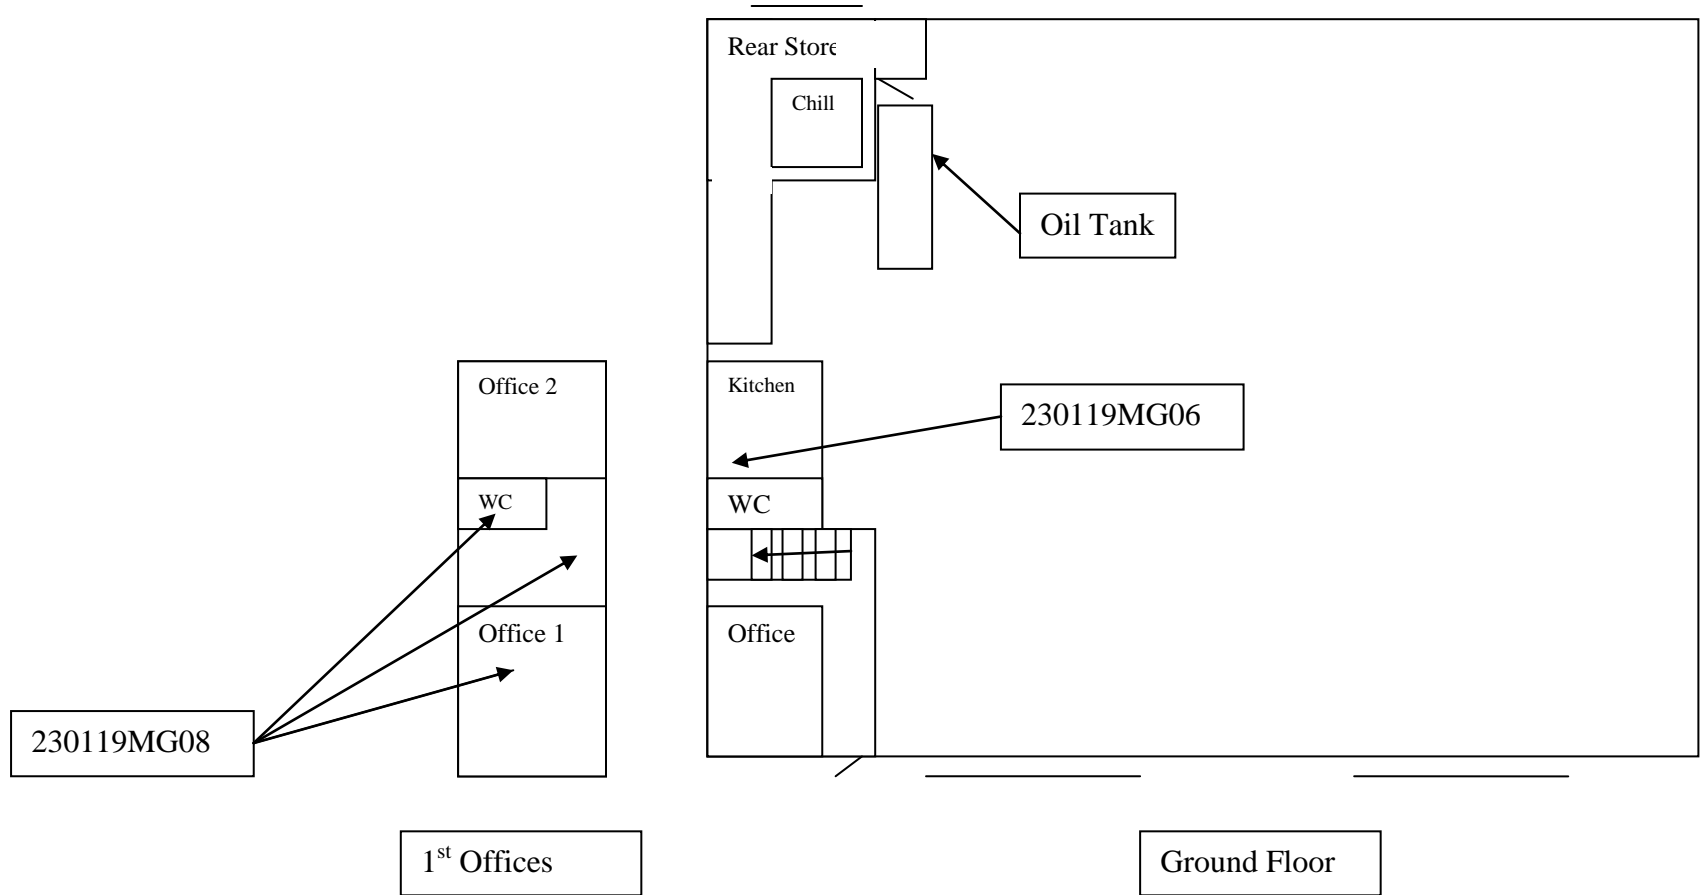
Limerick Transport - Rheboug		Drawing Title	Date	Client	Survey Report Number	Survey Type
Drawing 2 of 2		Internal	04-01-19	Verde Environmental	23-01-19-MG-V1	R&D
Room/ Area Number	OG01	Sample/inspection/presumed= Asbestos Present 01			Sample/inspection = Not Asbestos Containing 01

The tops of the external walls have not been fully examined Ref Section 2.2 of the report
