Historic Building Record
The Farm, Bessboro, Ballinure, Blackrock, Cork City

Prepared by
John Cronin BA MRUP MUBC
John Cronin & Associates
3a Westpoint Trade Centre
Ballincollig
County Cork

February 2022

1. Introduction

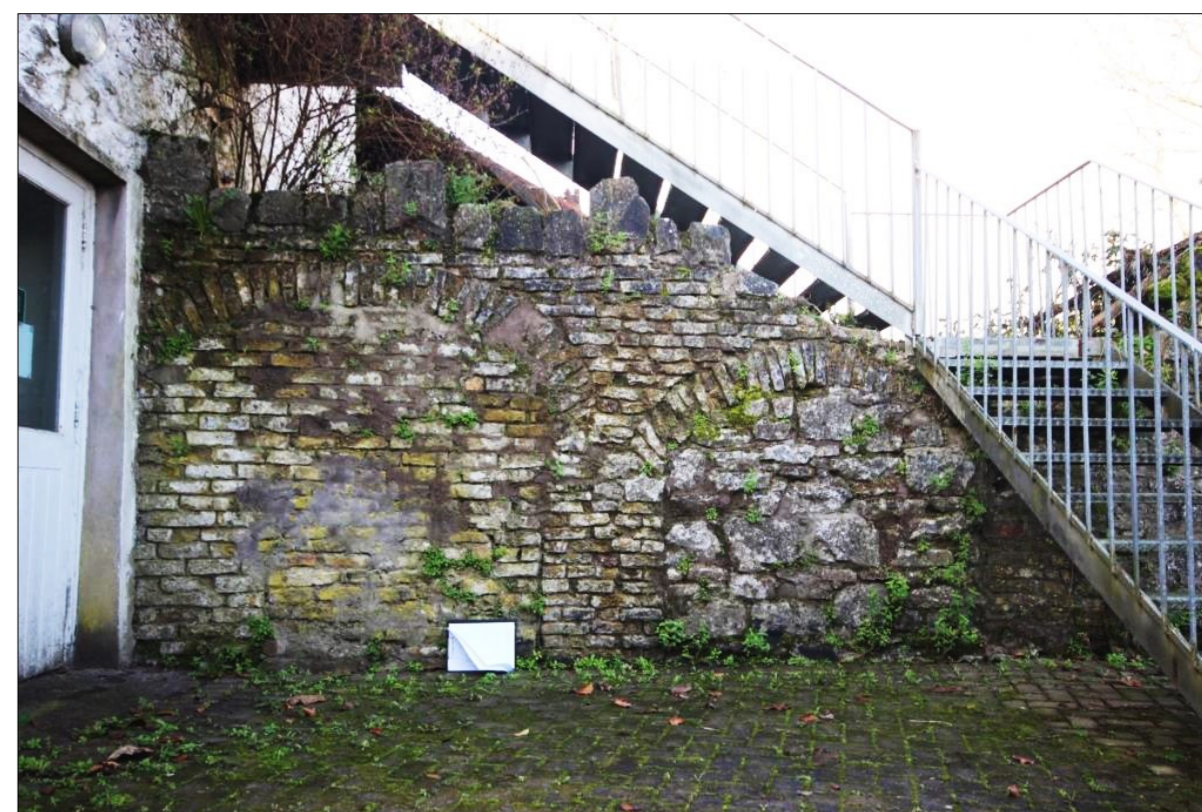
Plate 7: Blocked up brick arches in boundary wall to east of Building A

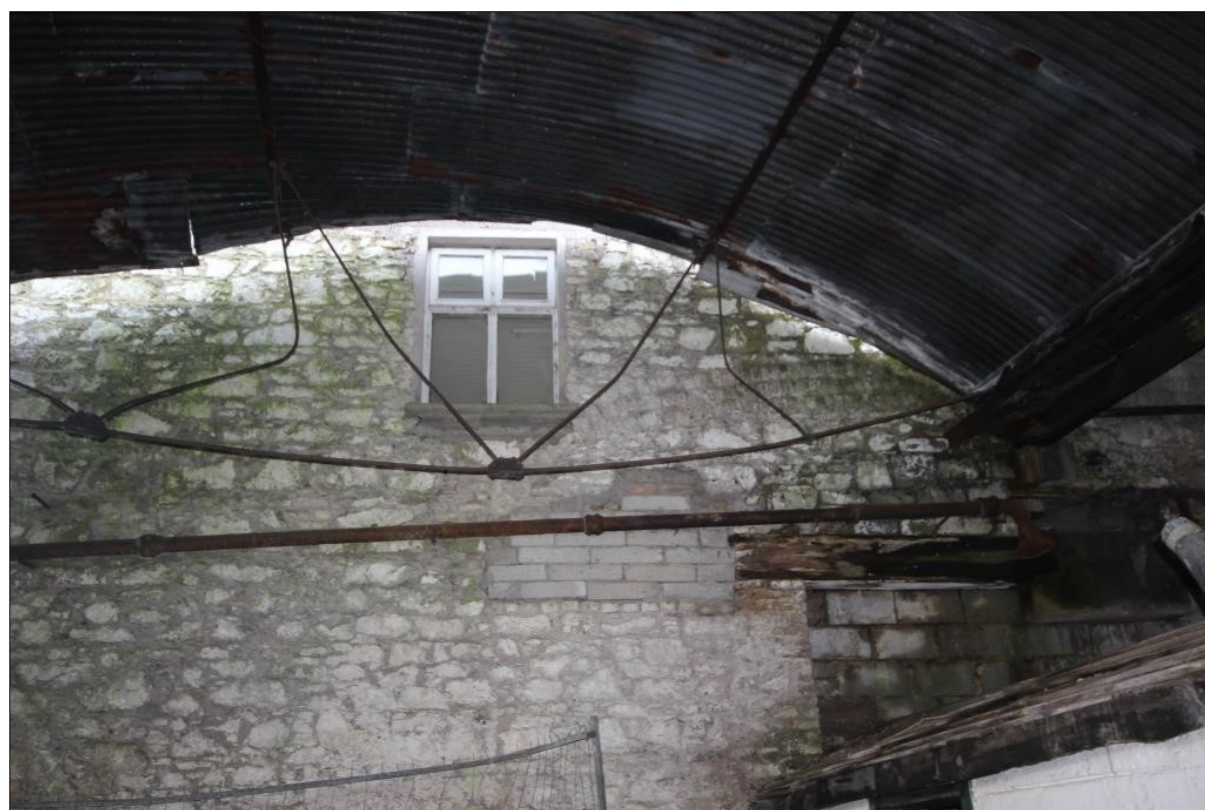
Plate 9: Blocked-up openings in north-western elevation of Building A

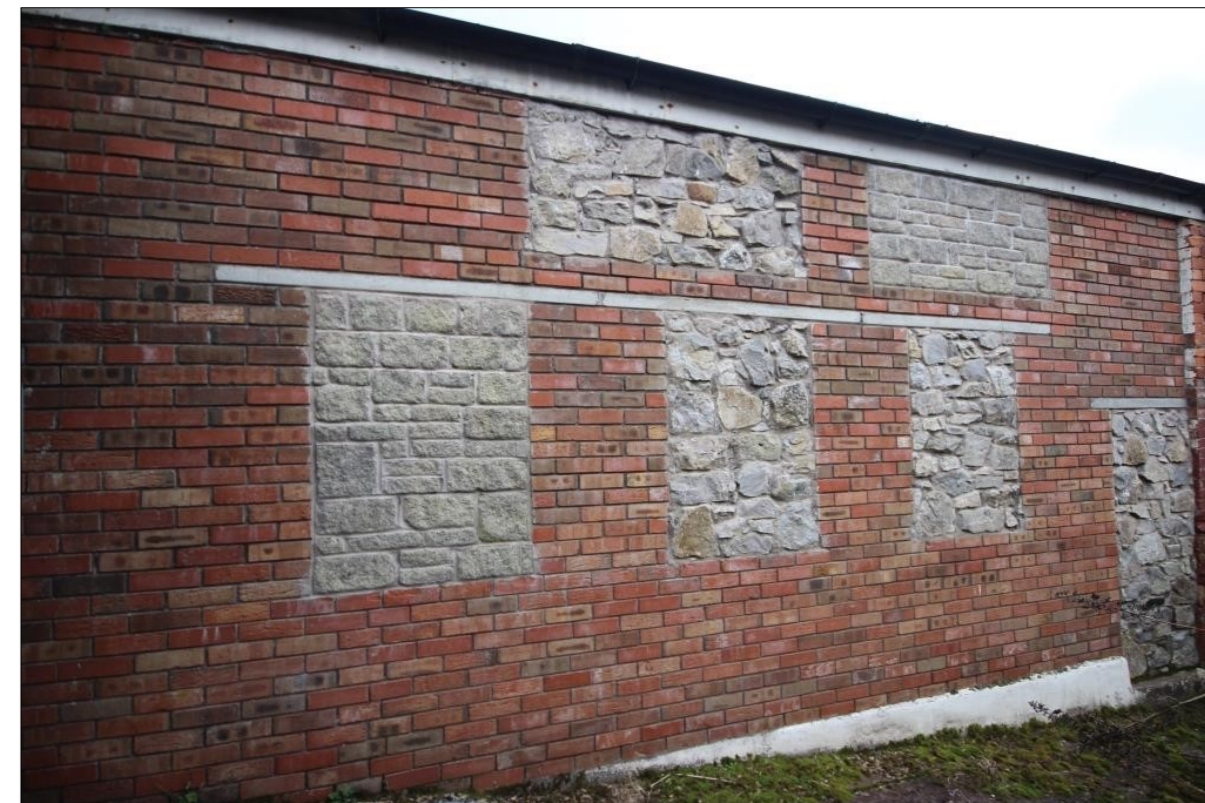
Plate 14: Northern end of western elevation of Building B rebuilt with modern brick and stone finishes

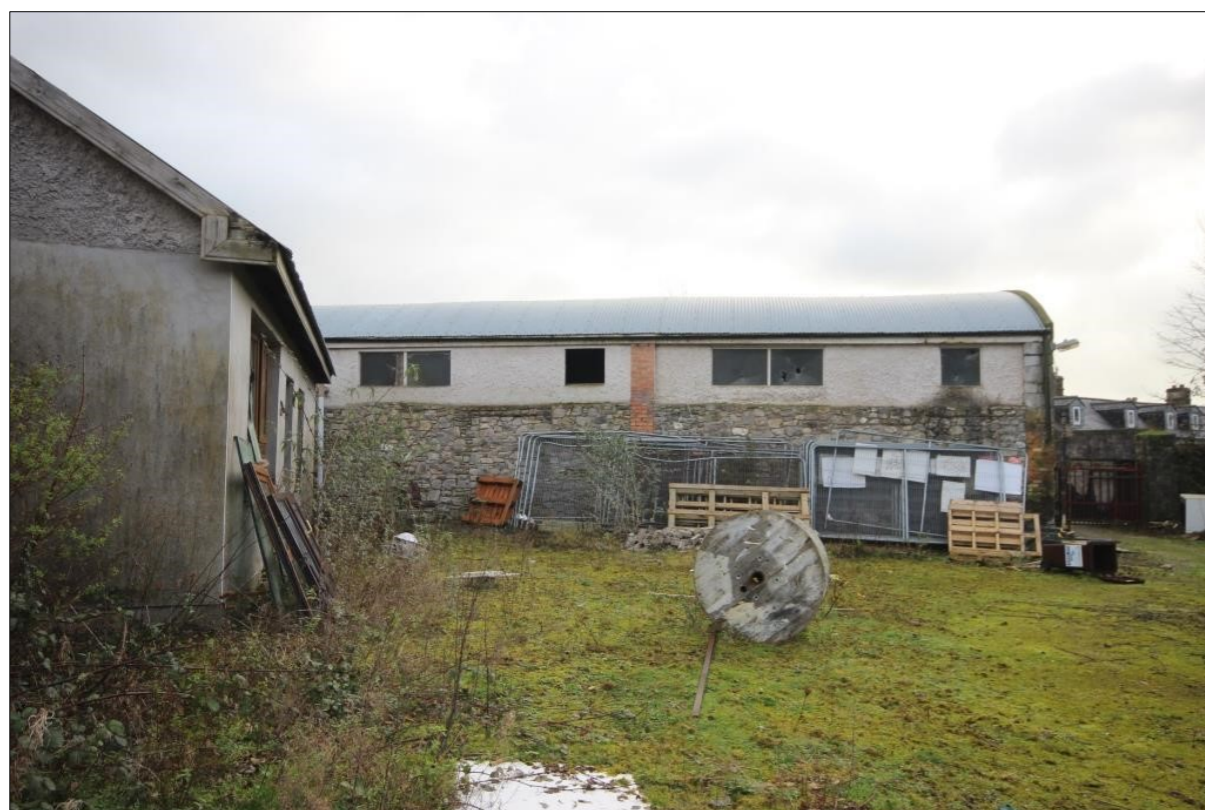
Plate 13: Western elevation of Building B. Note upper section rebuilt

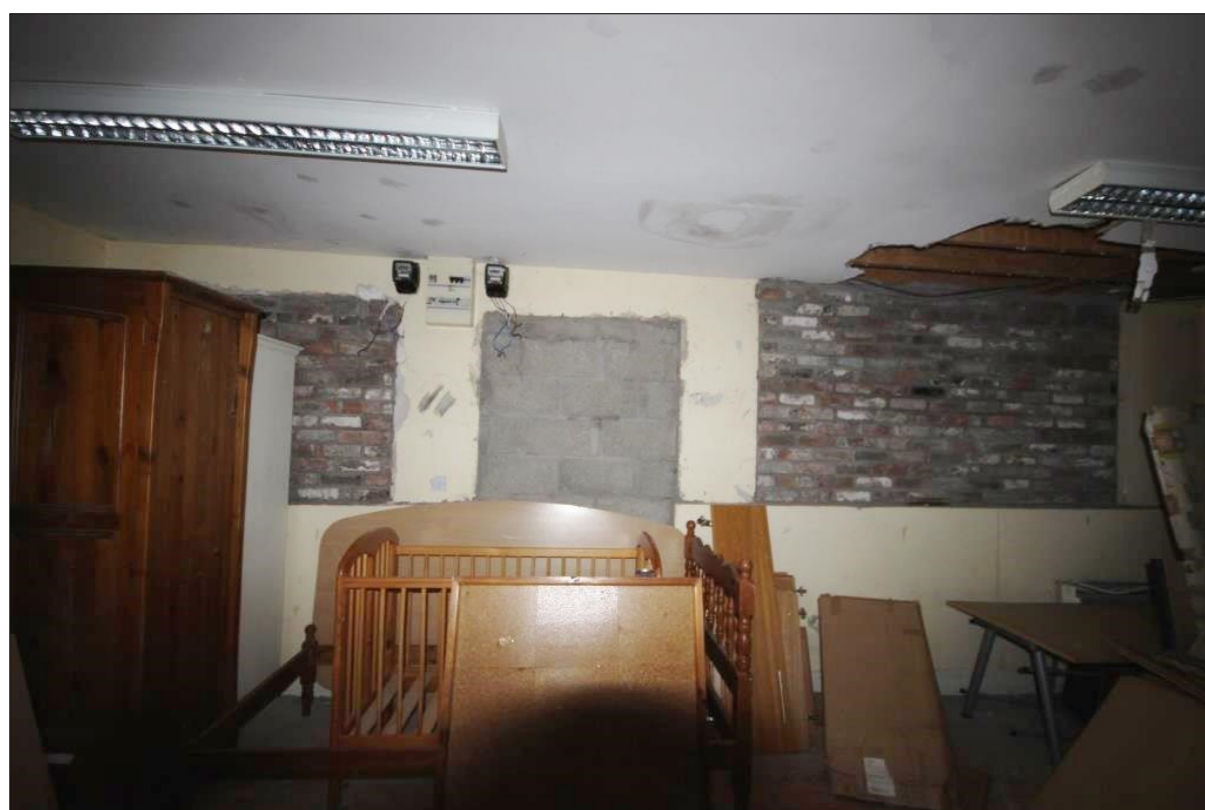
Plate 17: Interior of western wall of Building B with blocked-up openings

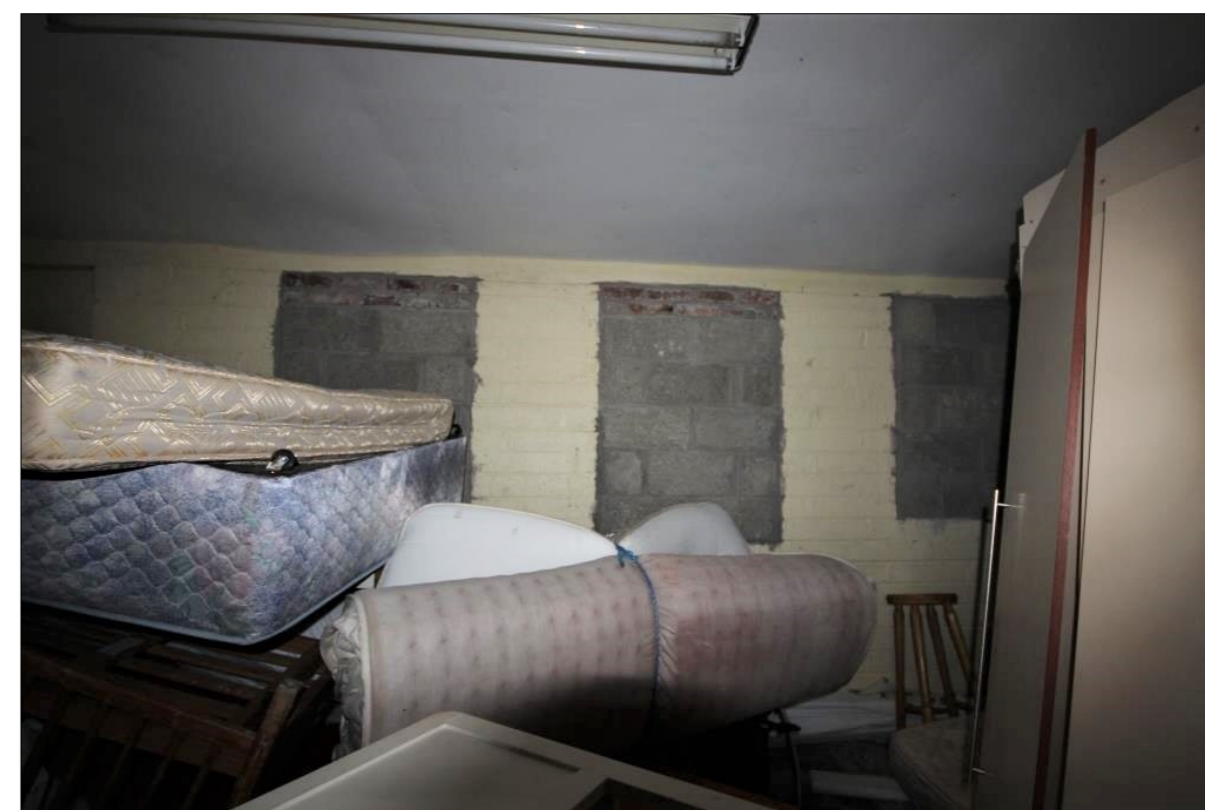
Plate 19: Interior of western wall of Building B with blocked-up openings

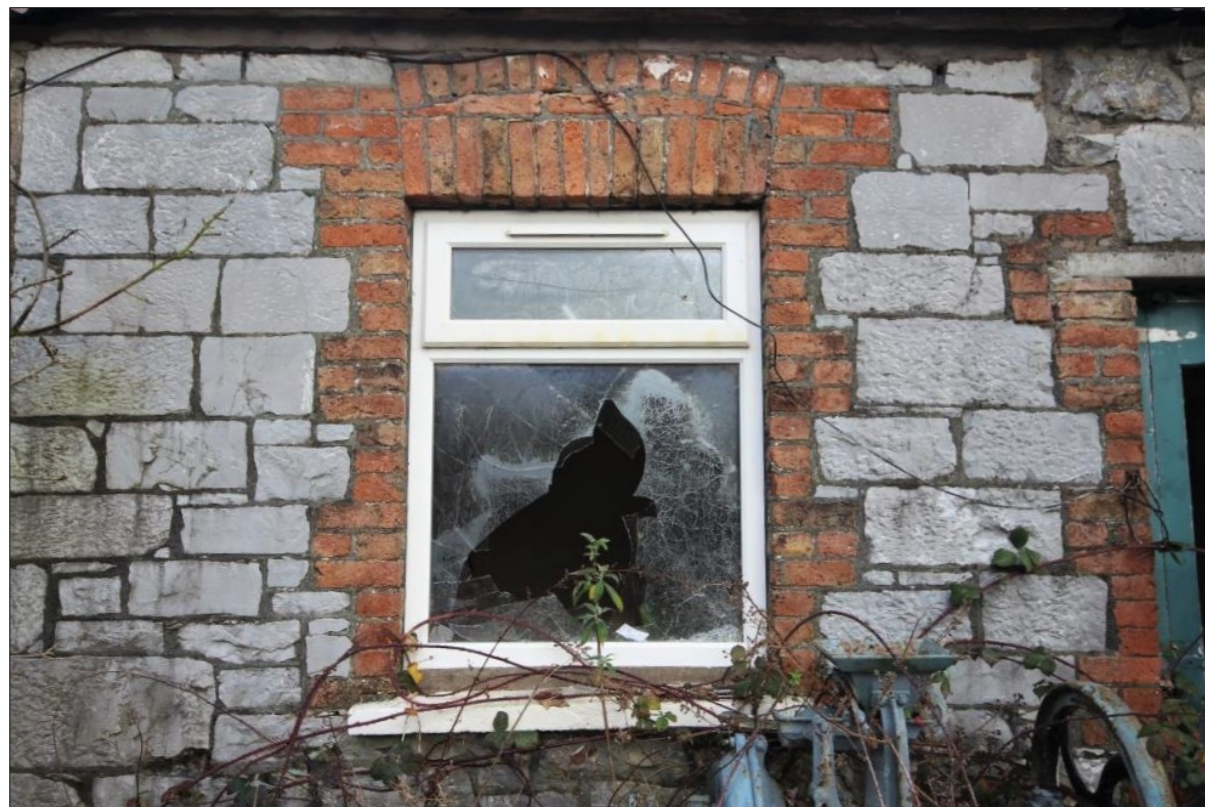
Plate 28: Window detail on southern elevation of Building E with replacement uPVC frame

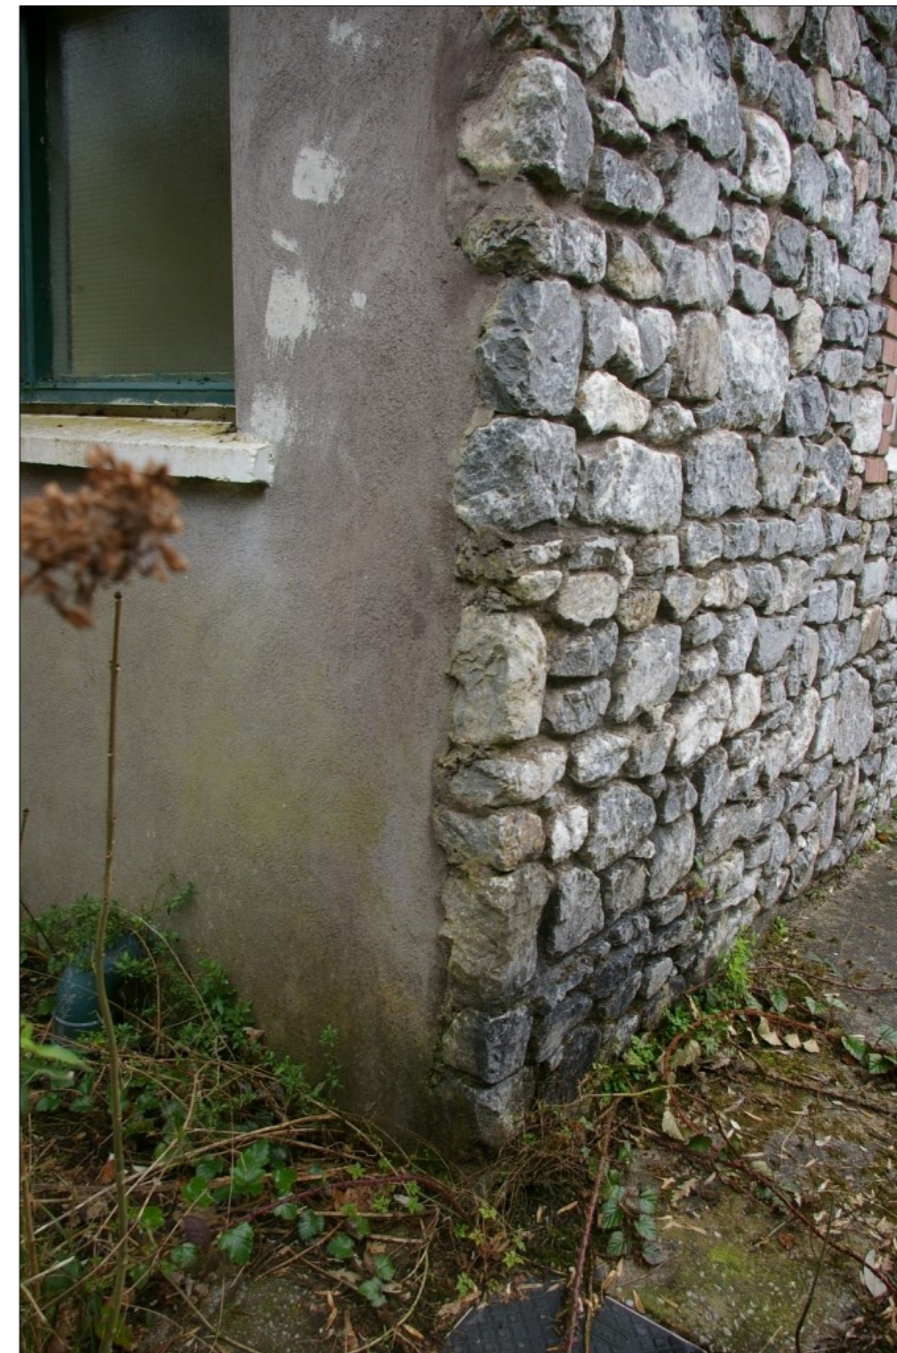
Plate 34: Detail of modern stonework and render on corner of southern elevation of Building G

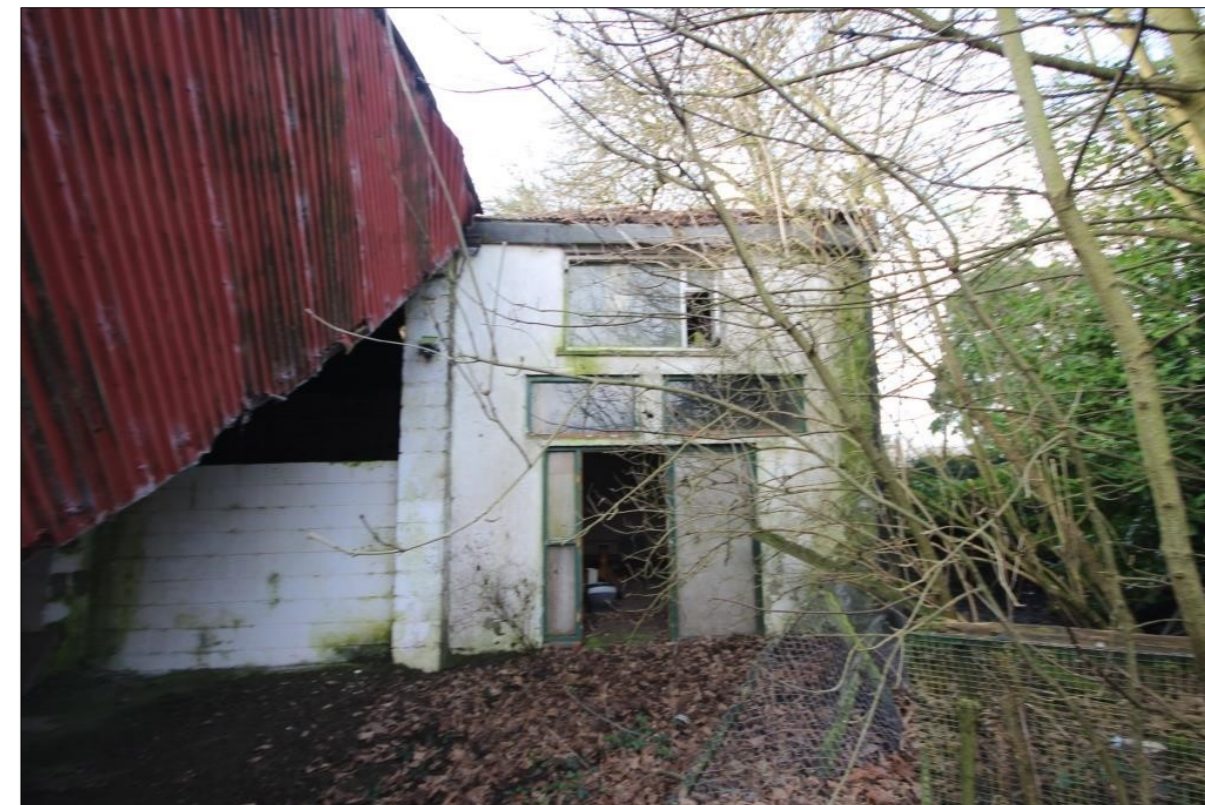
Plate 41: Modern concrete built addition to northern portion of Building H
