ARBORICULTURAL REPORT
ARBORICULTURAL INVENTORY
AND IMPACT ASSESSMENT

Incorporating a
TREE PROTECTION STRATEGY

GA2; RESIDENTIAL DEVELOPMENT, BALDOYLE, CO. DUBLIN

LISMORE HOMES LTD.

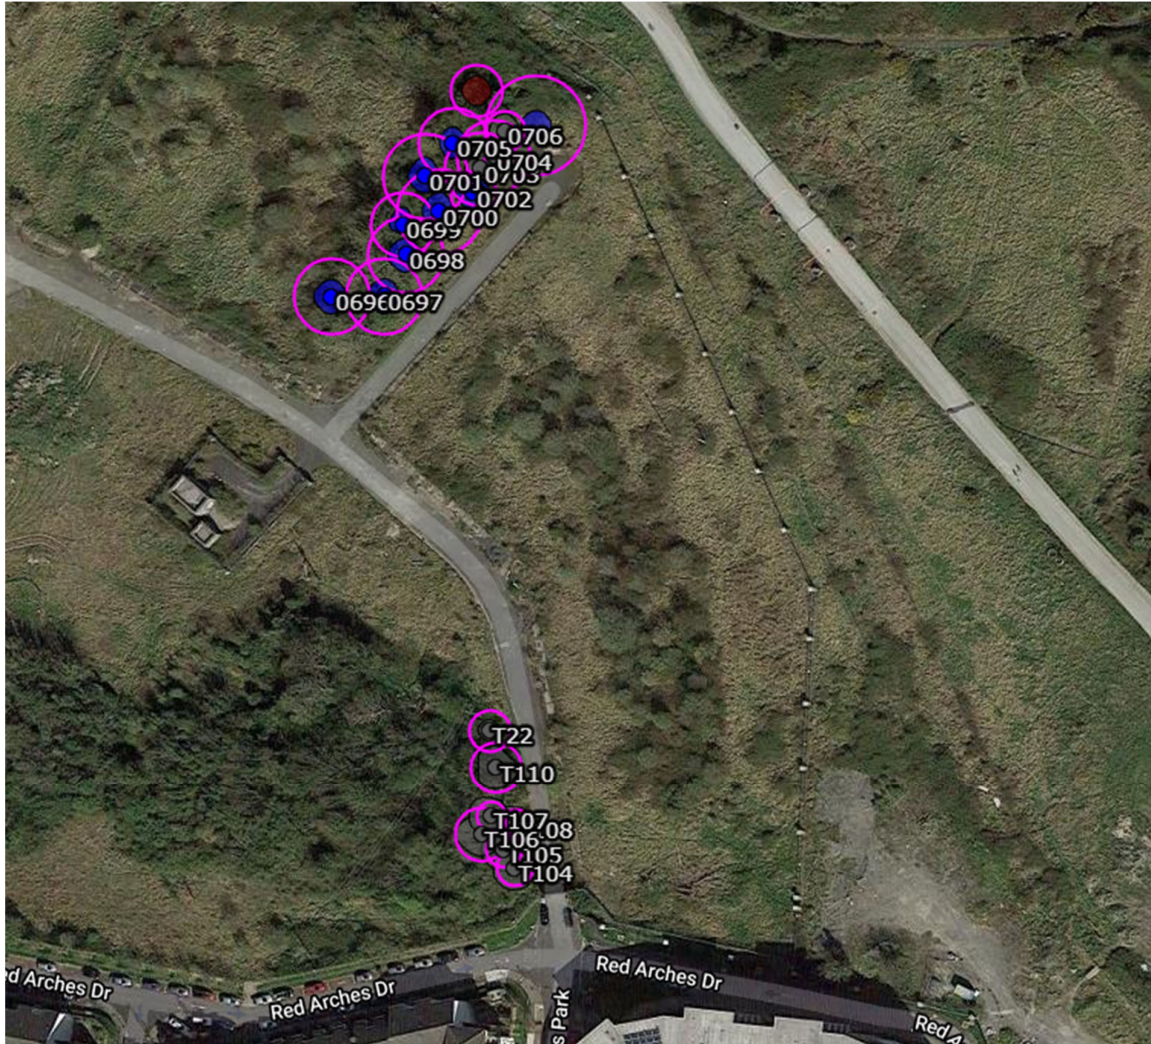
Figure 2 – Tree inventory on TreePlotter

ID	Latin Name	Common Name	Stem Dia. [mm]	Tree Height [m]	Branch Spread [m]				Life Stage	Structural Condition	Physiological Condition	Quality Category	RPA [m]	Comments	Recommendations
					N	E	S	W							
					T104	Acer pseudoplatanus	Sycamore	280							
T105	Acer pseudoplatanus	Sycamore	280	10	4	4	5	5	Early-mature	Fair	Fair	C2	3.36	Competition - Adjacent trees. Deadwood - Minor. Epicormic growth - Base. Ivy or climbing plant. Multi-stemmed.	Overhaul crown and remove all deadwood. Reduce crown by 20%. Remove all Ivy
T106	Acer pseudoplatanus	Sycamore	510	12	4	5	5	6	Mature	Fair	Fair	C2	6.12	Deadwood - Minor. Epicormic growth - Base. Ivy or climbing plant. Pruning wounds - Decayed. Suppressed crown - Minor. Unbalanced crown - Minor.	Overhaul crown and remove all deadwood. Reduce crown by 20%. Remove all Ivy

T107	Acer pseudoplatanus	Sycamore	280	10	4	4	5	5	Early-mature	Fair	Fair	C2	3.36	Competition - Adjacent trees. Deadwood - Minor. Epicormic growth - Base. Ivy or climbing plant. Multi-stemmed.	Overhaul crown and remove all deadwood. Reduce crown by 20%. Remove all Ivy
T108	Acer pseudoplatanus	Sycamore	280	10	4	4	5	5	Early-mature	Fair	Fair	C2	3.36	Competition - Adjacent trees. Deadwood - Minor. Epicormic growth - Base. Ivy or climbing plant. Multi-stemmed.	Overhaul crown and remove all deadwood. Reduce crown by 20%. Remove all Ivy
T110	Acer pseudoplatanus	Sycamore	490	11	5	5	5	4	Mature	Fair	Fair	C2	5.88	Branch - Broken. Competition - Adjacent trees. Deadwood - Minor. Excavation within root zone - Suspected. Ivy or climbing plant. Root damage - Suspected.	Overhaul crown and remove all deadwood. Reduce crown by 20%. Remove all Ivy
T696	Acer pseudoplatanus	Sycamore	730	14	4	3.5	4.1	4.1	Mature	Good	Good	B1	8.76	Heavily suppressed by ivy

T697	Acer pseudoplatanus	Sycamore	730	14	4	3.5	4.1	4.1	Mature	Good	Good	B1	8.76	Heavily suppressed by ivy

T698	Acer pseudoplatanus	Sycamore	730	14	4	3.5	4.1	4.1	Mature	Poor	Dead	B1	8.76	Heavily suppressed by ivy
T699	Acer pseudoplatanus	Sycamore	620	14	4	2.5	2.1	3.2	Mature	Good	Good	B1	7.44	Heavily suppressed by ivy
T700	Acer pseudoplatanus	Sycamore	820	14	4.5	3.2	4	4	Mature	Fair	Fair	B2	9.84	Heavily suppressed by ivy
T701	Acer pseudoplatanus	Sycamore	820	14	4.5	3.2	4	4	Mature	Fair	Fair	B2	9.84	Heavily suppressed by ivy
T702	Acer pseudoplatanus	Sycamore	440.9 1	9	4	4	4	4	Mature	Good	Good	B1	5.29	Heavily suppressed by ivy
T703	Acer pseudoplatanus	Sycamore	710	11	2.8	3.8	3.7	3.8	Mature	Fair	Fair	C1	8.52	Heavily suppressed by ivy
T705	Acer pseudoplatanus	Sycamore	680	14	3.7	3.2	3.7	3.2	Mature	Good	Good	B2	8.16	Heavily suppressed by ivy
T704	Acer pseudoplatanus	Sycamore	710	11	2.8	3.8	3.7	3.8	Mature	Fair	Fair	C1	8.52	Heavily suppressed by ivy
T706	Acer pseudoplatanus	Sycamore	393.7	7	4	3.5	4	3.5	Mature	Fair	Fair	C2	4.72	Heavily suppressed by ivy

T707	Acer pseudoplatanus	Sycamore	960	11	3.5	3.5	3.5	3.5	Mature	Good	Good	B1	11.52	Heavily suppressed by ivy
T708	Alnus cordata	Italian Alder	500	14	3.5	3.5	3.5	3.5	Mature	Poor	Poor	U	6	Heavily suppressed by ivy; in decline
