## Stage 1 Road Safety Audit

Proposed Residential Development, Coolagad, Greystones, Co Wicklow

| <b>Document No:</b> | 211517-ORS-XX-XX-RP-TR-7d-001 |

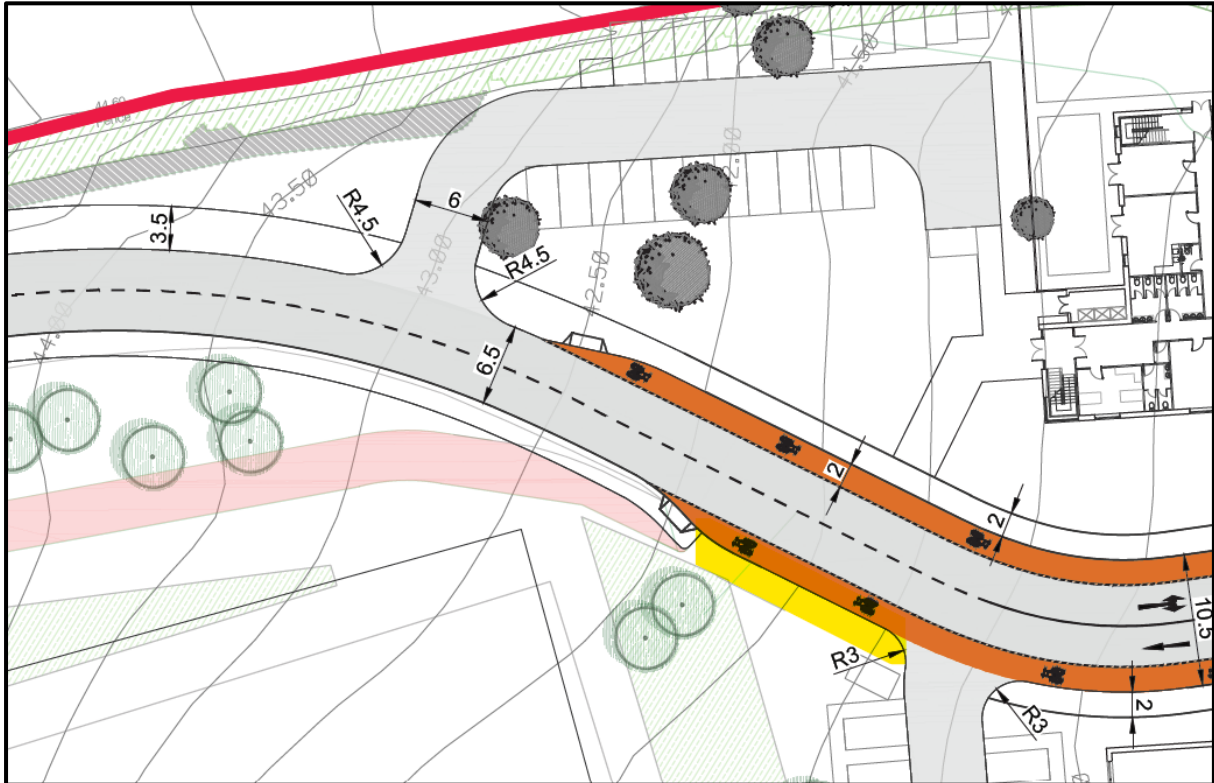
### Problem No. 03: Cycle Path Transition

#### Location: Site Access Junction

The audit team note from the proposed drawings that the proposed west bound cycle lane transitions to an offline cycle track. The segregated footpath appears fragmented in the vicinity of the cycle track transition, and it is unclear as to right of way at this location which may result in pedestrian cycle conflicts resulting in injury.

The design team should include additional details to clarify right of way and travel direction for both pedestrians and cyclists in this location.

The footpath and cycle lane layout has been updated in this location to ensure that the right of way and travel direction for both pedestrians and cyclists in this location is clear. Refer to drawing COO-ACM-00-00-DR-CE-00-0004.

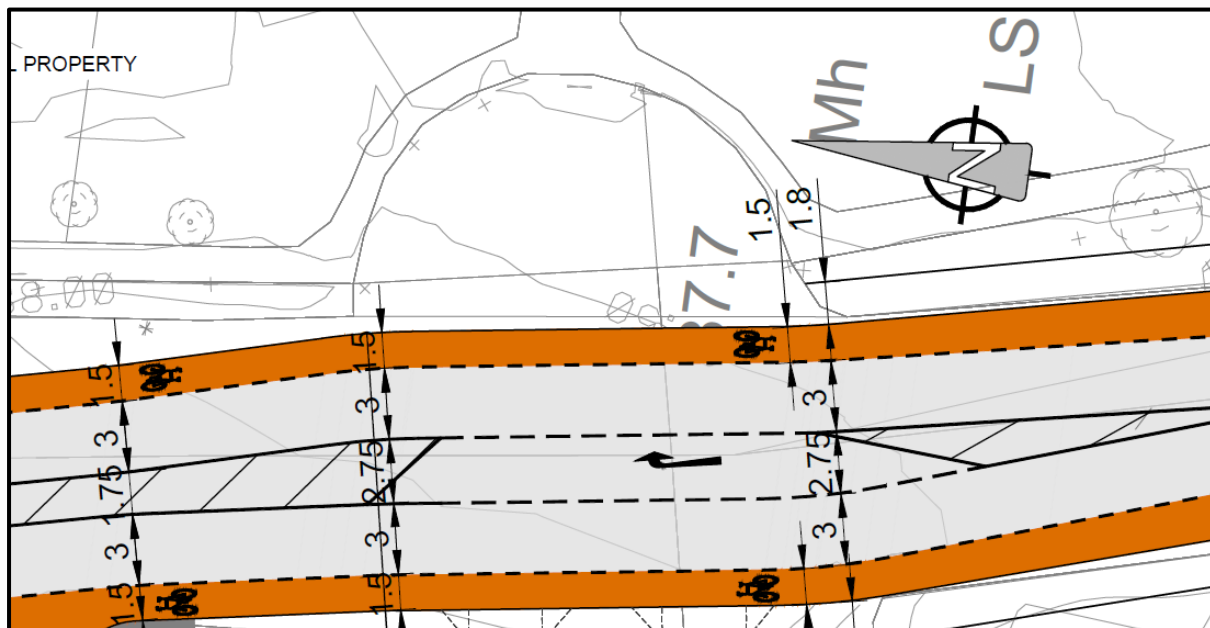
#### Problem No. 04: Pedestrian Permeability

##### Location: Redford Cemetery Entrance

The audit team note from the drawings provided that proposed pedestrian paths are shown to terminate to the north and south of the cemetery entrance with no drop kerb and tactile paving. Insufficient pedestrian permeability may put vulnerable users at risk. Inadequate disabled facilities may result in slips trips or falls resulting in injury.

The design team should review the existing footpath layout to ensure continuity of all surrounding paths within the scheme boundary in line with DMURS guidelines.

Please note that the footpaths north and south of the cemetery are not proposed, the existing footpaths are proposed to remain as is. The existing footpaths are asphalt pavements that ramp down to the area fronting the cemetery entrance. See below.

This area is outside the remit of our scheme, and if brought up by WCC for improvement, it could be considered to be further addressed at detailed design stages.

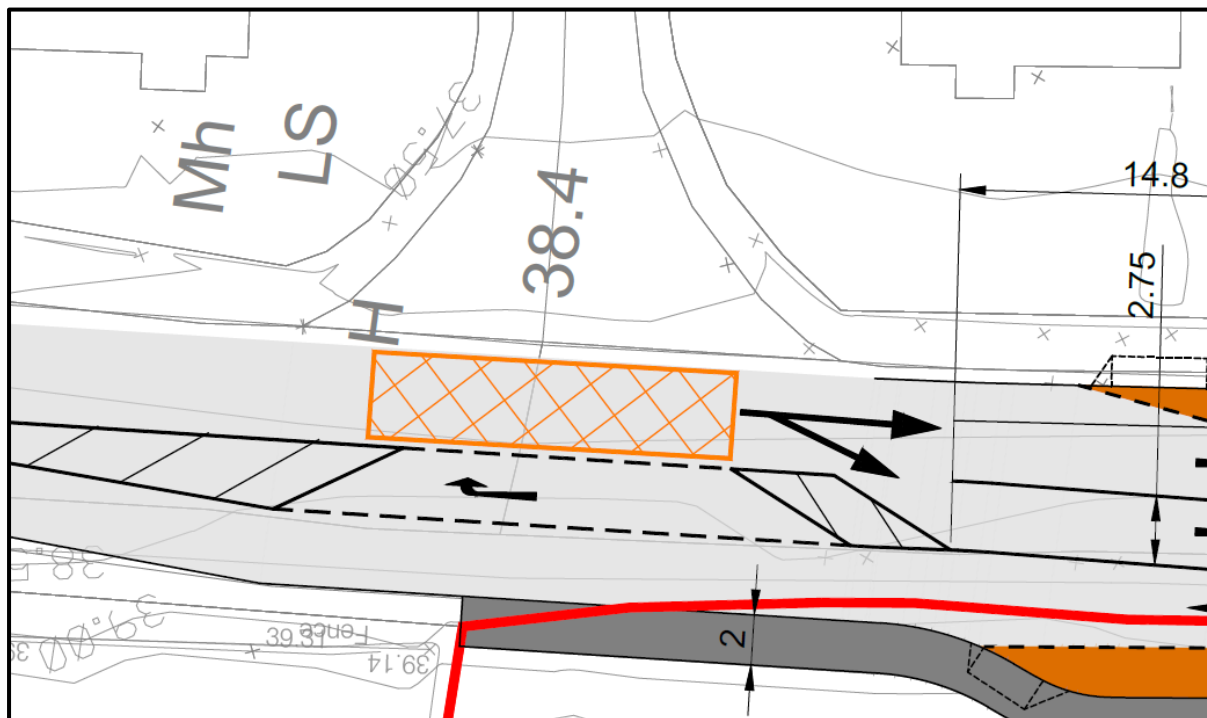
## Problem No.06: Pedestrian Disabled Access

### Location: Seaview Road Junction

The audit team note that 'drop kerbs' and tactile paving are not identified throughout the scheme. These facilities aid users with specific mobility needs in particular and the omission of dropped kerbs will require vulnerable road users to travel in the roadway to find a suitable location to mount the footpath putting them at risk of conflicts with vehicles.

The design team should ensure that details and locations of 'drop kerbs' and tactile paving is provided throughout the scheme at proposed crossing points

This is outside the remit of our scheme, and if brought up by WCC for improvement, it could be considered to be further addressed at detailed design stages.

The junction is very wide and has no pedestrian crossing facilities and could be redesigned to provide drop kerbs, tactile and improved radii on corners, but we don't believe it is within the client's remit to upgrade this existing junction.

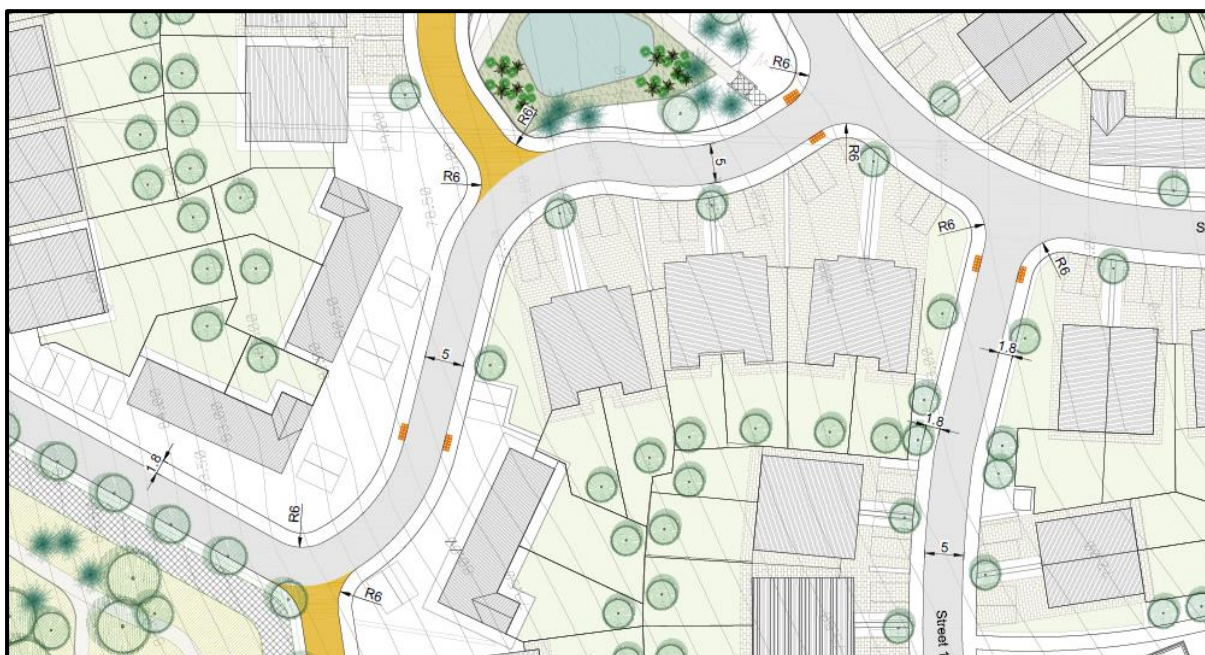
## Problem No. 07: Road Markings and Signage

### Location: Internal Roads

The audit team note from the proposed drawings that there is a lack of road markings and signage depicting stop lines, travel direction, lane demarcation, raised table markings, and designated shared roadways. Road markings and signage aid in informing road users of any hazards, locations of Stop and/or Yield lines at pedestrian crossings and shared roadways. Inadequate road markings may lead to motorists becoming confused which could pose a risk of pedestrian/vehicle or vehicle/vehicle collisions resulting in injury.

The design team should include additional details for road markings and signage to be installed on the proposed intersections and internal roads throughout the scheme.

Proposed road markings and signage on the proposed internal intersections and roads throughout the scheme will be addressed at the detailed design stage.

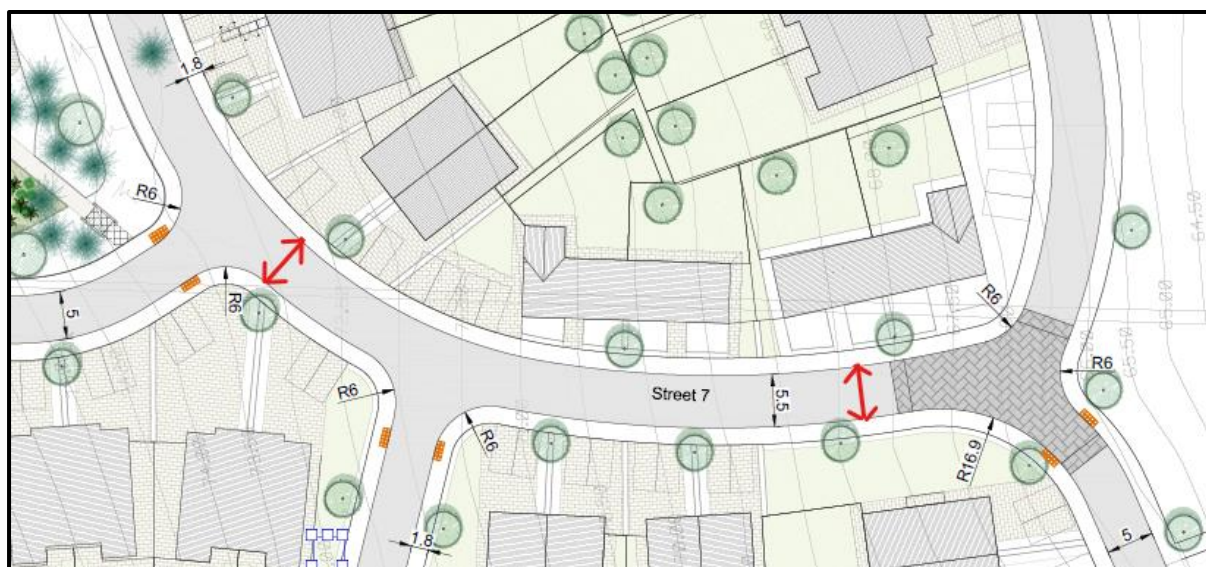
## Problem No. 012: Pedestrian Disabled Access Permeability

### Location: Internal Site Layout

The audit team note that 'drop kerbs' and tactile paving are identified throughout the scheme. The positioning and frequency however do not allow for sufficient access throughout the site. These facilities aid users with specific mobility needs in particular and the omission of dropped kerbs will require vulnerable road users to travel in the roadway putting them at risk with vehicle conflicts and injury.

The design team should ensure that the frequency and locations of 'drop kerbs' and tactile paving is provided throughout the scheme to allow crossing movements for all probable movements.

The general arrangement plans have been updated accordingly. Refer to drawings COO-ACM-00-00-DR-CE-00-0002 to 0006.

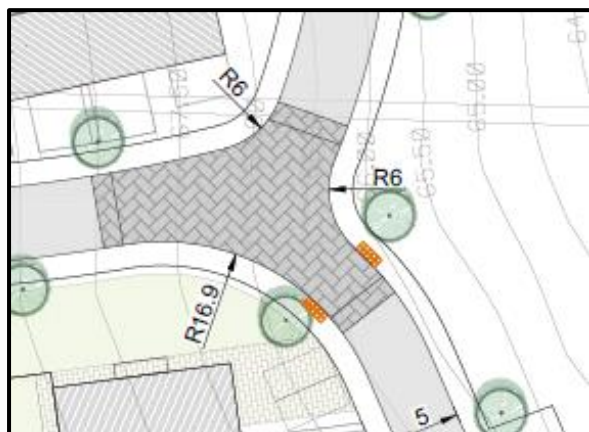
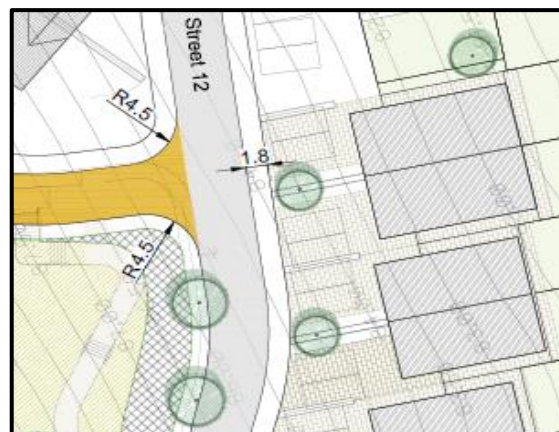
### Problem No. 014: Landscaping

#### Location: Internal site layout

The audit team note from the drawings provided that proposed landscaping within the development may impact the visibility of road users if positioned inappropriately. Trees, high bushes and shrubbery should be avoided in areas where visibility is to be maintained to ensure that drivers are clearly able to see approaching vehicles and pedestrians at junctions and designated pedestrian crossing locations. This could potentially lead to instances of vehicle-vehicle or pedestrian-vehicle collisions resulting in injury.

The design team should ensure that any proposed landscaping does not impact on visibility of the internal roads and junctions or forward visibility at the proposed pedestrian crossings.

Refer to drawings COO-ACM-00-00-DR-CE-00-0101 to 0102 for the sight line analysis. Landscaping will be kept out of the sight lines.

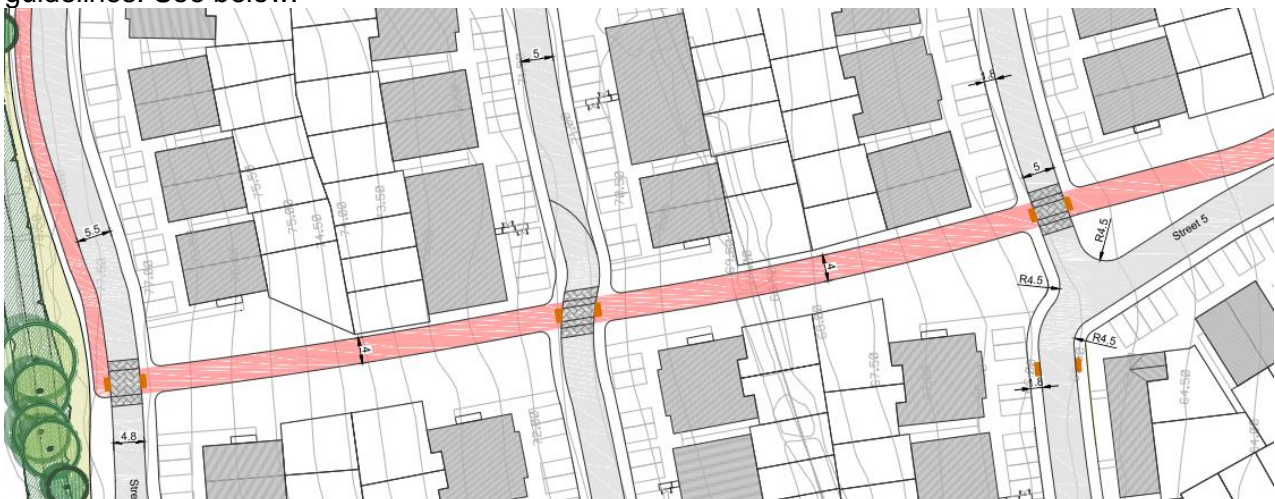
#### **Problem No. 08: Markings, Signage and Tactile Paving**

Additional details have been included on the plans for markings and signage and tactile paving to be installed on the proposed shared paths in line with DMURS and the National Cycle manual guidelines. See below.
