**Arboricultural Report**  
**Trees at Proposed Site at**  
**Coolagad**  
**Greystones**  
**Co Wicklow**

**March 2022**

**The Tree File Ltd**  
**Consulting Arborists**  
**Ashgrove House**  
**26 Foxrock Court**  
**Dublin 18**  
**D18 R2K1**  
**086-3819011**

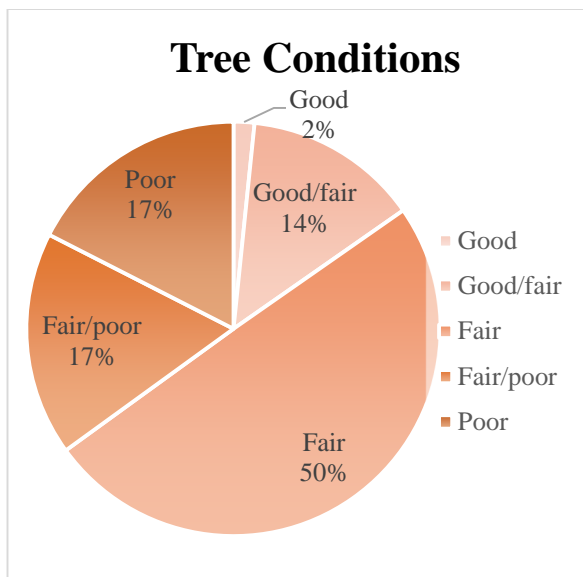
Fig 1

4.8 Sustainability issues are also illustrated by other criteria . We note that 34% of trees have been categorised as being of poor or fair/poor (see fig 2). Similarly, 37% of trees

offer little or no sustainability (See fig 1). These issues are likely reflective of the high proportion of mature trees when compared to younger specimens.

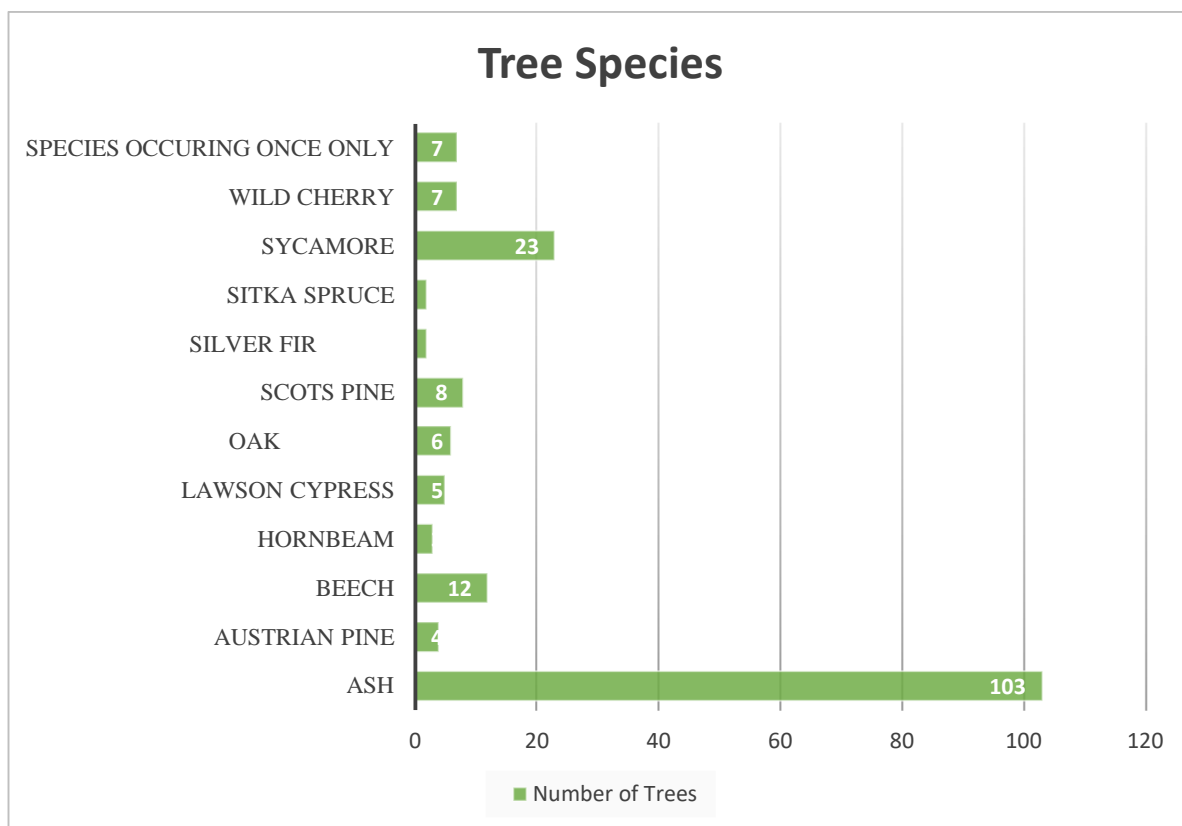
Fig 5

4.7 Considering the above, we must appreciate a clear numerical dominance of Ash across the site (see fig 5), with circa 103 Ash specimens recorded among a total of 183 individually recorded trees (circa 56%). Tree sustainability across the site will be highly reliant on additional and new planting. Such planting must avoid the creation of monocultures and to minimise pathological threats and to address issues of climate change, should aim for maximum possible species diversification.

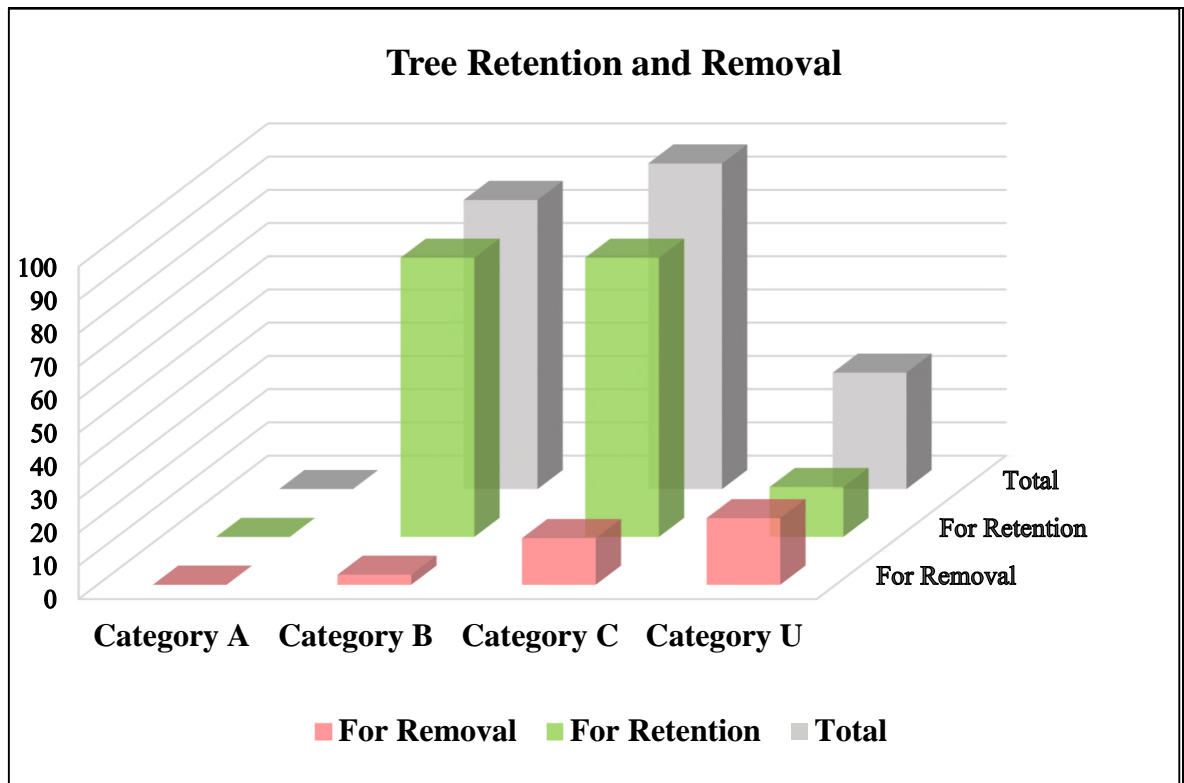
Fig 5 Graphic Representation of Tree Loss/Retention Scenario

<b>Category A</b>	None
<b>Category B</b>	1, 40 and 126.
<b>Category C</b>	2, 34, 60, 61, 62, 63, 80, 93, 127,128, 144, 145, 153 and 157
<b>Category U</b>	3, 35, 59, 59a, 64, 67, 79, 92, 94, 97, 129, 130, 131, 132, 137, 142, 143, 147, 151 and 159.
<b>Groups/Hedges</b>	Hedge A, Hedge I, Hedge N, Part Hedge k, Part Hedge P, Part Hedge Q, Part Hedge Y, Part Tree Group 1.
