Fermoy Housing Development at Cork Rd, Fermoy Co. Cork

Stage 1 Road Safety Audit

January 2022

Client	Cumnor Construction			
Project Title	Fermoy Housing Development			
Document Title Report for Stage 1 – Road Safety Audit				
Job No. 19099TT				
Document No.	19099TT-Doc05

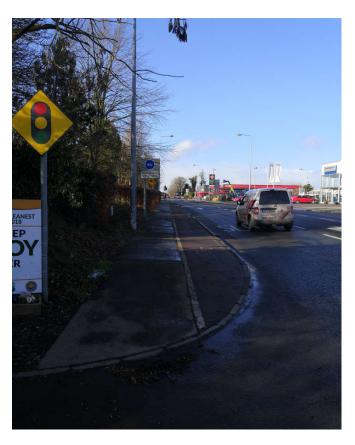
Figure A.1: Existing cycling lane present on northern side of ABEC entrance junction

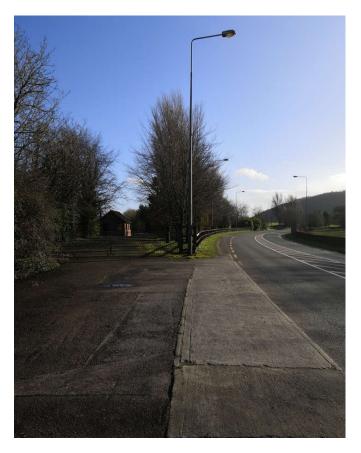
Figure A.2: Existing weigh-station gate to north of proposed entrance junction

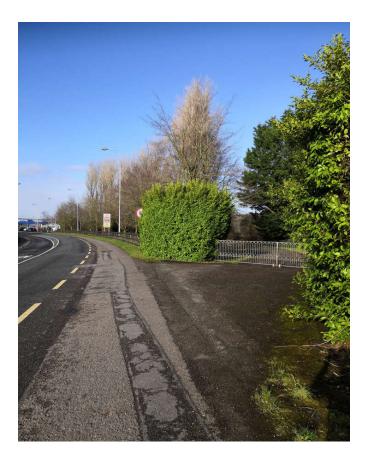
Figure A.3: Existing weigh-station gate to south of proposed entrance junction

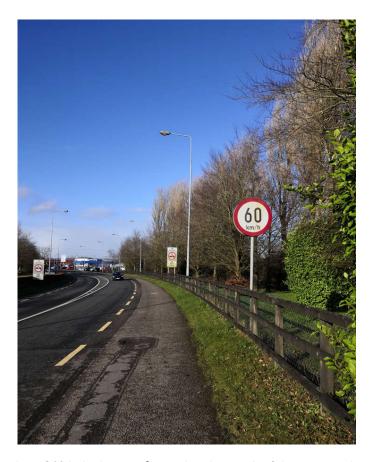
Figure A.4: Location of 60 kph signpost located to the south of the proposed entrance junction

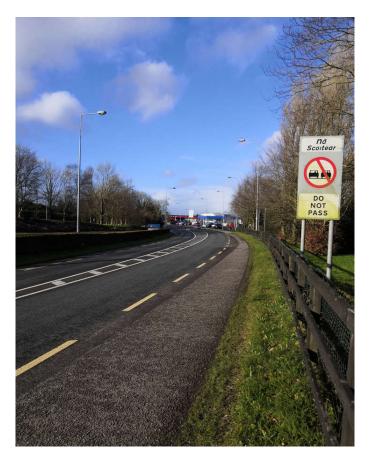
Figure A.5: Sightlines at the proposed entrance junction when looking to the right

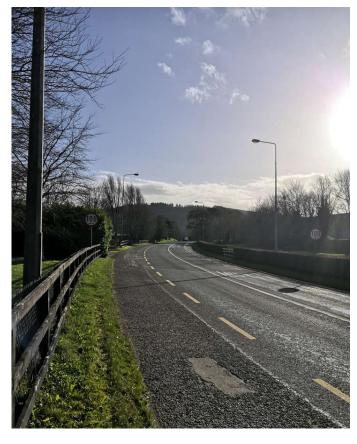
Figure A.6: Sightlines at the proposed entrance junction when looking to the left

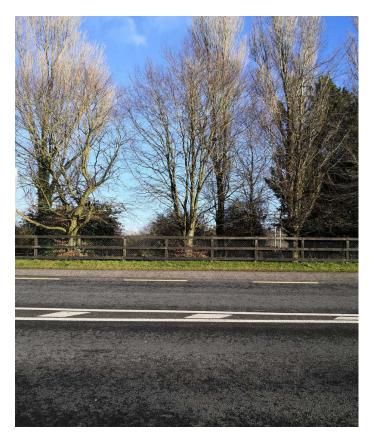
Figure A.7: Image of the approximate location of proposed entrance junction

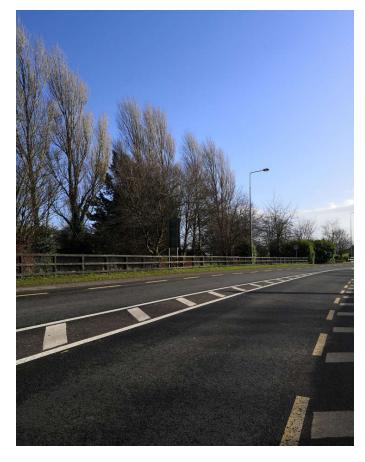
Figure A.8: Image at other angle of the approximate location of proposed entrance junction
