**Title: QUALITY AUDIT
INCLUDING
Road Safety Audit, Access Audit, Cycle Audit and Walking
Audit.
For;
Barrington SHD, Brennanstown Road, Cabinteely.**

Client: Waterman Moylan

Date: March 2022

Report reference: 1432R01

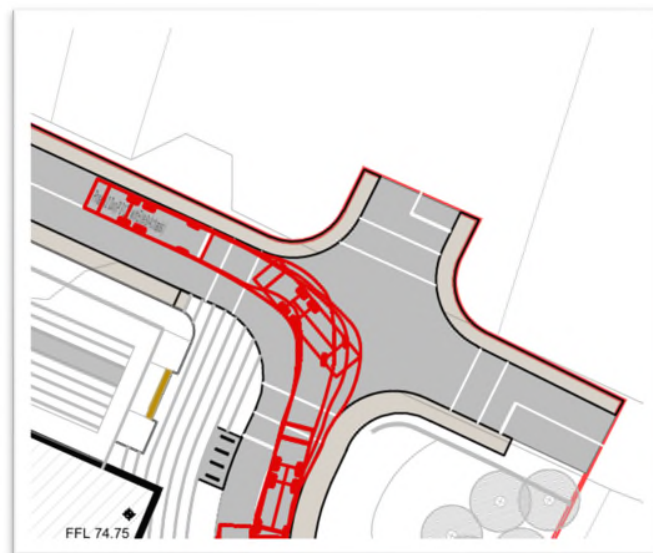
Drawing BRR-WM-ZZ-00-DR-C-P013 – Rev -, Brennanstown Road Junction.

The swept path of a refuse vehicle is shown on the drawings. The junction will have to cater for large heavy goods vehicles during construction and future upgrades etc. albeit on an infrequent basis. There is a risk that such vehicles will not be able to turn at the junction and will mount the footpaths and possibly damage street furniture and put vulnerable road users at risk.

Ensure that the junction can cater for the turning of large goods vehicles.

3.1	Yes	YEs	As shown on drawing BRR-WM-ZZ-00-DR-C-P015 which shows the autotrack analysis of a large good vehicle entering the site, the junction can accommodate the turning of infrequent large goods vehicles to the site. In line with DMURS, the junction has been designed to accommodate pedestrian and cyclist movements and to encourage slow movement of vehicles.	Yes

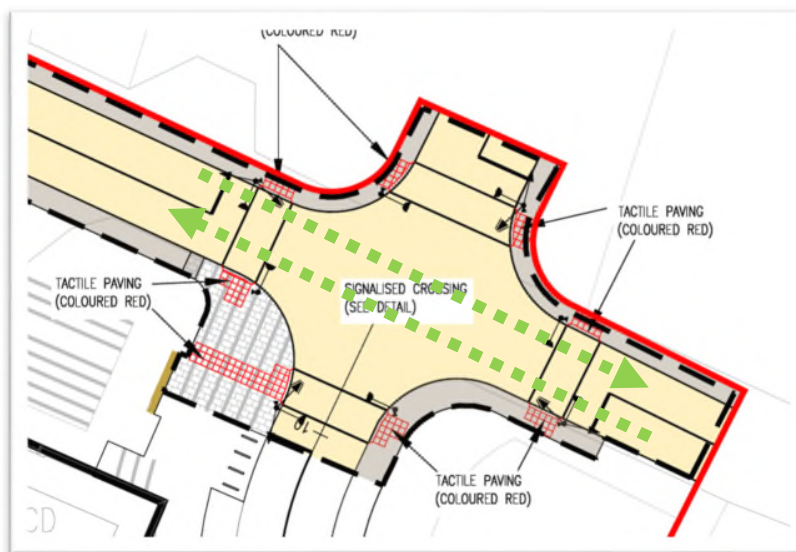
Drawing BRR-WM-ZZ-00-DR-C-P017 – Rev -, Brennanstown Road Junction.

Brennanstown Road is a narrow road. It is unclear what the overall width of the carriageway will be when the works are complete. At present if two wide vehicles meet they pass using a passing bay type arrangement at private accesses. There is a risk that if two wide vehicles queue at the signals they will not be able to pass when they get the green signal. This could lead to mounting of the footpaths or reversing, both of which could put vulnerable road users at risk.

Ensure that the carriageway width is sufficient at the junction to allow two wide vehicles pass.

3.2	No	No	There is a 3 Tonne weight restriction on Brennanstown Road. Therefore, it is unlikely that there will be large good vehicles passing as the site junction. Should two large vehicles meet at the junction, the bell mouths of the junction can accommodate large vehicles pulling in temporarily.	Yes

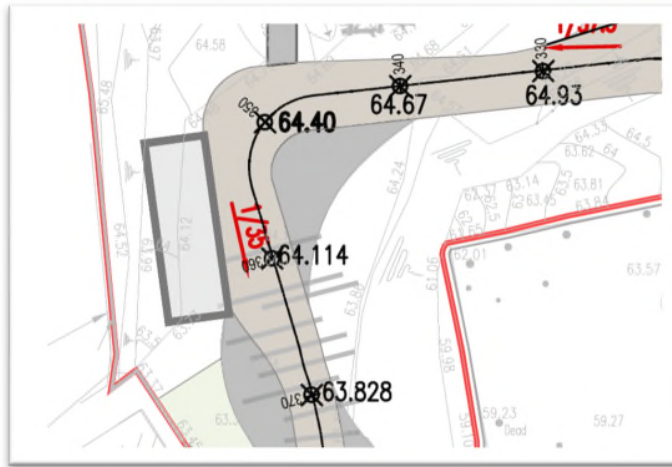
Drawing BRR-WM-ZZ-00-DR-C-P011 – Rev -, Southern end of access road. Ch 360

It is unclear if there is sufficient space for vehicles to U-turn at the end of the access road. A lack of space could lead to damage to structures and material damage of vehicles.

It is recommended that a turning space be provided at the end of the route intended for vehicle use.

3.3	Yes	Yes	Refer to drawing BRR-WM-ZZ-00-DR-C-P013 attached which shows the autotrack analysis for a refuse vehicle which can turn at 2 No. locations without any problem.	Yes
