Tree Survey and Arboricultural Report
Trees at Proposed Site at
Barrington Tower
Brennanstown Road
Dublin 18

March 2022

The Tree File Ltd
Consulting Arborists
Ashgrove House
26 Foxrock Court
Dublin 18
D18 R2K1
086-3819011

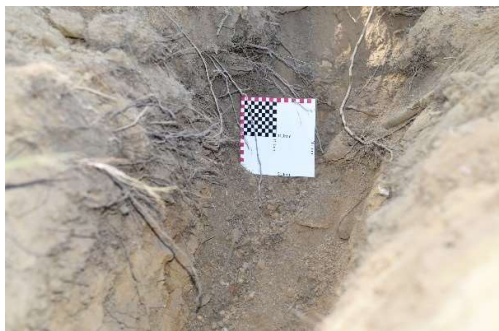
Photo 1 – TP1
Pit adjoining laneway – no roots

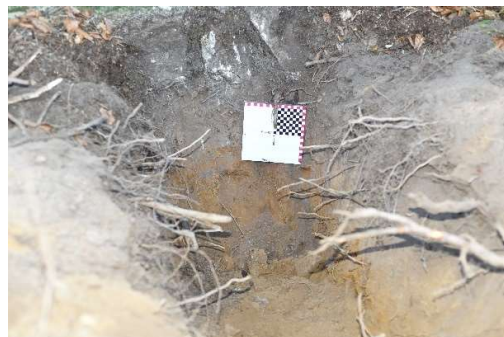
Photo 2 – TP2
Pit at Burial Ground – Scrub roots noted, but no roots under-passing wall

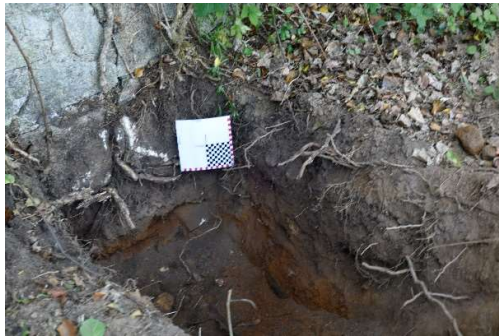
Photo 3 – TP3

Pit south of Burial Ground – Scrub roots noted, with only two small roots penetrating masonry.

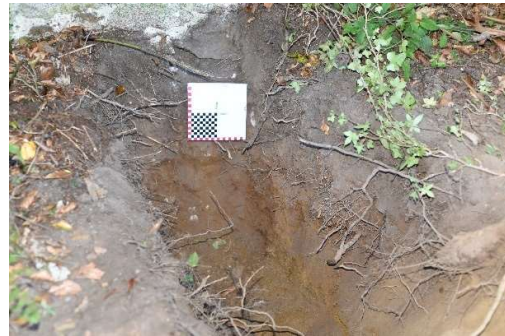
Photo 4 – TP4

Pit south of Burial Ground – Scrub roots noted, but no roots under-passing wall
