# Fassaroe Phase 1 Strategic Housing Development

Stage 1 Quality Audit

Cosgrave Property Group

April 2022

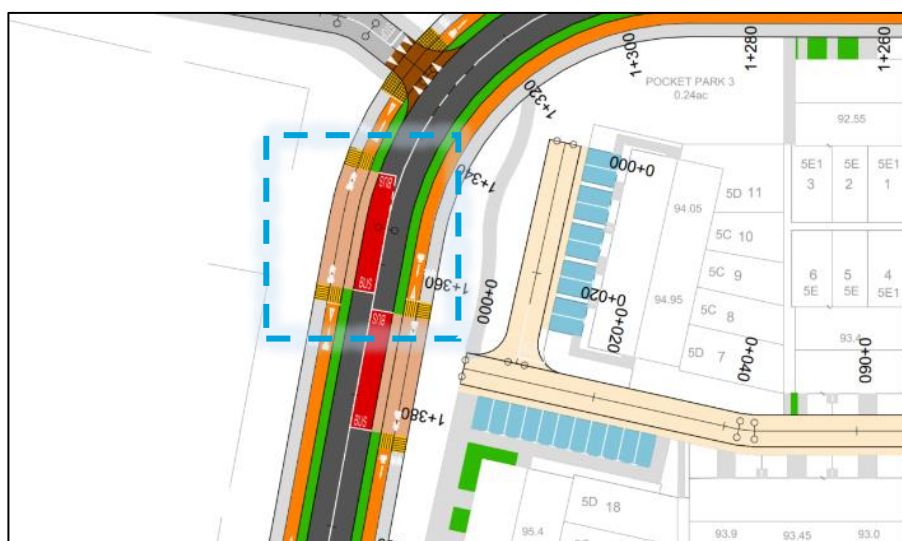
#### 2.2.1. Problem: Location of Bus Stop

**Location:** Main Road of Scheme (Chainage 1+360)

The proposed bus stop is located at the beginning of the bend in the road and is in close proximity to the junction on the bend (shown below in Figure 2-1). Sightlines for northbound vehicles and vehicles emerging from the junction may be blocked or at least impaired by a stopped bus which may create the hazard of drivers manoeuvring around the bus with limited visibility. This could lead to head-on and side-on collisions between vehicles.

Furthermore, the position of a stopped bus on the bend may make it difficult for the bus to stop sufficiently near to the kerb to allow users to enter / exit safely; in particular for less-abled users, visually impaired users and those with buggies. This could lead to slips, trips and falls for passengers.

The location of the bus stop should be moved to a straight section of road, taking into account opposing bus stops and designated pedestrian crossing points.

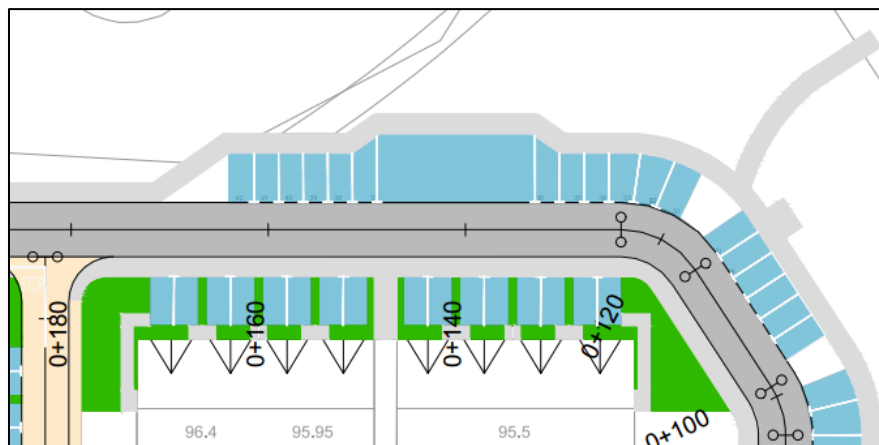
Figure 2-2 – Large Unmarked Parking Area

## 2.2.2. Problem: Large Unmarked Parking Area

### Location: Main Road of Scheme (Chainage 1+030 – 1+190)

There is a large unmarked parking area adjacent to a local road carriageway which may result in poor parking discipline or positioning by drivers (shown in Figure 2-2). This hazard could lead to an increased risk of collision.

The parking area should be formalised.

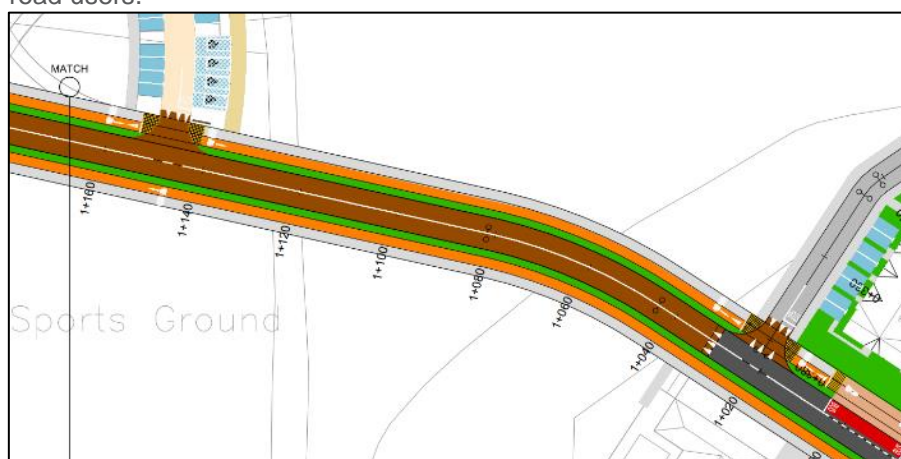
Figure 2-3 – Proposed Raised Table

## 2.2.3. Problem: Proposed Raised Table

### Location: Main Road of Scheme (Chainage 1+030 – 1+190)

There is a proposed 160m long raised table along the main road of the scheme (as shown in Figure 2-3). The merit of such a long table is unclear, perhaps it is intended to slow traffic along this section and at the junction at Ch 1+150, and if this is the case its functionality will be limited considering its length. Where vehicle speeds are not reduced as intended there may be a risk of increased collisions with other road users.

The provision of this is to be reviewed and confirm that the intended slowing of traffic will be achieved, if required.

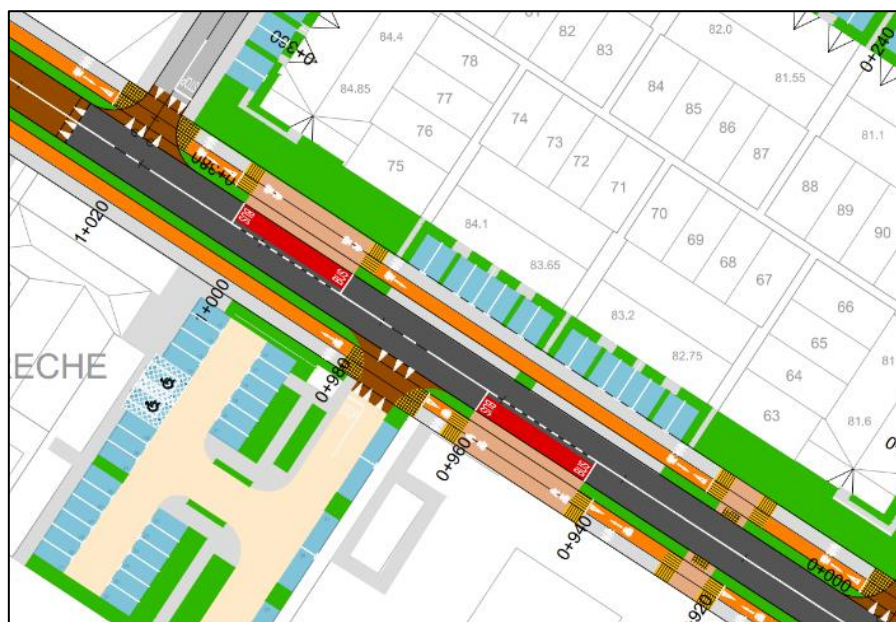
Figure 2-4 – Congested Area in Centre of Scheme

### 2.2.4. Problem: Congested Road Elements

**Location:** Main Road of Scheme (Chainage 0+720, 0+840, 0+930 to 1+000)

The proposed layout of this area contains a series of junctions, bus stops and residential parking in a relatively confined space (shown below in Figure 2-4); the congested nature of such elements may contribute to a number of road safety concerns.

Where buses are stopped (at Chainage 0+950 or 1+000), visibility from the junctions may be impeded for road users. This may result in side-on or head-on collisions. Additionally, drivers performing overtaking manoeuvres (of a stop bus) on the major road may be ill-prepared to stop for vehicles emerging from a junction.

At Chainage 0+940 to 0+980, the proposed residential parking is only accessible by crossing the cycle track and footpath. The parking is orientated in such a way that it requires drivers to either perform turning manoeuvres on the main road (to reverse-in) or more likely to reverse out onto the major road, which may result in collisions with passing NMUs. The parking issue is compounded by the nearby bus stops and junctions, which adds to the risk of conflict for those parking. It shall be noted that this problem is also present at chainage 0+720 and 0+840.

The proposed layout of this area should be reviewed to ensure adequate sightlines are achieved when buses are stopped.

The parking should also be reconfigured to reduce the conflicts between passing NMUs and mainline traffic/buses.

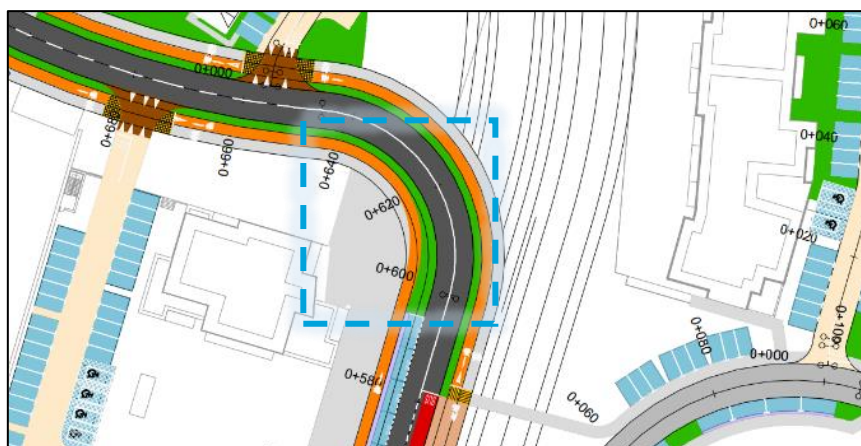
**Figure 2-5 – Abrupt End to Footpath**

### 2.2.5. Problem: Abrupt End to Footpath

**Location:** Main Road of Scheme (Chainage 0+620)

The proposed footpath ends abruptly and merges into a cycle track (shown below in Figure 2-5). This may result in the hazard of pedestrians unknowingly entering the cycle lane, or cyclists unknowingly entering the footpath. This could lead to head-on collisions between pedestrians and cyclists.

The footpath and cycle track terminations/alignments should be reviewed to remove the conflict.

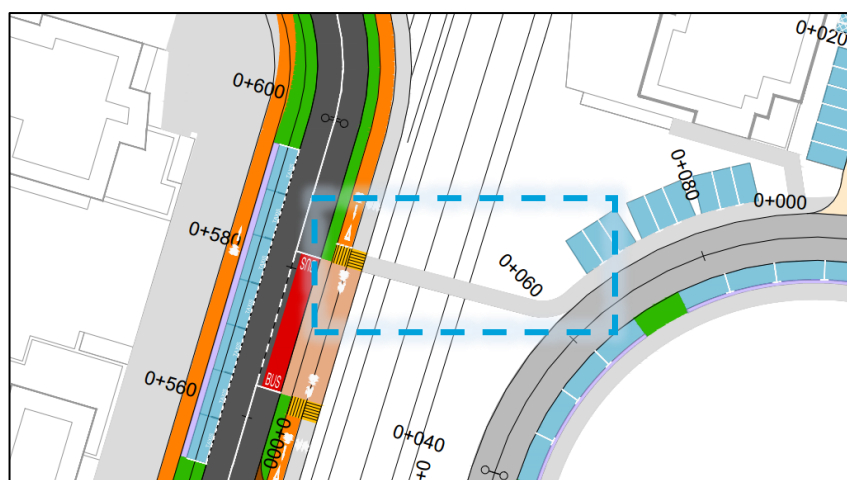
**Figure 2-6 – Footpath Tie-in with Tramline Paving**

#### 2.2.6. Problem: Footpath Tie-in with Tramline Paving

**Location:** Main Road of Scheme (Chainage 0+580)

The proposed footpath ties in perpendicularly to the tramline paving of the shared area on the main road (as shown in Figure 2-6). This tramline orientation would indicate to visually impaired NMUs that they are entering onto a cycle track.

The footpath tie-in should be reconfigured to remove the potential for confusion for visually impaired users.

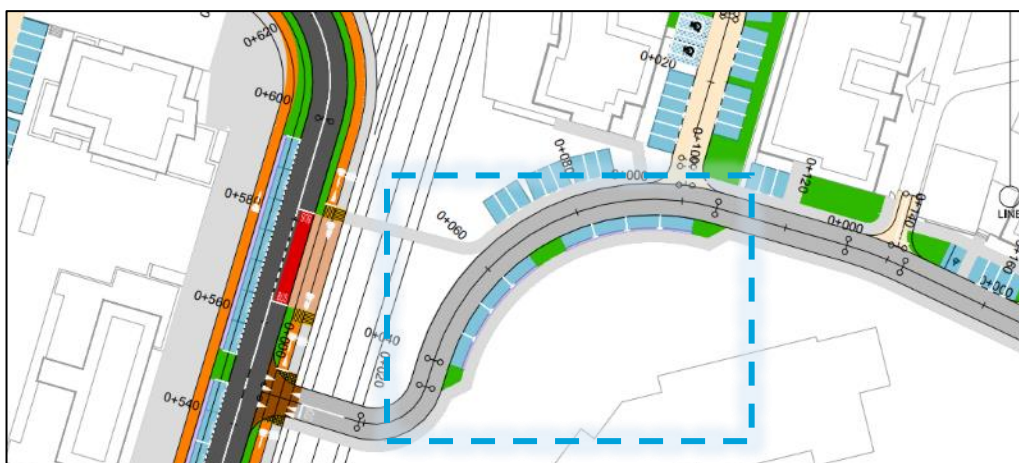
**Figure 2-7 – Parallel Parking on Inside of Bend**

#### 2.2.7. Problem: Parallel Parking on Inside of Bend

**Location:** Local Road of Scheme (Connected to Main Road at Chainage 0+540)

Road users attempting to use the proposed parallel parking (shown below in Figure 2-7) will likely tend to stop and reverse into a parking space. Other parked and adjacent vehicles may obstruct forward visibility to those vehicles stopped / reversing into the parking space, which may result in the risk of rear-end shunts by through traffic.

Sufficient visibility for through traffic should be confirmed, considering parked vehicles (including taller vans / 4x4s). If insufficient, the parking should be relocated or removed.

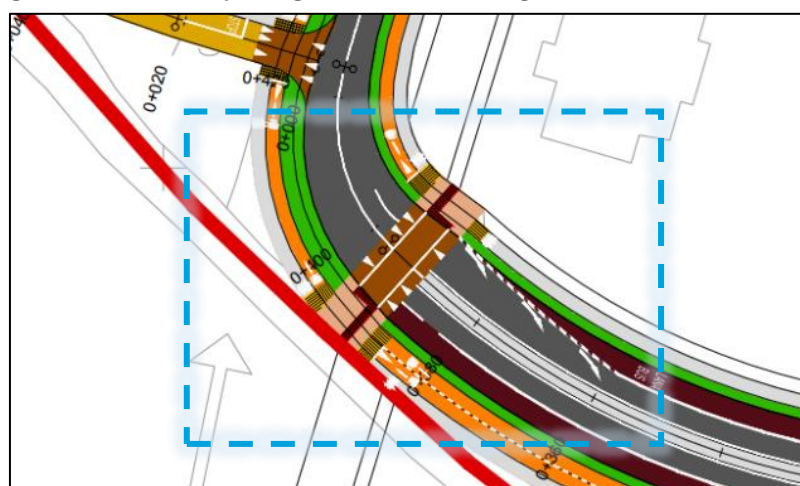
**Figure 2-8 – Series of Road Elements on Bend**

## 2.2.8. Problem: Series of Road Elements on Bend

**Location:** Main Road of Scheme (Chainage 0+390)

The proposed signalised crossing at Chainage 0+390 is located on the bend in the road, which may reduce forward visibility to it, for approaching southbound/eastbound traffic (shown below in Figure 2-8). Furthermore, the southbound/eastbound lane widens in advance of the crossing, which may promote an increase in speed for road users. These issues could lead to drivers being ill-prepared to stop for the crossing, which may lead to the risk of collisions with NMUs.

In addition, on the westbound/northbound lane there is no provision for buses to merge into the general traffic lane, as the bus lane ends abruptly at the crossing. This may lead to vehicles and buses attempting to simultaneously merge after the crossing, which could lead to side-impacts.

Sufficient visibility of the signalised crossing for through traffic should be confirmed. If insufficient, the crossing should be moved. Road widening (southbound/eastbound) should commence after the crossing, if possible.

Provision for westbound/northbound buses to merge into the general traffic lane should be provided.

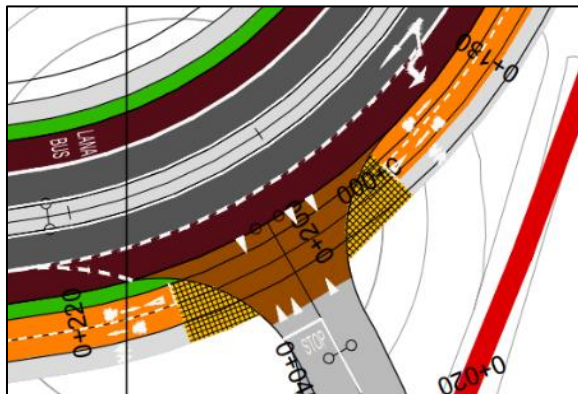
Figure 2-9 – Large Radii at Junction

### 2.2.9. Problem: Large Radii at Junction

**Location:** Main Road of Scheme (Chainage 0+200) and Fassaroe Link Road

The large radii for the proposed junction (shown below in Figure 2-9) may result in increased speeds for road users, while increasing the crossing distance for NMUs. The combination of these factors may result in the risk of collisions between vehicles and NMUs.

The junction should be tightened, if possible, considering anticipated vehicle movements.

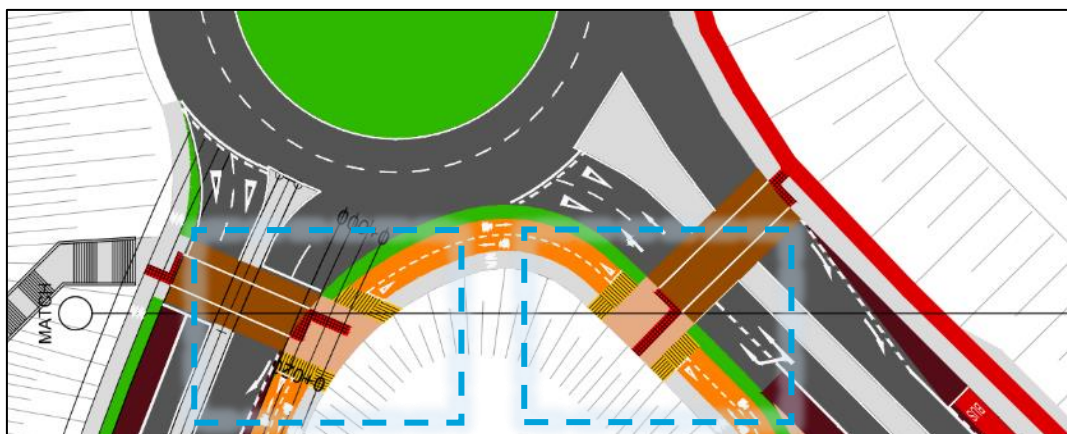
Figure 2-10 – Short Sections of Shared Areas

### 2.2.10. Problem: Short Sections of Shared Areas

**Location:** Main Road of Scheme (Chainage 0+000) and Fassaroe Link Road

The proposed shared areas, facilitating two-way cycle tracks and a pedestrian footpath, have relatively short approach lengths, considering the potential number of users that may congregate in the area (shown below in Figure 2-10), and considering the possible speed of approach by cyclists. This may result in collisions between users.

The shared areas should be increased in size to enable more space for users to avoid one another.

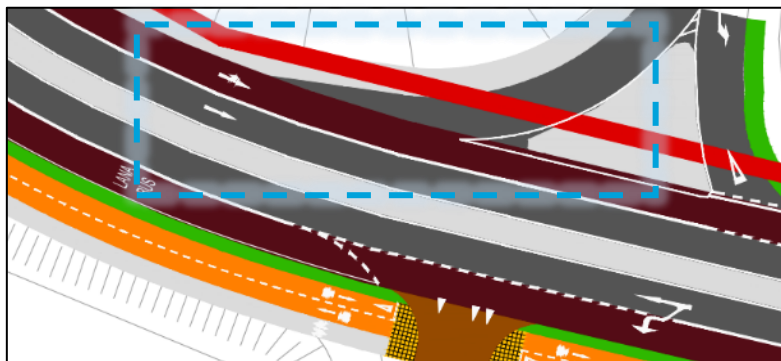
Figure 2-11 – Proposed Road Markings

### 2.2.11. Problem: Proposed Road Markings

**Location:** Fassaroe Link Road

The proposed road markings at this location do not facilitate general vehicles to cross the bus lane to enter the junction (shown in Figure 2-11). This may result in unexpected manoeuvres leading to collisions between road users.

The Design Team should provide a broken line and a 'Bus Lane Ends arrow' (M 130L) to allow general vehicles to cross the bus line to enter the junction, as included on the northbound lane shown in Figure 2-11.

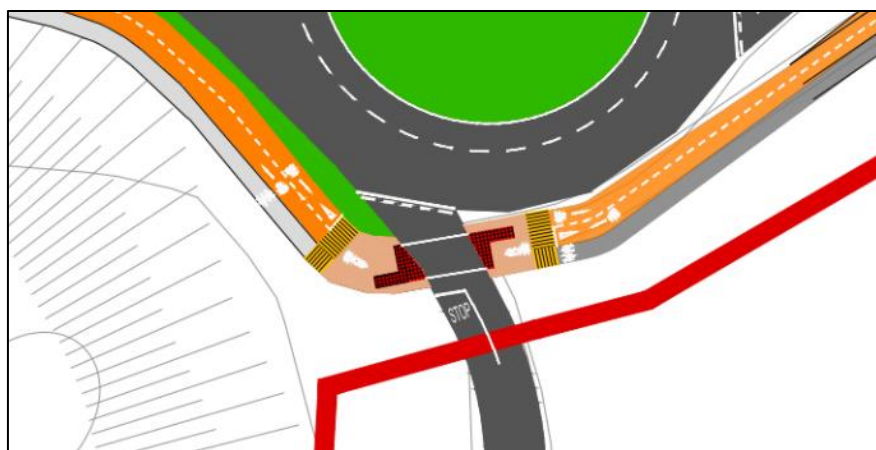
Figure 2-12 – Toucan Crossing in Close Proximity to Junction

### 2.2.12. Problem: Toucan Crossing in Close Proximity to Roundabout

**Location:** Roundabout at N11 Northbound Slip Lane

The proposed toucan crossing is in close proximity to the roundabout, where drivers are expected to yield for traffic on the roundabout (shown below in Figure 2-12). This may lead to drivers mistaking the green light at the toucan crossing as a green light to enter the roundabout. This may lead to the risk of road users entering the roundabout without yielding, which could result in side-impact collisions between vehicles.

Furthermore, a yielding vehicle (at the roundabout) may block the toucan crossing when stopped. In this case and when the toucan crossing is green for NMUs, their path may be blocked, which may cause them to enter the carriageway unsafely, and would be particularly problematic for wheelchair users or those with visual impairments.

Additionally, the Stop and two-way road markings on the slip lane are misleading to approach drivers, as the N11 slip lane is one-way.

The toucan crossing should be relocated to allow space for drivers to yield and to not impede the crossing while yielding. Only flashing amber or red signals should be used for the toucan crossing to avoid displaying a green signal to drivers. The Stop and two-way road markings should be removed and a yield marking provided before entering the roundabout.

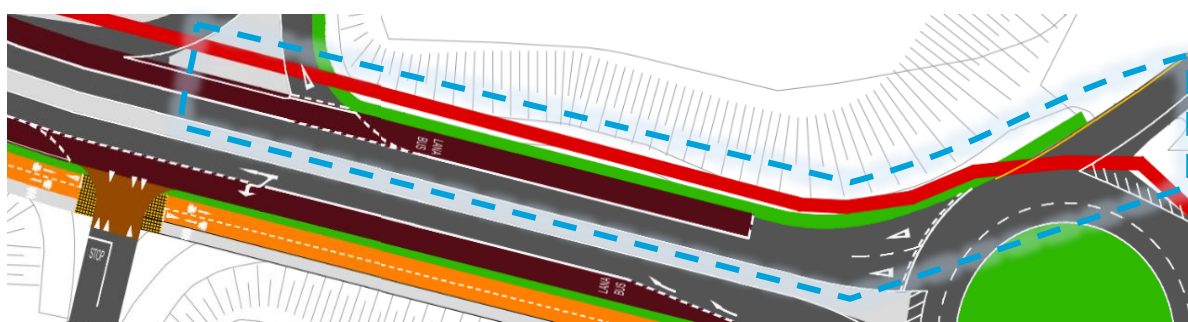
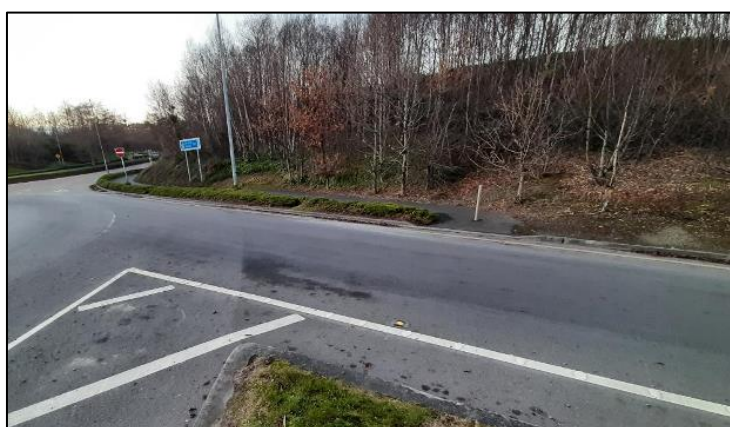
Figure 2-13 – Footpath Leads onto Carriageway

### 2.2.13. Problem: Footpath Leads onto Carriageway

**Location:** West Side of N11 Junction 6

There is an existing footpath on the north side of the road which leads to a drop kerb onto the carriageway at the northbound exit from the roundabout (shown below in Figure 2-13). This leads pedestrians directly onto the carriageway with no pedestrian provision on the other side of the road. This arrangement may lead to the hazard of pedestrians traversing the carriageway, which could lead to the risk of collisions between vehicles and pedestrians.

The existing footpath should be removed (e.g. replaced with a grass verge, or similar).

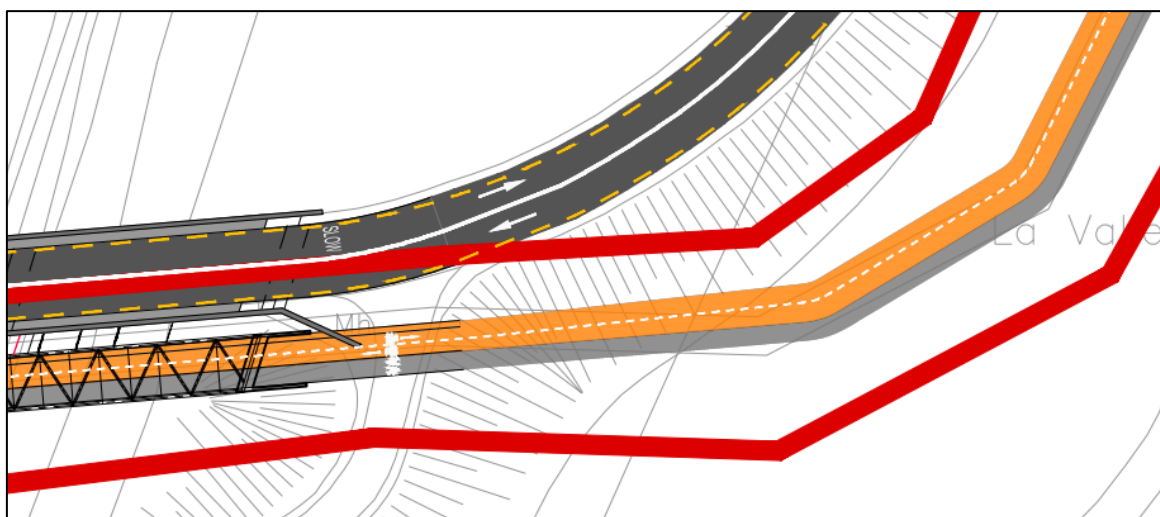
**Figure 2-14 – Significant Change in Levels for Existing Ground**

### 2.2.14. Problem: Significant Change in Levels for Existing Ground

**Location:** East Side of N11 Junction 6 Pedestrian Bridge

There are significant changes in existing ground levels where a footpath and two-way cycle track is proposed at the east end of this scheme (shown below in Figure 2-14). The proposed length of this facility, as allowed for in the design, may result in a steep incline / decline for NMUs. This would be especially problematic for wheelchair users and less-abled pedestrians, and would promote high speeds for cyclists; all of which may result in slips, trips and falls for NMUs. Steep drop offs may be a result, each side of the proposed facility, which could increase injury severity during falls.

The Design Team should ensure that gradients are suitable for NMUs, and sufficient protection is put in place at any steep side-slopes, such as parapets or fencing along the extents of the slope.

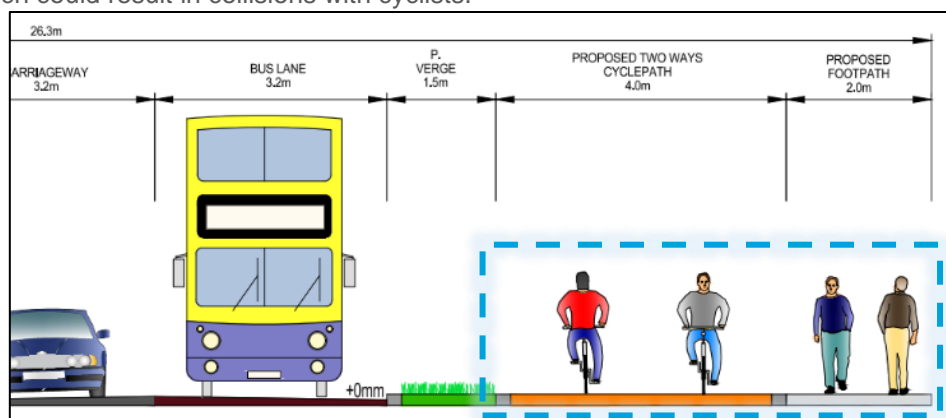
**Figure 2-15 – Footpath and Cycle Track Delineation**

## 2.2.15. Problem: Footpath and Cycle Track Delineation

### Location: Scheme Wide

The proposed footpath and cycle lanes across the scheme are flush with no kerb in between. This may lead to the hazard of visually impaired pedestrians unknowingly straying onto the cycle track which could result in collisions with cyclists.

The Design Team should provide a delineating kerb in between the footpath and cycle lane to inform visually impaired pedestrians of the boundary of the footpath.

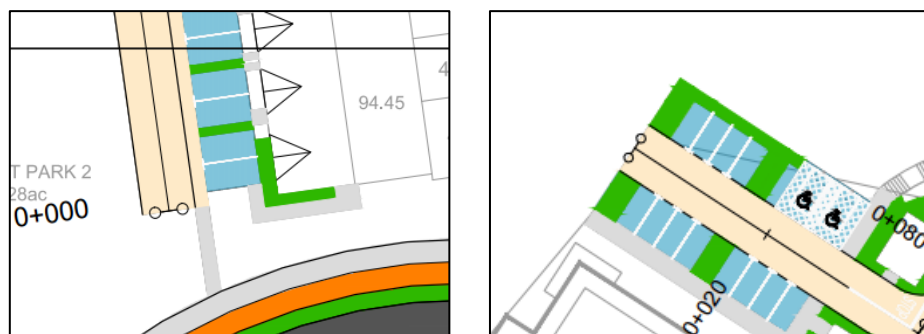
**Figure 2-16 – Provision for Turning areas for Vehicles**

## 2.2.16. Problem: Provision for Turning areas for Vehicles

### Location: Scheme Wide

There are numerous cul-de-sacs on the homezone carriageways across the scheme that do not contain provision for vehicles to turn around (non-exhaustive examples shown in Figure 2-16), such as refuse vehicles. This may result in vehicles making multi-point turns or reversing along the road to the closest junctions where there is more space on the carriageway to perform a turning manoeuvre. These manoeuvres can increase the risk of conflict with pedestrians or other road users.

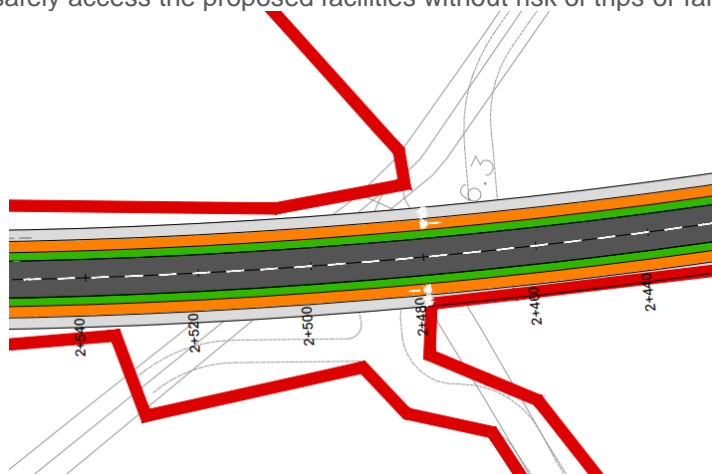
**Figure 2-17 – Intersection of Existing Routes and Proposed Main Road**

#### **Location: Scheme Wide**

A number of existing routes intersect with the proposed main road (example shown in Figure 2-17). Adequate tie-in/transition provision for pedestrians and cyclists may be required to ensure that these users can safely access the proposed facilities without risk of trips or falls.

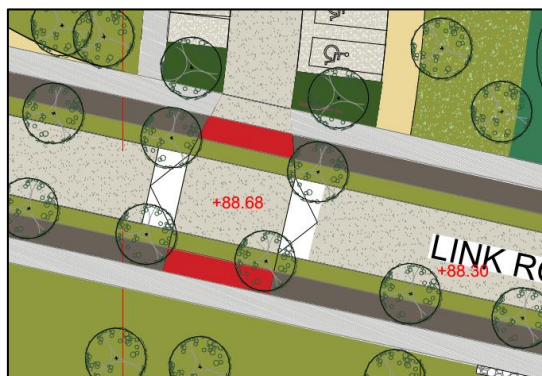
Figure 2-18 - Trees Impeding Sightlines Across Scheme

### Location: Scheme Wide

The proposed trees located along all roads in the scheme may impede sightlines for drivers and NMUs depending on the size and scheduled maintenance of the trees (example shown in Figure 2-18). If the trees are large in nature, with thick trunks or broad foliage, this may lead to collisions between drivers and NMUs (if visibility is blocked at crossings), or other drives (if visibility is blocked at junctions).

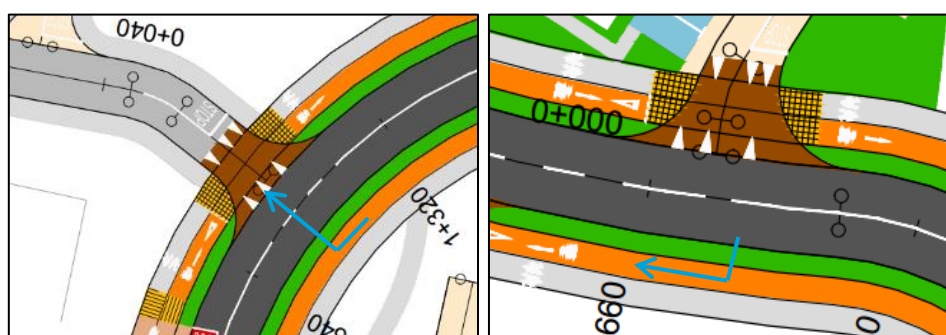
Figure 3-1 – No Provision for Cyclists Turning Right

#### Location: Scheme Wide

There are junctions across the scheme (non-exhaustive examples shown in Figure 3-1) that have no provision for cyclists to enter/exit from the other side of the road. Current arrangements expect cyclists to use crossings relatively far from the junction, which may result in cyclists crossing the verge or using the carriageway.

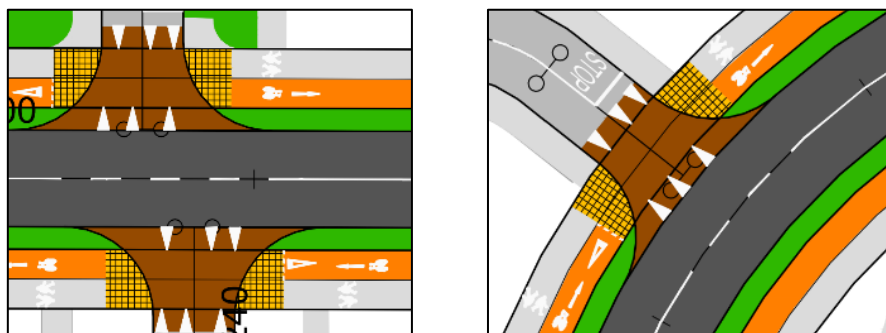
Figure 3-2 – Tactile Paving on Cycle Tracks

**Location:** Scheme Wide

Across the scheme, tactile paving is shown on cycle tracks prior to and after junctions (shown in Figure 3-2). This may cause unnecessary destabilisation of cyclists at crossings.

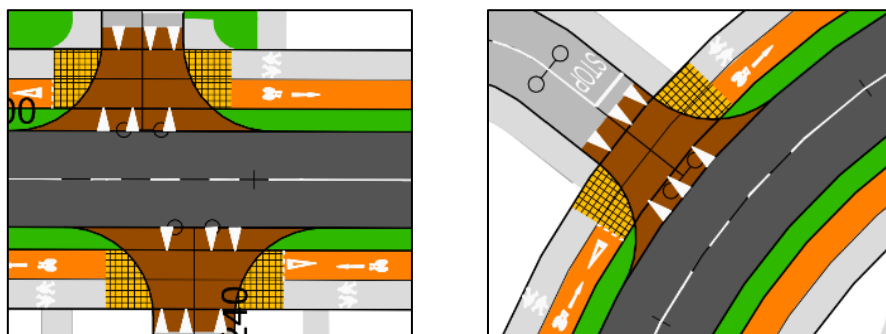
Figure 3-3 – Right of Way for Junctions Across Scheme

**Location:** Scheme Wide

Across the scheme, junctions are designed to give right of way to vehicles while NMUs are expected to yield (as shown in Figure 3-3). DMURS states “*This Manual recognises the importance of assigning higher priority to pedestrians and cyclists, without unduly compromising vehicle movement, in order to create secure, connected places that work for all members of the community*”.

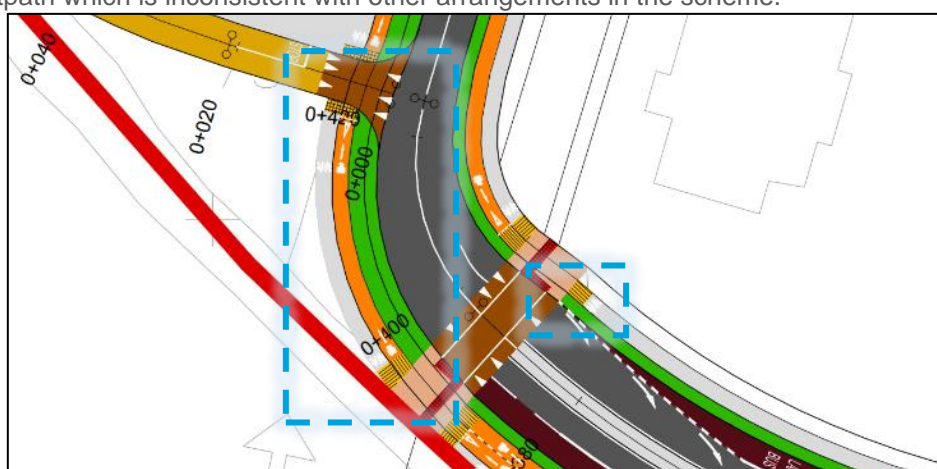
Figure 3-4 – Proposed Tramline Paving

At the junction where the realigned Berryfield Lane merges with the main road of the scheme, there is no provision for southbound cyclists existing Berryfield Lane (as shown in Figure 3-4). This may result in southbound cyclists using the northbound cycle track or using the carriageway, which may lead to collisions with other cyclists and vehicles respectively.

Additionally, the tramline tactile paving on the east side of the crossing is orientated parallel to the footpath which is inconsistent with other arrangements in the scheme.

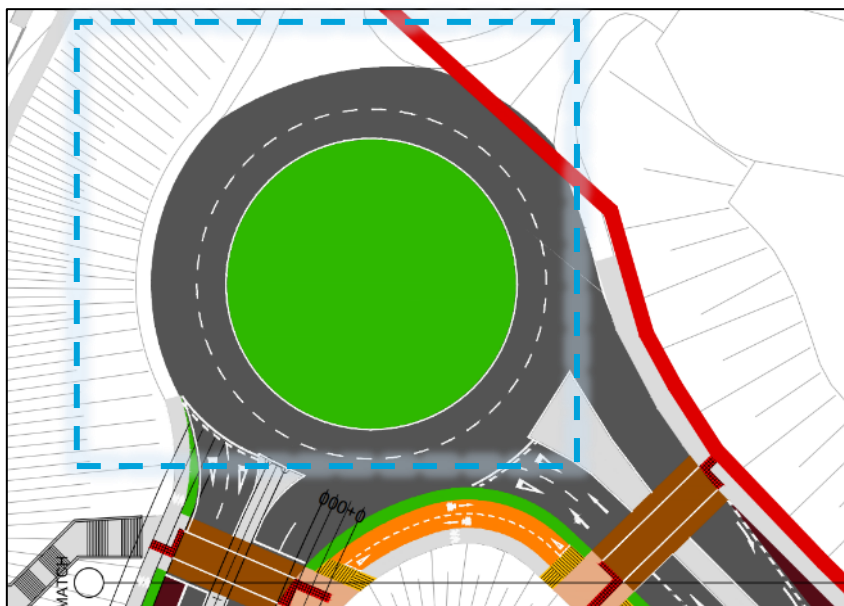
**Figure 3-5 – Provision for Pedestrians at Roundabout**

#### Location: Main Road / Thornhill Road Roundabout

The footpath at chainage 0+000 of the scheme ends abruptly on the west side of the roundabout scheme (as shown in Figure 3-5). This may encourage pedestrians using the footpath to traverse the roundabout on the existing verge or on the main carriageway on the west side, which could result in collisions with vehicles. Furthermore, there is no ramp access to the residential area to the west, only steps are provided, which will present a barrier for access for mobility impaired users.

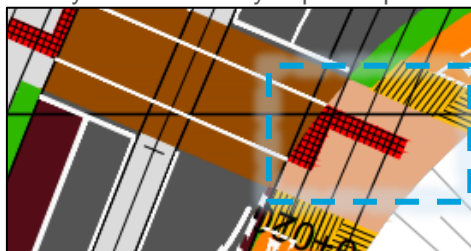
**Figure 3-6 – Proposed Tactile Paving**

**Location: Main Road of Scheme (Chainage 0+015)**

The proposed tactile paving at the toucan crossing does not extend to the back of the footpath (as shown in Figure 3-6). This may lead to visually impaired pedestrians being unaware of the crossing.

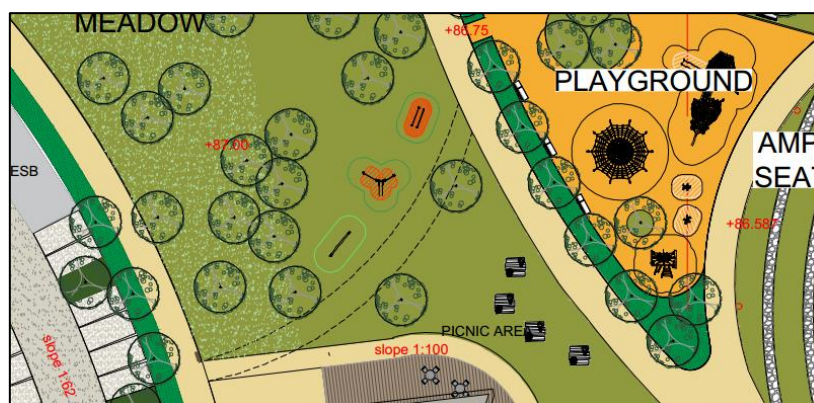
**Figure 3-7 – Lack of Direct Access to Playground**

**Location: Recreational Area**

There is a lack of direct access to playground from the parking area to the west which may result in users walking across the grass along the dashed path (as shown in Figure 3-7).
