Title: STAGE 1 ROAD SAFETY AUDIT For;

Holybanks Swords

Client: Cairn Homes/Waterman Moylan

Report reference: 0934R01

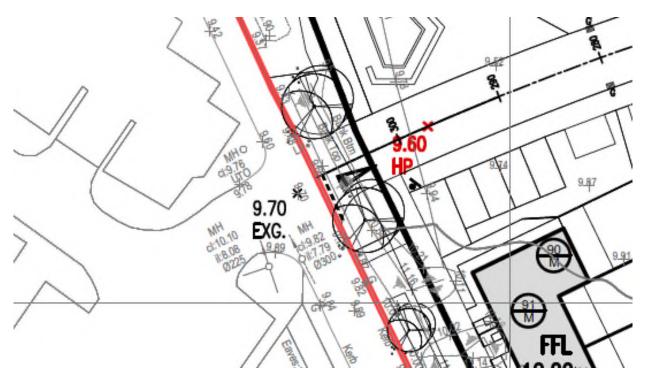
Drawing 17-088 P002 Rev -, Jugback Terrace vehicular access.

It is proposed to provide a crossroads on Jugback Terrace with a yield control for vehicles exiting the proposed development. There is a risk that given the relatively low number of vehicles that will be travelling from the single dwelling at the end of Jugback Terrace that drivers exiting the proposed development may not expect conflicting traffic and may travel across Jugback terrace without yielding or stopping resulting in side-impact collisions.

It is recommended that the development access be staggered from the access to Applewood Lane.

3.1	Yes	No	Due to the very low traffic likely to be on Jugback Terrace it is proposed to change the priority. A stop line will be installed on both sides of Jugback Terrace. See attached amended drawing no. 17-088/ P002 Rev A	Yes

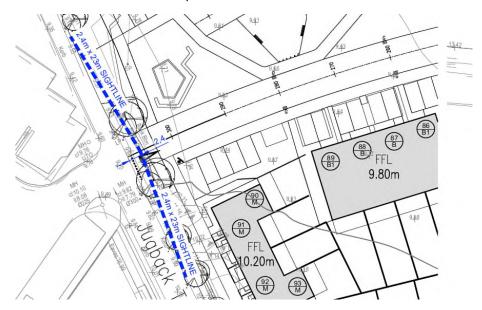
Drawing 17-088 P010 Rev -, Jugback Terrace.

The sightlines on Jugback Terrace are shown for a design speed of 30km/hr. It is unclear if this is based on measured speeds. The speed limit is 50km/hr. An underestimate of the actual speed of vehicles post construction could lead to side-impact or rear-end collisions.

It is recommended that the speed limit on Jugback Terrace be reduced to 30km/hr.

3.3	No	No	Junction priority is proposed to be changed as per response to Problem 3.1 above.	Yes
3.4	Yes	Yes	Continuity of cycle track along Glen Ellan Road is outside the applicants control. The matter will be referred to Fingal County Council. We would note that the lands fronting this section of Glen Ellen Road are zoned for development and consequently are likely to be developed in the future. Continuity of the cycle lane can be provided at this time.	Yes

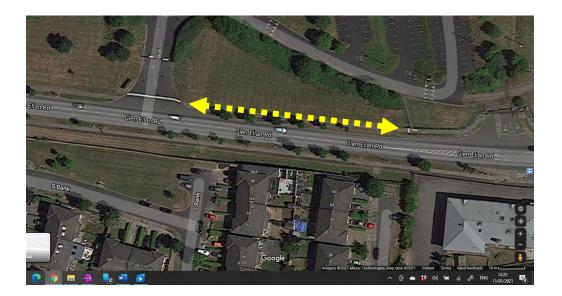
Drawing 17-088 P011 Rev -, Glen Ellan Road, Cycle Track.

It is proposed to terminate the cycle track at the access to private lands at the eastern boundary of the development. This will lead to a short discontinuity in cycle facilities between this point and the approach to the Balheary Road Junction where the cycle track recommences. The merging of cyclists with general traffic will lead to an increased likelihood of a collision.

It is recommended the cycle track be made continuous along the verge of Glen Ellan Road.

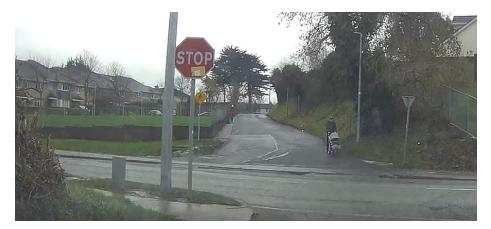
LOCATION Drawing 17-088 P011 Rev -, Glen Ellan Road.

There is a pedestrian desire line across Glen Ellan Road for those wishing to travel via Jugback Lane to Swords town centre or to Swords Community College. The demand will increase when the new development is constructed. It is unlikely that pedestrians are going to cross at the existing signalised crossing to the West of Jugback Lane.

It is recommended that a controlled signalised crossing be provided on Glen Ellan Road that caters for the desire line along Jugback Lane.

3.5	Yes	No	Due to locations of existing bus stops it is not possible to locate the pedestrian crossing at the desire line. The existing crossing is only 60m from the junction.	Yes

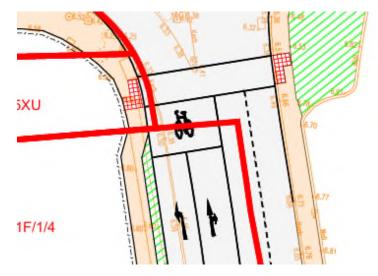
Drawing 17-088 S105 Rev -, Balheary Road Junction.

It is proposed to provide an advance stop line for cyclists at the Balheary Road Junction on Balheary road, northbound. There is however no proposed cycle lane or cycle track leading up to that facility. This may lead to cyclists weaving between queuing traffic to get to the turning facility without adequate space to

do so and without any warning for drivers. This could result in collisions between cyclists and vehicular traffic.

It is recommended that the verge be converted into a cycle lane which connects to the advance stop line for cyclists.

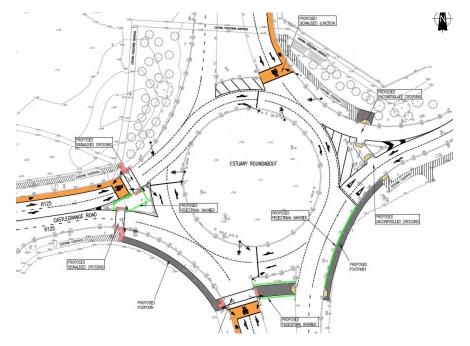
Drawing 17-088 S135 Rev -, Estuary Road Roundabout.

It is proposed to partially signalise Estuary Road Roundabout. It is also proposed that cyclists will use the circulating carriageway and enter the spiral type lane system with other traffic and move into the outer lane at the signals via an advance stop line. There is a risk that cyclists will be struck by weaving traffic on the circulating carriageway.

It is recommended that the roundabout be converted to a signalised junction similar to the layout currently being displayed to the public on the Fingal Co. Co. website for the Swords Connectivity Project.

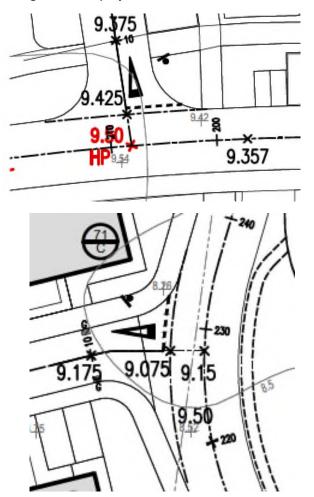
Drawing 17-088 P002 Rev -. General Internal Roads.

The corner radii at the internal junctions appear to be large which leads to higher turning speeds, longer crossings and higher severity injuries if vulnerable road users are struck.

It is recommended that corner radii are provided in accordance with the guidance provided in DMURS.

3.11	No	No	Corner Radii are generally 4.5m to accommodate occasional large vehicles (refuse trucks). See drawing 17-088/P004 and P005 which complies with DMURS for occasional larger vehicles as per Figure 4.43 in DMURS	Yes

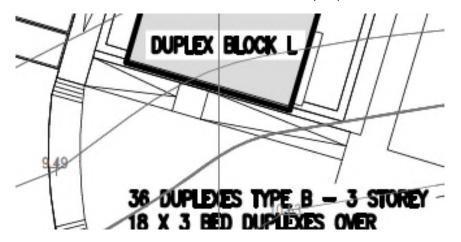
Drawing 17-088 P002 Rev -. General Internal Footpaths.

The internal footpaths within the development have ramp type markings and transverse markings. It is unclear what the transverse markings represent. There is a risk that if the gradients are excessive on the footpaths that certain areas will not be accessible to the mobility impaired.

It is recommended that footpath gradients within the development comply with the limits set out in Part M of the Building Regulations.

3.13	Yes	Yes	Footpath gradients will be reviewed at detailed design stage in order to comply with Building Regulation guidelines for mobility access. The traverse lines are a landscape architect paving feature which have been removed from our engineering drawings.	
3.14	Yes	Yes	Uncontrolled pedestrians' crossings have been amended to ensure perpendicular crossings.	
3.15	Yes	Yes	Gullies have been relocated immediately upstream of all uncontrolled pedestrian crossing points and road levels adjusted to have the low at the new gully locations.	
3.16	Yes	Yes	Disabled space has been relocated	
3.17	Yes	Yes	Additional traffic calming measures will be provided at detailed design stage, which may include build outs along the open space to reduce traffic speeds and or raised tables.	
3.18	Yes	Yes	Road has been extended to provide safe access to on-curtilage parking at

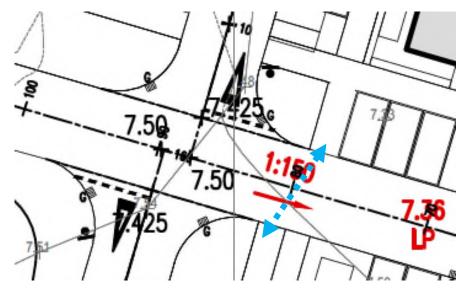
Drawing 17-088 P002 Rev -. General Internal Footpaths.

Some internal footpaths do not align at uncontrolled crossing points of the road network. This could lead to difficulties for crossing of the carriageway for blind or partially sighted pedestrians.

It is recommended that footpaths at the opposite side of uncontrolled crossings align perpendicular to the direction of vehicular traffic travel.

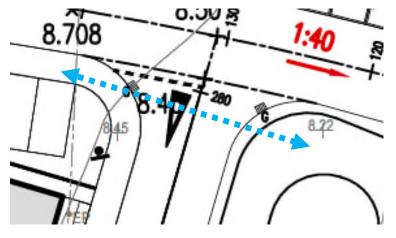
Drawing 17-088 P002 Rev -. General Internal Footpaths.

There is a risk of surface water ponding at the dropped kerbs associated with uncontrolled pedestrian crossings without adequate drainage upstream. There is a risk of trips and falls if gully gratings are provided in the line of an uncontrolled crossing.

It is recommended that surface water gullies are provided immediately upstream of all uncontrolled pedestrian crossing points .

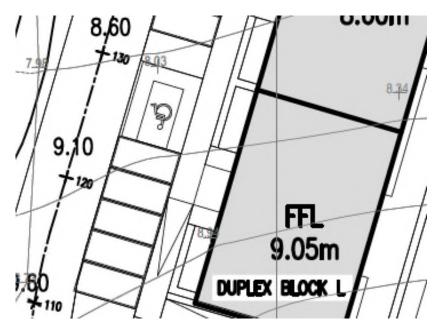
LOCATION Drawing 17-088 P002 Rev -.

The proposed disabled parking space outside Block L is orientated at 90 degrees to the adjacent parking spaces. It is unclear how a driver could enter/exit this space if the adjacent spaces are occupied. This could result in a lack of facilities for disabled drivers, resulting in parking in areas that may be hazardous for other road users such as footpaths.

It is recommended that the parking layout be revised.

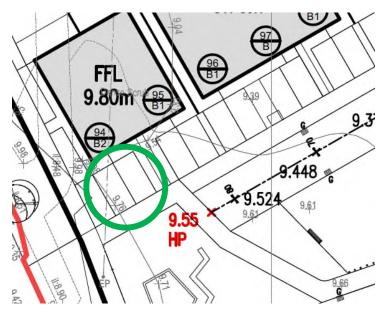
Drawing 17-088 P003 Rev -. Parking spaces at unit 94.

There is no access for the on-curtilage car parking spaces for unit 94. This could lead to drivers travelling/reversing on the footpath or green areas where they could collide with children

It is recommended that road access be provided to unit 94.

unit 94.
