CUNNANE STRATTON REYNOLDS

TREE SURVEY

Hollybank,
Swords,
Co Dublin.

Updated December 2021

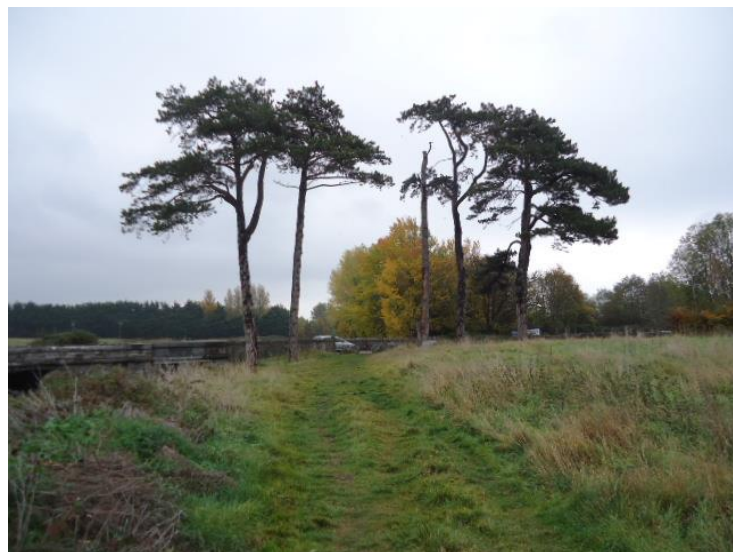
T548/T549/T550/T551/T552 (left to right)

3.2 Category 'U' trees are recommended for immediate removal, (fell or monolith to safe height), on general management grounds, irrespective of site development. One tree (T550) was included in this category during the first survey in 2018 and has since been removed. Fifteen additional trees are now included following the Oct 2021 update survey due to Ash Dieback disease.

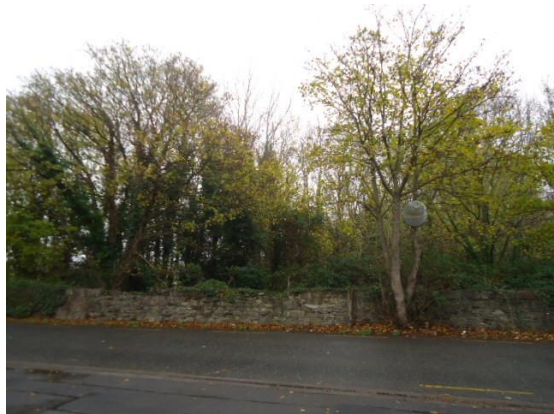
T1* & T2* (left to right)

There are potentially three exceptions, (T2* / T3* / T4*) to the above. These trees are all Sycamore that have presumably self-seeded within the margin of the roadway and have developed in their location between the road and the roadside wall. Their locations are very close to the carriageway and their long-term retention is probably not viable in this context. The trees are of relatively low merit, one has already developed a sizeable wound / decay at the base of its trunk. Whilst their retention may possible with the scope of the proposed works, (depending on to what extent their rootzone has extended beneath the existing carriageway), it is suggested that this might also be an opportune time to remove them.
