Arboricultural Assessment, Arboricultural Impact and Tree Protection Strategy Report

Tack site,
Sandyford Business Park,
Dublin 18

Project No.	TTAC001	Date	21/03/22
Project Name	Tack Sandyford SHD	Revision	-

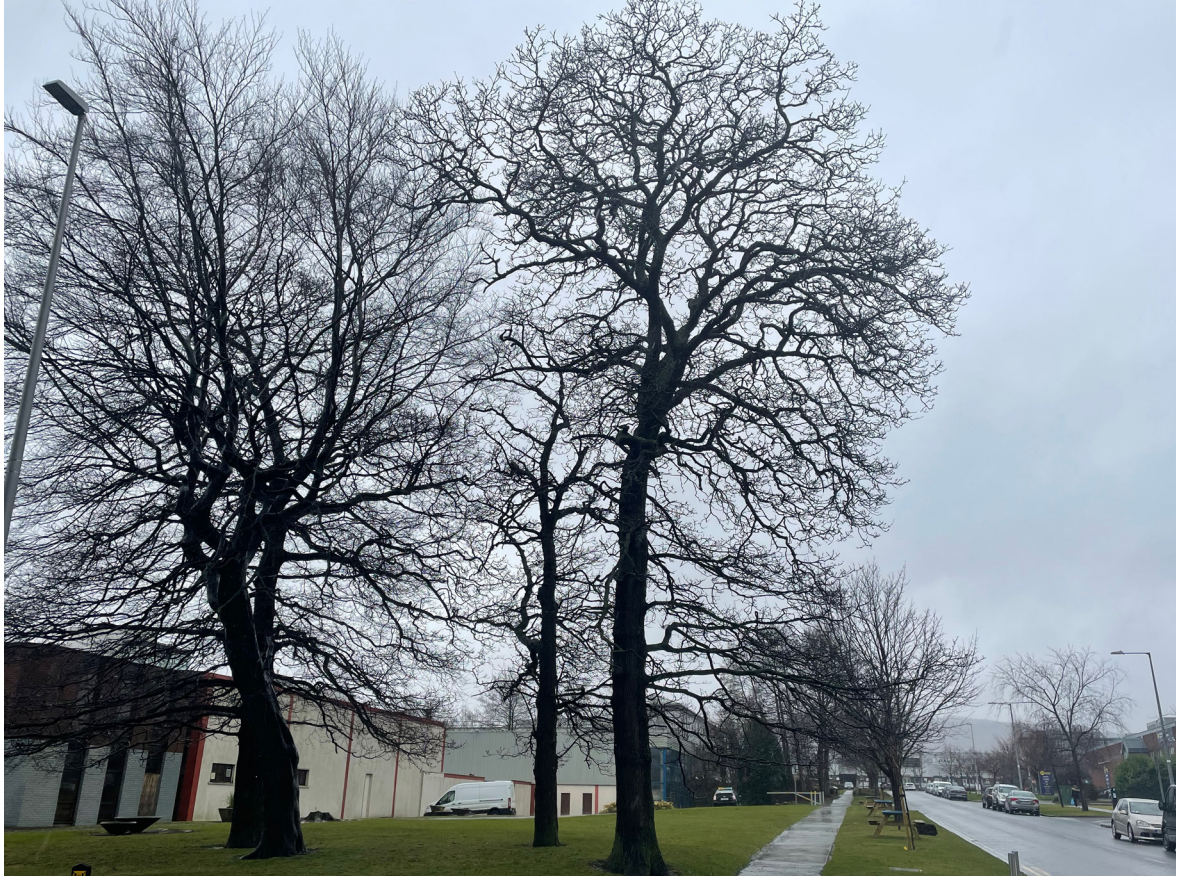
The highest value trees are the mature oak (*Quercus robur*) and beech (*Fagus sylvatica*) located in the north-west corner of the surveyed site (image 2). The condition and categorisation of individual trees is contained within section 5 of this report and with locations shown on drawing TTAC001 101.

Image 2. Oak #1 shown right in the foreground.

The construction of the proposed apartments south (block 'B') is likely to have an impact on roots for the mature oak tree #4. To avoid any severe impact on these roots it is recommended that building excavation be constrained if possible to 1m north of the proposed northern wall for block b.

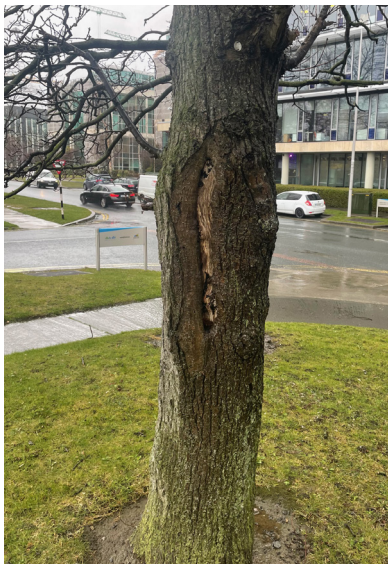
Image 3. Bark damage with associated decay on oak #2.

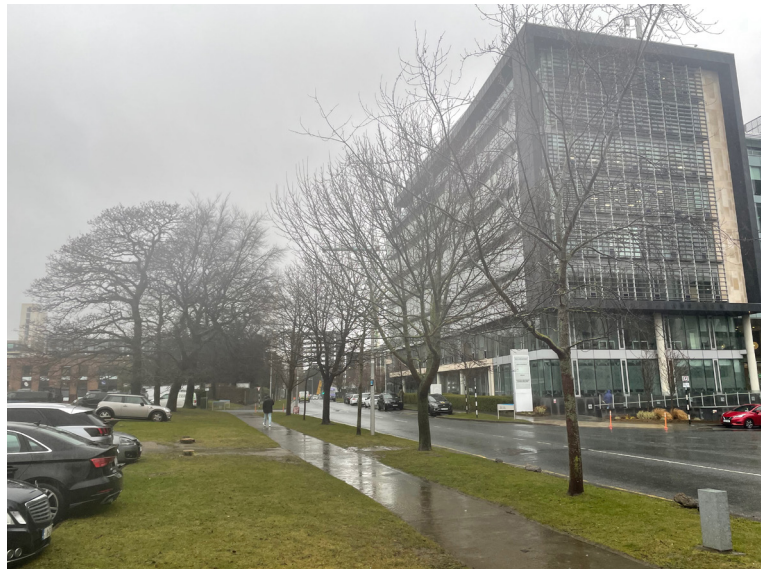
In addition 10 trees on open public lands were located and measured for root and canopy intrusion into the site (PUB 1-10). These were all found to be in good condition (image 4).

Image 4. Public street trees outside the northern boundary of the site on a grass verge adjacent to Carmanhall road..

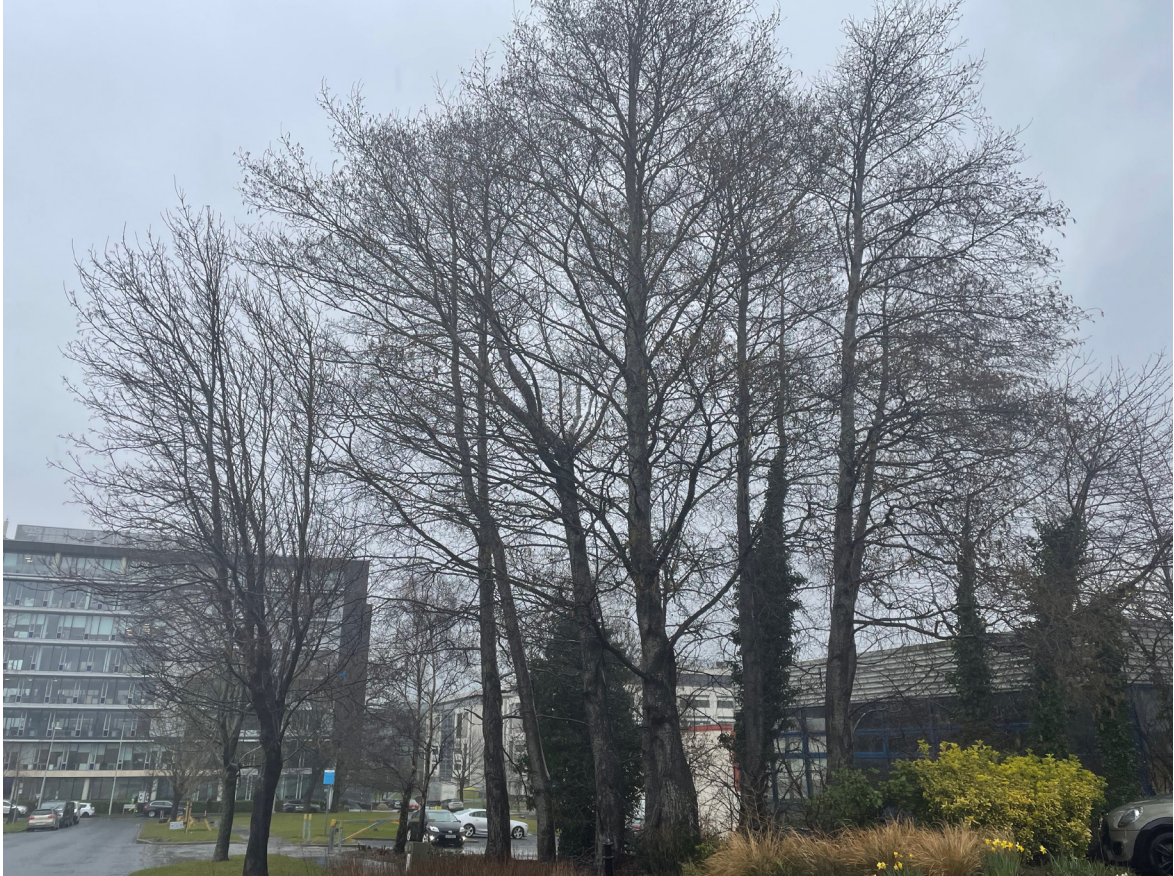
Located within the south-western corner of the survey boundary are a group (G13) of mature alder (*Alnus spp.*). These

suffer due to close planting and are drawn up with reduced crown cover as a result. Due to potential from windthrow, these trees should only be considered for retention as part of a group (image 5).

Image 5. Mature alder #G13 in the south-west corner of the site.

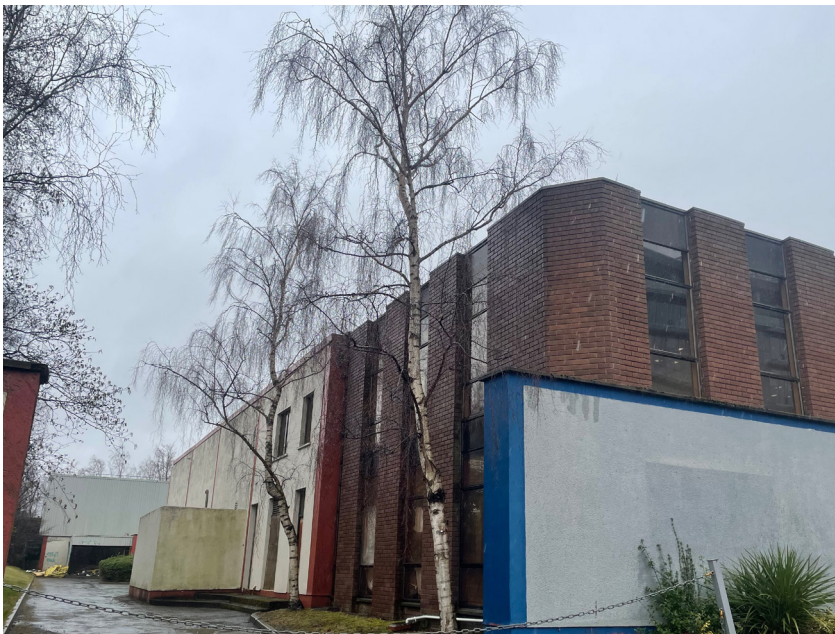
Image 6. Young and early mature birch (#5 & #7) in the north-east corner of the site.

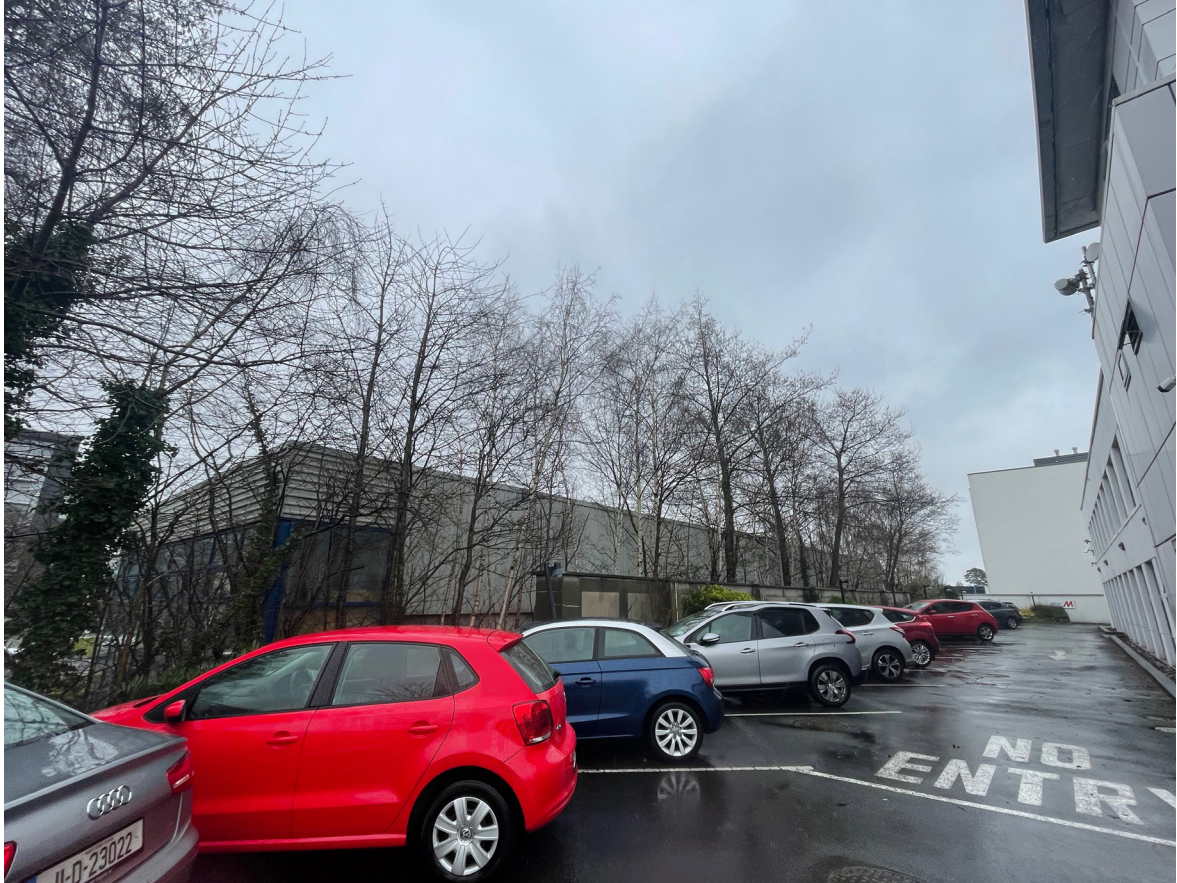
Trees that have been given group descriptions provide screening to the southern and eastern site boundaries (images 5&7). These are generally of poorer condition and predominantly consist of birch (*Betula pendula*), which due to closely spaced planting exhibit drawn/extended form.

Image 7. Juvenile birch, young self seeded sycamore and alder #G14 & G15 screen the southern boundary with Mercury House.

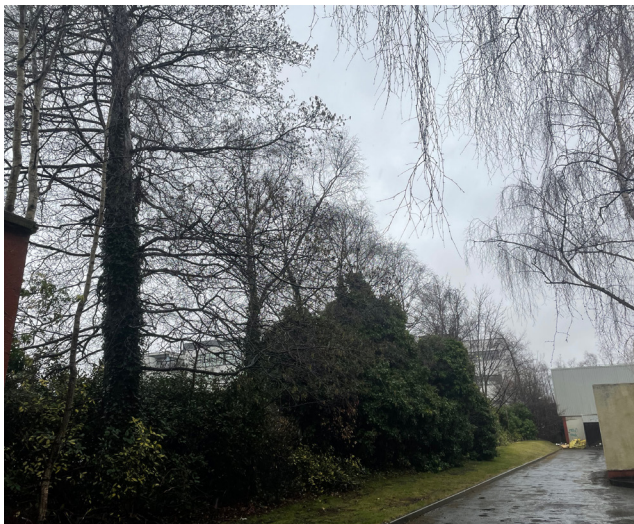
The southern site boundary chiefly features young birch (*Betula pendula*) with occasional self-seeded sycamore (*Acer pseudoplatanus*) and more mature alder (image 8).

Image 8. Birch #G8 screening the eastern site boundary.
