PHOTOGRAPHIC RECORD

Auburn House, Malahide, Co. Dublin.

Kinwest Ltd.,

April 2022

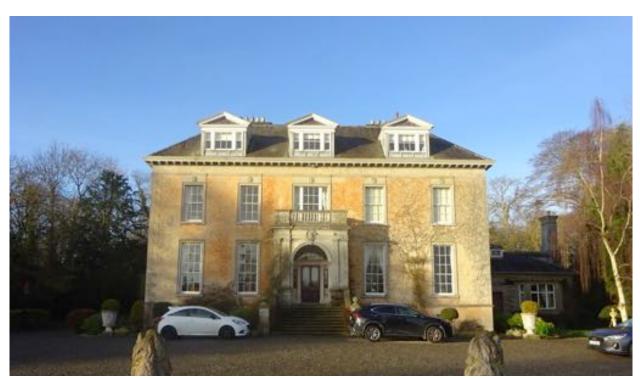
Fig 1: Front (east facing elevation) showing 5 bay 2 storey over basement elevation with attic storey. Later alterations include porch and front steps; widened dormer windows to attic and new Billiard Room wing of 1907 to the right and set back. Embellishments to window surrounds and eaves.

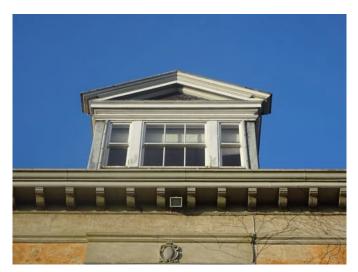
Detail above (Fig 6) of the dormer window with its prominent moulded pediment and unusual Wyatt type format and a detail of the open porch (above right Fig 7) and steps which were added most likely in the late 19th century or early 20th century.

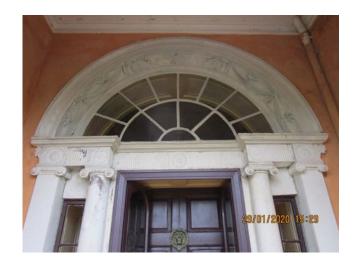
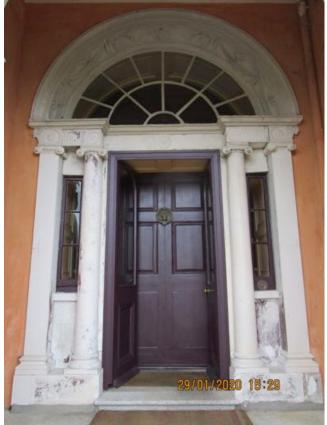
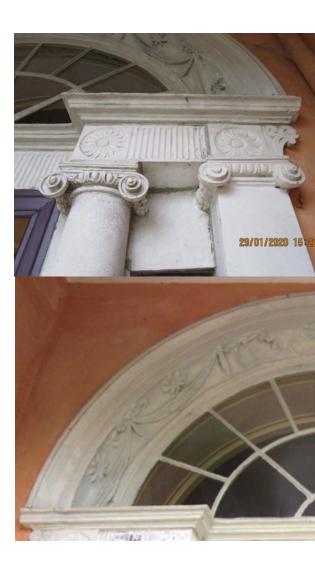
Details above of the original door-case (Figs 8 and 9 - above left and right) held within the later porch. Ionic capital and decreveal to the fanlight. Pilasters (top right – Fig 9) appear to have been restored recently. Further details Fig 10 and 11 below

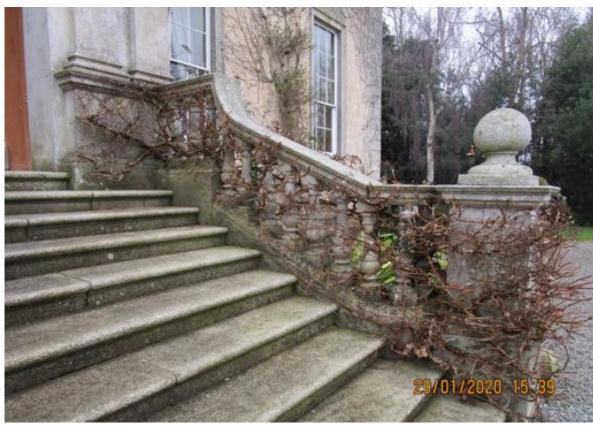
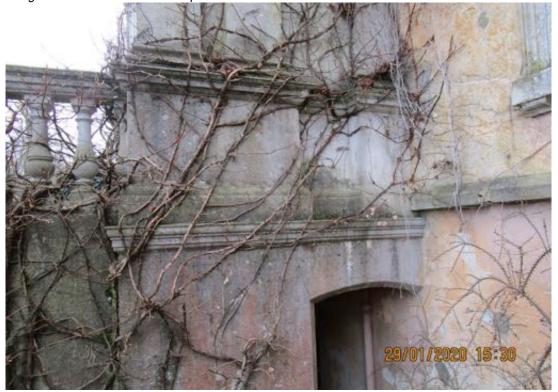
Fig 12 Detail above of the later steps with granite stone balustrade and pillar. Paired pilasters are applied to the porch. Side view (below - Fig 13) with pilasters carried to the side elevation of the porch articulating the surfaces above moulded string course above vaulted below porch.

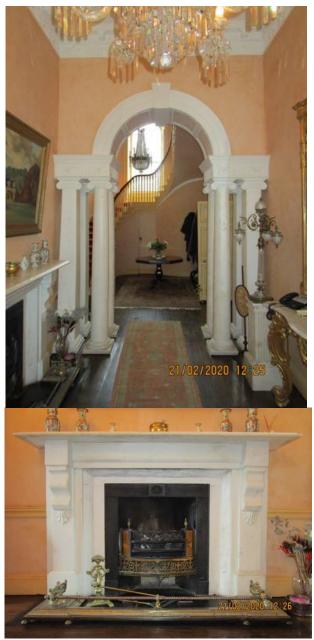
Views above the Entrance Hallway (GF-01) with quadruple columns formed of circular and square columns supporting a decorated frieze below the archway. White marble chimneypiece and fine original joinery at the inner face of the entrance door. (Figs 17, 18, 19, and 20 – clockwise from top left corner)

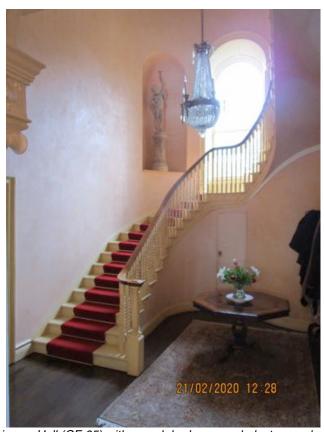
Fig 21 - Staircase Hall (GF-05) with superb barley sugar balusters and curtail step (above right) with turned newel post and tread end detail (Fig 22 – below left) with decorated scroll (below right - Fig 23).

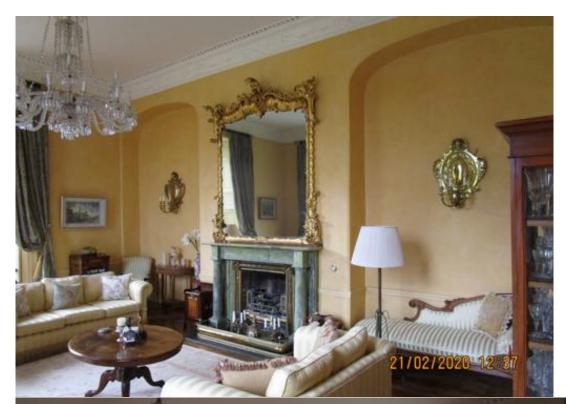
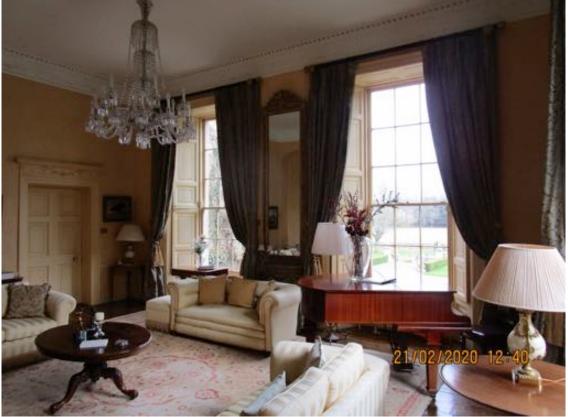
Fig 24 above and Fig 25 below) General view above of Drawing Room (GF-02) with excellent original joinery, plasterwork and chimneypiece.

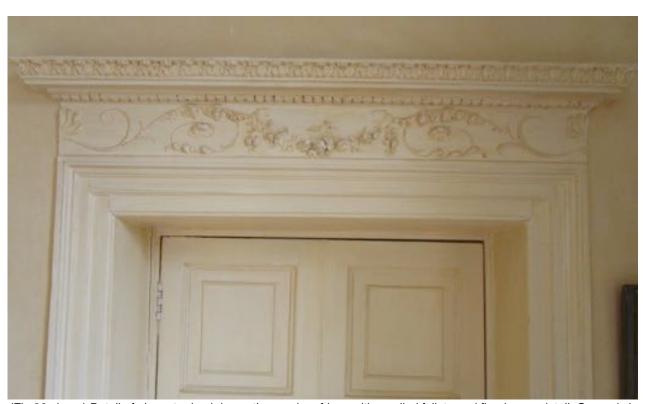
(Fig 26 above) Detail of elegant raised decoration on door frieze with scrolled foliate and floral swag detail. General view Below (Fig 27) of the Dining Room (GF-11) with chimneypiece in the same style as the Drawing Room. Curved and arched recesses to either side with jib door and decorated frieze to cornice.

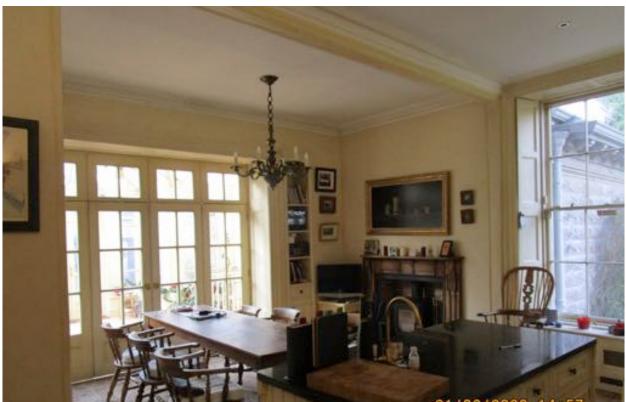
View (Fig 31 above) of modern kitchen - Room GF-08 - with modern conservatory (GF-09 - Fig 32) to the rear which links to t rear stable yard to the 1907 Billiard Room wing. View (bottom right - Fig 33) of the simpler joinery of the secondary

staircase (GF-06) leading to the upper floors and basement.

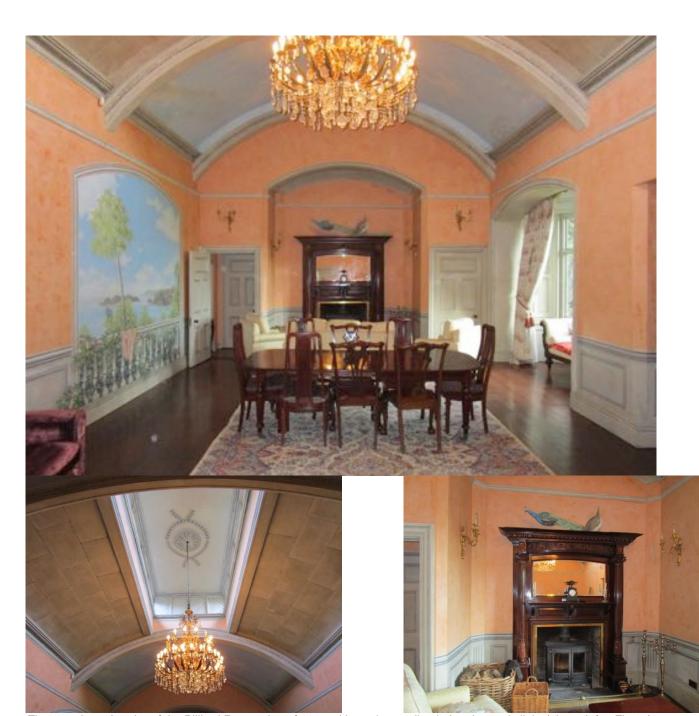
Fig 34 – above Interior of the Billiard Room wing of 1907 with modern wall painting; large skylight (above left – Fig 35) with plaster decoration and hardwood mantelpiece with integrated mirror and richly modelled hardwood carving (Fig 36 – lower left).

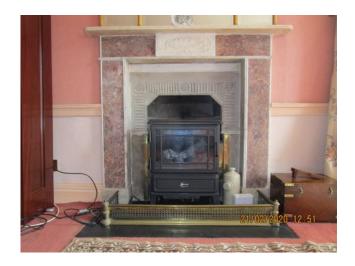
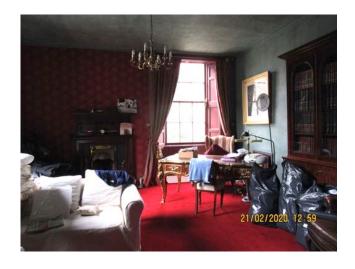
Eigtheenth century chimneypiece with stone insert (Fig 43 above left); arched recess on main landing with study room (FF-11) (Fig 44 – above right); Fig 45 – Below left- room on half landing off secondary staircase at mezzanine level with hardwood chimneypiece (Fig 46 – below right) - likely dating from the time of the 1907 wing addition).

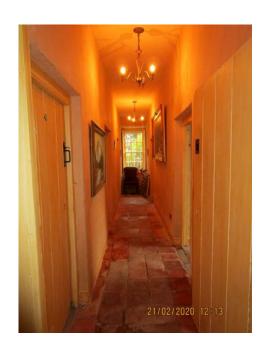
Access stairs (above left – Fig 53) and main hallway BM01 (Fig 54); granite fireplace in old kitchen (BM-03 – Fig 58) and heavy cornice in old kitchen; Corridor (bottom left BM-06) and original chimneypiece in rear centre room (BM-06)

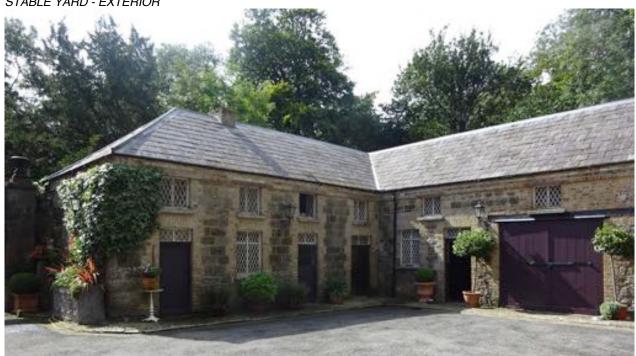
Views (above – Fig 59) of the south range and connecting west range and general view towards west range (below – Fig 60).

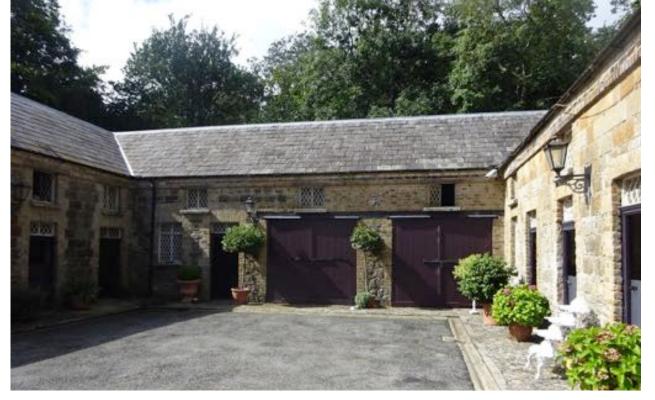
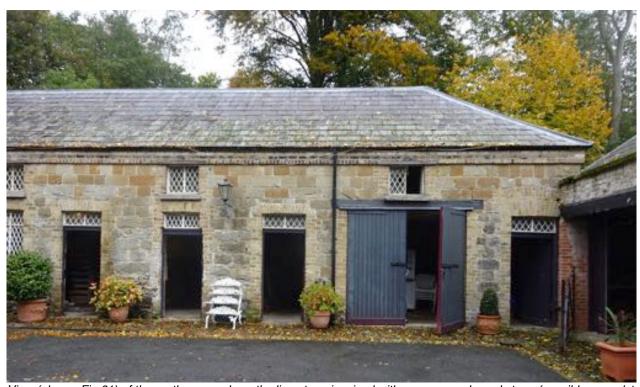
View (above- Fig 61) of the north range where the limestone is mixed with a warmer coloured stone (possibly a sandstone) and view (below – Fig 62) of the single storey connecting storage building and the rear of the main house.

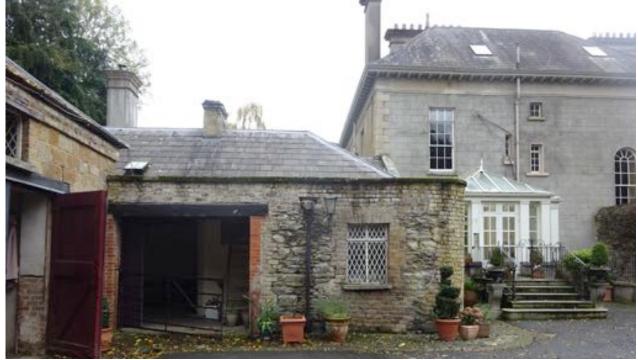
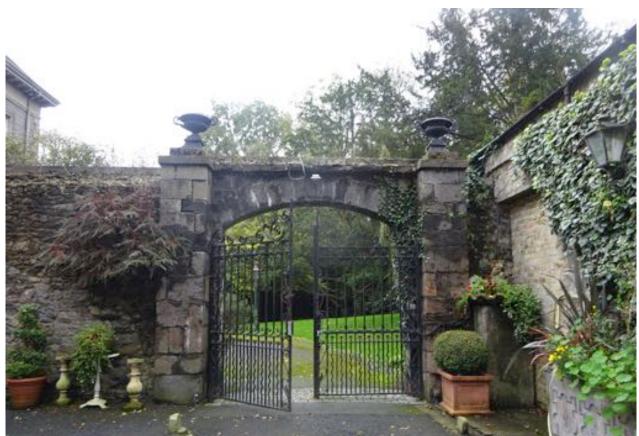
Views (above - Fig 63 and below - Fig 64) to the entrance archway at the south wall of the stable yard.

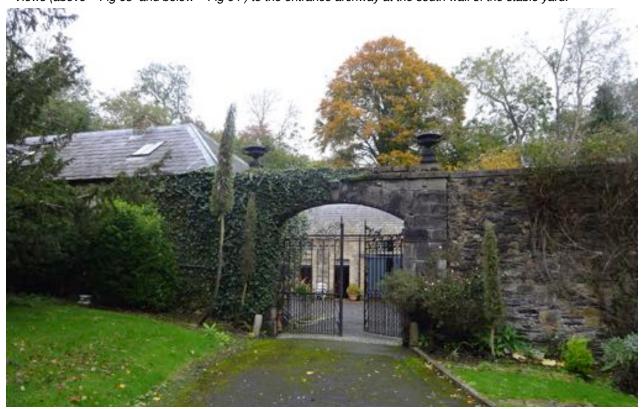
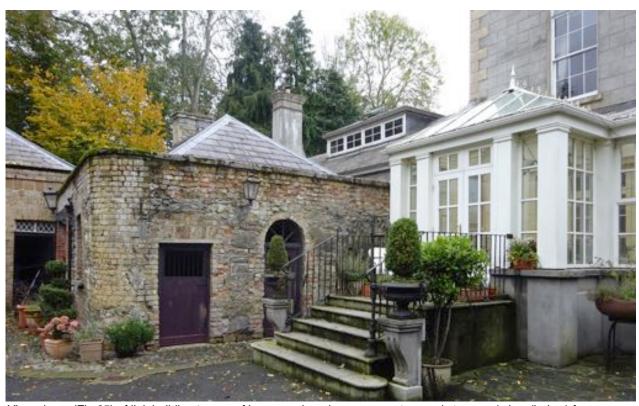
View above (Fig 65) of link building to rear of house and modern conservatory and steps and view (below) from rear service yard to south-west of stable yard structure. Modern dormer windows at roof level (Fig 66).

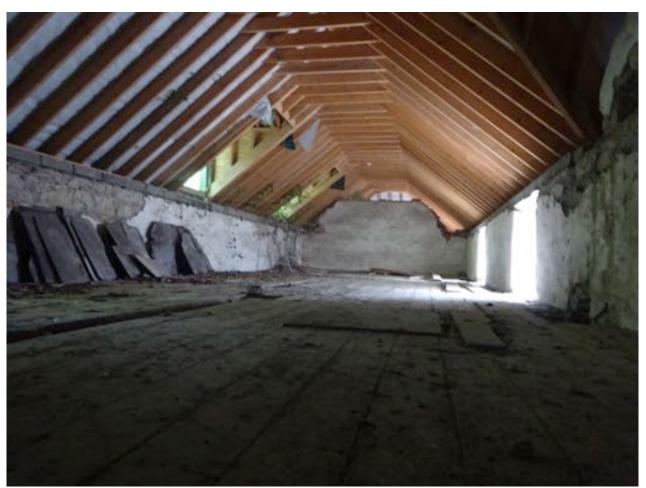
View above at first floor level (north range – Fig 70) of the stable yard buildings.

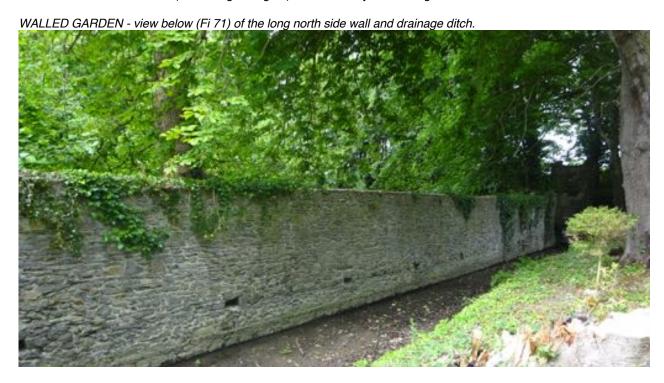
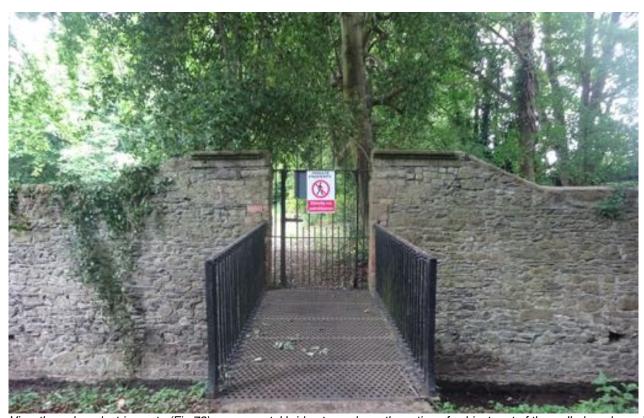
View through pedestrian gate (Fig 72) across metal bridge towards north section of subject part of the walled garden; view (below left – Fig 73) of walled garden stone boundary constructed in coursed limestone rubble towards north-east tower and view from inside walled garden of the north-west corner tower or bastion. (Fig 74 – lower right).

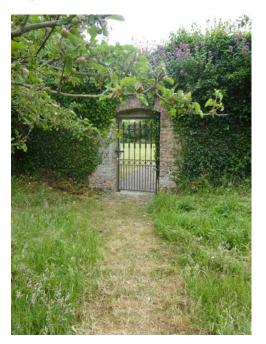
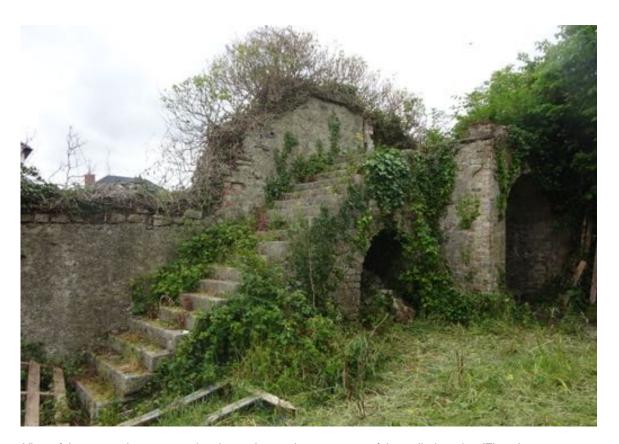
View of the more ruinous corner bastion at the south west corner of the walled garden (Fig 79).

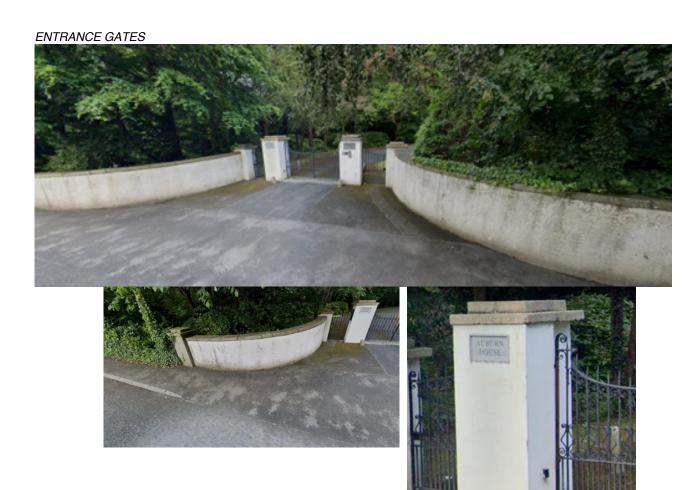
The entrance gates are in their original position with convex quadrant walls and are rendered masonry with plain granite cappings and modern wrought iron gates (Fig 80 – general view above and Figs 81 – detail of gate pier and Fig 82 – flanking wall)
