Report on Current Condition, proposed repair  
and advice on conservation based alterations for re-use to

## The Walled Garden Walls and corner Bastions at Auburn House, Streamstown, Malahide, Co Dublin

Project 21549

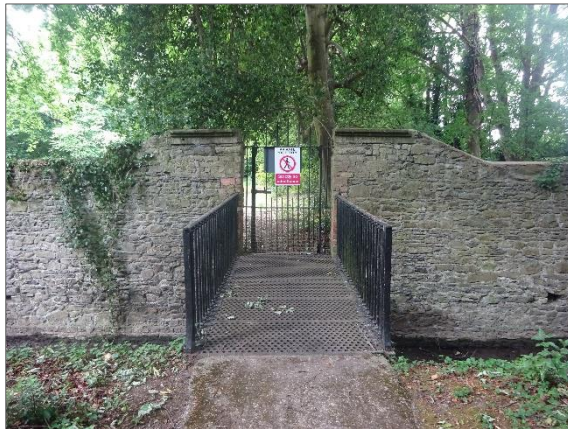
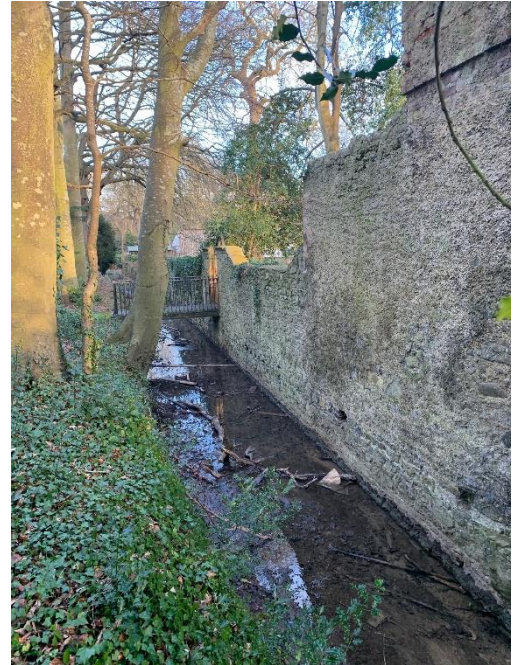
*Entrance form north over moat*  
*Photographs courtesy of Sheehan Barry Architects*

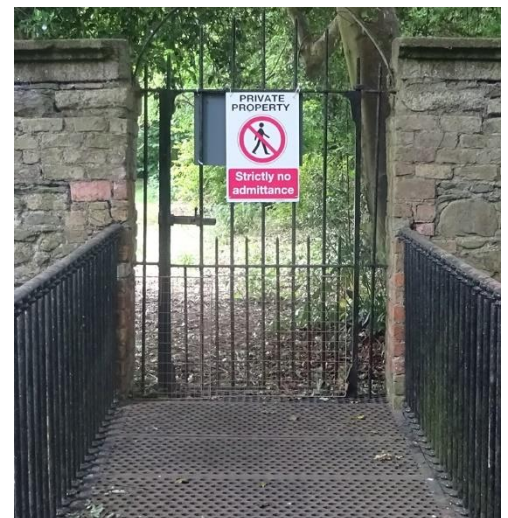
The north wall is interrupted by scooped ends framing the metal gate at the end of the bridge. The gate piers are formed of both random rubble and brick.

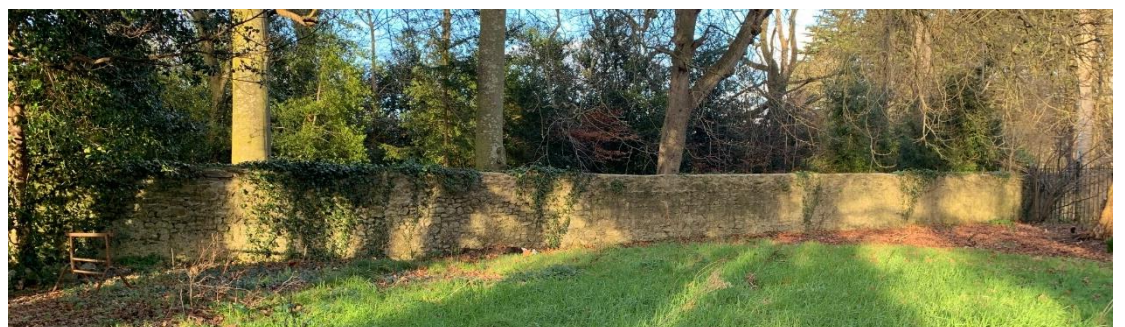
Within the garden because of the change in levels between the moat and the garden the height of the wall is more modest.

*View of north wall from within the Walled garden. Photograph courtesy of Sheehan Barry Architects*

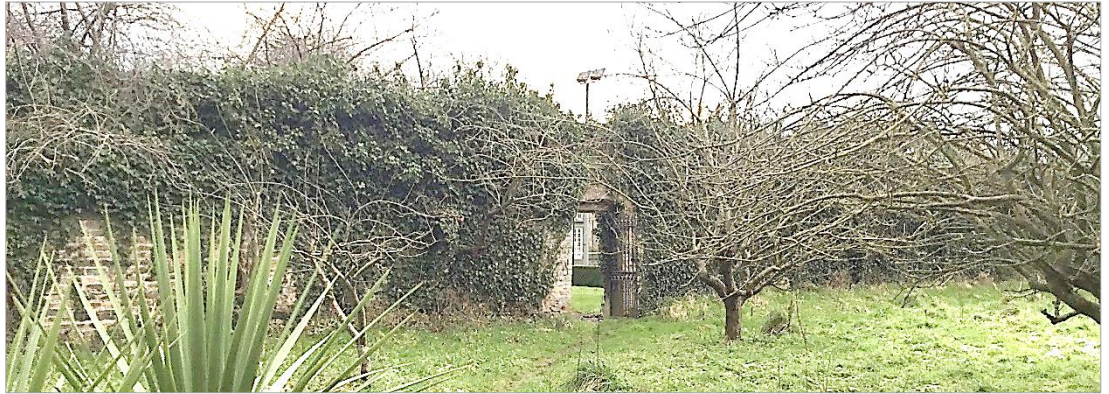
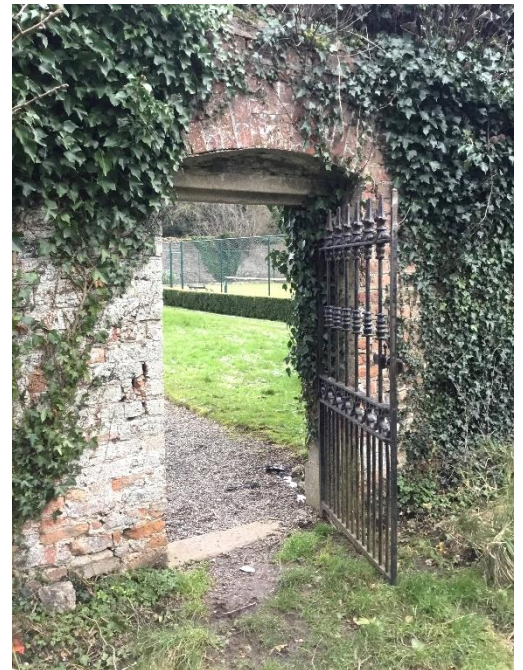
The 70m of east wall is more substantial than the other walls. It is brick lined akin to a typical Walled Garden wall for growing of fruit crops etc.

The gateway through to the eastern areas is worth noting for its brickwork as a possible theme for new works.

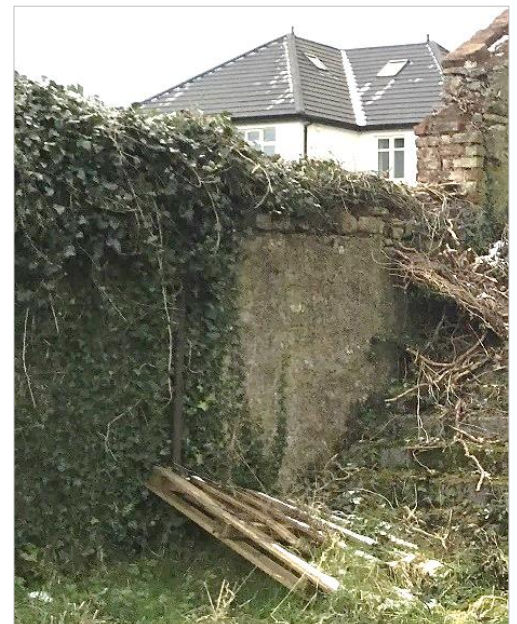
The south wall appears to be of random rubble with a dash to the vertical face and a rusticated random rubble top.

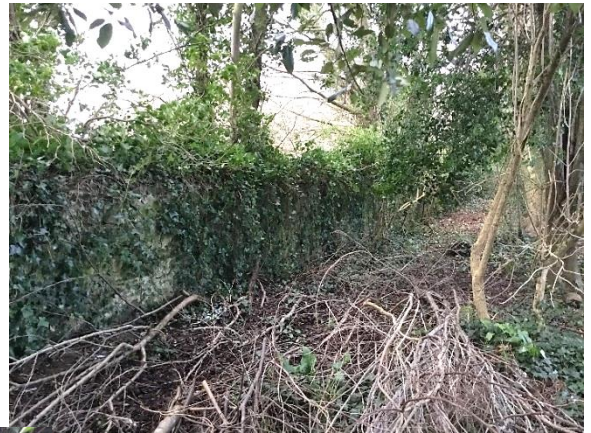
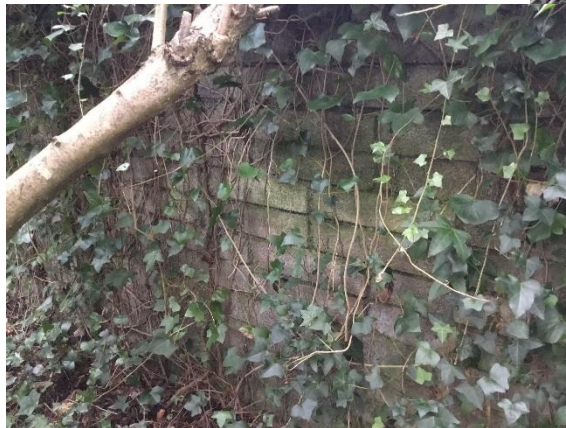
The wall is covered in Ivy and hard to discern, let alone establish its condition.

It was noted in two locations that there were more recent blockwork repairs. There may be more interventions

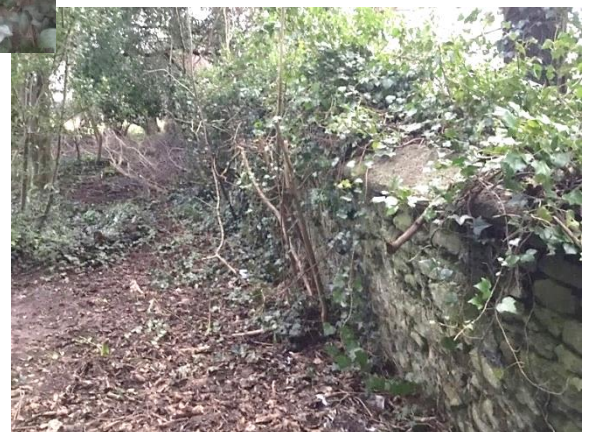
Significant lean to the wall both inwards and outwards was also noted.

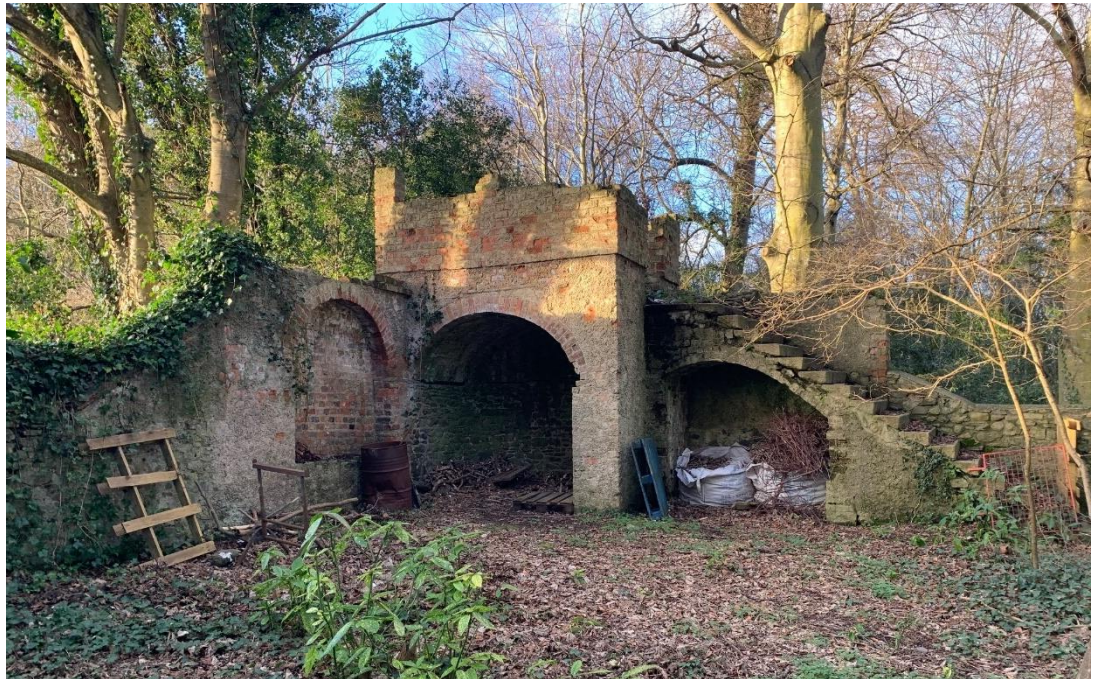
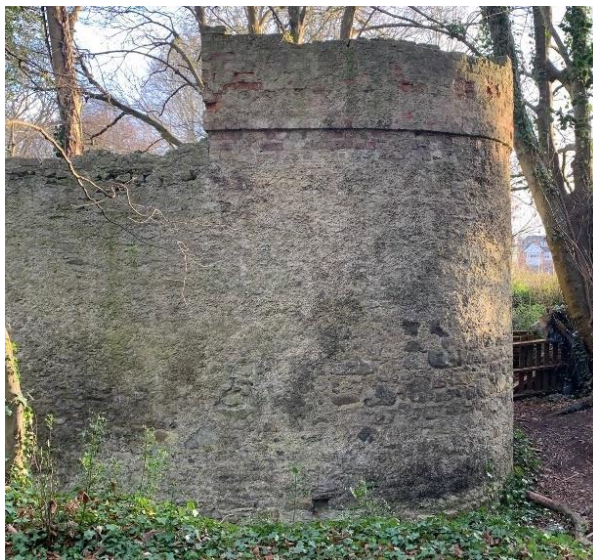
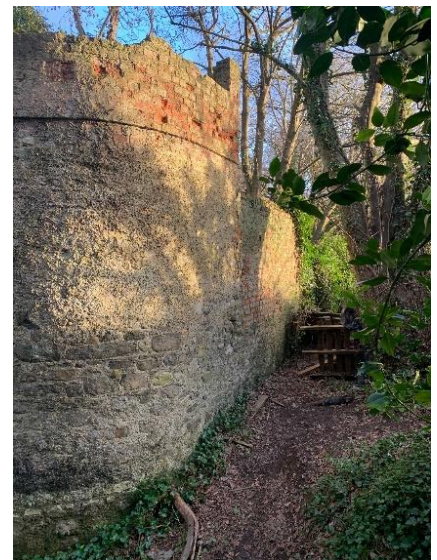
To the northwest corner there is a brick arched masonry 2 storey bastion nestled into the curve of the walled garden northwest corner, accompanied by a blind arch to the west wall.

*Northwest Bastion and outer northwest corner of walled garden.  
Photos courtesy of Sheehan Barry Architects*

- Careful control and removal of vegetation
- Back propping as deemed necessary to arches for safety and to allow repair of arches
- Temporary removal of granite steps if deemed necessary to facilitate repair of arches under
- Repair of brick arch vaults using bricks to match set in new lime mortar as specification.
- Reseating of granite steps, including re-bedding / pointing to ensure falls down the steps and limit water penetration into brick vaults.
- Re-establishment of parapet detail to Architects drawings using materials to match existing, set in lime mortars.
- Security fencing / guarding to prevent unauthorised access to platforms.

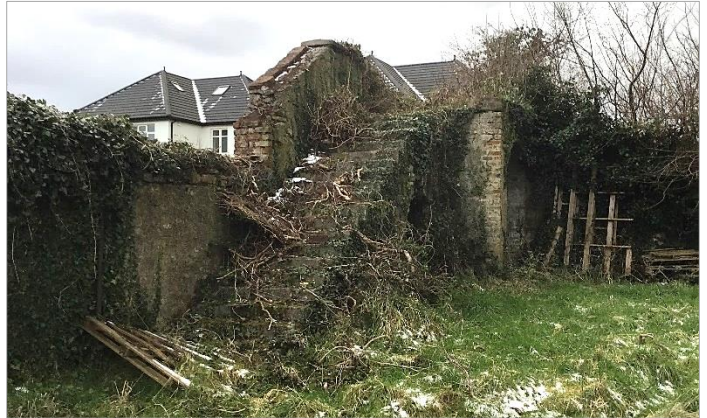
To the southwest corner the Bastion design is repeated albeit housed into a squared corner where south and west walls join.

*Southwest corner Bastion and detail of brick arches*

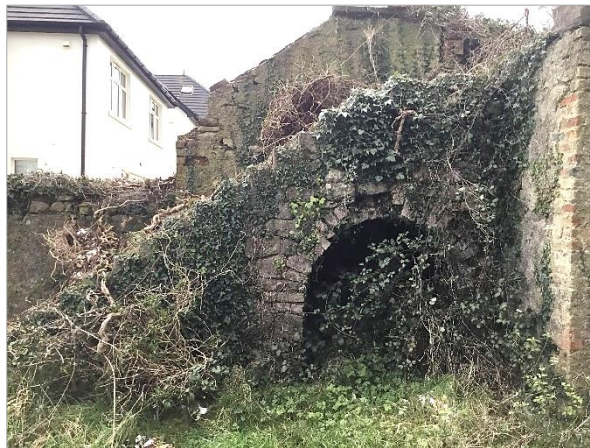
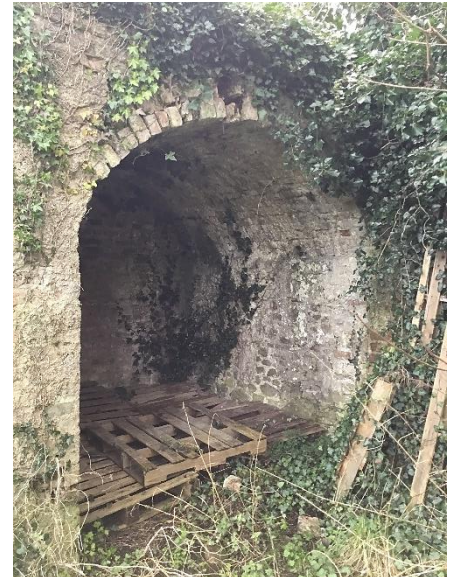
Both bastions have brick masonry vaults supporting the stairs and first floor platforms, solid granite steps laid onto the vault, and brick parapet walls.

The brickwork has suffered degradation from plant growth and general neglect, the parapet walls are missing in places.

The granite steps are uneven and in places slipped and tilted backwards towards the structure.
