**Re: An Arboricultural Assessment on the Site Area for a Strategic Housing Development (SHD) at 'Mooretown Phase 3', Swords, Co. Dublin.**

## **An Arboricultural Assessment on the Site Area for a Strategic Housing Development (SHD) at 'Mooretown Phase 3', Swords, Co. Dublin.**

**Prepared for: Gerard Gannon Properties**

**Date: 6<sup>th</sup> April 2022**

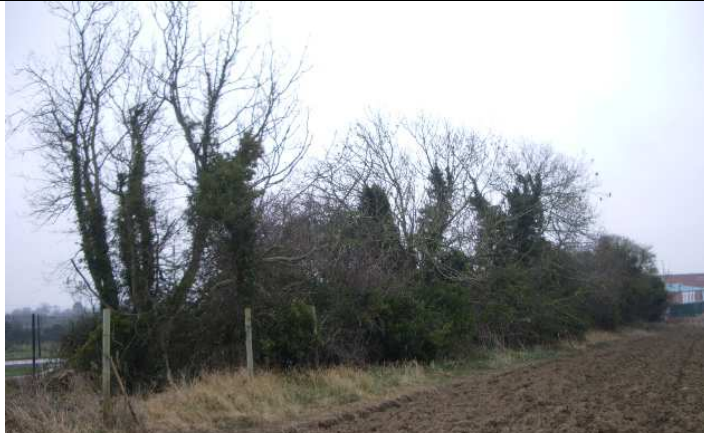
<p>The following trees are located within Hedge No. 5, working from west to east.</p>												
0223	<b>Ash</b> <i>Fraxinus excelsior</i>	9	480/ 480/ 280	6	4	6	2	2	Mature	Fair/ Poor	Poor It is located on the hedgerow bank and on the west side the bank has been removed by the previous construction works resulting in soil and root damage to the point where the stability of this tree at its current size is comprised. Its crown is showing signs of decline/ dieback and the side branches on the west side have been broken off leaving its crown open and asymmetrical. It forms a multiple-stemmed tree from base and is growing from an old stump with heavy Ivy cover on the main stems.	Cut /coppice to a height of 1m and allow to sprout to form part of the hedge bulking.	<10	U

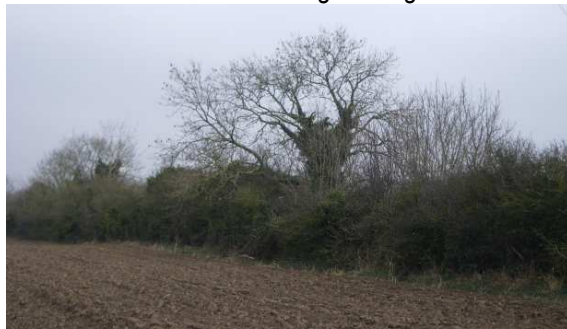
0683	<b>Ash</b> <i>Fraxinus excelsior</i>	16	1200	6	6	8	8	3	Mature	Fair/ Poor	Poor It is a very large, prominent visual tree with a broad spreading crown formation. It contains deadwood throughout its crown along with some hangers and has also suffered storm damage which has left its crown slightly more open as a result. The lower scaffold limbs/ branches have been removed over the	At present, remove dead/ unstable growth and lighten in heavy scaffold limbs / branches by up to c.2m to help reduce the overall windsail of its crown.	<10	U

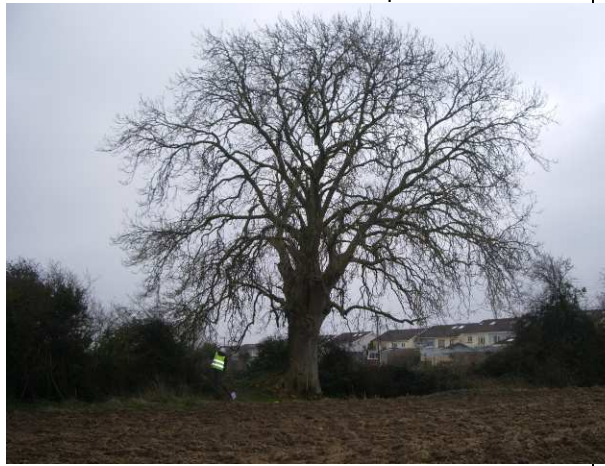
Tree No.	Tree Species	Ht. (m)	Stem Dia. (mm)	Branch Spread (m)				C-Ht. (m)	Age Class	Phys Con.	Structural Condition Other Comments	Preliminary Recommendation	Remaining years	Category Grade
				N	S	E	W				N-North S-South E-East W-West Ht.- Height C- Crown Phy Con.- Physiological Condition	A- Average Dia.- Diameter Cat.- Category		
											<p>years in order to raise up its crown with some decay wounds developing at the old pruning wounds. It has also suffered bark wounds on surface roots with a large area of internal basal decay evident underneath this tree. As a result, the stability of this tree is questionable. It has also been impacted upon by ploughing, in particular on the west side which has come to within c.3m of its base. This tree would not be ideal for retention within a developed area.</p>

Its retention will need to be reviewed within any development layout.

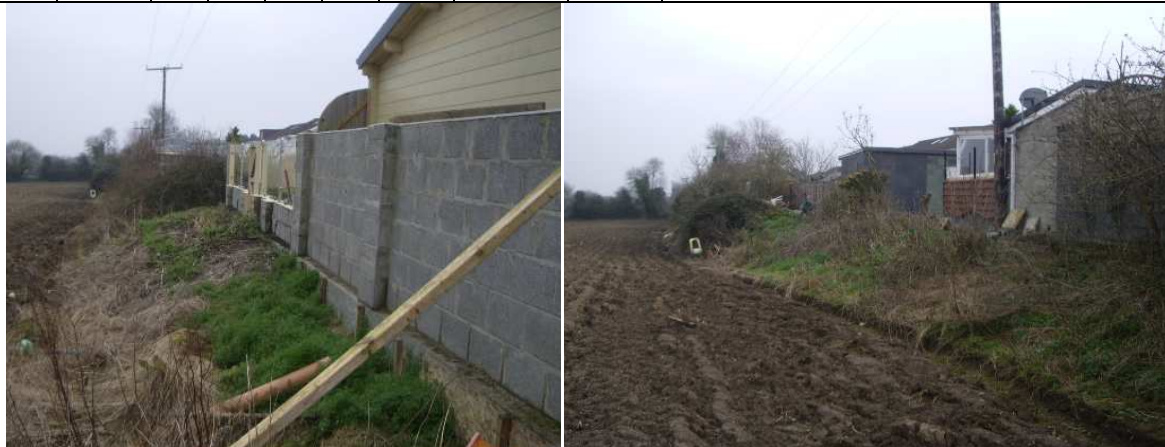
Hedge No. 7B	Hawthorn <i>Crataegus monogyna</i> Bramble <i>Rubus fruticosus</i> Elder <i>Sambucus nigra</i> Dogrose <i>Rosa canina</i> Gorse <i>Ulex europaeus</i>	It extends eastwards from Hedge No.7A and forms the boundary between the field and the rear gardens of the houses that back onto these lands. It is of a mature age class in fair condition physiologically and in fair/ poor condition structurally. It varies in condition along its length and consists of clumps of Hawthorn, Gorse and Elder with infill areas of Bramble and Dogrose. The ditch has been filled and some of the gardens have been extended out into this area. In places, a lot of the garden debris/ rubbish has been piled in onto of this hedge causing damage. It has been kept cut due to the overhead utility lines that run above the full length of this hedge. It has some value for screening and some gardens have bulked up this hedge by adding planting on their side. The main hedge line remaining is located on the site side (north side) of the drainage ditch, which has been filled in most instances by the rear gardens extending out into this area. <table><tr><th>Average Height</th><th>Average Width</th></tr><tr><td>3m</td><td>5m</td></tr></table>										Average Height	Average Width	3m	5m	It would benefit from general tidying works. Trim in encroaching hedge species. Augment with new hedge planting.	C2
Average Height	Average Width																
3m	5m

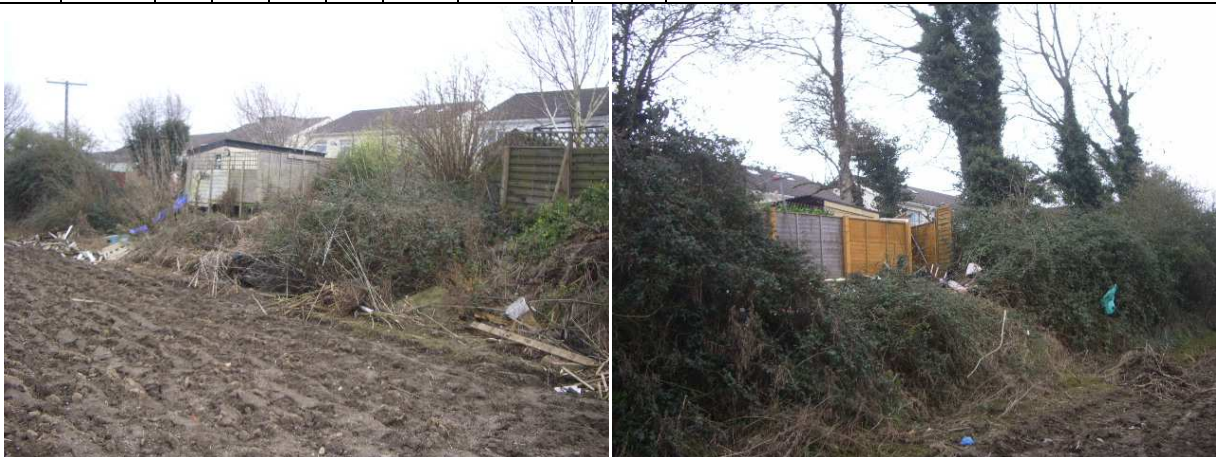
The following 4No.trees (Nos. 0684-0686 + Tree No.1) form part of the upper canopy formation within.												
0684	Ash <i>Fraxinus excelsior</i>	15	220	1	6	2	3	5	Mature	Fair	Fair/ Poor It forms part of a group, has been drawn up for the light and is a tall tree. Multiple-stemmed from base and has been heavily cut back on the site side due to the overhead utility lines, which has left its crown very asymmetrical and weighed towards the neighbouring properties. Heavy Ivy cover on the main trunk is extending up into its crown. Due to location, it was difficult to carry out a full assessment.	Cut Ivy at ground level.  Tidy up the undergrowth and remove from around base to allow a more detailed assessment of its base and lower trunk. It is likely to require pruning to address structural issues due its close proximity to the houses.	10-20	C1

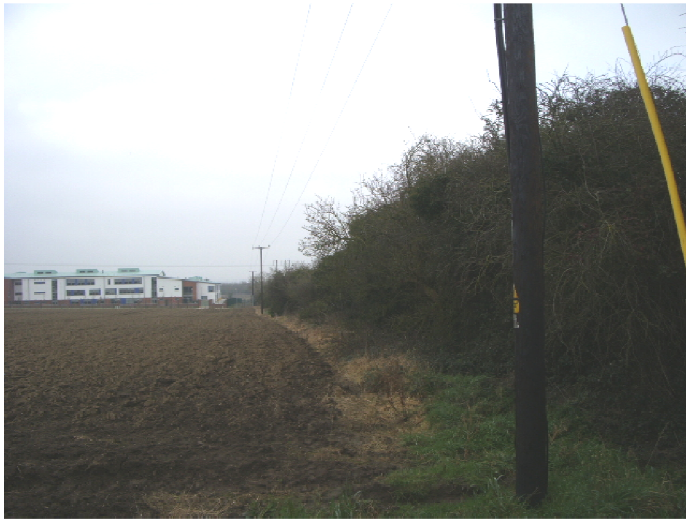
The following trees are located within hedge No. 8.																		
0687	<b>Ash</b> <i>Fraxinus excelsior</i>	8	300	3	2	3	1	2	Semi Mature	Fair	Fair It is growing up within Hedge No. 4 on the hedgerow bank and is beginning to establish up over the hedge. A section of its crown on the west side has been cut back due to the overhead utility lines.	Requires no work at the present time.	20-40	C1

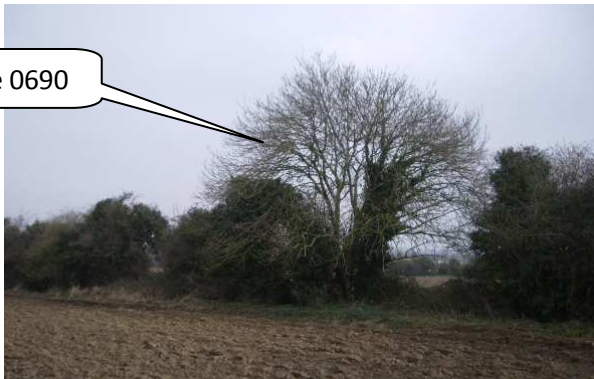
<p>Tree 0690</p> </div> <div style="text-align: center;">

<p>Trees 0691 &amp; 0692</p> </div> </div> <p>The following trees are located within Hedge No. 9 working from south to north.</p>														
0690	<b>Ash</b> <i>Fraxinus excelsior</i>	13	210	4	4	5	5	2	Early Mature	Fair	Fair It subdivides up into multiple-stems from low down with an acute union formation between some stems. Heavy Ivy cover on the main trunk is beginning to extend up into its crown. It is located on the west side of the drainage ditch and has been cut back on the south side due to the overhead utility lines and this has left its crown slightly asymmetrical as a result with heavy new growth developing from the old pruning points.	Tidy up the undergrowth and cut Ivy at ground level.	20+	B1

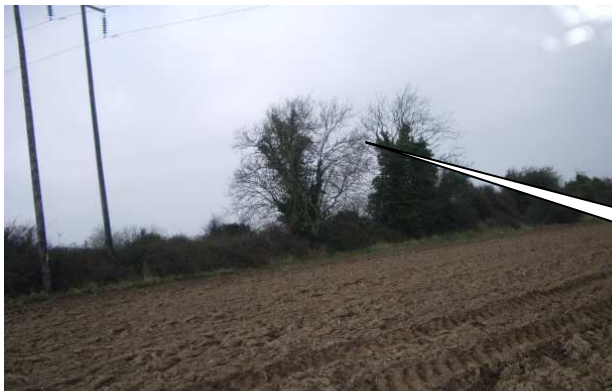
0691	<b>Ash</b> <i>Fraxinus excelsior</i>	11	290	4	6	6	5	2	Mature	Fair/ Poor	Fair/ Poor Multiple-stemmed from base and is growing on the east side of the drainage ditch. It is infected by 'Bacteria Canker' of Ash and this may have an impact	Tidy up the undergrowth and cut Ivy at ground level.	10+	C1
