Report on Current Condition and advice on conservation based repair to:

The Historic Landscape Features

Structures associated with the two Lakes – Inlet, Causeway and Weir; Bridge over Mayne; Rock House and Icehouse at Belcamp Hall, Malahide Road, Dublin D17

Project 1947 Document Issue Record:

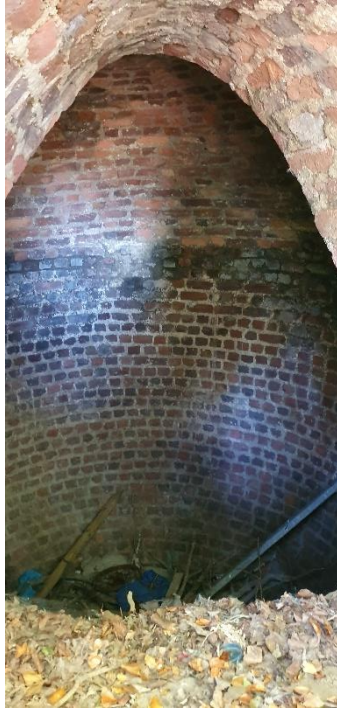
Icehouse interior – CORA 2019

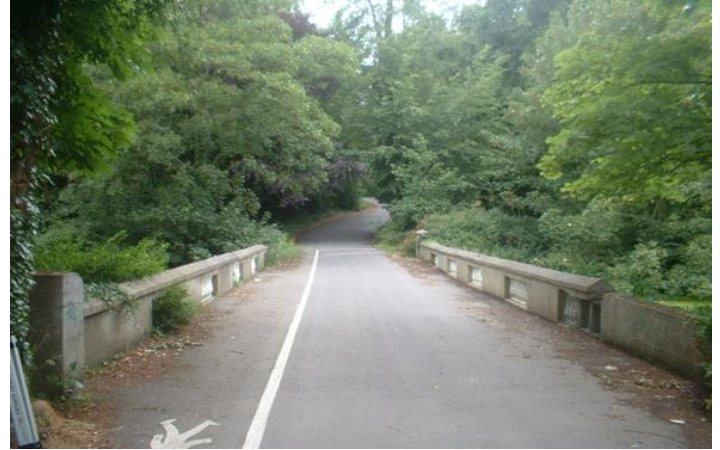
Causeway between the two lakes – WM 2004

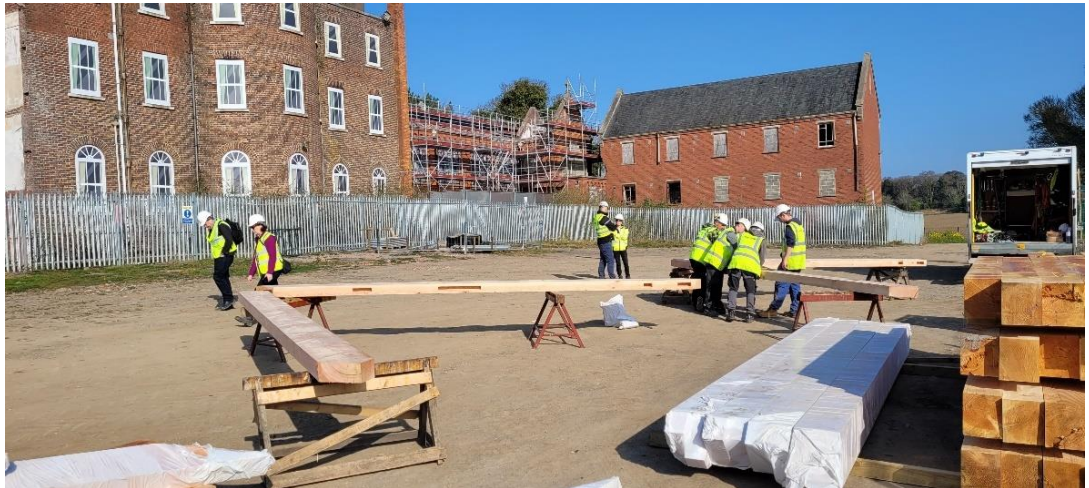
Chapel Roof repairs underway March 2022 – CORA Main Hall on the left

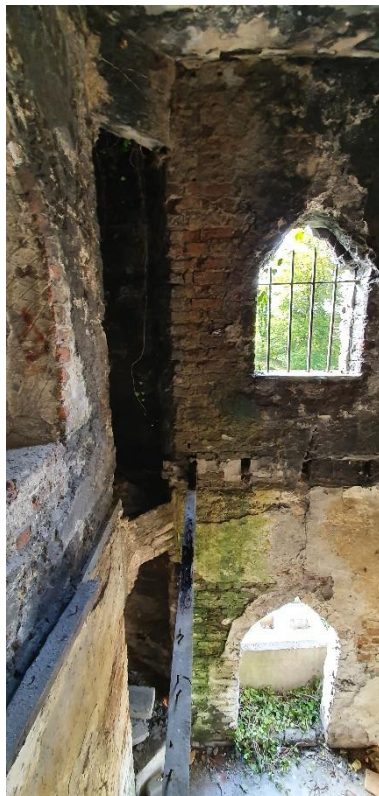
*The Washington Monument
2020-10 CORA*

Constructed in 1778 by Sir Edward Newenham it was repaired in 1984 but requires further repair particularly the filler joist roof consisting of corroding ferrous metal joists and clinker concrete infill.

Further repairs will be formulated and applied for via a separate Section 5 application.

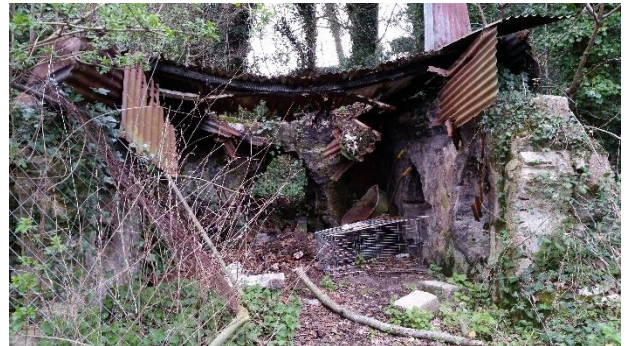
The remaining walls appear to be just a fragment of its former plan. The Ordnance survey maps show this structure to be nearly double the size of the Washington Monument at approximately 9m x 4m with a front outshot facing south towards the lakes.

It is suspected that the remnants are the front outshot and that the mound behind is the former bulk of the building.

The Rock house – only a small part of original stands

To properly assess the walls vegetation control needs to take place in the form of a hard haircut of all plant growth on the walls. There are more ecologically friendly times to carry this out such as between 1st Sept and 28th February. Refer to vegetation control specification in the Appendix.

- Careful control and removal of vegetation post 31st August 2022.
- Removal of all later roofing / camp construction materials.
- Careful excavation of mounds to reveal upstanding remains of other walls.
- Repair of all upstanding walls with matching masonry in lime mortar to stabilise (ensuring no conjecture or addition)
- Repair of wall tops with combination of lime mortar flaunching and soft tops.
- Integration of building with landscape pathways and vista of lake.

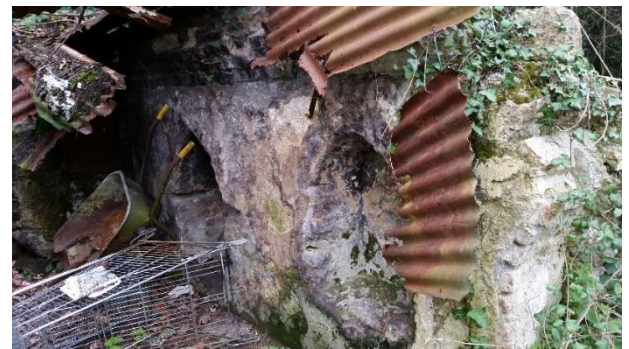
The remains nonetheless are of interest containing daubed out masonry niches, in the very substantial thick masonry walls. The walls are extensively lime washed.

The Rock house, lime washed niches

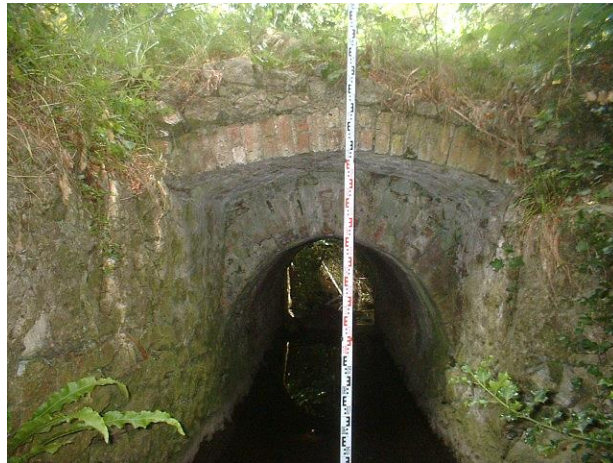
The condition of the masonry is generally reasonable albeit the upstream abutments will require stabilisation and the instream debris needs to be removed to ensure unimpeded flows..

Original short span masonry arch bridge

Note extensive debris downstream

Repair the water features as outlined in CORA Consulting Engineers drawings formulated for planning compliance F15A/0609.

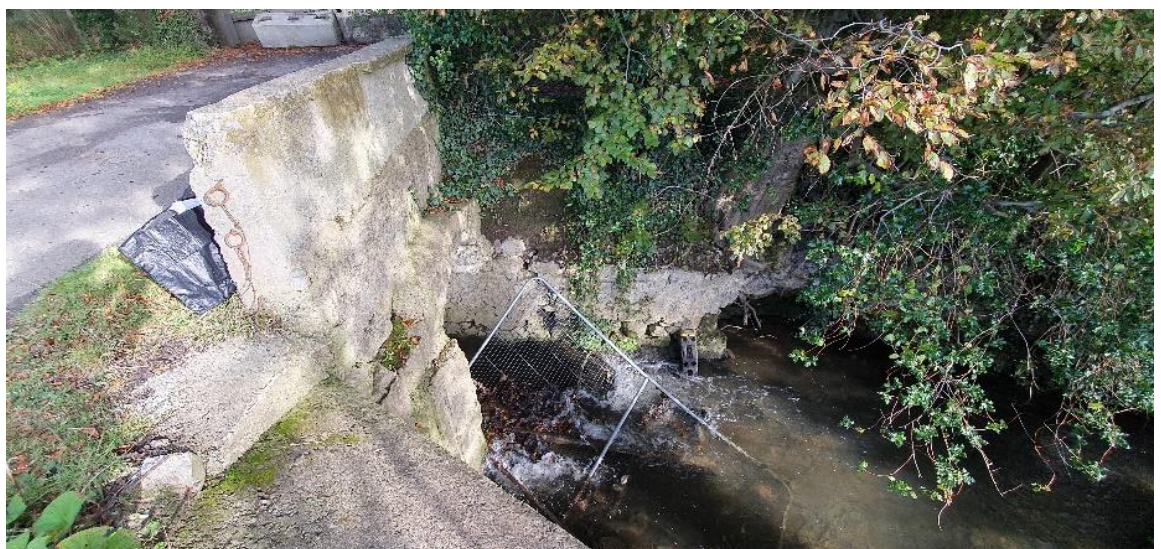
The development of the causeway possibly required the width to be revised and extended to the west with a flatter formed thin brick arch.

Later flatter, brick arch to upstream side in foreground. This later span is considered as inadequate for Vehicular loading.

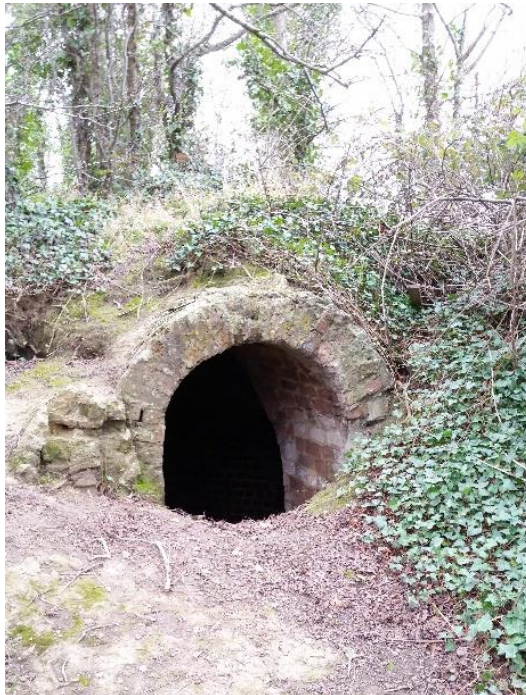
Icehouse entrance

The entrance tunnel was possibly longer and more extended at one stage, but now the dome-shaped arch leads immediately to the interior. Under the earthen cover, the ice house is covered with slate. The structure remains intact generally and is in a good state of preservation albeit filled with rubbish.

The icehouse needs clearing of debris from within and ivy cover form with out. After such a full assessment and set of repair specifications can be pulled together.

The longer term security also needs to be thought about with possibly a set of stainless steel security gates at both tunnel entrance and entrance to egg shaped brick vault.

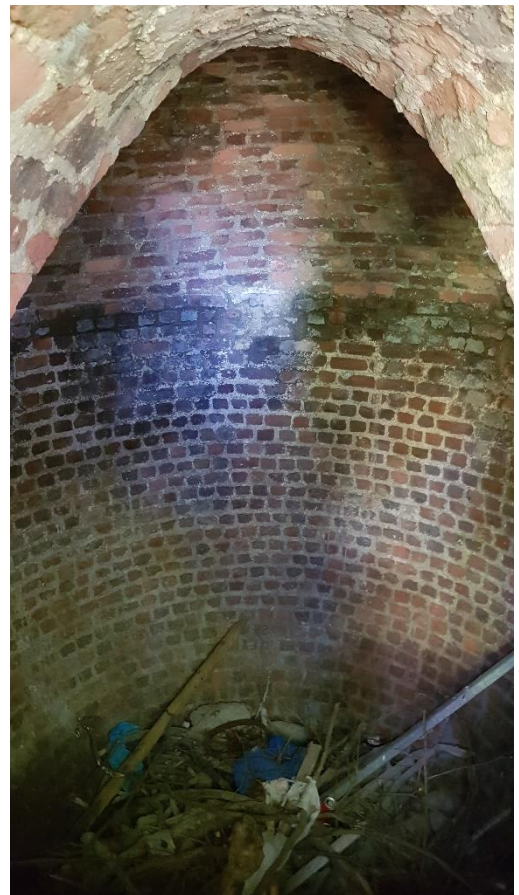
The exterior is covered by earth and is somewhat overgrown. The interior is formed of an egg-shaped red clay brick vault with the wider circumference of the egg to the top and the point of the egg towards the base. There is certainly a drain to the base. The levels would likely put this level with or just above the typical adjacent river level.

*Icehouse main brick vaulting in egg shape red brick.
Note debris in base of vault*
