# Appendix I1

## Accessibility Audit Report

National Transport Authority  
**Belfield / Blackrock to City Centre  
Scheme**  
Accessibility Audit Report

Issue | 16 December 2021

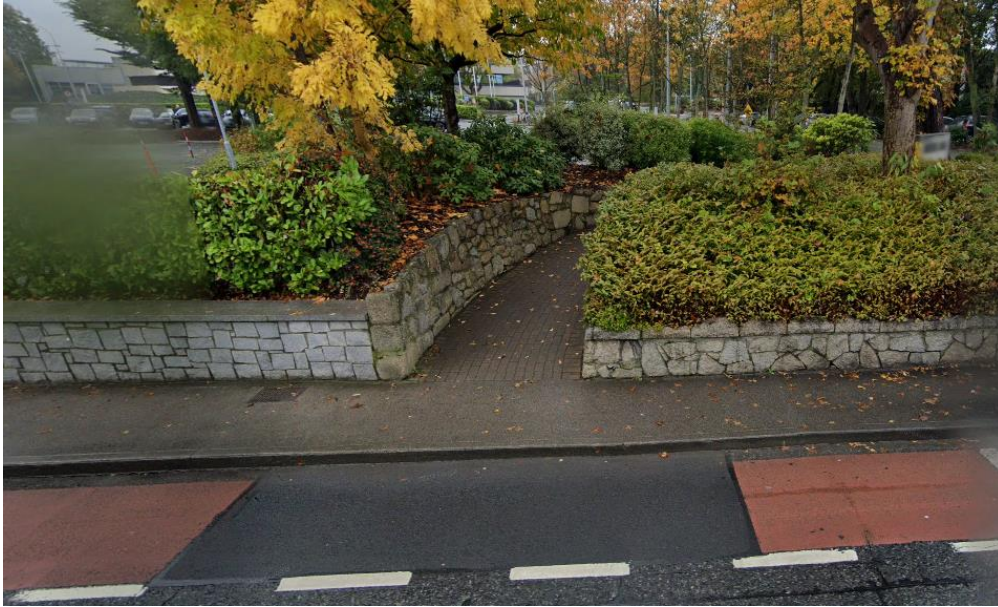
Footpaths along this section of the route vary from approximately 1.3m to 4.5m in width. Along the Rock Road, footpaths on both sides are generally wide, and largely unobstructed. The southern footpath adjacent to the entrance to Blackrock Clinic tapers to a minimum of approximately 1.3m as shown in **Figure 6**.

**Figure 6: Footpath at Blackrock Clinic narrows, before rewidening**

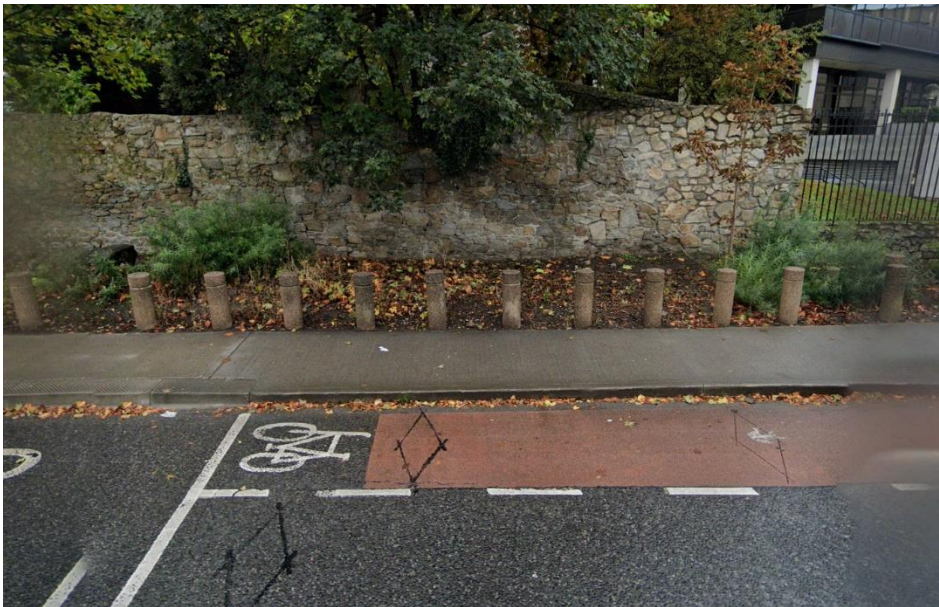
There are multiple areas along Rock Road where the narrow footpath runs alongside a strip of vegetation or a grassy verge.

**Figure 7: Narrow footpath alongside area of vegetation offers opportunity to widen footpath - Rock Road**

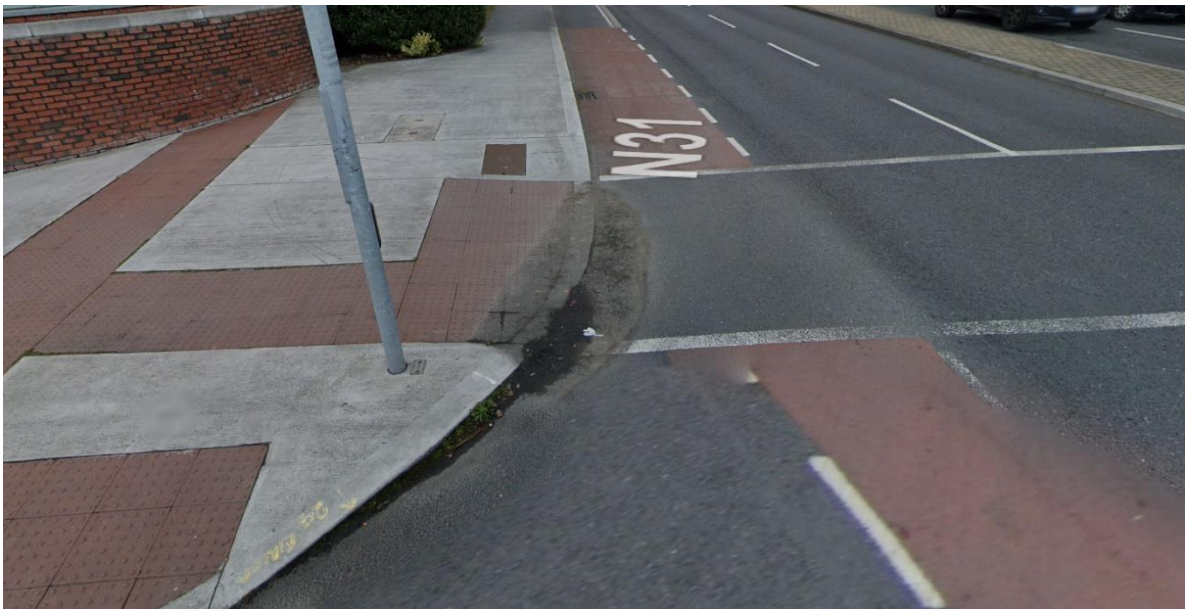
The condition of the crossing on the eastern footpath at the junction between Frascati Road and Carysfort Avenue, as shown in **Figure 8**, shows evidence of consistent ponding during wet weather. This is indicative of a drainage issue at this location.

**Figure 8: Pedestrian Crossing Point - junction of Frascati Road and Carysfort Avenue**

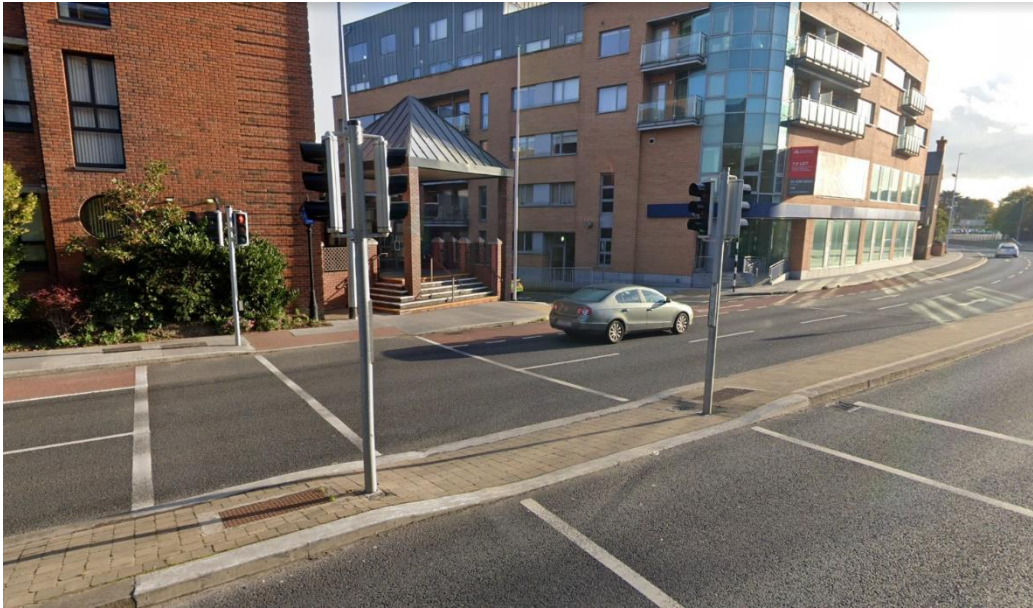
None of these islands have pedestrian guardrails installed, but the traffic signals and tactile paving set-up at each crossing suggests that the crossing movement is carried out in one single phase from one side of Frascati Road to the other through the central median, without the need to use the median as a landing.

**Figure 9: Pedestrian Crossing Point - Frascati Road**

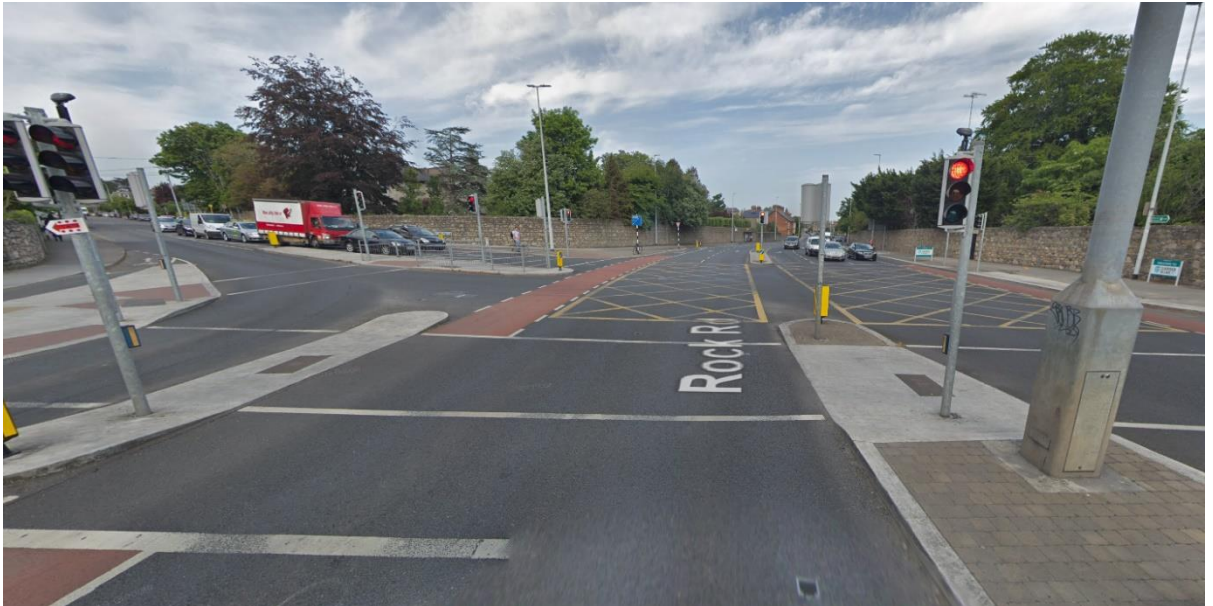
The crossing at the Rock Road and Mount Merrion Avenue junction does not feature any tactile paving or pedestrian crossing traffic signals, at either of the two refuge islands as shown in **Figure 10**. Both islands feature a cast in-situ concrete surface, which again suggests that the crossing from one side of Rock Road to the other is carried out in one single phase of the traffic lights, without the need to use the medians as pedestrian landings.

**Figure 10: Tactile Paving - Rock Road**

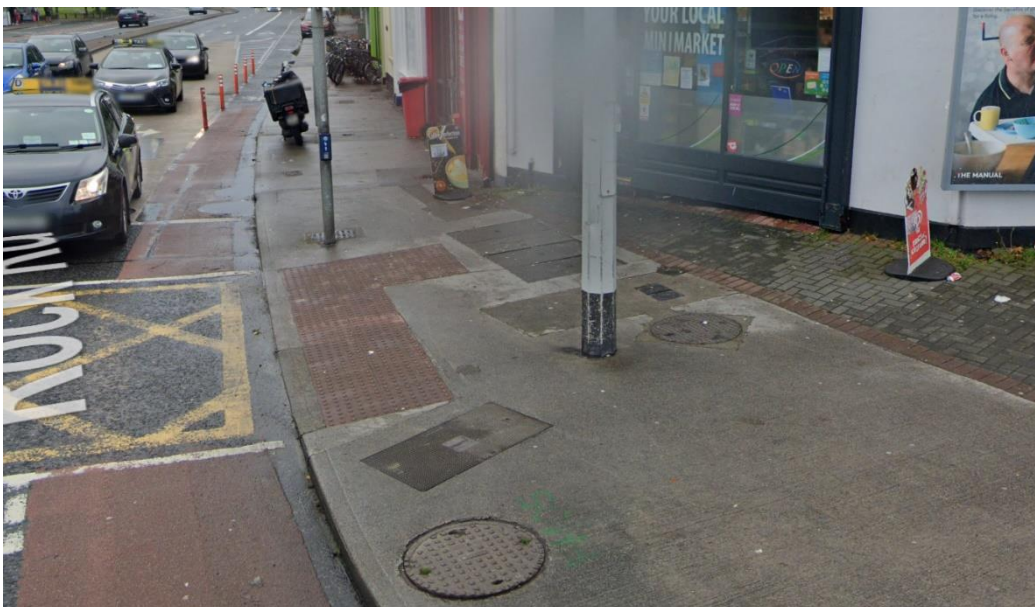
The crossing of Rock Road at Booterstown Avenue features multiple different surfaces as shown in **Figure 11**.

**Figure 11: Tactile Paving - Rock Road / Booterstown Avenue**

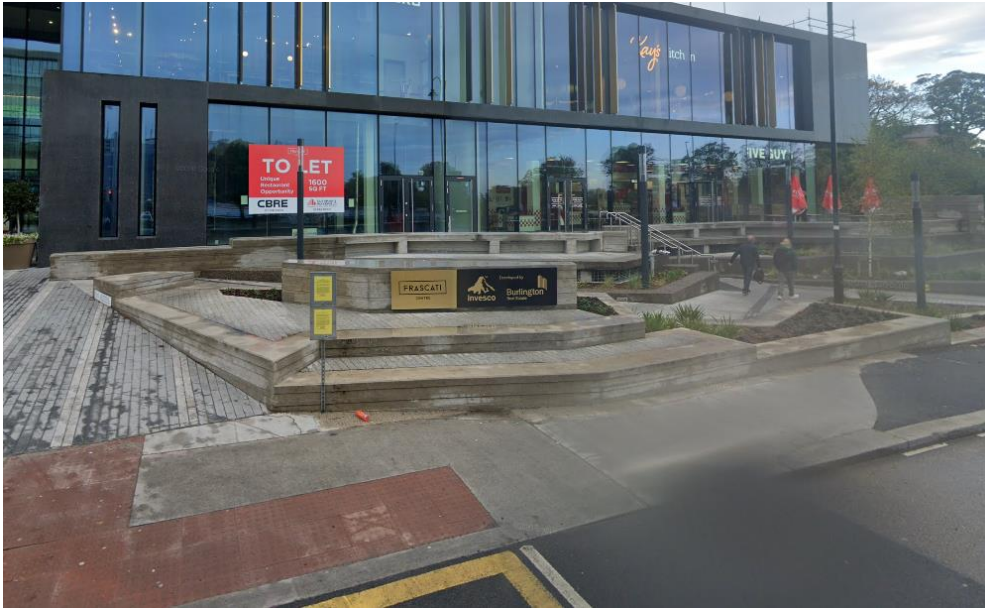
The stepped change in level appears to be featured seating for the new public realm, but could be considered access steps, and could be used by pedestrians approaching the entrance from the north to ‘cut the corner’ to the ramped entrance.

**Figure 12: Changes in Level - Frascati Centre**

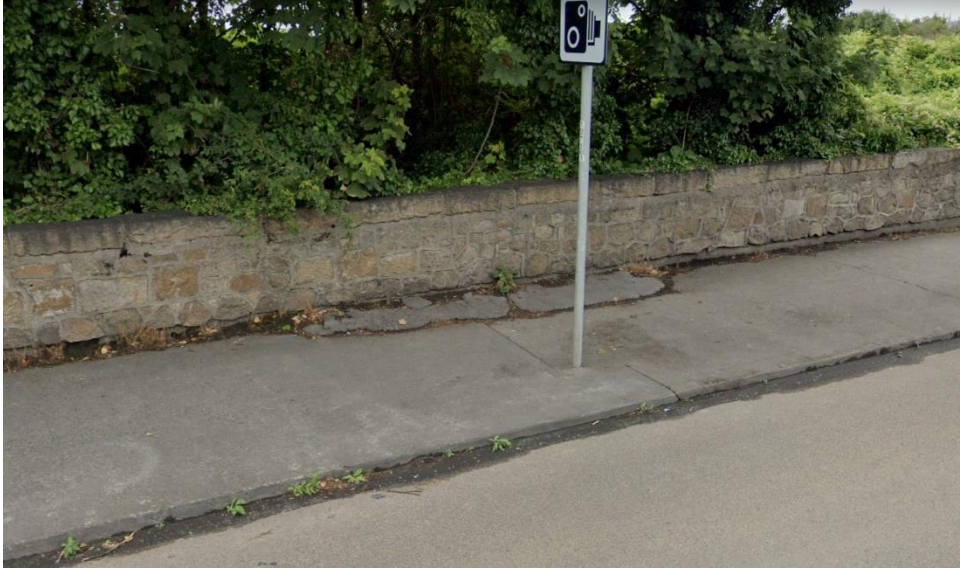
While these pinch points exist, both footpaths are relatively wide in general, and in good condition. Infrequent asphalt patch repairs were noted along the route as shown in **Figure 16**.

**Figure 16: Example of poor-quality patch repair - Merrion Road**

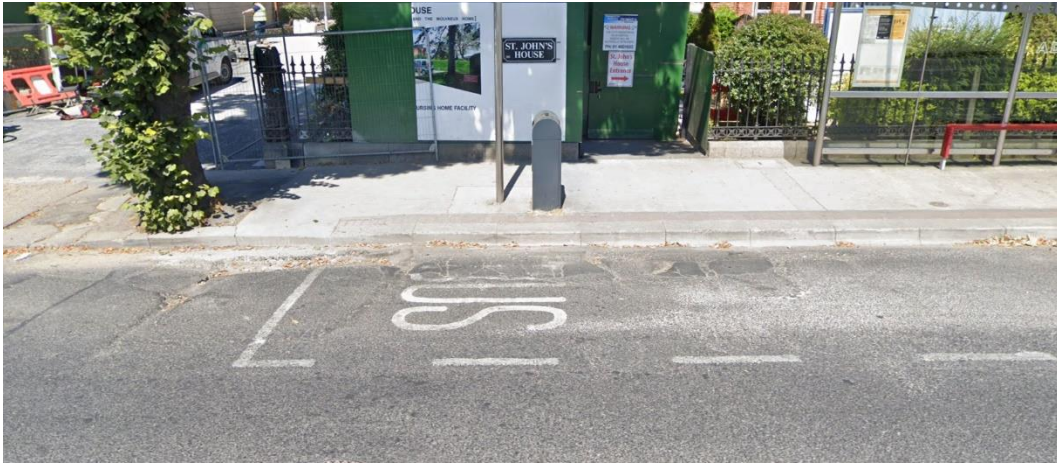
No sunken or blocked gullies were observed along this section of the route, however, areas of damaged road surface can lead to drainage problems, as rainwater that ponds in damaged areas cannot drain away. This poses a threat to all road-users, in particular cyclists, who may be unaware of damaged or pot-holed road surfacing as they travel through the ponding. An area of damaged surface can be seen in **Figure 17**.

**Figure 17: Drainage - St. John's House, Merrion Road**

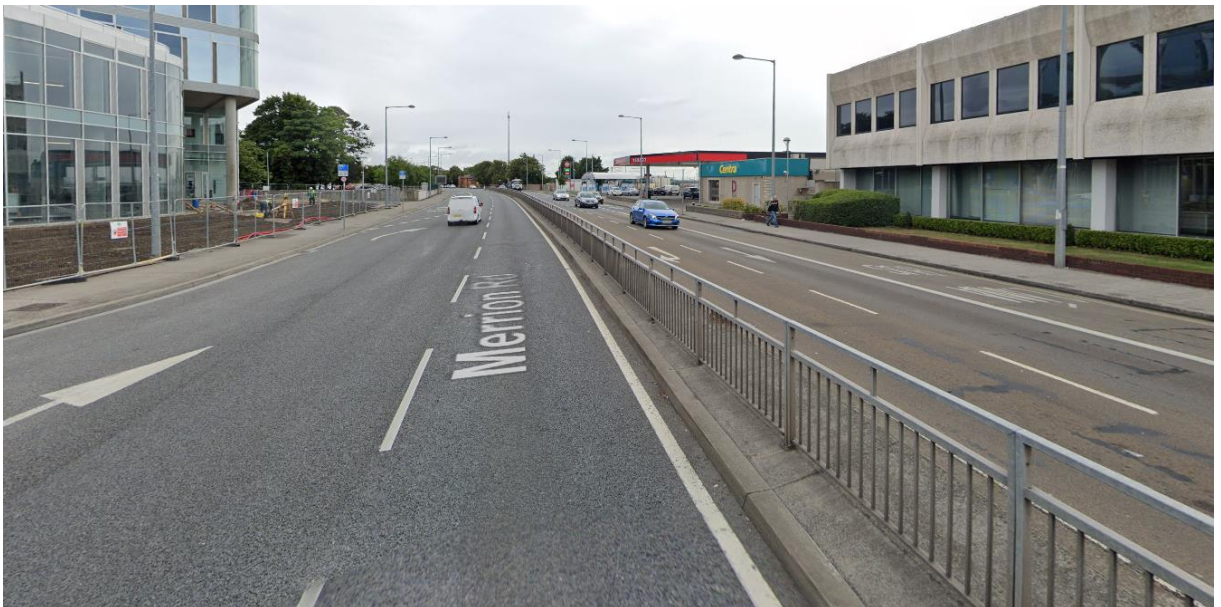
Pedestrian Guardrails were observed at the junction of Merrion Road and the entrance to Landaff Terrace – at each of the 3 refuge islands at the junction. Immediately north of the junction, the central median of Merrion Road is fitted with a guardrail for approximately 150m as shown in **Figure 18**. The guardrail is in the centre of the narrow island, which prevents pedestrians attempting to cross Merrion Road without the use of a designated pedestrian crossing.

**Figure 18: Guardrail - Merrion Road**

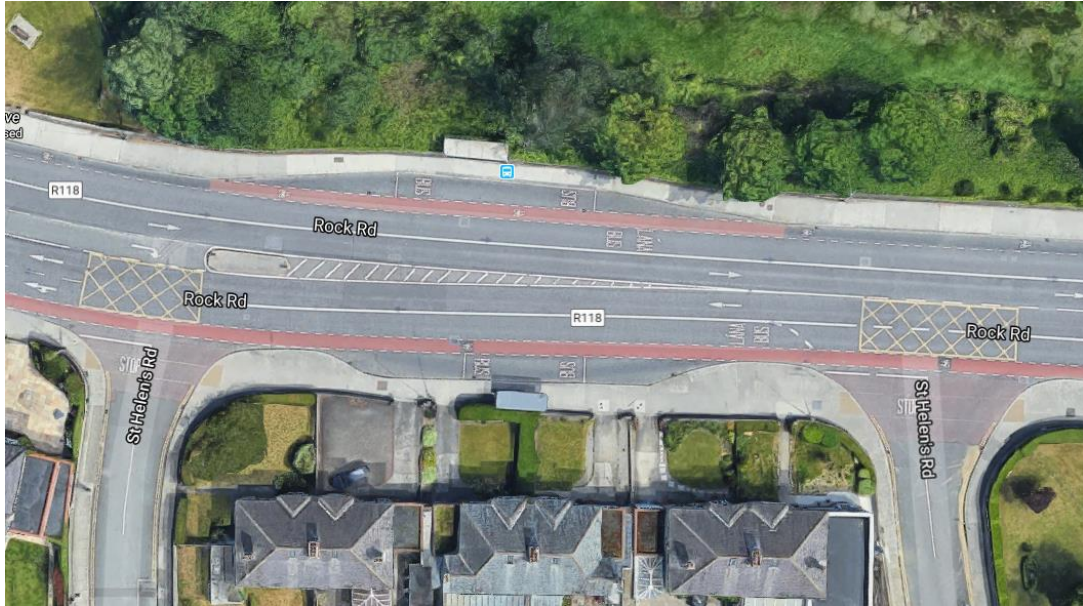
This should be considered part of a desire line for residents of St Helen's Road using the southbound bus service.

**Figure 19: Pedestrian Crossings - No Pedestrian Crossing at either end of St Helen's Road**

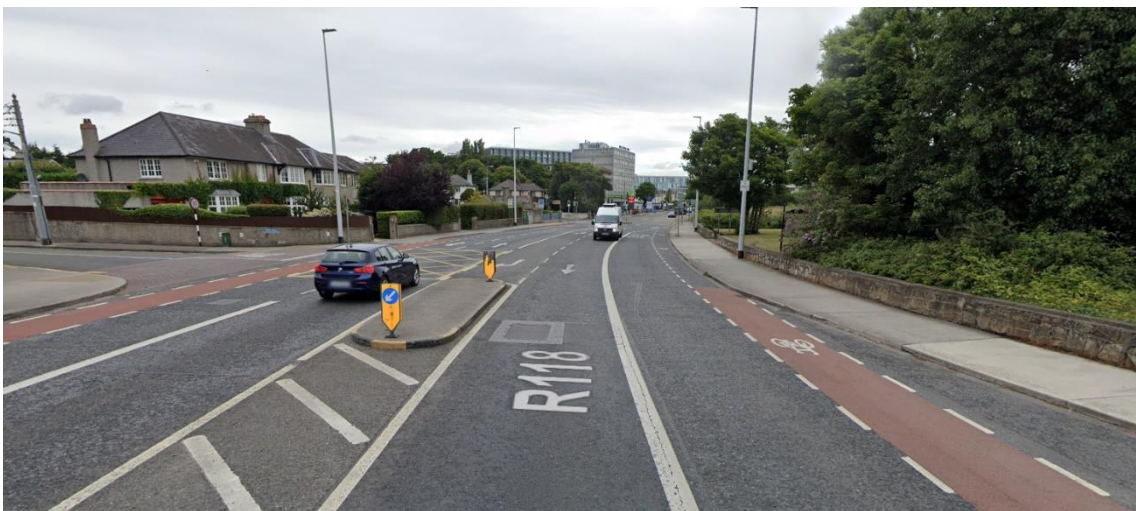
Due to the lack of pedestrian crossing at either end of St Helen's Road, it is likely that the existing island, in place to alert motorists to the end of the central reserve as shown in **Figure 21**, is used by pedestrians as an unofficial crossing point, instead of walking approximately 70m to the closest controlled crossing at Trimleston Avenue.

**Figure 21: Uncontrolled Crossing - St. Helen's Road**

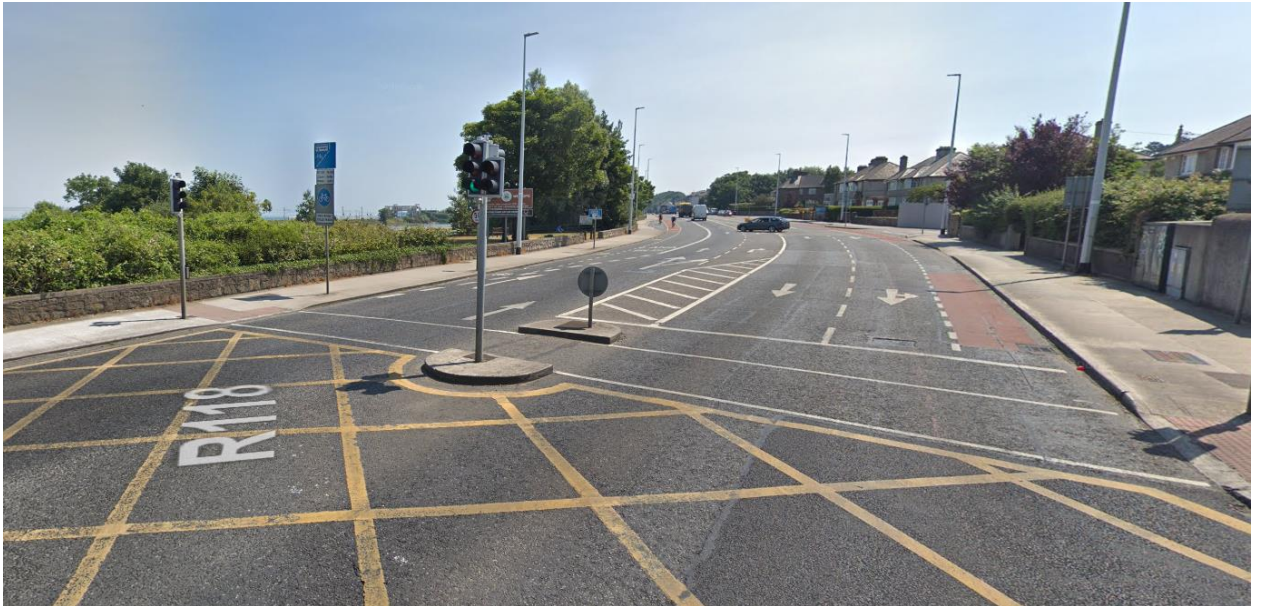
Appropriate tactile paving has been used at every pedestrian crossing along this section of the route, however the refuge island at the Rock Road/Trimleston Avenue Junction has no surface discernible from that of the carriageway as shown in **Figure 22**. The island is not signalled, and it therefore probably acts as a single crossing phase, but could pose a challenge to the visually impaired to detect.

**Figure 22: Controlled Crossing - Rock Road / Trimleston Avenue**

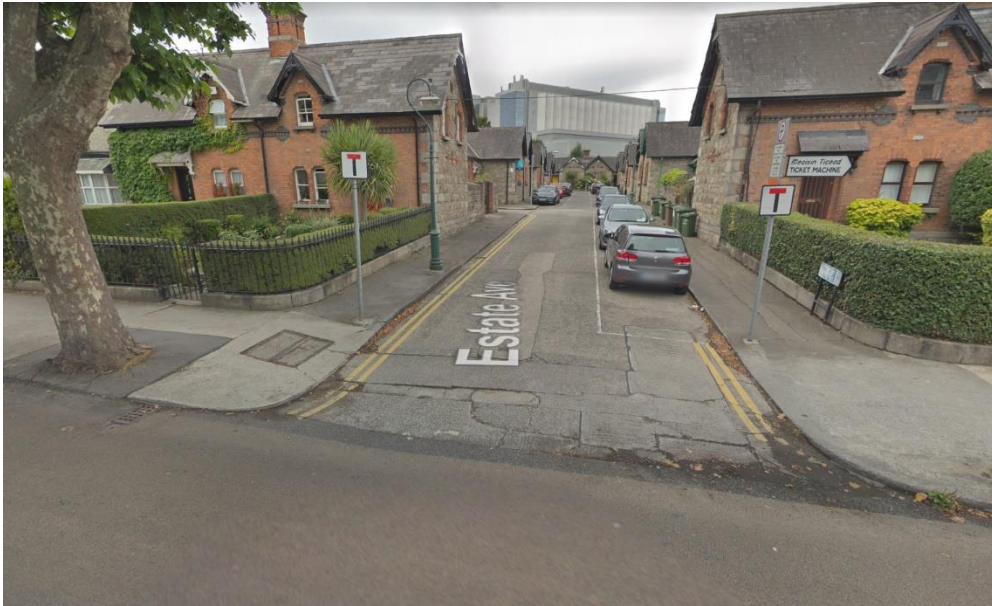
The majority of the footpath along this section of route is cast in-situ concrete. There are multiple examples of patch repairs throughout this section of route, where surface material has cracked or where the concrete has been cut out to install underground services. Asphalt indicates that the surface forms part of the vehicular carriageway and thus including asphalt on the footpath may incorrectly indicate that the area is subject to vehicular priority.

**Figure 23: Surface Material - Merrion Road**

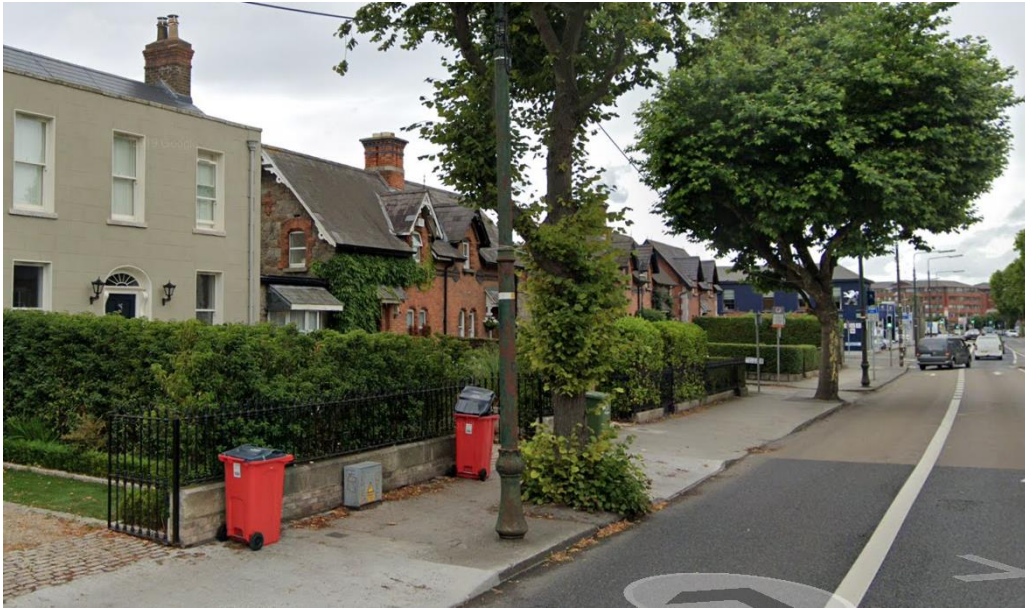
From Nutley Lane to Strand Road, street lighting poles and traffic signalling poles are located to the edge of the kerb of Merrion Road. This section of Merrion Road is lined with trees, in some cases narrowing the footpath considerably.

**Figure 24: Street Furniture - Merrion Road**

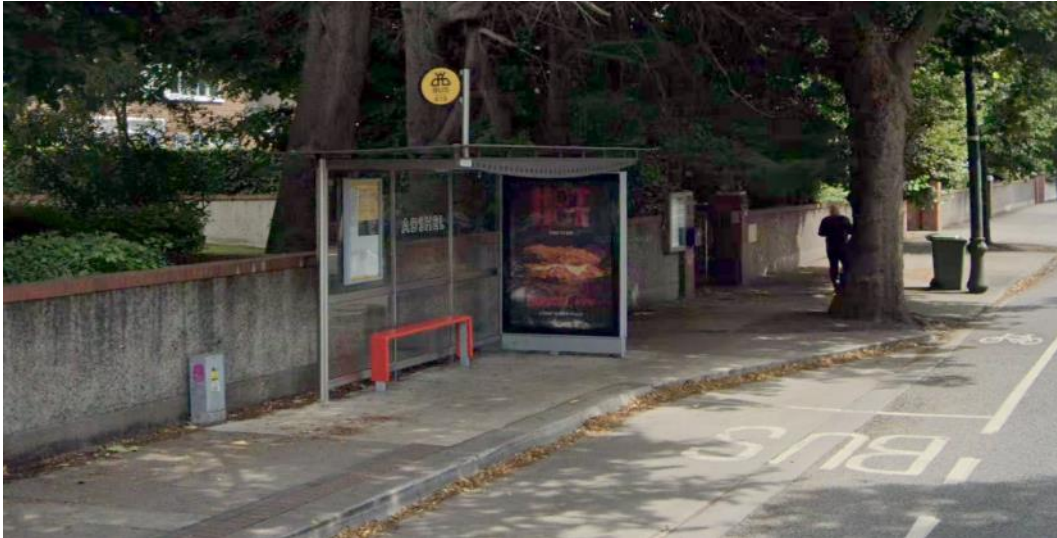
While footpath widths are generally adequate for disabled users along this section of the route, there are some locations where street furniture and trees result in physical constraints. Refer to examples along Merrion Road in **Figure 27** and **Figure 28**.

**Figure 27: Constrained Footpath – Merrion Road**

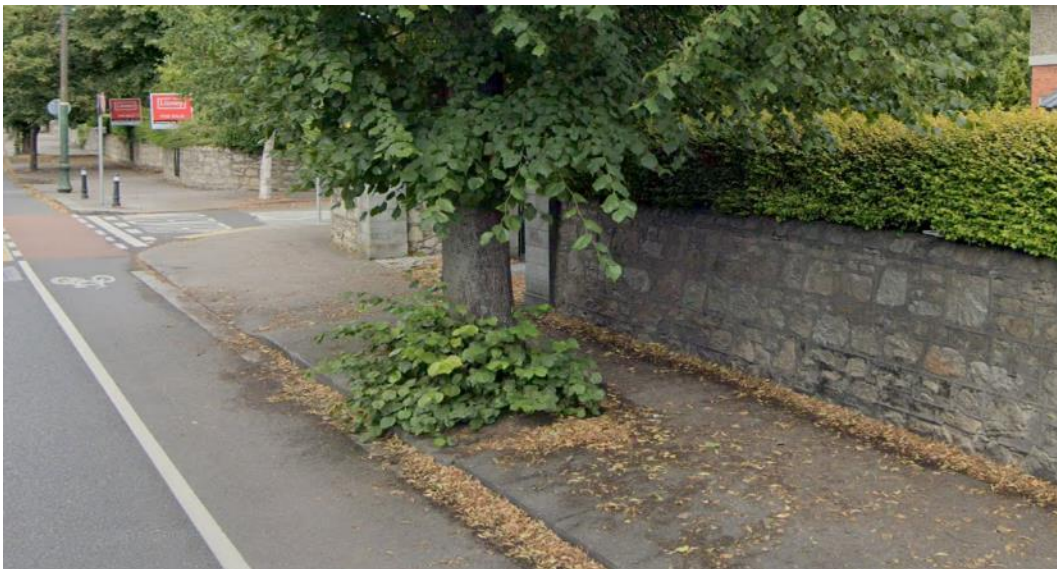
**Figure 28: Constrained Footpath – Merrion Road**

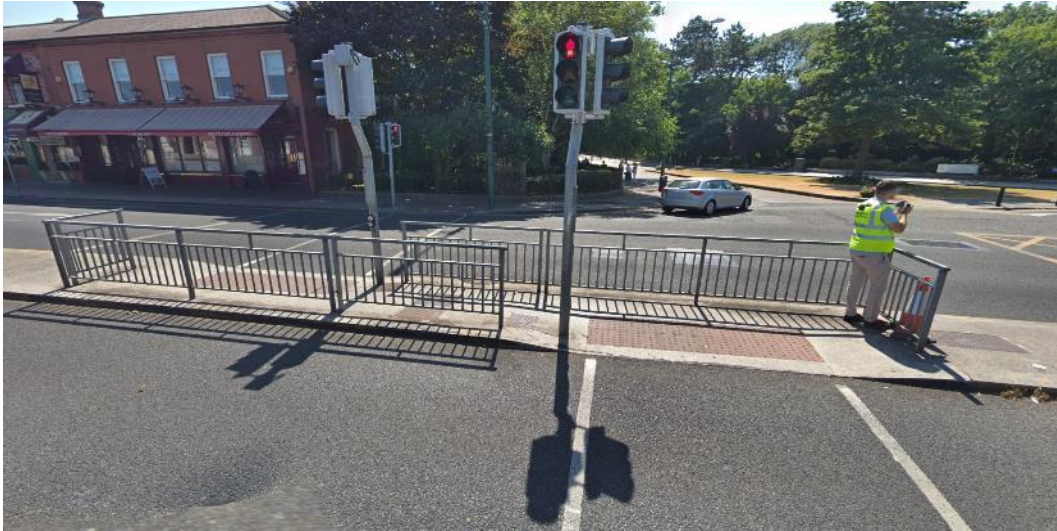
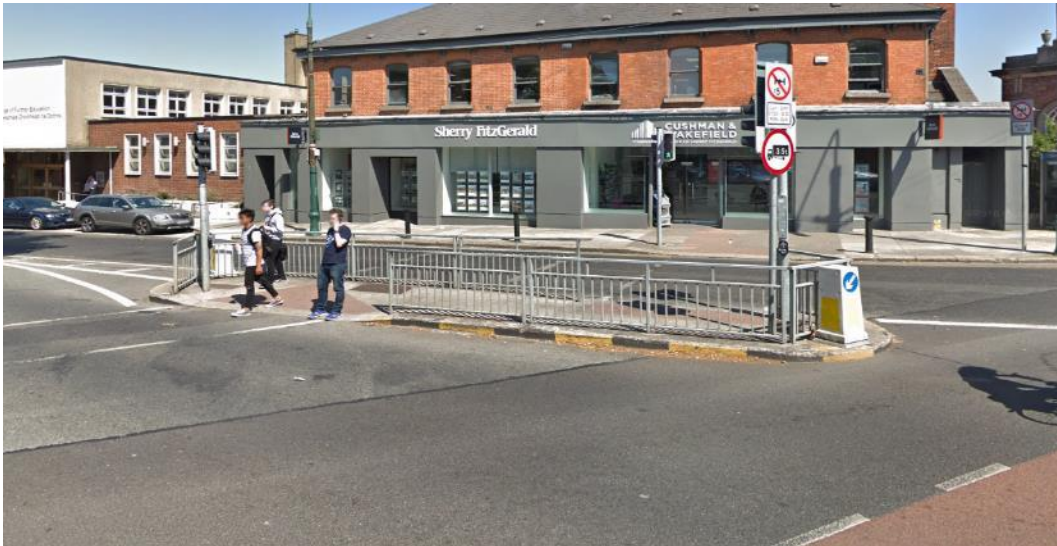
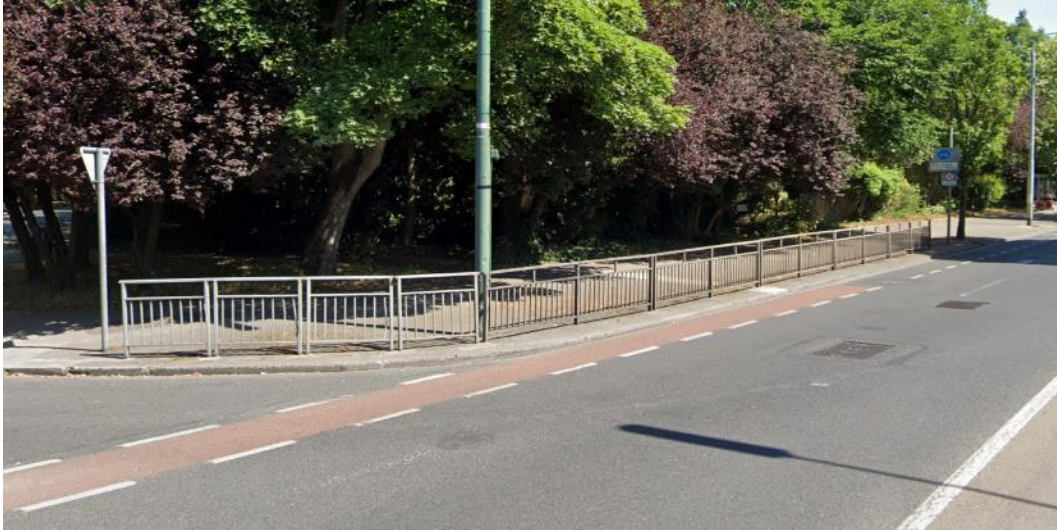
Each of the guardrails are located at or adjacent to intersections. Two of the guardrails along Pembroke Road are adjacent to pedestrian crossings. At both of these locations, the width of the footpath is generous enough to accommodate disabled users, even with the reduced effective width caused by the pedestrian guardrails.

**Figure 29: Guardrails – Ballsbridge**

**Figure 30: Guardrails – Ballsbridge**

**Figure 31: Guardrails – Merrion Road**

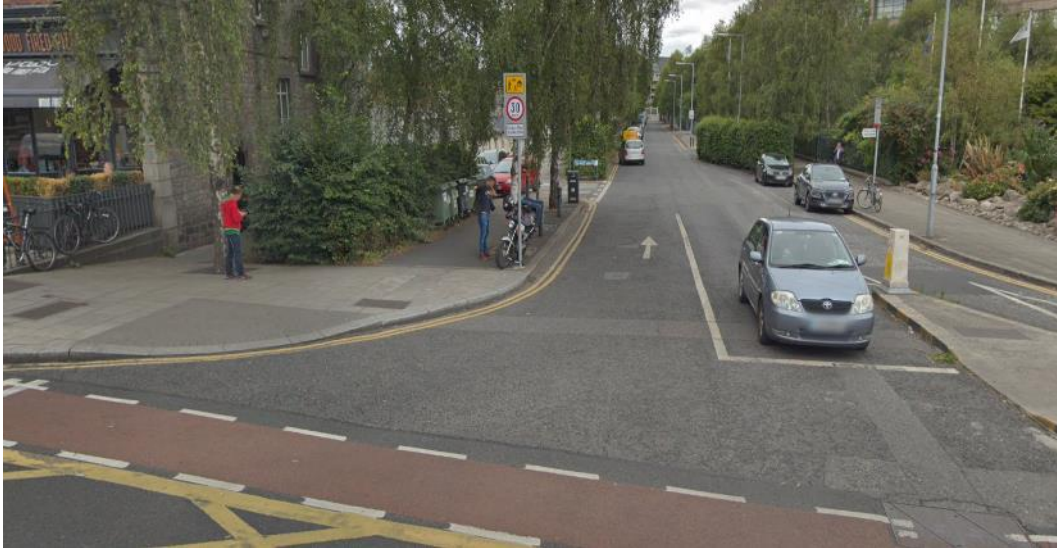
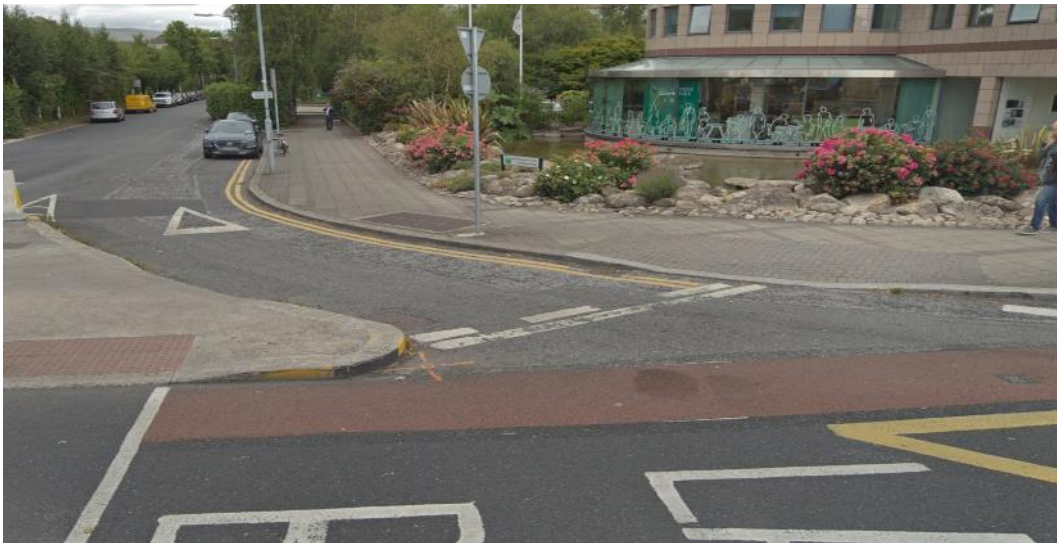
There are a number of uncontrolled crossings along this section. Most of these are of a reasonably good standard. However, some are noticeably of poor standard particularly when catering for the mobility and visually impaired. For instance, at the junction of Merrion Road and Ballsbridge Park, there are two instances of dropped kerbs being located on the curve of the road and not in the direct line of travel at the junction. Refer to **Figure 37** and **Figure 38**. Locating the dropped kerbs on the curve of a road can cause a risk of visually impaired users being misdirected by the orientation of the kerb.

**Figure 37: Uncontrolled Crossing Point with Dropped Kerb on Curve of Road – Merrion Road / Ballsbridge Park Junction**

**Figure 38: Uncontrolled Crossing Point with Dropped Kerb on Curve of Road – Merrion Road / Ballsbridge Park Junction**

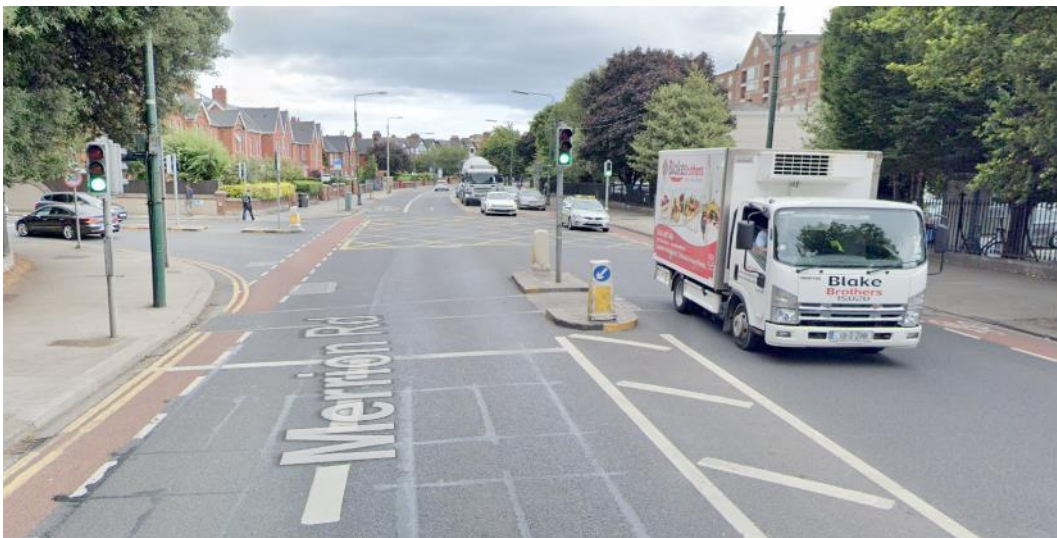
**Figure 41: Controlled Junction without Tactile Paving Surface – Merrion Road**

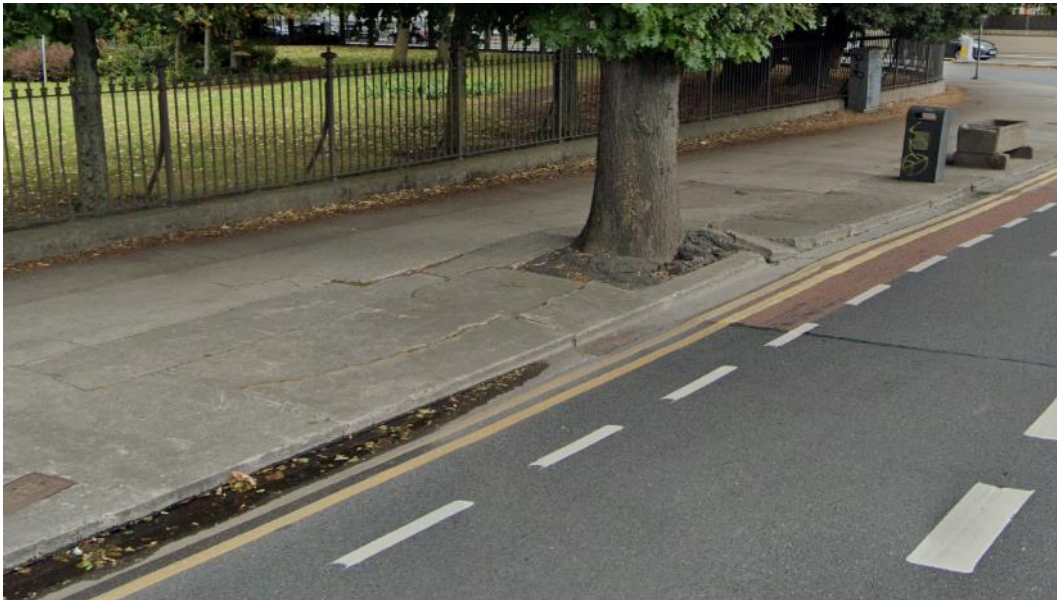
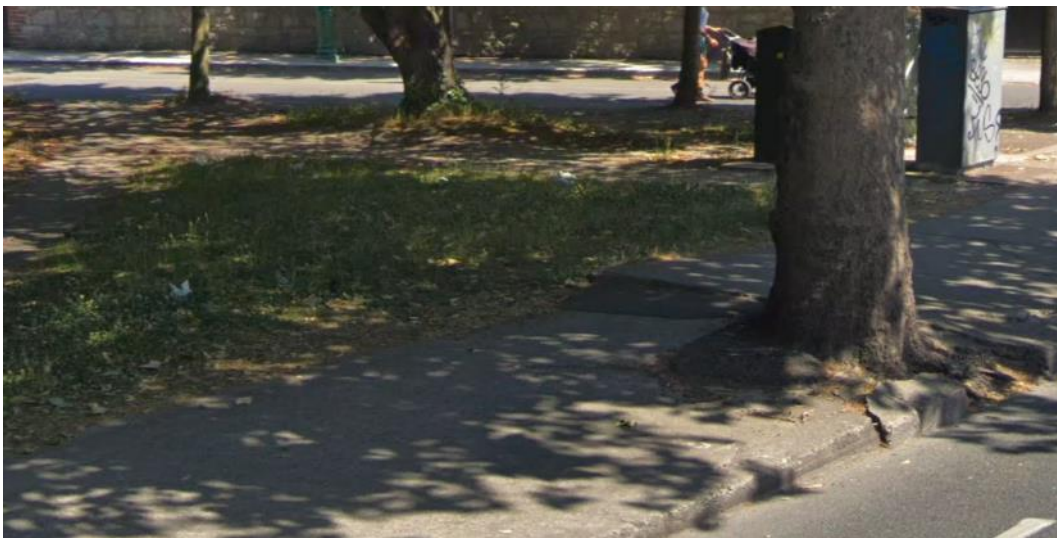
Asphalt and concrete have both been used as materials to make patch repairs along both footpaths. In some instance this has led to undulating, uneven surfaces caused by settlement of patch repair material. This is a hazard to pedestrians and cyclists alike. Damage to concrete kerbs and footpaths was also observed at locations where trees were positioned, and this was most likely due to the growth of the tree roots.

**Figure 42: Surface Material – Footpath along Merrion Road**

**Figure 45: Surface Material – Footpath along Merrion Road**

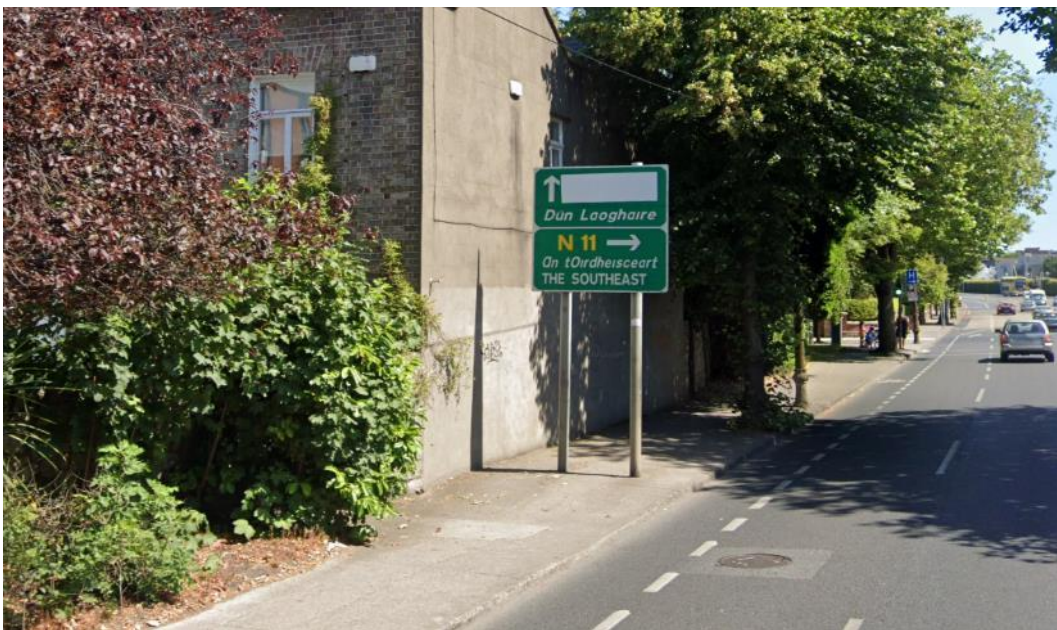
In some instances, street furniture did not appear at the edge of the footpath. An example is presented in **Figure 49**, below, where traffic signage is positioned centrally on the footpath of Merrion Road. This greatly reduces the effective width of the footpath, making passage difficult for the mobility impaired.

**Figure 49: Street Furniture – Merrion Road**

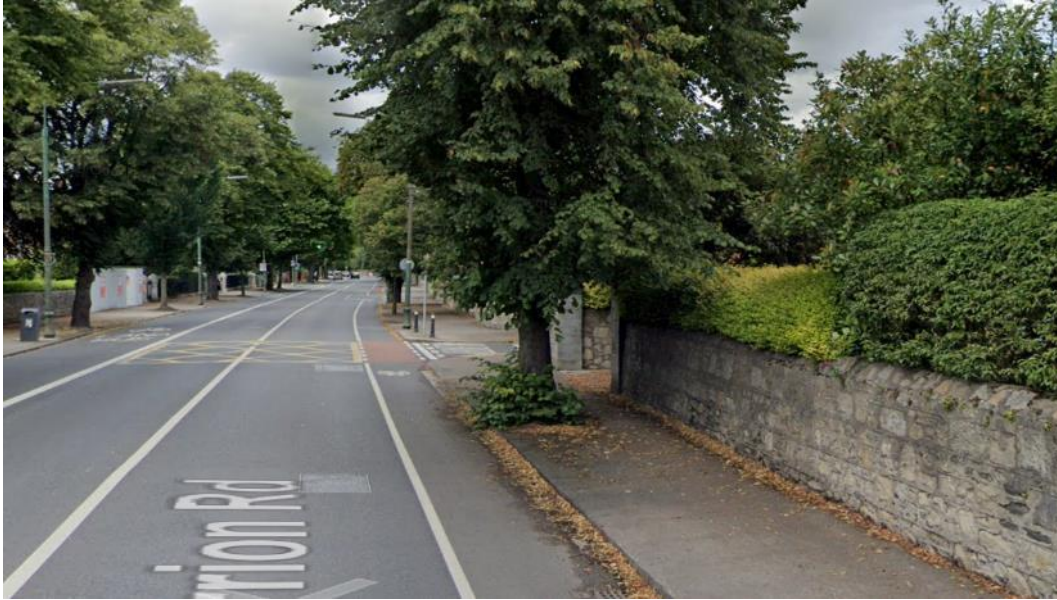
While not street furniture as such, a number of trees are located within footpaths along the route. Some of these along Merrion Road reduce the effective width of the footpath considerably, thereby making passage difficult for the mobility impaired. Refer to **Figure 50** as an example.

**Figure 50: Tree reducing footpath effective width – Merrion Road**

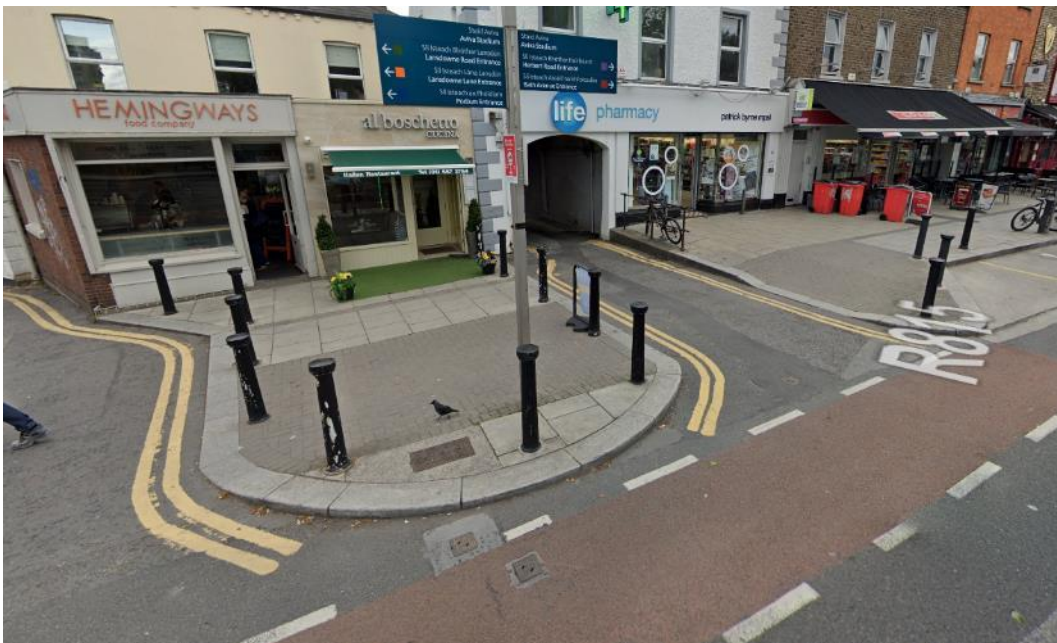
Street furniture positioned along the footpath on the eastern side of Ballsbridge results in this location being particularly constrained for the mobility impaired. The number of bollards positioned at this point (refer to **Figure 51**) are likely to cause difficulty to the mobility impaired.

**Figure 51: Street Furniture – Merrion Road**

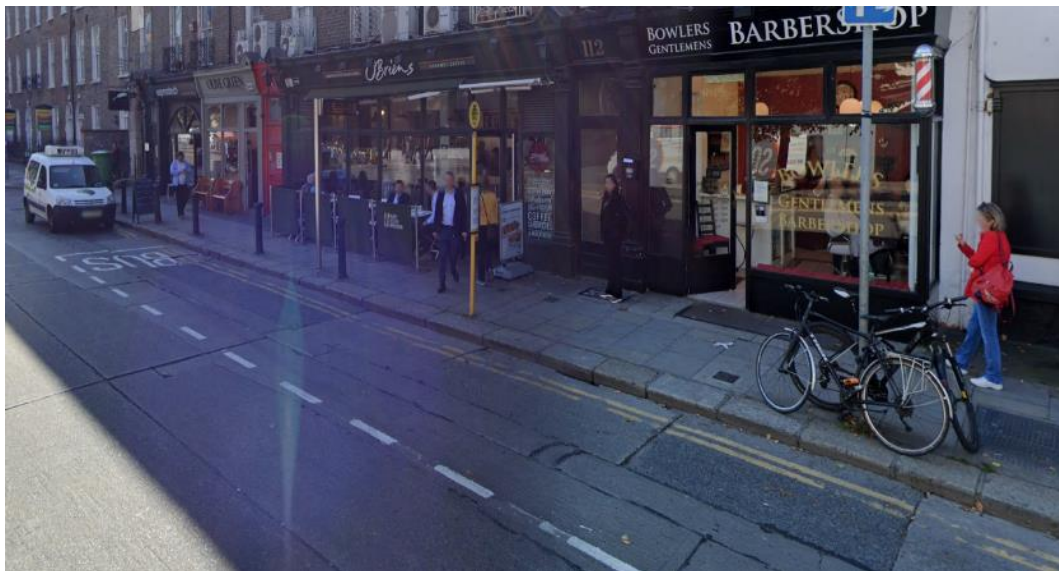
**Figure 56: Constrained Footpath – Baggot Street Lower**

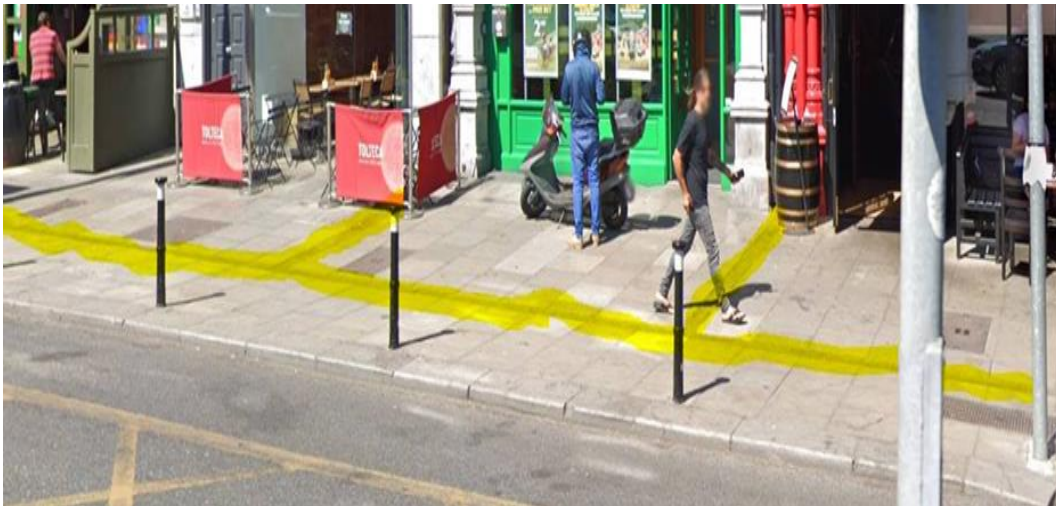
Only minor drainage issues were noted along this section of the route. Local incidences of sunken gullies leading to ponding of rainwater and associated debris were observed. Drainage channels were also noticed along the footpath on Baggot Street Upper. Refer to **Figure 57**.

**Figure 57: Drainage Channels – Baggot Street Upper**

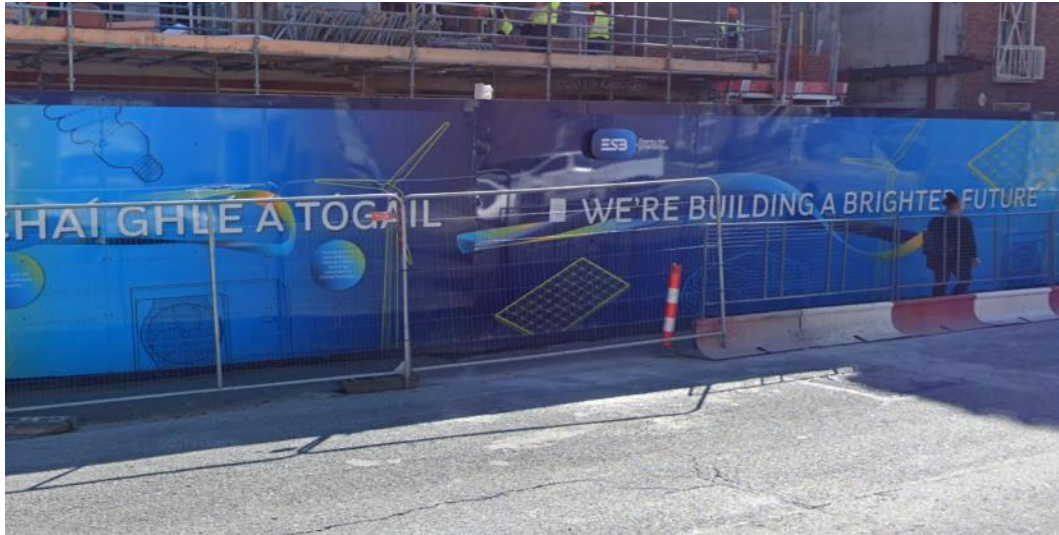
The 1 no. temporary guardrail observed is located along Fitzwilliam Street Lower and is positioned here due to the construction works along the eastern side of this street. Refer to **Figure 60**. This guardrail is positioned at a tight geometry which could prove difficult for disabled users to navigate.

**Figure 60: Temporary Guardrails – Fitzwilliam Street Lower**

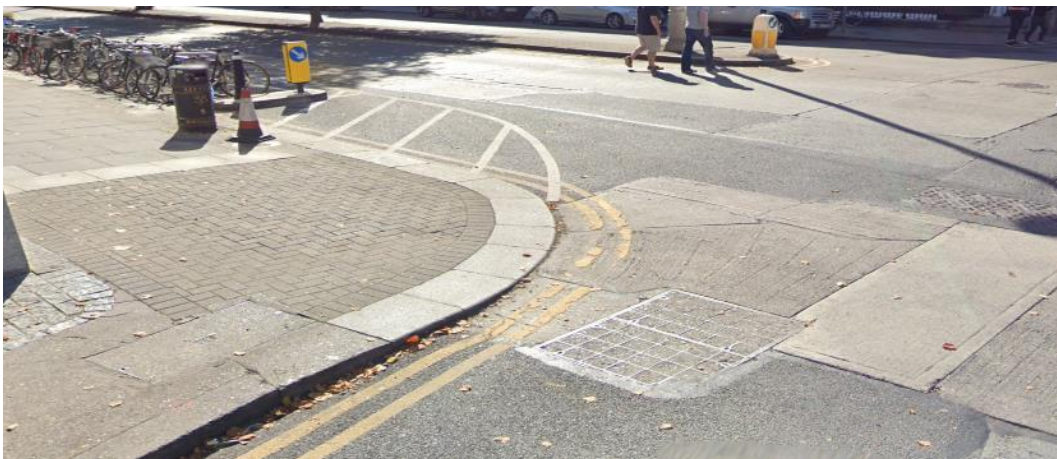
There are a number of uncontrolled crossings along this section. Some of the crossing facilities at side roads are of a poor standard, particularly in terms of catering for the mobility and visually impaired. For instance, on Baggot Street Lower, the dropped kerb at the uncontrolled crossing at the junction of James Street East is located on the curve of the road and not in the direct line of travel at the junction. Refer to **Figure 66**. Locating the dropped kerbs on the curve of a road can cause a risk of visually impaired users being misdirected by the orientation of the kerb.

**Figure 66: Uncontrolled Crossing Point with Dropped Kerb on Curve of Road – Baggot Street Lower**

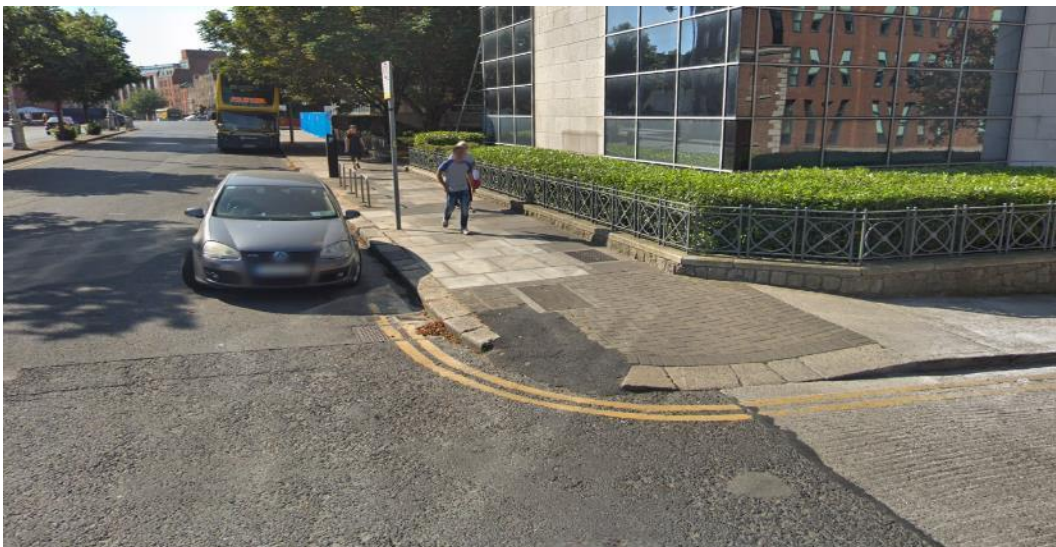
Asphalt and concrete have both been used as materials to make patch repairs along some footpaths. In some instance this has led to undulating, uneven surfaces caused by settlement of patch repair material. This is a hazard to pedestrians and cyclists alike. The junction between Baggot Street Lower and Pembroke Row is a particularly poor example of patch repair, where asphalt has been poured onto a raised kerb to produce the effect of a lowered kerb. Refer to **Figure 71**.

**Figure 71: Surface Material – Baggot Street Lower / Pembroke Row Junction**
