# Appendix I1

## Accessibility Audit Report

National Transport Authority  
**Belfield / Blackrock to City Centre  
Scheme**  
Accessibility Audit Report

Issue | 16 December 2021

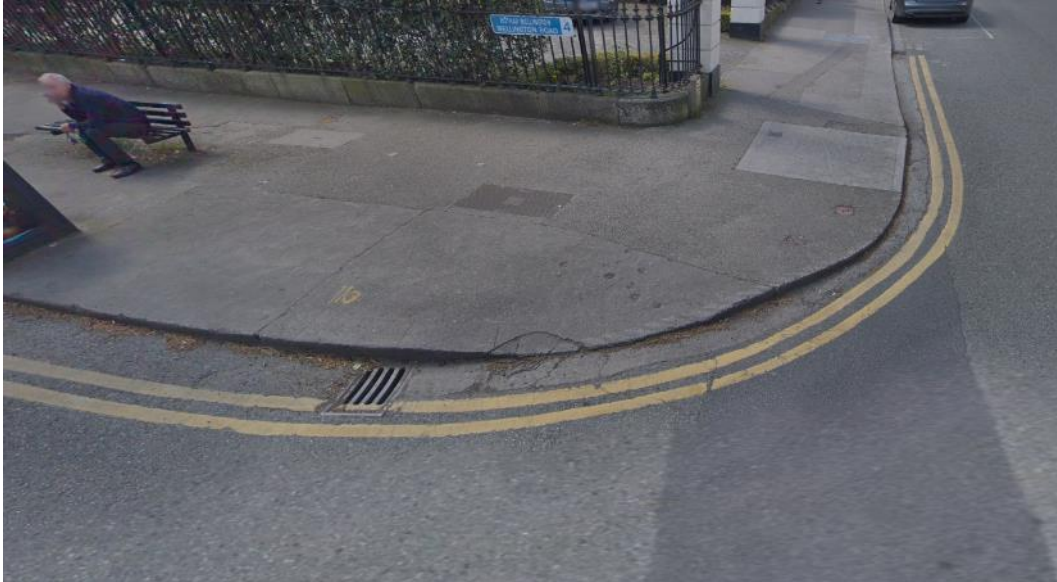
A damaged concrete kerb was also observed at the junction between Pembroke Road and Wellington Road, representing a further potential danger to pedestrians and cyclists. Refer to **Figure 72**.

**Figure 72: Surface Material – Pembroke Road / Wellington Road Junction**

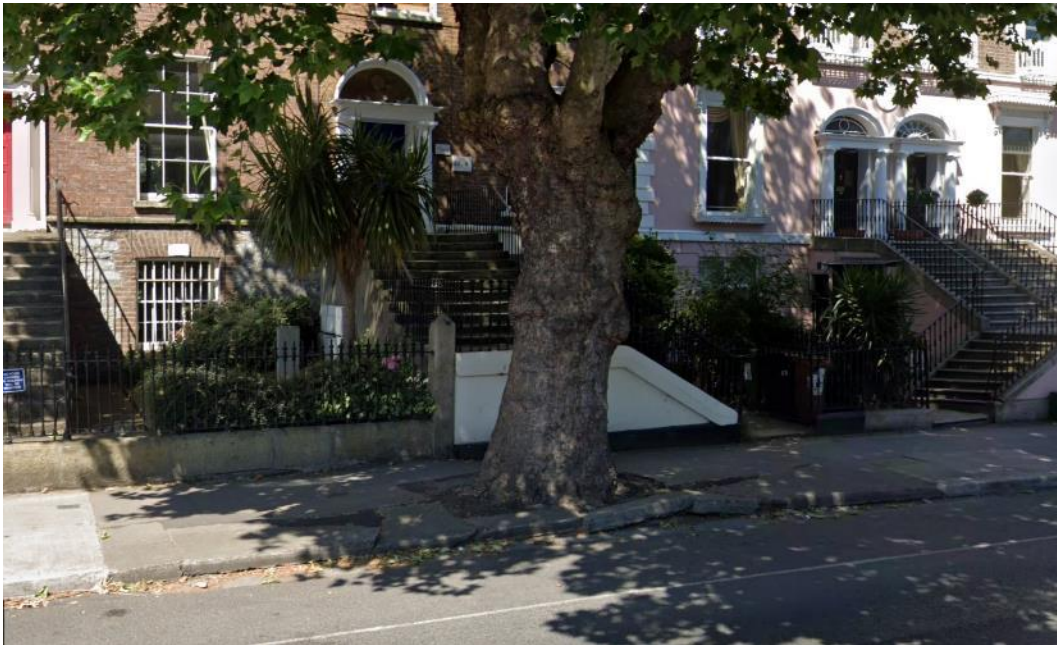
While not street furniture as such, a tree located along Pembroke Road, is also positioned centrally in the footpath, thereby reducing the effective width of the footpath. Refer to **Figure 80**. The footpath is also damaged in this location, most likely due to the effect of the tree roots. This is likely providing a further issue for the mobility impaired.

**Figure 80: Street Furniture – Pembroke Road**

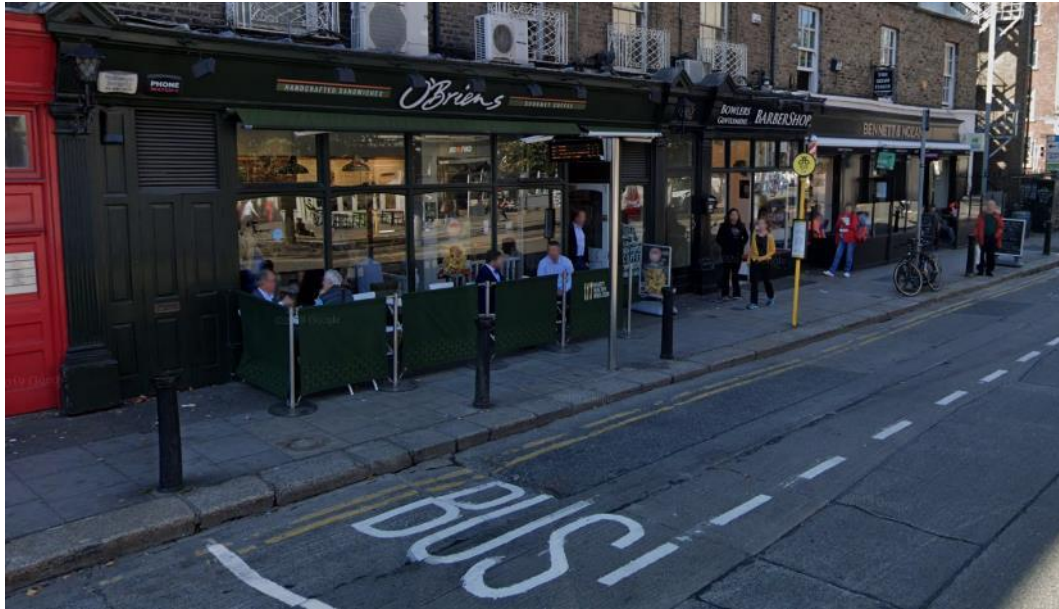
Street furniture positioned along the footpath on southern side of Baggot Street Lower, immediately after the junction with Fitzwilliam Street Lower, results in this location being particularly constrained for the mobility impaired. Refer to **Figure 81**. The footpath is narrow at this point and the combined effect of café seating and street furniture, including bollards and bus stop poles, are likely to cause difficulty to the mobility impaired.

**Figure 81: Street Furniture – Baggot Street Lower**

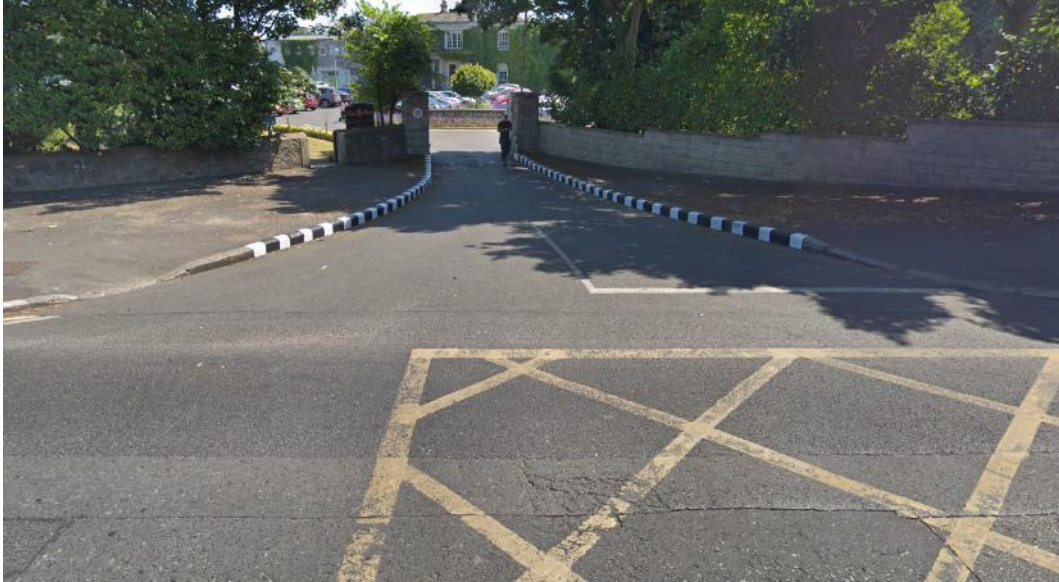
There are a number of uncontrolled crossings along this section. Most of these are of a reasonably good standard. However, some are noticeably of poor standard particularly when catering for the mobility and visually impaired. There are two instances of dropped kerbs along Nutley Lane being located on the curve of the road and not in the direct line of travel at the junction. Refer to **Figure 89**. Locating the dropped kerbs on the curve of a road can cause a risk of visually impaired users being misdirected by the orientation of the kerb.

**Figure 89: Uncontrolled Crossing Point with Dropped Kerbs on Curve of Road – Nutley Lane**

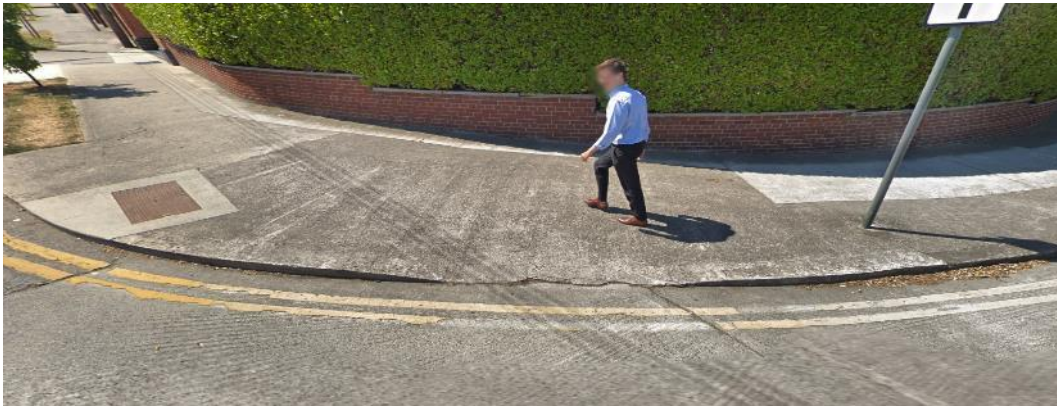
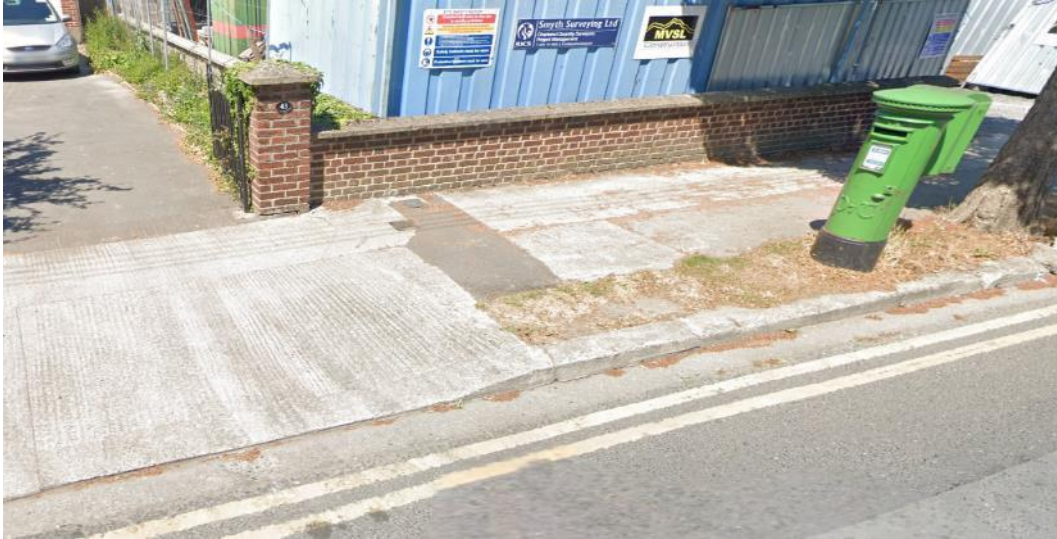
Asphalt and concrete have both been used as materials to make patch repairs along footpaths. In some instance this has led to undulating, uneven surfaces caused by settlement of patch repair material. This is a hazard to pedestrians and cyclists alike.

**Figure 91: Surface Material – Nutley Lane / Nutley Avenue Junction**

**Figure 93: Surface Material – Nutley Lane**

Footpath materials should be selected to ensure surfaces are free of undulations, with no trip hazards where there is a transition between surface materials – or where the Proposed Scheme ties into the existing infrastructure.
