An Arboricultural Assessment of the Tree and Hedge Vegetation on 'SHD Lands' at Ratoath South, Co. Meath.

Prepared for: Beo Properties Ltd.

Prepared by: Felim Sheridan F. Arbor. A, RFS Dip, Nat. Dip & NCH in
Arboriculture

Date: 20th April 2022

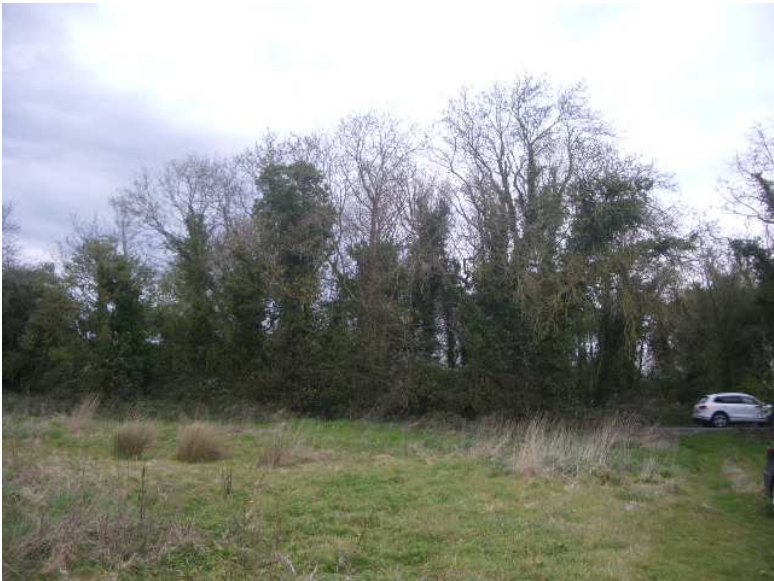
Tree No.	Tree Species	Ht. (m)	Stem Dia. (mm)	Branch Spread (m)	C-Ht. (m)	Age Class	Phys. Con.	Structural Condition Other Comments	Preliminary Recommendation	Remain Contribute in years	Cat. Grade
								N-north S-south E-east W- west Phys.-physiological.	A- average		
A Condition Assessment of the trees on lands at 'Ratoath' Co. Dublin.											
Hedge No. 1	Hawthorn <i>Crataegus monogyna</i> Bramble <i>Rubus fruticosus</i> Dogrose <i>Rosa canina</i> Ash <i>Fraxinus excelsior</i>	It extends north to south along the road frontage, from the boundary with a field. It is of a mature age class in fair condition physiologically and structurally. It consists of clumps Hawthorn, Bramble and Dogrose with the Ash trees mixed throughout forming the upper canopy formation. Due to lapsed management the hedge vegetation has become very sparse with Bramble and Dogrose dominating the undergrowth and encroaching out, in particular on the field side, creating scrub areas. It has been kept trimmed on the road side due to its close proximity to the road. I suspect that this hedge has been impacted upon by the previous road works and possibly the filling in of the original field drainage ditch.

Cut in all encroaching hedge species and cut back the poor structured hedge plants to encourage lower growth development and to improve structure.	-	C2

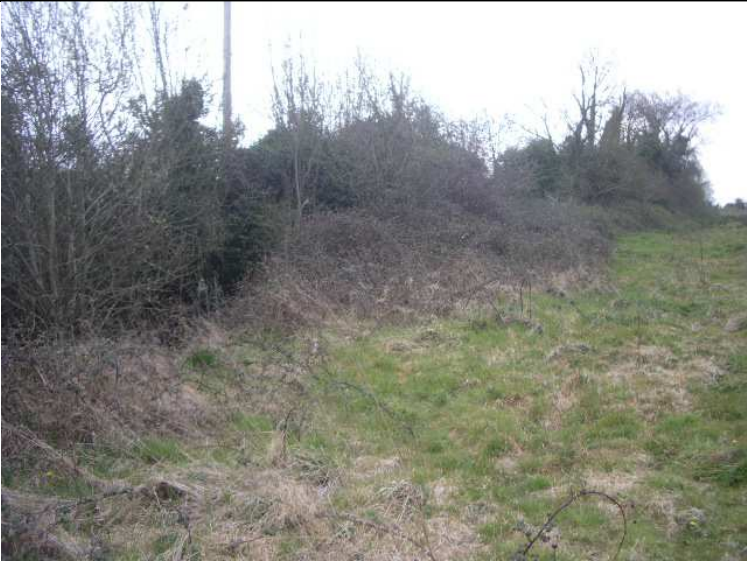
Tree No.	Tree Species	Ht. (m)	Stem Dia. (mm)	Branch Spread (m)	C-Ht. (m)	Age Class	Phys. Con.	Structural Condition Other Comments	Preliminary Recommendation	Remain Contribute in years	Cat. Grade
								N-north S-south E-east W- west Phys.-physiological.	A- average		
	Ash <i>Fraxinus excelsior</i> Goat Willow <i>Salix caprea</i>

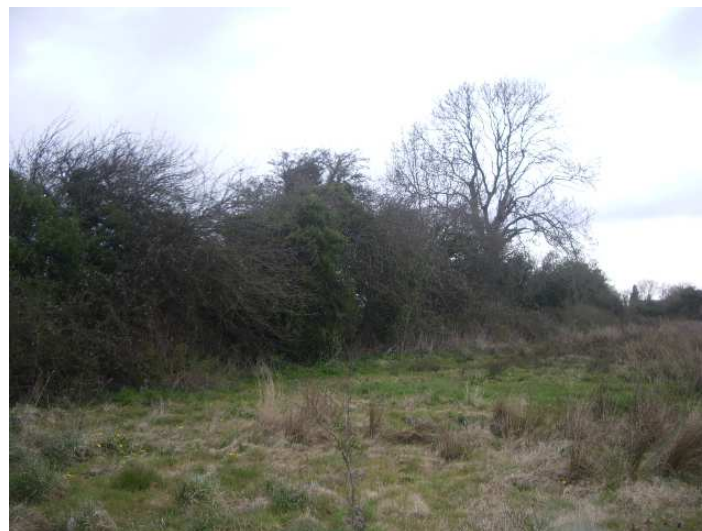
<p>The following trees are located within Hedge No. 3.</p>									
1456	Ash <i>Fraxinus excelsior</i>	12	340	N3 S3 E4 W2	4	Semi Mature	Fair	Fair It is growing on the site side of the drainage ditch and has been drawn up and out for the light due to competition and is beginning to establish its crown	Requires no work at the present time.	10-20	C1

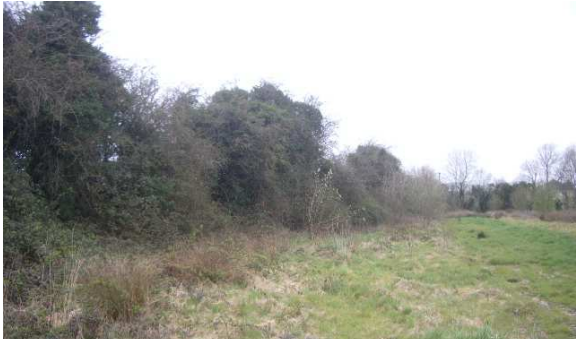
Hedge No. 4	Hawthorn <i>Crataegus monogyna</i> Elder <i>Sambucus nigra</i> Bramble <i>Rubus fruticosus</i> Dogrose <i>Rosa canina</i> Ash <i>Fraxinus excelsior</i>	It runs at ninety degrees to Hedge No. 3 and runs in a north to south direction along the site boundary with the adjoining field. It is of a mature age class in fair condition both physiologically and structurally. It consists of predominately Hawthorn with some Elder, Bramble and Dogrose dominating the lower vegetation and are encroaching out due to lapsed management. It is growing on a high soil bank with no defined boundary ditch on either side of this hedge line. There are young seedling Ash trees forming part of the bulking within this hedge.

Trim in all encroaching hedge species in order to tidy up the hedge structure. The poorly structured sections of hedge would benefit from being cut back in order to encourage lower growth development and to help improve its stability and structure.	-	C2

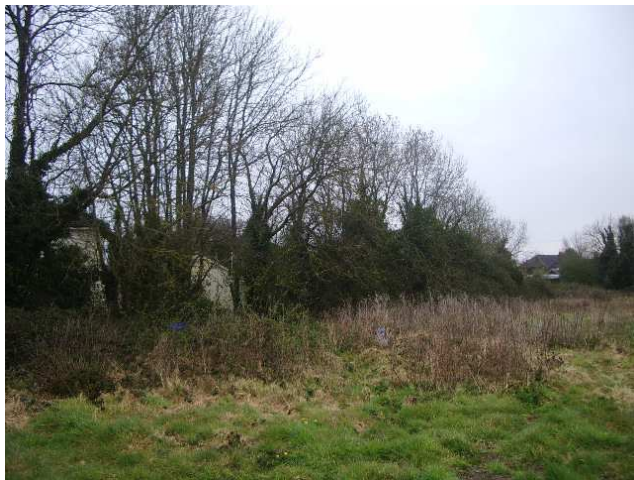
Tree No.	Tree Species	Ht. (m)	Stem Dia. (mm)	Branch Spread (m)	C-Ht. (m)	Age Class	Phys. Con.	Structural Condition Other Comments	Preliminary Recommendation	Remain Contribute in years	Cat. Grade
								N-north S-south E-east W- west Phys.-physiological.	A- average		
Hedge No. 5	Hawthorn <i>Crataegus monogyna</i> Crab Apple <i>Malus sylvestris</i> Elder <i>Sambucus nigra</i> Privet <i>Ligustrum sp.</i> Goat Willow <i>Salix caprea</i>	<p>It runs at ninety degrees to Hedge No. 4 and extends in a north-south direction along the western boundary of the site area and on the boundary with the adjoining linear open space belonging to the existing residential development to the west.</p> <p>It consists of predominately Hawthorn with Elder, Bramble and Dogrose encroaching out onto the lands, in particular on the site side due to lapsed management creating scrub areas. It has been trimmed back on the open space side to maintain a tidy appearance. It has been allowed to grow up tall with the lower vegetation being impacted upon due to overcrowding. It has been cut back at the northern end behind the rear gardens of the neighbouring houses.</p>

<p>Make safe large size dead/ unstable growth and prune back the poor quality sections of hedging in order to address stability and to encourage lower growth development.</p> <p>Trim in all encroaching hedge species in order to tidy up the hedge structure. Cut Ivy at ground level where it is heavy on the hedge plants in order to reduce wind sail and further wind damage.</p>	-	C2

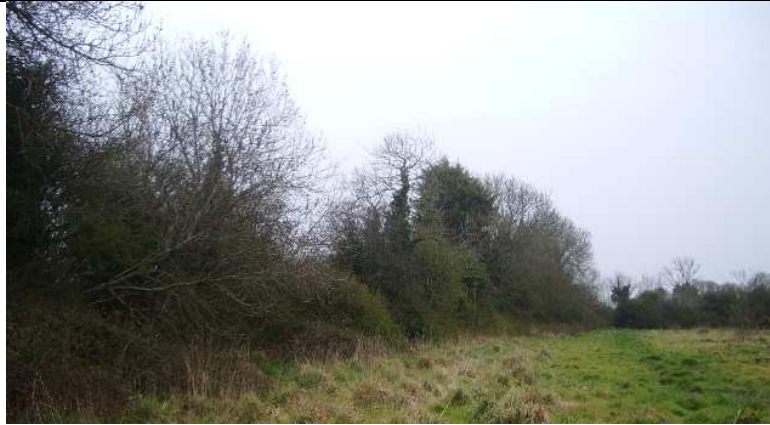
Tree Line No. 2	Ash <i>Fraxinus excelsior</i>	A 12	200 X 3 Stems	A N4 S4 E4 W4	A 2	Mature	Fair	Fair It is located at the western end of Hedge No. 6 and those located at the very western end have received pruning in the past in order to reduce their size and their overhang to the north has been cut back in the past due to the overhead utility lines. Heavy lvy cover on some trees is extending up into their crowns.	They would benefit from general tidying works within this area in order to open up this area and to allow for a more detailed assessment to be carried out. Cut lvy at ground level where it is heavy on trees. They will require ongoing pruning in order to maintain clearance with the overhead utility lines.	10-20	C2

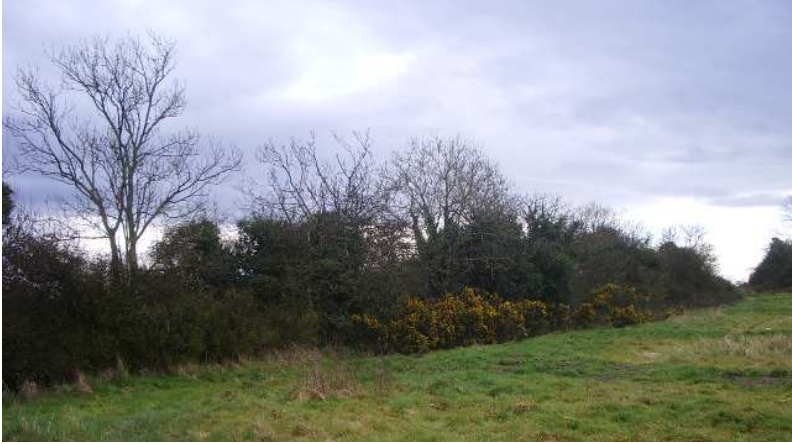
The following trees are located within Hedge No. 7 working from north to south.											
1463	Ash <i>Fraxinus excelsior</i>	10	220	N4 S5 E3 W3	2	Early Mature	Fair / Poor	Fair It is growing on the hedgerow bank and forms part of the hedge bulking. Its crown is showing signs of reduced vigour / decline most likely due to infection by Ash Dieback (<i>Hymenoscyphus Fraxineus</i>). There is heavy Ivy cover on the main trunk.	Cut Ivy at ground level and monitor its condition on an annual basis.	10+	C2
1464	Ash <i>Fraxinus excelsior</i>	13	120/ 300/ 150	N5 S4 E5 W2	5	Early Mature	Fair/ Poor	Fair Multiple-stemmed from base and is growing up forming part of the higher hedge bulking. Its crown is showing signs of reduced vigour most likely due to infection by Ash Dieback (<i>Hymenoscyphus Fraxineus</i>).	Monitor its condition on an annual basis.	10+	C2

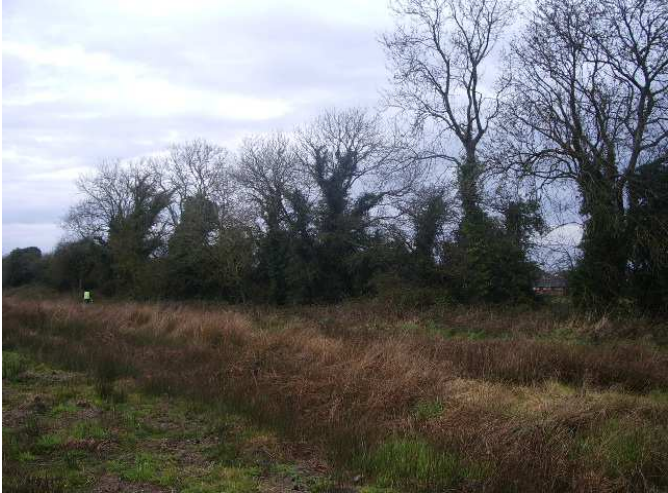
<p>The following trees are located within Hedge No. 8. They are growing within an open tree line with an overall combined canopy which is of some prominence within the treescape of this area.</p>										
1466	Ash <i>Fraxinus excelsior</i>	17	470	N7 S6 E6 W6	5	Mature	Fair	Fair It is a tall tree beginning to be heavily suppressed by Ivy. It is located on the north side of the drainage ditch and is twin-stemmed from base with other smaller stems present. It forms part of the upper canopy formation with a slightly asymmetrical crown formation.	Cut Ivy at ground level and tidy up the area around its base.	10-20	C2

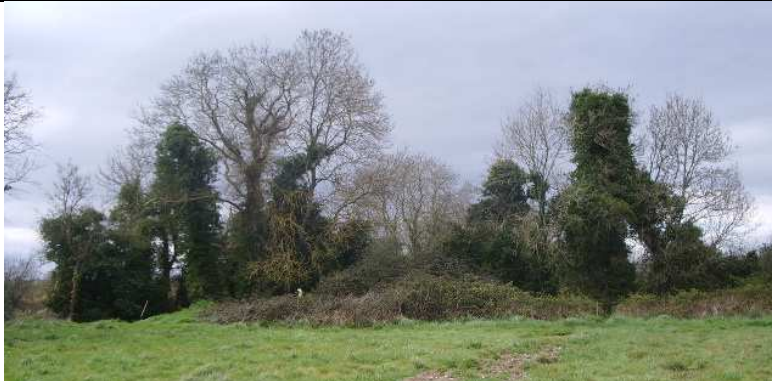
<p>The following trees are located within Hedge No. 9. The assessment works from south to north in direction.</p>							
1479	Ash <i>Fraxinus excelsior</i>	9	410	N2 S6 E5 W4	3	Mature	Fair	Fair/Poor It is growing up within a sheltered group environment and is located on the edge of the entrance between two fields. It has suffered soil and root damage with soil and debris piled into this area. It has also suffered a large size bark wound on the lower trunk allowing for the entry of decay. Heavy Ivy cover on the main trunk is extending up into its crown. Its crown is showing signs of stress/decline throughout.	Cut Ivy at ground level and tidy up the area around its base.	10+	C2

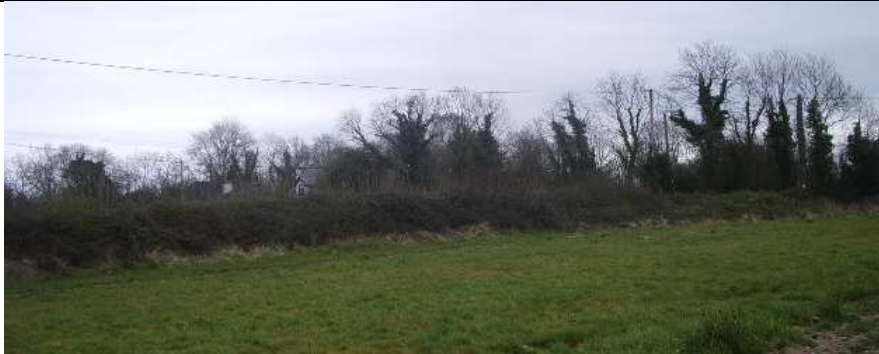
Hedge No. 11	Hawthorn <i>Crataegus monogyna</i> Elder <i>Sambucus nigra</i> Ash <i>Fraxinus excelsior</i> Sycamore <i>Acer pseudoplatanus</i> Bramble <i>Rubus fruticosus</i> Dog Rose <i>Rosa canina</i>							<p>It runs at ninety degrees to Hedge No. 10 and extends in a north-south direction along the east boundary of the site area and is bordering with the lane.</p> <p>It is of a mature age class and in fair condition both physiologically and structurally. It is located on the field side (west side) of a deep drainage ditch cordoning if off from the laneway. The main hedge species consist of Hawthorn, Elder, Ash and Sycamore.</p> <p>It has been cut, clipped and maintained from the lane way which has helped to maintain a good structured hedge. It has been allowed to grow more unmanaged on the field side with scrub species, in particular Bramble encroaching out onto the lands with Ivy dominating some of the hedge plants.</p>	<p>Continue present maintenance.</p> <p>Trim on the field side to contain its width and structure.</p>	-	C2

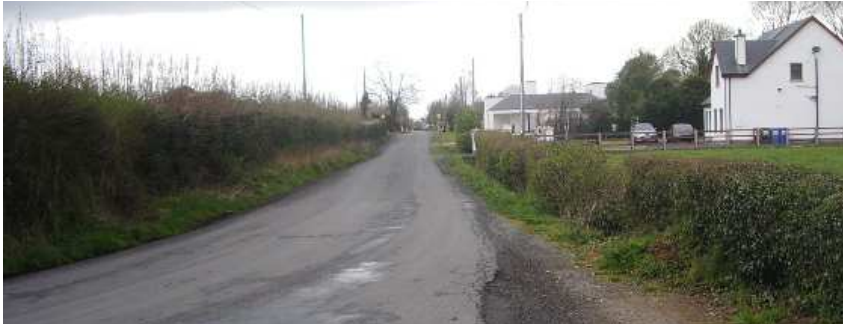
Hedge No. 13	Hawthorn <i>Crataegus monogyna</i> Elder <i>Sambucus nigra</i> Bramble <i>Rubus fruticosus</i> Dogrose <i>Rosa canina</i>	<p>It runs north-south along the eastern side of the lane and is located on the field side of the drainage ditch that cordons it off from the road.</p> <p>It is of a mature age class in fair condition both physiologically and structurally. The main hedge species include Hawthorn, Elder, Bramble, Dogrose and Privet with Gorse on the field side and Ash trees forming part of the upper canopy formation. There is evidence of where it was cut in the past including a lot of the Ash trees that form part of the upper canopy formation at a height of 1.5m up and have since been allowed to grow up tall, with a lot of the Ash trees forming multiple-stemmed trees from the previous cut points. Some sections of the hedge are being heavily suppressed by Ivy. It has been trimmed on the roadside in order to maintain clearance with the road, but has been allowed to grow more unmanaged on the field side. It has also been allowed to grow up tall in recent years, which has impacted on the lower vegetation and its structure.</p>

<p>It would benefit from the trimming in of encroaching hedge species.</p> <p>The poorly structured sections of Hedge should be cut back in order to address stability and safety issues.</p> <p>Where Ivy is suppressing the sections of hedge, this needs to be cut at ground level.</p>	-	C2

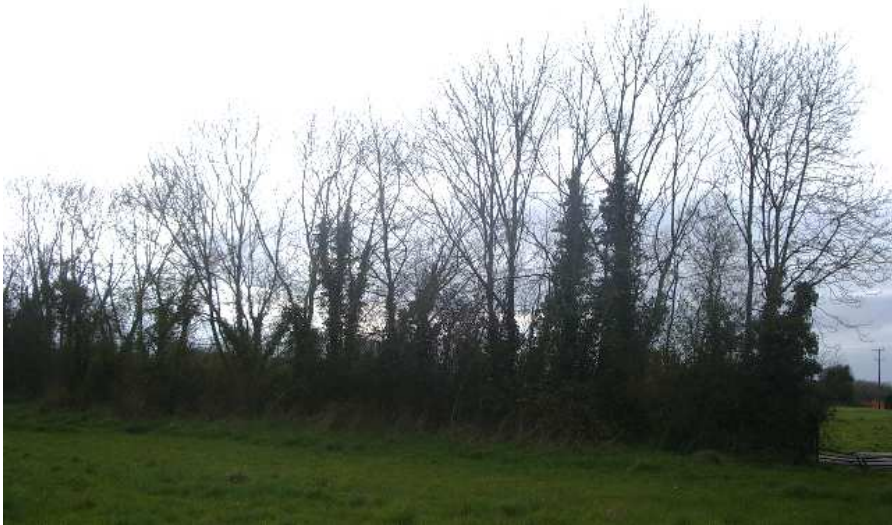
<p>The following are the more prominent trees within this hedge. The assessment works from north to south.</p>									
1484	Ash <i>Fraxinus excelsior</i>	15	490	N7 S4 E5 W6	8	Mature	Fair	Fair It has an independent crown towering over the hedge. It is showing some signs of minor stress/ decline throughout due to infection by 'Ash Dieback (<i>Hymenoscyphus Fraxineus</i>). Heavy Ivy cover on the main trunk is beginning to extend up into its crown. It contains deadwood throughout its crown.	Remove dead/ unstable growth. Cut Ivy at ground level. Monitor its condition on an annual basis.	10+	C2
1485	Ash <i>Fraxinus excelsior</i>	14	380	N2 S4 E6	5	Early Mature	Fair	Fair It is a tall tree growing up within a sheltered group environment. Its crown is showing early signs of	Remove dead/ unstable growth at the present time. The Ivy will require	10+	C2

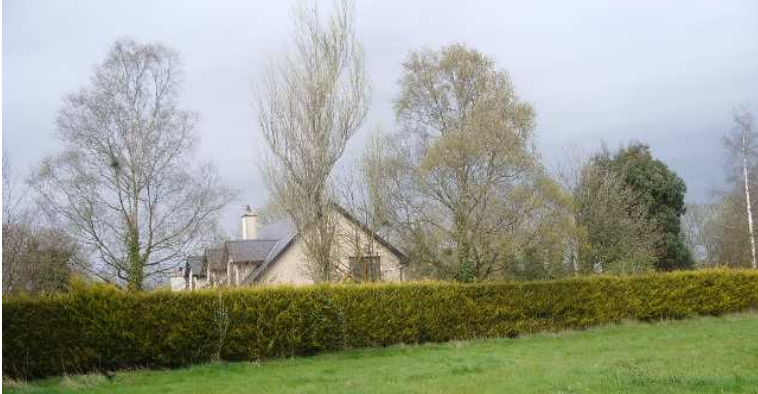
Hedge No. 15	Hawthorn <i>Crataegus monogyna</i> Gorse <i>Ulex europaeus</i> Elder <i>Sambucus nigra</i> Privet <i>Ligustrum sp.</i> Bramble <i>Rubus fruticosus</i> Dogrose <i>Rosa canina</i>	<p>It runs in a north-south direction and forms the boundary between the two fields.</p> <p>The main hedge line is located on the west side of a deep wet drainage ditch with some vegetation located on the east side. It consists of predominately Hawthorn with Gorse, Elder, Privet, Bramble and Dogrose dominating some sections. The lower vegetation has been impacted upon and is being grazed off by the livestock sheltering/ grazing within this area. The hedge plants have been allowed to grow up tall with some sections being suppressed by Ivy.</p>

<p>Make safe large size dead/ unstable growth.</p> <p>Cut Ivy at ground level where it is heavy and trim in all encroaching hedge species.</p>	-	C2

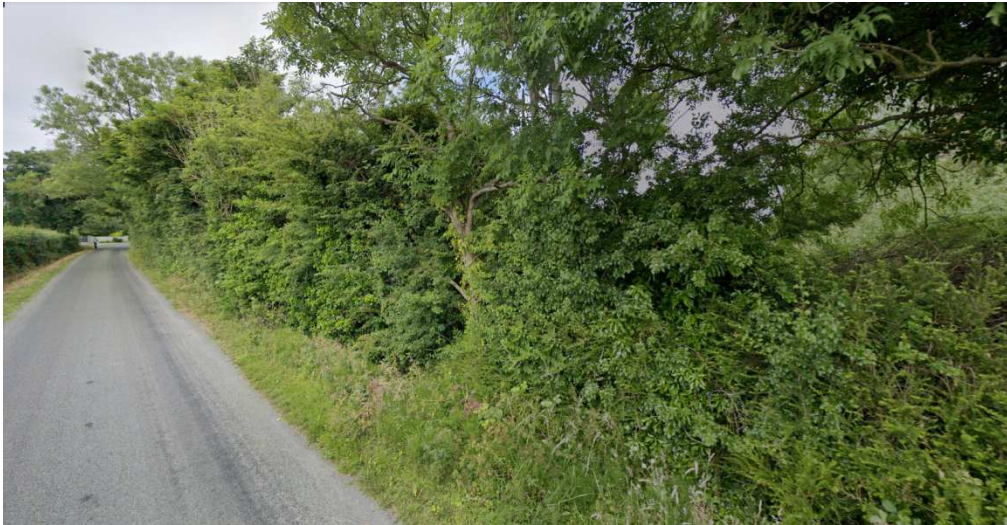
Hedge No. 19	<p>Hawthorn <i>Crataegus monogyna</i> Elder <i>Sambucus nigra</i> Privet <i>Ligustrum sp.</i> Bramble</p>	<p>It runs at ninety degrees to Hedge No.8 and runs in a north-south direction. It is of a mature age class in fair condition physiologically and structurally. The main hedge species consist of Hawthorn with some Elder, Privet, Bramble, Dogrose and Gorse on the outer edges with Ash trees forming the upper canopy, along with some Elm and Poplar. The main hedge line is located on the west side of a deep wet boundary ditch. Due to lapsed management, the hedge species, in particular the Bramble and Gorse have encroached out to create a broad hedge line and scrub areas. Some sections of this hedge have been reinforced with fencing wire.</p>						<p>Make safe large size dead/ unstable growth. Trim in encroaching hedge species.</p>	-	C2

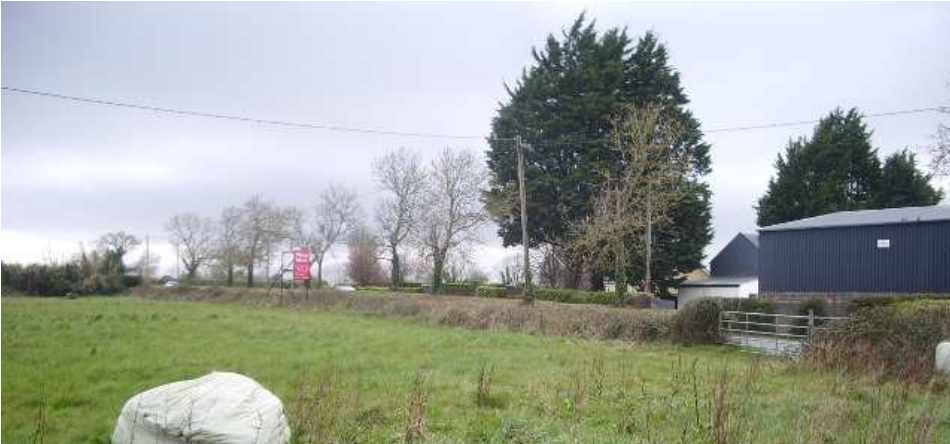
<p>The following trees are located within this hedge working from north to south.</p>					
1928	Ash <i>Fraxinus excelsior</i>	11	280	N5 S4 E2 W2	4	Early Mature	Fair/ Poor	Fair/ Poor It is located on the roadside of the boundary hedge and has suffered bark wounding on the lower trunk during the hedge cutting works with decay developing into these wounds. Its crown development/ structure has been affected due to cutting back from the overhead utility lines on the east side. There is 'Bacteria Canker' of Ash evident within its crown with reduced vigour as a result.	Monitor its condition on an annual basis.	10+	C1
