County Tree Care Ltd

Tree Survey and Arboricultural Impact Assessment of mature large trees and understorey tree species at a site in Carrigaline, Co. Cork

Date : 12/09/21

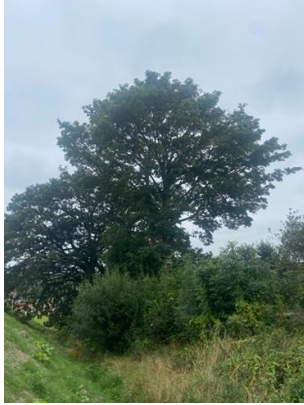
Image A1 : T811

Tag No.	Species	Age	Height	Diameter	Condition	Crown Spread	RPA (M ²)	Comments	Recommendations	RC	ERC
811	Sycamore (<i>Acer pseudoplatanus</i>)	M	16m	105cm (X 2)	Poor	N 7m S 6m E 8m W 5m	499	Hazardous tree, Tall tree on the edge of a earth ditch, drainage dyke running 1m from West side, co-dominant stems @ the base, Northern stem sub-divided @2m, cracking bark and signs of a shear crack on Northern stem from base - 2m East side, Union @2m Northern stem is poor - compressed wood, Large rip out on Southern stem from base to 2m, lack of sufficient structural wood to ensure good structural integrity	Fell Tree	U	< 5

Generally the trees on the site are of fair standard. There are 9no. trees that are recommended to be removed. At the Southern end of the site there are 6no. that are in poor condition. One of these trees T811 is a sycamore (*Acer pseudoplatanus*). This is a hazardous tree and should be removed immediately. The other 5no. in this section are recommended to be felled because of their poor appearance and lack of contributory value to the landscape presently or going forward into the future. This is primarily due to past work that was done on them. T812 is an ash (*Fraxinus excelsior*). This has had all of its branches removed by cutting them back to the main trunk. The result is a burst of epicormic growth (resembling suckers) from the cuts and this means that the tree is now displaying a huge amount of soft leafy growth at different points on the trunk. Aesthetically not pleasing and physiologically compromising. The tree will never have a proper branch structure again and the epicormic growth as it gets heavier can become a hazard as it tends to break off in high winds.

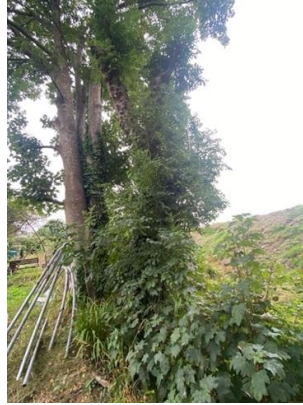
Image A2 : T812

Tag No.	Species	Age	Height	Diameter	Condition	Crown Spread	RPA (M ²)	Comments	Recommendations	RC	ERC
812	Ash (<i>Fraxinus excelsior</i>)	M	7m	45cm	Poor	N 1m S 1m E 1m W 1m	92	Pollarded tree, Main trunk has a proliferation of epicormic growth on the top of the stem and on the sides where branches were cut back all the way to the main stem. It has no shape and offers nothing going forward, epicormic growth in time will be a hazard	Fell Tree	U	< 5

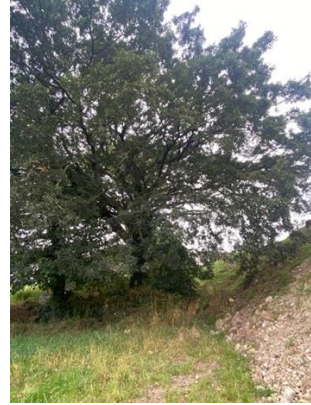
Image A3 : T813

Tag No.	Species	Age	Height	Diameter	Condition	Crown Spread	RPA (M ²)	Comments	Recommendations	RC	ERC
813	Turkey oak (<i>Quercus cerris</i>)	M	15m	90cm	Good	N 11m S 4m E 12m W 9m	366	Healthy oak, growing on an earth bank, dyke running 2m from base on West, crown growing extensively North and East, Some minor dieback on tips @5m NE, NW, dead branches @ 3m N & 5m W, Fine bole to 3m, divides into 5 major limbs at this point, good healthy crown, flush and showing signs of good vigour, lower crown is close to the ground @1.5m	Clean crown of any dead or cracked branches, crown raise to 3m all around NB : Spikes are not to be worn by climbing arborist	A2	50+

There is one tree in category A. It is a Austrian oak (*Quercus cerris*) more commonly referred to as Turkey oak. It is not indigenous and was brought to the British isles in the 1800s as an ornamental tree. It is considered by some to be an invasive species. It is also the host of the knapper gall wasp which can damage native oaks. This tree is growing on the edge of an earth bank next to a drain on the West. Its roots would not have spread extensively Westward. Its crown is slightly underdeveloped on the South because of T811. There is some evidence of minor dieback at the tips on the North-east upper crown and North-west upper crown, but this is minor and not reflective of the health of the tree. The leaf is a good colour and the crown is flush with growth. The main scaffold branches that divide off at 3m are strong and well balanced.

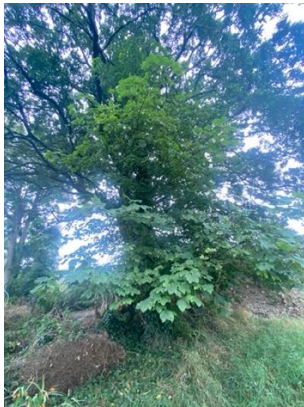
Image A4 : T814

Tag No.	Species	Age	Height	Diameter	Condition	Crown Spread	RPA (M ²)	Comments	Recommendations	RC	ERC
814	Sycamore (<i>Acer pseudo platanus</i>)	EM	12m	20cm	Fair	N 4m S 3m E 3m W 2m	18	Crown unbalanced, tree is growing into T813 on West, 90° of crown is on North and East, Heavy ivy on main stem, tree will never develop in its position and will restrict the oak	Fell Tree	U	<20

There is another tree a sycamore (*Acer pseudoplatanus*) T815 in this section that had the same work done to it as the ash with the same results and prognosis going forward. There is another sycamore T814 that is growing into the Turkey oak (*Quercus cerris*) and will eventually create cambium damage in the oak and restrict branch and leaf development because it is growing within its crown on the North-east side. The sycamore itself will never develop into a well formed tree because of the oak.

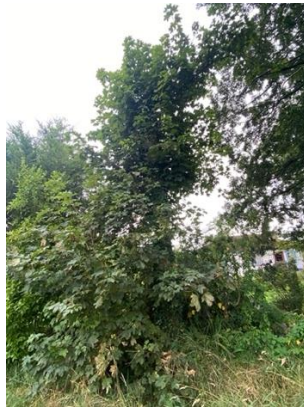
Image A5 : T815

Tag No.	Species	Age	Height	Diameter	Condition	Crown Spread	RPA (M ²)	Comments	Recommendations	RC	ERC
815	Sycamore (<i>Acer pseudo platanus</i>)	EM	6m	30cm	Poor	N 1m S 1m E 1m W 1m	41	Tree was pollarded severely in the past and there is no crown left. Much epicormic growth, much sucker growth at the base. The tree offers nothing to the site presently or going forward.	Fell Tree	U	<10

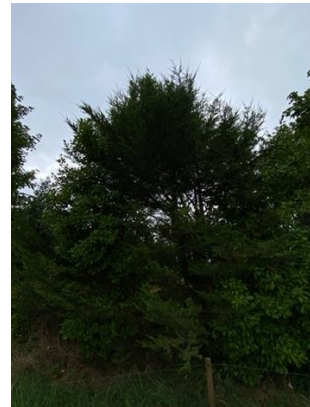
Image A6 : T816

Tag No.	Species	Age	Height	Diameter	Condition	Crown Spread	RPA (M ²)	Comments	Recommendations	RC	ERC
816	Leylandii cypress (<i>Cupressus X leylandii</i>)	EM	5m	30cm	Fair	N 2m S 2m E 2m W 2m	41	Stand alone leylandii as opposed to being in a hedge, Poor crown formation, lower crown all removed, crowded by grisilinia species at the base East & West side, growing in neighbour's garden	Tree is not posing a hazard at present	C3	10+

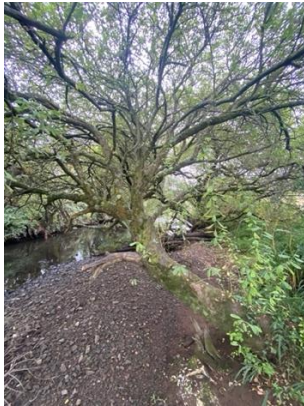
Image A11 : T820

Tag No.	Species	Age	Height	Diameter	Condition	Crown Spread	RPA (M ²)	Comments	Recommendations	RC	ERC
820	Willow (<i>Salix caprea</i>)	M	4m	30cm	Poor	N 3m S 2m E 6m W 4m	41	Growing on the side of the riverbank, signs of decay on the main stem @2m, deadwood @1m,2m & throughout crown	Retain as part of riverbank hedgerow, cut back to field edge on West reduce to 4m in height	C2	10+

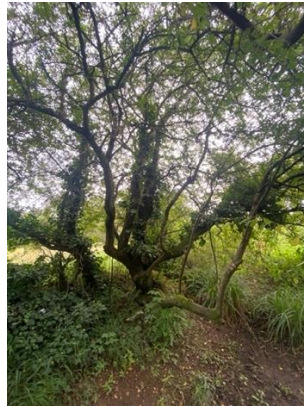
Image A12 : T821

Tag No.	Species	Age	Height	Diameter	Condition	Crown Spread	RPA (M ²)	Comments	Recommendations	RC	ERC
821	Hawthorn (<i>Crataegus monogyna</i>)	M	6m	30cm	Fair	N 2m S 1m E 2m W 2m	41	Mature tree growing on the side of a river bank, leaning 80° East, minor ivy on main stem, poor lower crown formation, no branches due to poor light levels from dense crown overhead of T820, growing into T820 on South	Clean crown, cut top to 4m and cut West side, retain, as with willows, as part of riverbank hedgerow	C1	10+

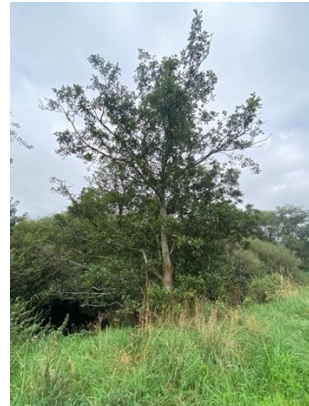
Image A13 : T822

Tag No.	Species	Age	Height	Diameter	Condition	Crown Spread	RPA (M ²)	Comments	Recommendations	RC	ERC
822	Alder (<i>Alnus glutinosa</i>)	M	5m	65cm (X 3)	Fair	N 4m S 3m E 3m W 3m	191	Growing over river to the North, crown heavy over river, broken branches @2m, South side lower crown, branches growing into field on South by 1m	Cut back branches to field edge on South, clean crown of any broken branches, retain as part of a riverbank tree group	B3	20+

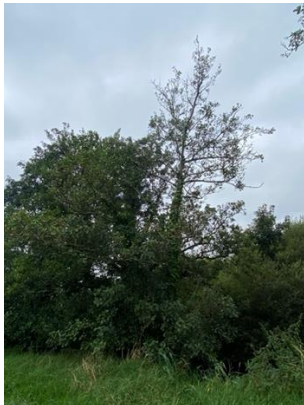
Image A14 : T823

Tag No.	Species	Age	Height	Diameter	Condition	Crown Spread	RPA (M ²)	Comments	Recommendations	RC	ERC
823	Alder (<i>Alnus glutinosa</i>)	M	7m	40cm (X 2)	Poor	N 3m S 2m E 2m W 0m	72	Dieback in the tips of the crown, tree is growing out from base of T824, leaning East 70° poor crown formation, weak tree	Fell tree as it will present a hazard in time	U	< 5

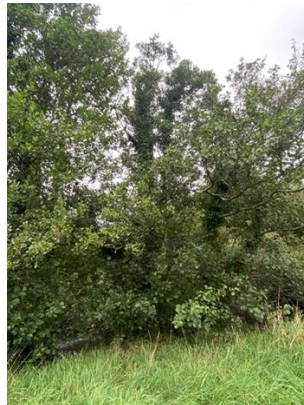
Image A15 : T8124

Tag No.	Species	Age	Height	Diameter	Condition	Crown Spread	RPA (M ²)	Comments	Recommendations	RC	ERC
824	Alder (<i>Alnus glutinosa</i>)	M	7m	40cm (X 2)	Poor	N 4m S 4m E 2m W 3m	72	Poorly shaped crown, impeded on East by T823 and West by T825, growing North over river, minor crown growth to the South, Heavy ivy on main stems and into crown, crowded and will not develop	Fell Tree and create space for T825 to develop its crown	U	< 2

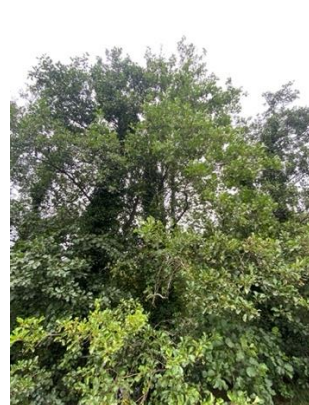
Image A16 : T825

Tag No.	Species	Age	Height	Diameter	Condition	Crown Spread	RPA (M ²)	Comments	Recommendations	RC	ERC
825	Alder (<i>Alnus glutinosa</i>)	M	8m	30cm	Fair	N 3m S 4m E 2m W 5m	41	Co-dominant stems from the base, heavy ivy growth on main stems into upper crown, poor crown formation, impeded on West by T824 and East by T826	Remove ivy, clean the crown of any defective branches, cut back branches on South to field edge, retain tree as part of a riverbank tree group	B3	20+
