# Arboricultural Report

Tree Survey,  
Arboricultural Impact Assessment &  
Arboricultural Method Statement

**Newcastle South**

**220301-PD-11-A**

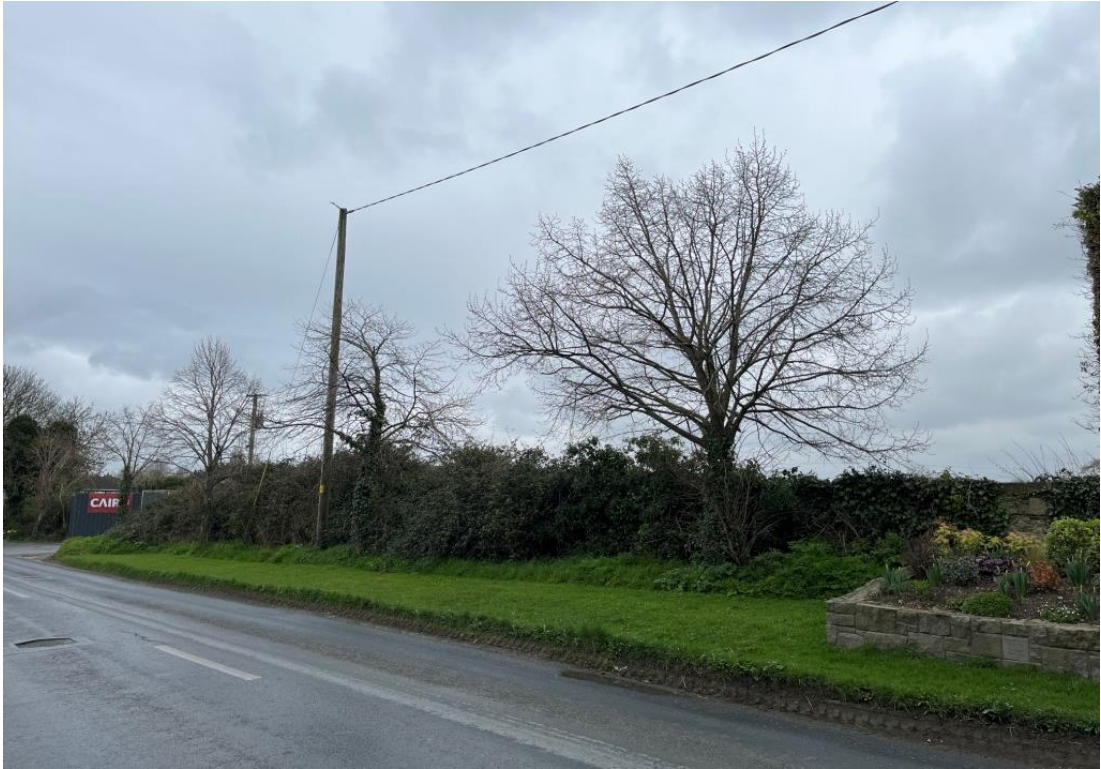
**Photo 1:** View of the lime trees (T903 to T906) located adjacent to Athgoe Road next to the existing site entrance.

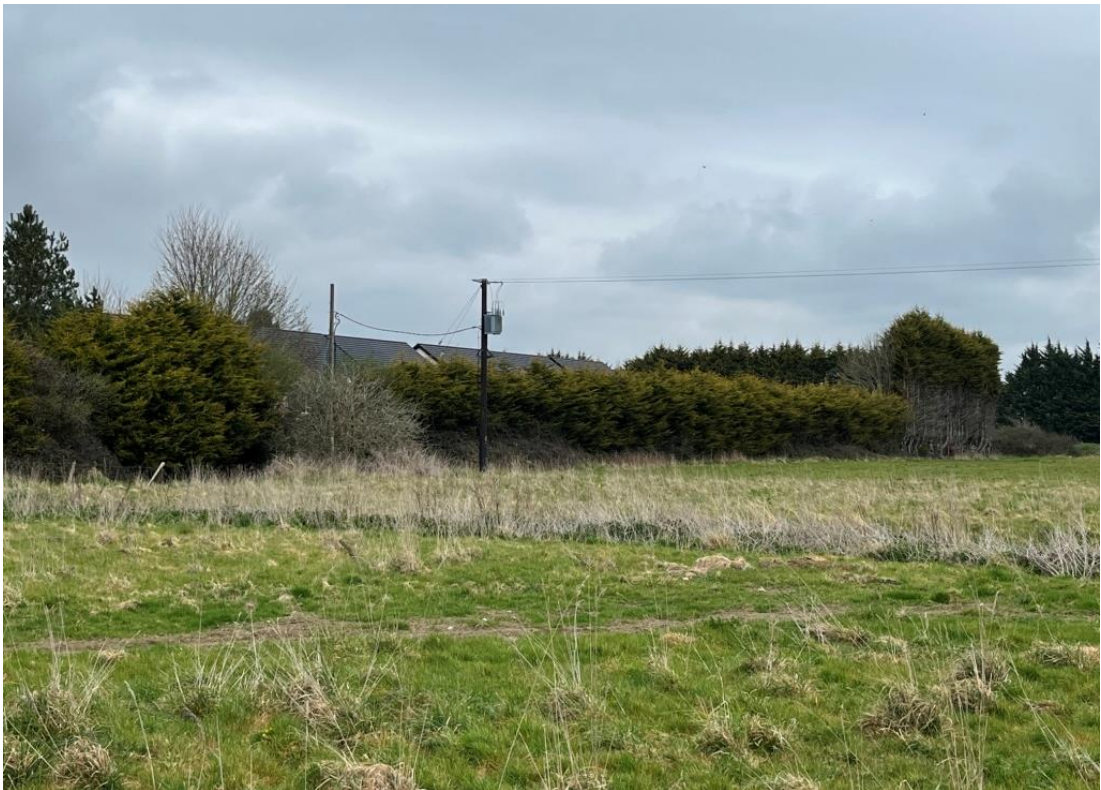
**Photo 2:** View of the neighbouring Leyland cypress trees (G8 & G11) located adjacent to the northern boundary.

Group G8	22 x Cupressocyparis leylandii (Leyland Cypress) 5 Sambucus nigra (Elder)	5.5	20 AVE	1									0.0		Early Mature	Structural condition Good. Physiological condition Good. Competition - Adjacent trees. Height and stem diameter are average for group. Neighbouring trees, quantities estimated only. Lateral growth overhanging boundary by approx. 3.5m.	29/03/2022	18.1	2.4	20-40	C2
Tree T9	1 Sambucus nigra (Elder)	4.5	31 COM	7	3.0		4.0		4.0		4.0		0.0		Early Mature	Structural condition Poor. Physiological condition Fair. Bark wound - Minor. Decay / structural defect - Base. Multi-stemmed. Natural regeneration.	29/03/2022	45.6	3.8	0-10	U
Tree T10	1 Acer platanoides (Norway Maple)	9.0	25	1	3.5		3.5		3.5		3.5		2.0		Early Mature	Structural condition Fair. Physiological condition Good. Access to inspect base - Not possible. Fork - Weak with included bark. Unable to inspect tree closely as located in neighbouring property.	29/03/2022	28.3	3.0	10-20	C1

Group G11	60 x Cupressocyparis leylandii (Leyland Cypress)	5.0	15 AVE	1									0.0		Early Mature	Structural condition Good. Physiological condition Good. Competition - Adjacent trees. Height and stem diameter are average for group. Neighbouring trees, quantities estimated only. Lateral growth overhanging boundary by approx. 1.5m.	29/03/2022	10.2	1.8	20-40	C2

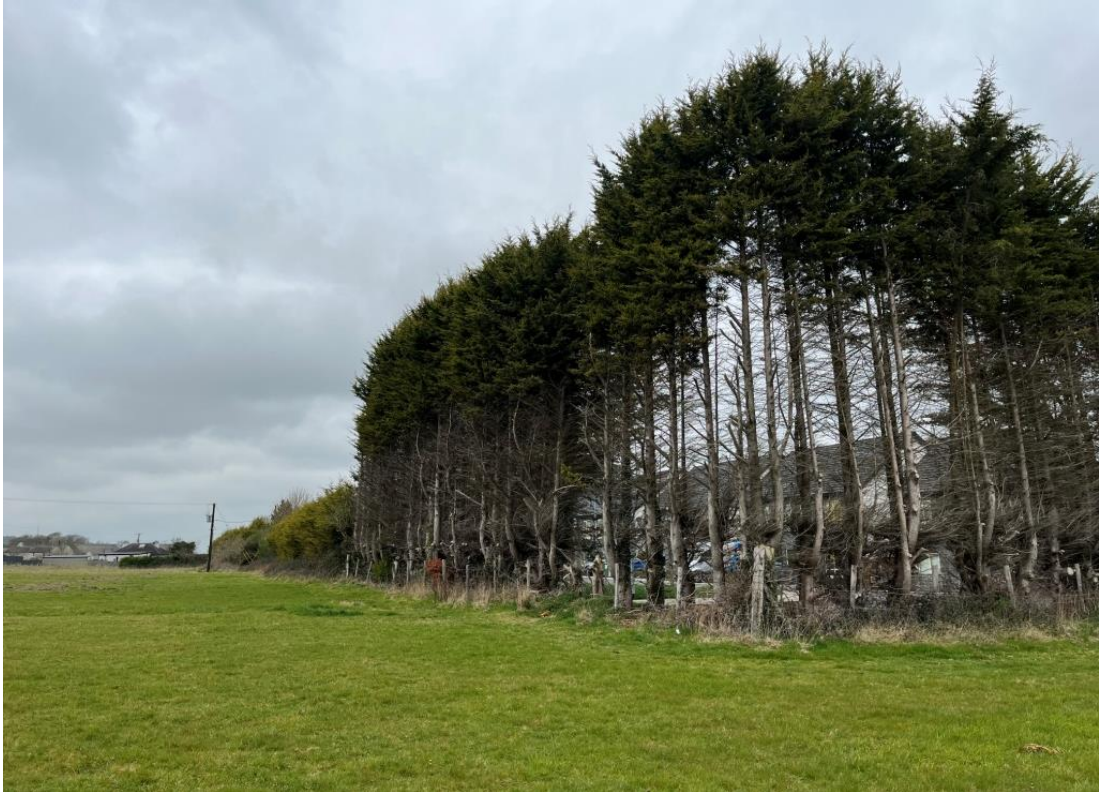
**Photo 3:** View of the neighbouring Leyland cypress trees (G12) located adjacent to the northern boundary. The trees within this group have been poorly pruned in the past.

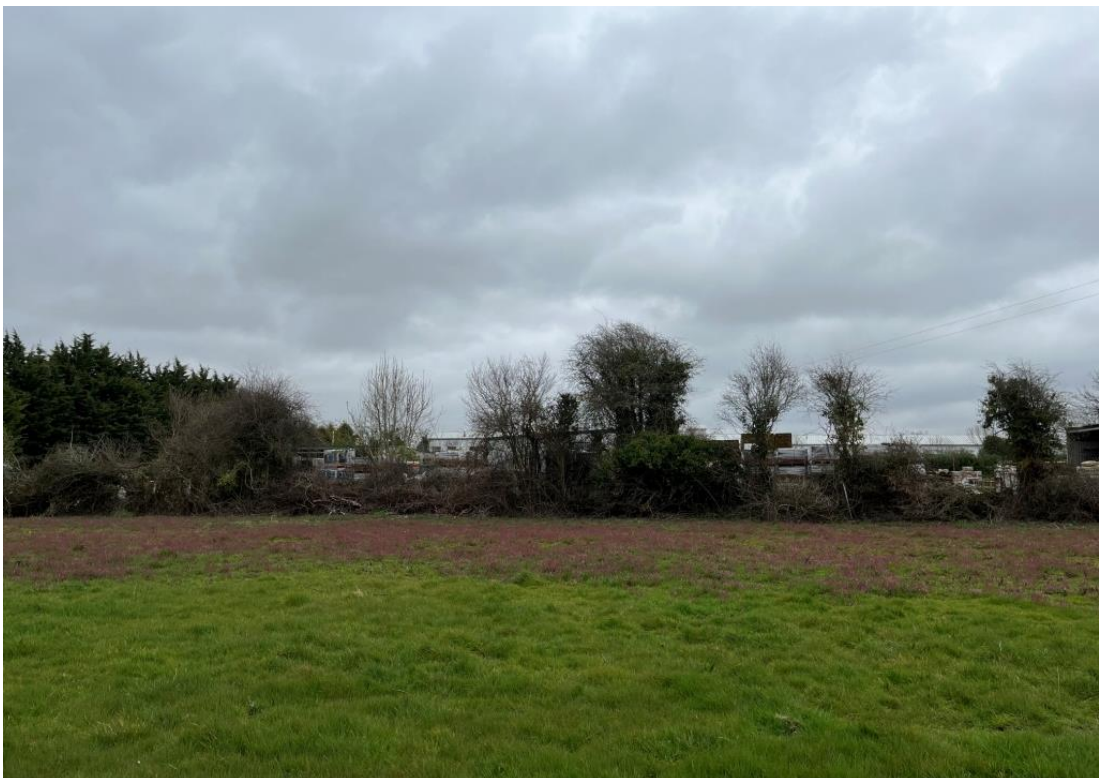
**Photo 4:** View of the eastern boundary mixed hedgerow (H32) that has been poorly managed in the past.

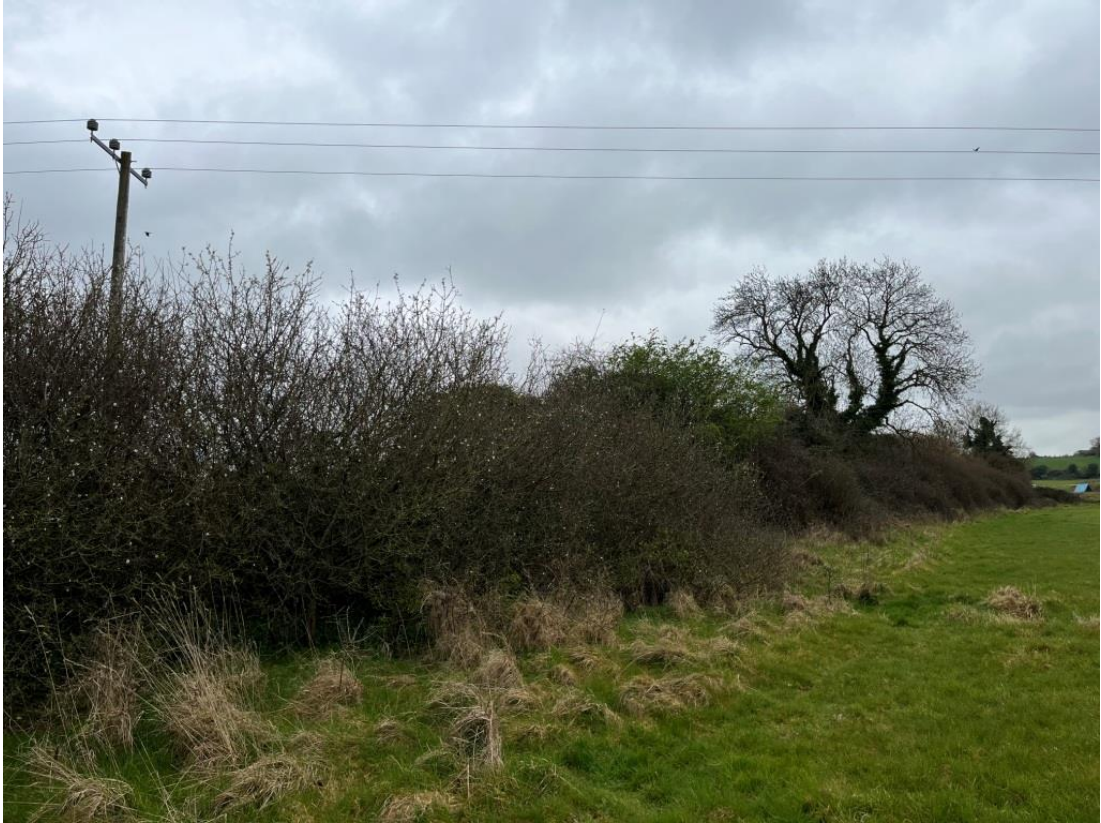
**Photo 5:** View of the central mixed native hedgerow (H28) and mature ash tree (T27).

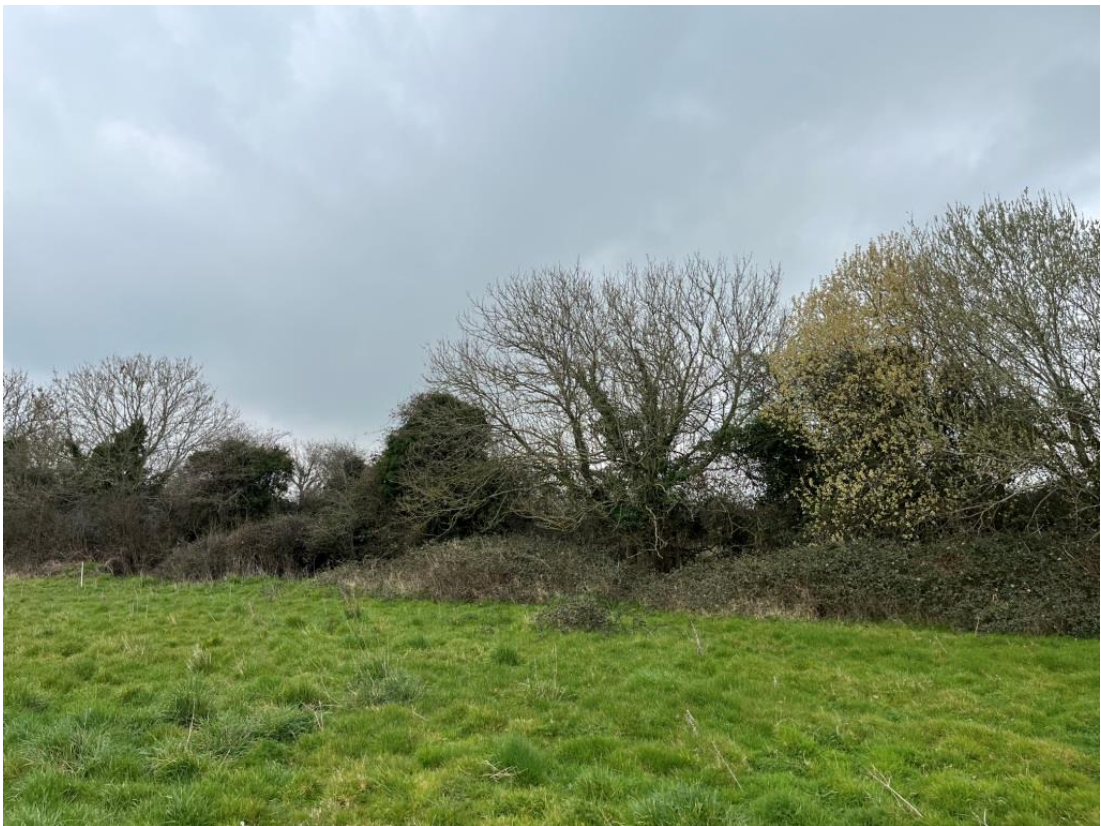
**Photo 6:** View of the eastern boundary mixed native hedgerow (H34).

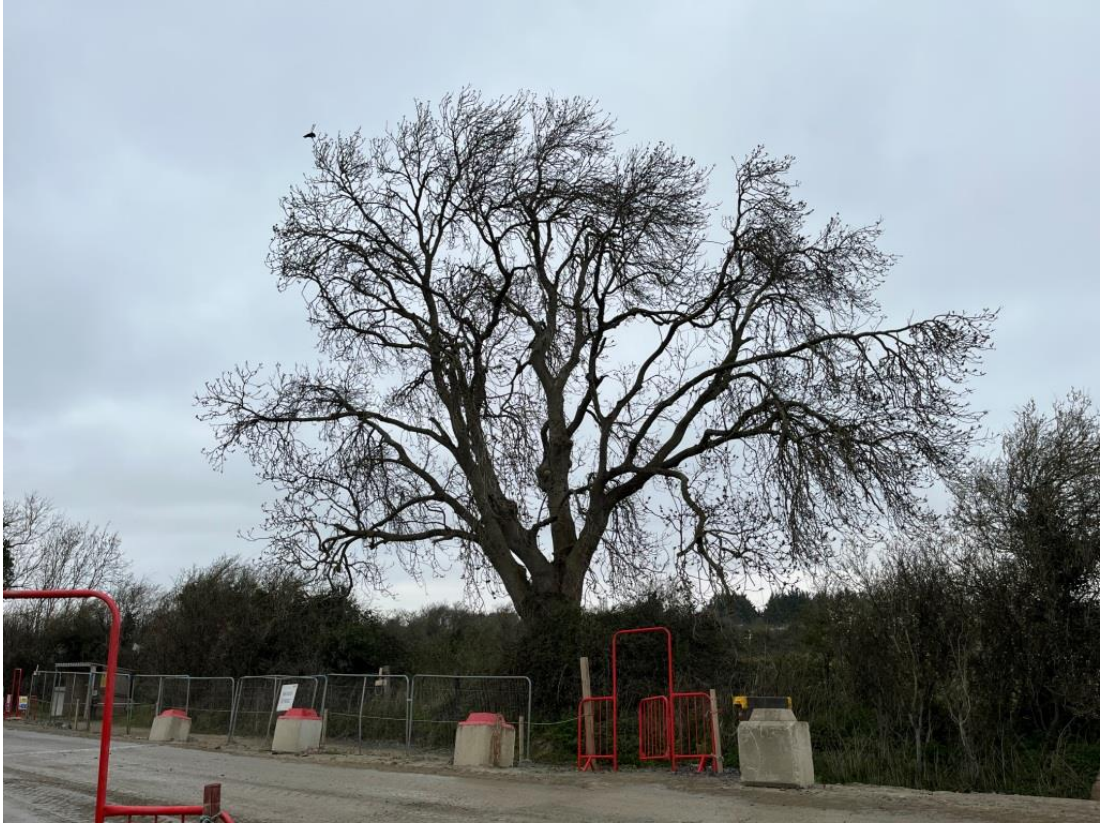
**Photo 7:** View of the late-mature ash tree (T38) that is in poor structural condition.

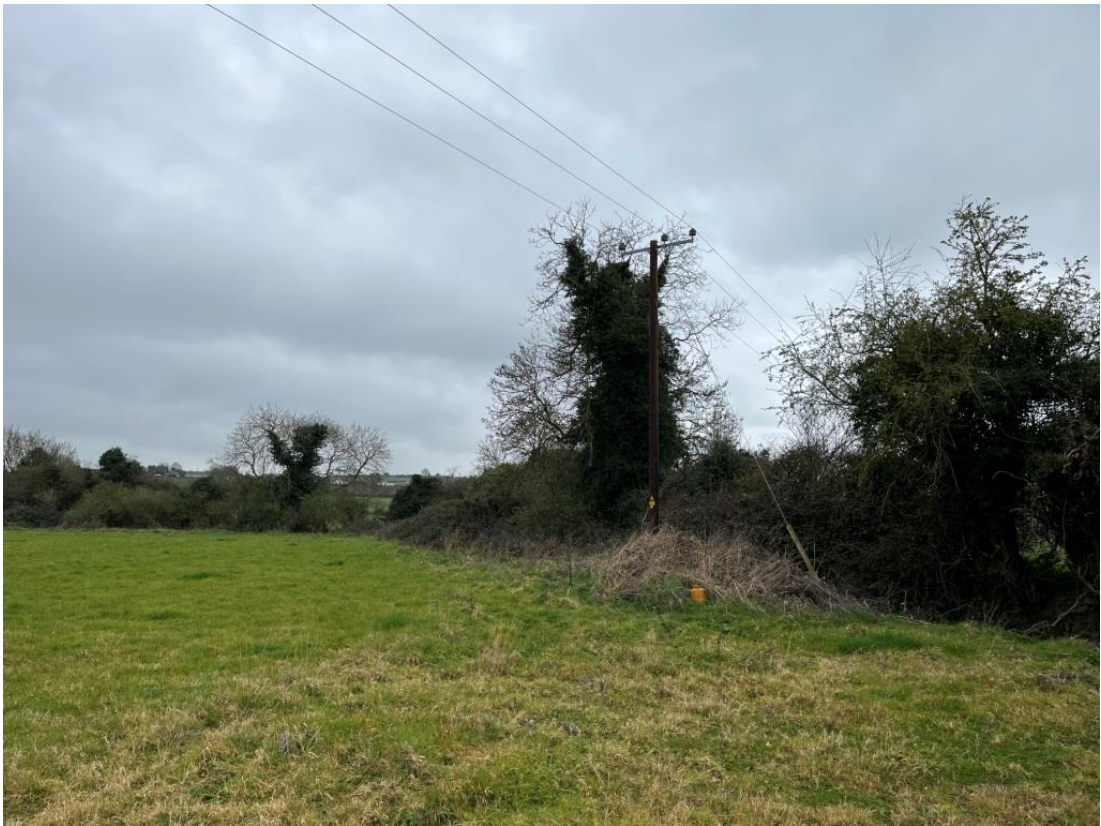
**Photo 8:** View of the western boundary mixed native hedgerow and mature trees (T43 to H46).

Tree T45	1 Fraxinus excelsior (Ash)	14.0	55	1		3.0		7.0		4.0		4.0	4.0		Mature	Structural condition Fair. Physiological condition Poor. Access to inspect base - Not possible. Competition - Adjacent trees. Crown conflict - Structure / boundary / wire / tree. Die-back - Upper crown. Decline - Suspected. Ivy or climbing plant. Tree is located on western side of ditch, ownership unknown. Unable to inspect tree closely due to dense scrub. Suspected ash dieback.	30/03/2022	136.8	6.6	0-10	U
