Arborist Associates Ltd.

An Arboricultural Assessment on the Site Area for 'Ballyoulster SHD (Phase 1), Ballyoulster, Celbridge, Co. Kildare.

Date: 31st May 2022

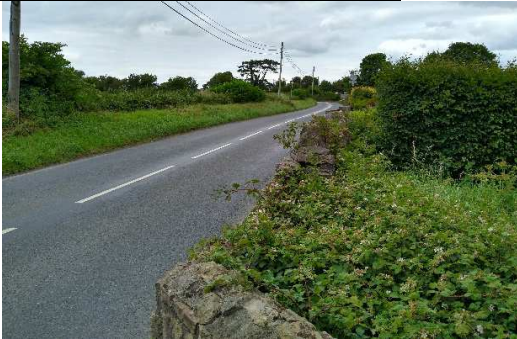
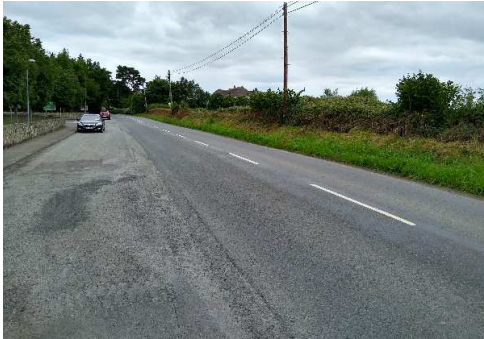
<p>Photo: Hedge No. 1 looking north.</p> <p>Photo: Hedge No. 1 looking south.</p>

Tree No.	Tree Species	Ht. (m)	Stem Dia. (mm)	Branch Spread (m)	C-Ht. (m)	Age Class	Phys. Con.	Structural Condition Other Comments	Preliminary Recommendation	Remain Contribute in years	Cat. Grade				
								N-north S-south E-east W- west Phys.-physiological.	A- average						
<p>A Condition Assessment of the Trees within the Site Area for ‘Ballyoulster SHD (Phase 1), Ballyoulster, Celbridge, Co. Kildare.</p>															
		<p>The survey commences on the eastern boundary of the site area/ field entrance on the Loughlinstown Road opposite Ballyoulster United AFC. It then proceeds along the field hedgerows on the eastern part of the site, moving in a broadly south to north direction and then continues on the western side of the drainage ditch, moving in a broadly anti-clockwise direction around the site, concluding on the southern boundary at Willow Estate.</p>													
Hedge No.1	<p>Snowberry <i>Symphoricarpos alba.</i> Elder <i>Sambucus nigra</i> Sycamore <i>Acer pseudo-platanus.</i> Hazel <i>Corylus avellana</i></p>	<p>This hedge extends in a broadly north to south direction along the eastern boundary of the site area with the Loughlinstown Road.</p> <p>It is of a mature age class in a fair condition physiologically and structurally. It is located on top of a small bank and has been regularly cut to its current height. There are isolated clumps of Elder, Hazel and Sycamore extending above the general line of the hedge. The roadside has also been trimmed in the recent past while the field (west) side is somewhat unmanaged with hedge specie encroaching out. An overhead power line extends along the length of the hedge.</p> <table border="1" data-bbox="465 906 869 970"> <tr> <td>A.1.5</td> <td>-</td> <td>A.3</td> <td>-</td> </tr> </table>							A.1.5	-	A.3	-	<p>Continue present maintenance on road side. It would benefit from cutting on the field (west) side to contain spread.</p>		C2
A.1.5	-	A.3	-

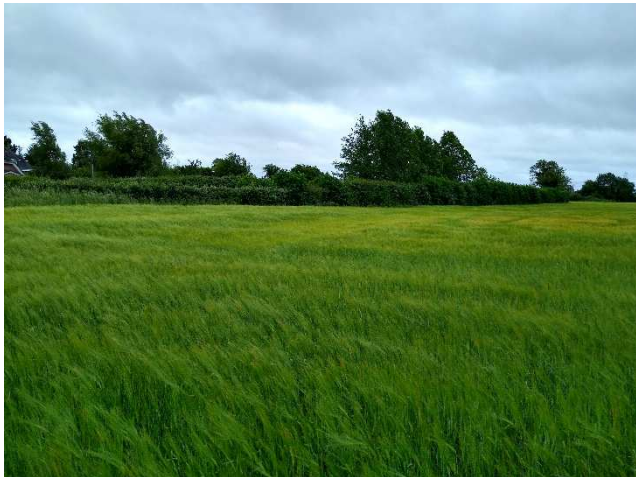
<p>Photo: Hedge 3B, looking south</p> <p>This hedge contains the following trees.</p>

Tree No.	Tree Species	Ht. (m)	Stem Dia. (mm)	Branch Spread (m)	C-Ht. (m)	Age Class	Phys. Con.	Structural Condition Other Comments	Preliminary Recommendation	Remain Contribute in years	Cat. Grade			
								N-north S-south E-east W- west Phys.-physiological.	A- average					
		Photo: Hedge No. 3A, looking south.												
Hedge No. 3B	<p>Hawthorn <i>Crataegus monogyna</i></p> <p>Elder <i>Sambucus nigra</i></p> <p>Bramble <i>Rubus fruticosus</i></p> <p>Ivy <i>Hedera helix.</i></p>	<p>This hedge extends south from Hedge 3A in a southerly direction and forms a field boundary with fields and gardens to the east.</p> <p>It is of a mature age class, in a fair/ good condition physiologically and a fair condition structurally. It has been cut to its current height and spread. It is continuous except for field access. Ivy and Bramble are colonising the hedge line.</p> <table border="1" data-bbox="465 691 869 751"> <tr> <td>A.3</td> <td>-</td> <td>A.3</td> <td>-</td> </tr> </table>							A.3	-	A.3	-	Continue present maintenance.	C1
A.3	-	A.3	-

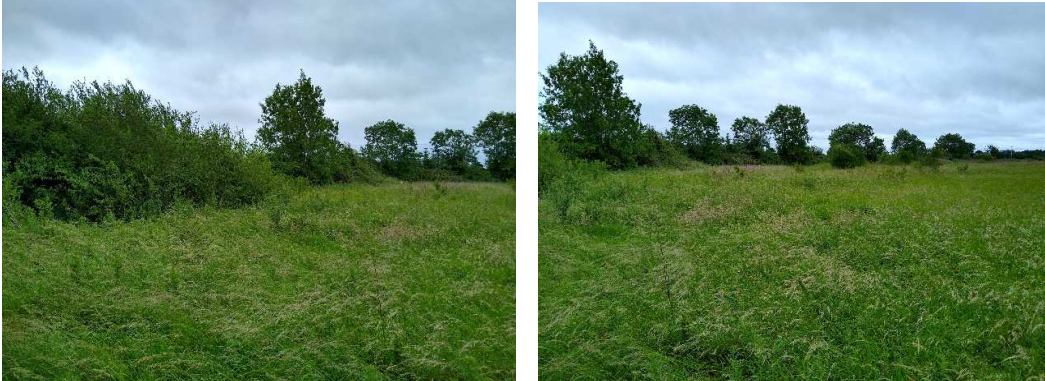
<p>Photo: Hedge No. 4, looking west</p> <p>This hedge contains the following trees.</p>									
0375	Ash <i>Fraxinus excelsior</i>	8	120/ 230	N3 S3 E3 W3	1	Early Mature	Fair / Good	Fair It is growing on top of a bank of a deep ditch. It divides at c.1.8m into a multi-stem tree with an acute union formation between the stems.	No works required at the present time.	10-20	C2
0376	Ash <i>Fraxinus excelsior</i>	8	130/ 120/ 110/ 120/ 130	N3 S2 E3 W2	1	Early Mature	Fair / Good	Fair / Good A group of stems, most of them multiple-stemmed from base, growing up together forming a combined canopy. They have an acute union formation between the stems. There is a stump on the south side which is starting to re-grow. Ivy growth is beginning to extend up some of the stems.	Ivy growth will require management in the future.	10-20	C2

0377	Ash <i>Fraxinus excelsior</i>	7	300	N5 S3 E3	0	Early Mature	Fair / Good	Fair A single stem tree to c.1.6m where it was cut into the hedge in the past and now	No works required at the present time.	10-20	C2

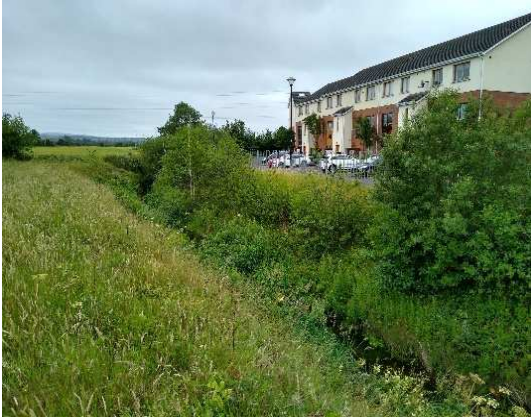
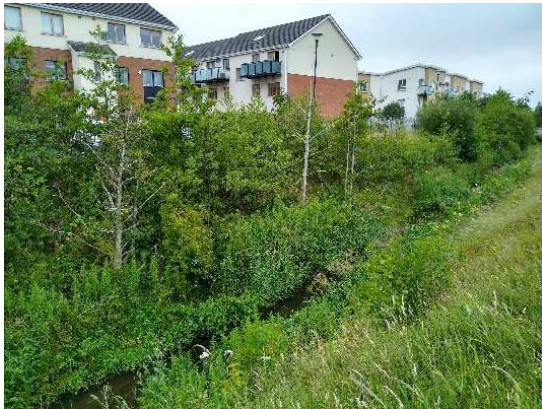
Tree No.	Tree Species	Ht. (m)	Stem Dia. (mm)	Branch Spread (m)	C-Ht. (m)	Age Class	Phys. Con.	Structural Condition Other Comments	Preliminary Recommendation	Remain Contribute in years	Cat. Grade	
								N-north S-south E-east W- west Phys.-physiological.	A- average			
	Bramble <i>Rubus fruticosus</i>	planted as part of the landscaping of the adjoining residential development and has some value for screening. There are dead trees along the line which is not continuous.										
		A.7	-	A.5	-

Photo: Hedge No. 6 looking south.		Photo: Hedge No. 6 looking north.								
Hedge No.7	Cherry <i>Prunus sp.</i> Blackthorn <i>Prunus spinosa</i> Elder <i>Sambucus nigra</i> Hawthorn <i>Crataegus monogyna</i> Privet <i>Ligustrum vulgare</i> Bramble	This hedge extends, at nearly 90 degrees from Hedge No. 6 in a broadly east to west direction back to Hedge No. 3B. It forms an internal division between two fields within the site area.								Cut back encroaching growth into the hedge line.	C2

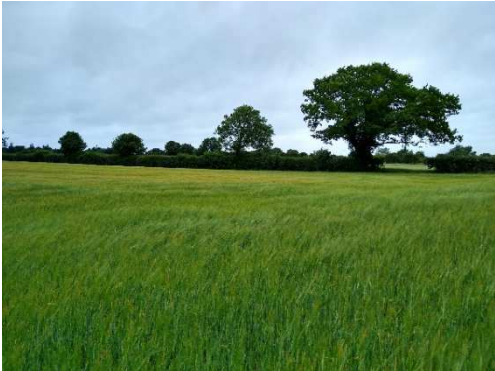
Tree No.	Tree Species	Ht. (m)	Stem Dia. (mm)	Branch Spread (m)	C-Ht. (m)	Age Class	Phys. Con.	Structural Condition Other Comments	Preliminary Recommendation	Remain Contribute in years	Cat. Grade			
								N-north S-south E-east W- west Phys.-physiological.	A- average					
Hedge No.8	Hawthorn <i>Crataegus monogyna</i> Ash <i>Fraxinus excelsior</i> Oak <i>Quercus robur</i> Elder <i>Sambucus nigra</i> Hazel <i>Corylus avellana</i> Holly <i>Ilex aquifolium</i> Privet <i>Ligustrum vulgare</i> Bramble <i>Rubus fruticosus</i> Dogrose <i>Rosa canina</i>	<p>This hedge extends in a broadly east to west direction from Hedge No. 2 to Hedge No. 9 to connect up with Hedge Nos.6 & Hedge No.7. It forms an internal division between two fields. It is of an early mature age class in a fair/ good condition physiologically and structurally. It has been maintained as a low hedge with regular trimming of its sides and top which has contributed to structure and stock-proof quality. A number of trees have been allowed to develop above the general hedge line.</p> <table border="1" data-bbox="465 635 869 676"> <tr> <td>A.3</td> <td>-</td> <td>A.3</td> <td>-</td> </tr> </table>

<p>Photo: Hedge No. 8 looking west.</p> <p>This hedge contains the following trees.</p>						A.3	-	A.3	-	Continue present maintenance		C2
A.3	-	A.3	-											
0387	Oak <i>Quercus sp.</i>	13	640	N7 S8 E8 W7	3	Mature	Fair / Good	Fair / Good A single stem tree growing up within the hedge line. Close ploughing on the north and south sides is likely to have impacted the root zone. There is deadwood in the lower crown, some of this of a large size.	Remove dead / unstable growth. Cut Ivy at ground level. Move ploughing line away from tree on both north and	20-40	B1

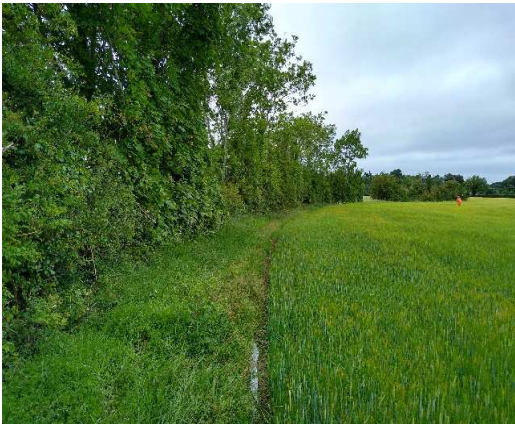
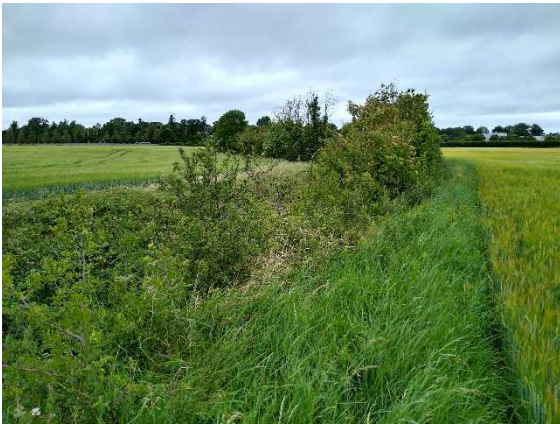
Tree No.	Tree Species	Ht. (m)	Stem Dia. (mm)	Branch Spread (m)	C-Ht. (m)	Age Class	Phys. Con.	Structural Condition Other Comments	Preliminary Recommendation	Remain Contribute in years	Cat. Grade		
								N-north S-south E-east W- west Phys.-physiological.	A- average				
	<i>Prunus spinosa</i> Elder <i>Sambucus nigra</i> Hawthorn <i>Crataegus monogyna</i> Ash <i>Fraxinus excelsior</i> Holly <i>Ilex aquifolium</i> Privet <i>Ligustrum vulgare</i> Hazel <i>Corylus avellana</i> Sycamore <i>Acer pseudo-platanus</i> Yew <i>Taxus baccata</i> Bramble <i>Rubus fruticosus</i>	<p>It is of a mature age class in fair condition physiologically and structurally. It has been maintained in the past and there are a number of trees which have been allowed to develop above the general hedge line. To the west is a deep water filled ditch. It has been cut on the east side to maintain clearance and control encroachment. It is not continuous along its length and it includes single trees and a line of trees (0399-0400). Arable crops/ ploughing has come to within 3m of base, most likely resulting in root damage, particularly to the trees. There is a group of dead Elm trees at the northern end.</p> <table border="1" data-bbox="465 625 869 684"> <tr> <td>A.3</td> <td>-</td> <td>A.2.5</td> <td>-</td> </tr> </table>		A.3	-	A.2.5	-

<p>Photo: Hedge No. 9 looking north. Photo: Hedge No. 9 looking north</p> <p>This hedge line contains the following trees.</p>		Remove dead trees near the north end.	
A.3	-	A.2.5	-										
0396	Cherry <i>Prunus sp.</i>	10	120 (9 stems)	N2 S5 E3 W6	3	Early Mature	Fair	Fair A group of stems growing up together with a combined canopy. Ivy growth is extending high into the crowns,	Cut Ivy at ground level.	10-20	C2

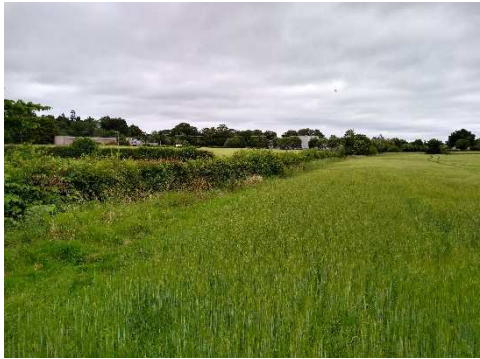
<p>Photo: Hedge No. 10 looking north.</p>

Tree No.	Tree Species	Ht. (m)	Stem Dia. (mm)	Branch Spread (m)	C-Ht. (m)	Age Class	Phys. Con.	Structural Condition Other Comments	Preliminary Recommendation	Remain Contribute in years	Cat. Grade		
								N-north S-south E-east W- west Phys.-physiological.	A- average				
								growth is extending high up into the crown.					
Tree Line (0402 – Tree No. 1.) (4 trees)	Ash <i>Fraxinus excelsior</i> Sycamore <i>Acer pseudo-platanus</i>	A.6	A.140 (6 stems)	A.N3 S3 E3 W3	A.3	Early Mature	Fair	Fair A short line of multi-stem trees growing at the junction of Hedge Nos. 8, 9 & 10, forming the higher bulking. Heavy Ivy growth on some stems extends high into the crowns.	Retain for now as part of the bulking of this area.	10-20	C2		
Hedge No. 10	Blackthorn <i>Prunus spinosa</i> Hawthorn <i>Crataegus monogyna</i> Ash <i>Fraxinus excelsior</i> Hazel <i>Corylus avellana</i> Holly <i>Ilex aquifolium</i> Sycamore <i>Acer pseudo-platanus</i> Bramble <i>Rubus fruticosus</i> Dog Rose <i>Rosa canina</i>	<p>This hedge extends in a broadly south to north direction from Hedge No. 9. It forms an internal division between two fields within the site area.</p> <p>It is of a mature age class in fair condition physiologically and structurally. It has been maintained in the past and has recently been cut to current height and spread and is of good structure at present. There is a deep, water filled ditch/ stream on the west side. It is mostly continuous along its length with occasional gaps for field access.</p> <table border="1" data-bbox="465 884 869 944"> <tr> <td>A.5</td> <td>-</td> <td>A.2</td> <td>-</td> </tr> </table>						A.5	-	A.2	-	<p>Continue present maintenance.</p>	C2
A.5	-	A.2	-

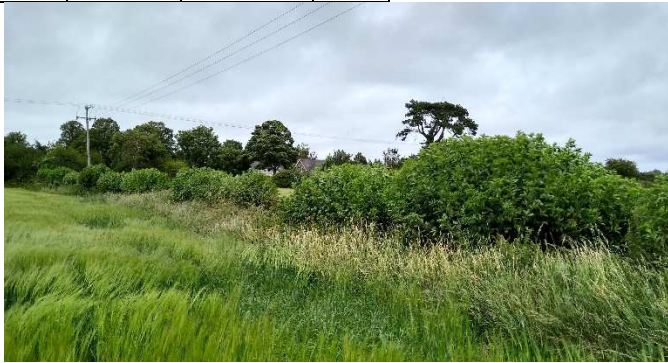
Tree No.	Tree Species	Ht. (m)	Stem Dia. (mm)	Branch Spread (m)	C-Ht. (m)	Age Class	Phys. Con.	Structural Condition Other Comments	Preliminary Recommendation	Remain Contribute in years	Cat. Grade			
								N-north S-south E-east W- west Phys.-physiological.	A- average					
				W5				growth extending up into the crown. Close ploughing is likely to have caused root damage on the north side. This species is vulnerable to infection and death by 'Dutch Elm Disease' and it may already be infected.	from tree on both north and south sides.					
Hedge No. 12	Elder <i>Sambucus nigra</i> Bramble <i>Rubus fruticosus</i>	<p>This hedge extends at 90 degrees from Hedge No. 11 to Hedge No. 13 in a broadly south to north direction. It forms an internal division between two fields within the site area.</p> <p>It is of a mature age class in a fair condition physiologically and structurally. It has recently been cut back to present height and spread and is re-growing. It forms an internal division between two fields. It is located on the west side of a drainage ditch. It has been cut down and allowed to re-grow which has helped its structure.</p> <table border="1" data-bbox="465 810 869 874"> <tr> <td>A.3</td> <td>-</td> <td>A.4</td> <td>-</td> </tr> </table>

<p>Photo: Hedge No. 12 looking north.</p>						A.3	-	A.4	-	Continue present maintenance.		C2
A.3	-	A.4	-											
Hedge No. 13	Elder <i>Sambucus nigra</i> Snowberry	<p>This hedge extends from hedge No. 1 to connect up with Hedge No. 12 along the northern boundary of the site. It provides some screening of the site from the adjacent residential</p>						Cut back encroaching vegetation. Interplant with hedge species such as		C2

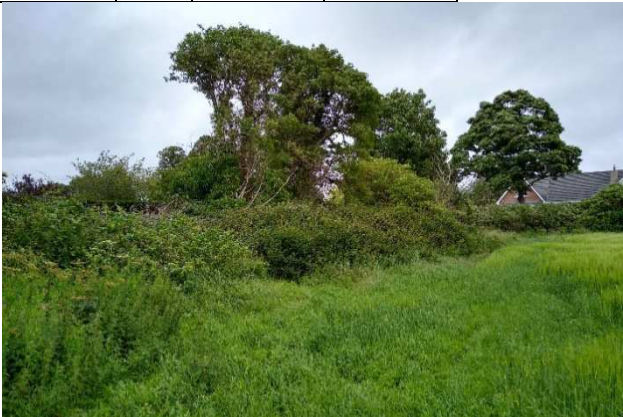
Tree No.	Tree Species	Ht. (m)	Stem Dia. (mm)	Branch Spread (m)	C-Ht. (m)	Age Class	Phys. Con.	Structural Condition Other Comments	Preliminary Recommendation	Remain Contribute in years	Cat. Grade
								N-north S-south E-east W- west Phys.-physiological.	A- average		
	<i>Symphoricarpos alba</i> Bramble <i>Rubus fruticosus</i>	properties to the north. It is of a mature age class in a fair condition physiologically and structurally. It has become overgrown due to lapsed management and there are gaps along the line. It consists of clumps of Elder with Snowberry at the base, encroaching out into the field.								Hawthorn and Blackthorn.	
		A.1.5	-	A.4	-

Photo: Hedge No. 13 looking east towards Tree group No. 1										
Tree Group No. 1	Sycamore <i>Acer pseudo-platanus</i>	7	A. 280	N4 S4 E4 W3	2	Early Mature	Fair	Fair A group of three trees growing up together at the east end of Hedge No.13. They have grown up together with a combined canopy.	These trees may be outside the management control of this site area.	10-20	C1

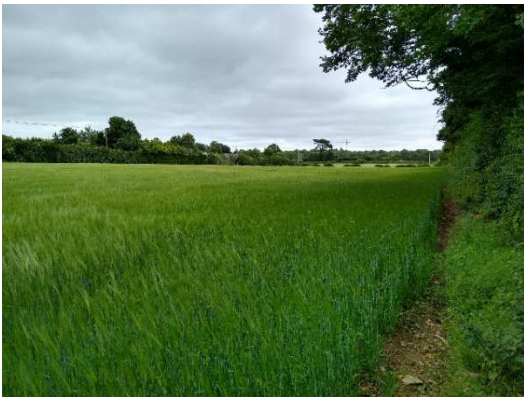
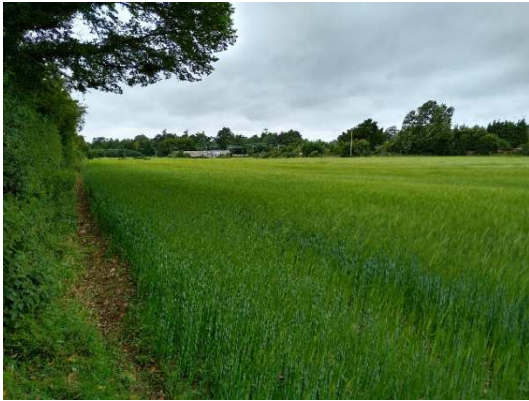
Tree No.	Tree Species	Ht. (m)	Stem Dia. (mm)	Branch Spread (m)	C-Ht. (m)	Age Class	Phys. Con.	Structural Condition Other Comments	Preliminary Recommendation	Remain Contribute in years	Cat. Grade			
								N-north S-south E-east W- west Phys.-physiological.	A- average					
	<i>Crataegus monogyna</i> Willow <i>Salix sp.</i> Sycamore <i>Acer pseudo-platanus</i> Leyland Cypress <i>xCupressocyparis leylandii</i> Aspen <i>Populus tremuloides</i> Holly <i>Ilex aquifolium</i> Lilac <i>Syringia vulgaris</i> Bramble <i>Rubus fruticosus</i>	residential properties to the north. It is of a mature age class in a fair condition physiologically and structurally. There is an overhead power line running along the south side of this hedge and it has been cut in the past to maintain clearance. It has been recently been trimmed on the south (site side) to allow for ploughing. There is a fire damaged section along the line following a fire on the adjacent property. It is mostly continuous along its length except for the western end where a section has been removed and replaced with a wall. It has value for screening and past pruning has helped its structure and condition. Ash and Sycamore form part of the hedge bulking along sections.		<table border="1"> <tr> <td>A.2</td> <td>-</td> <td>A.2.5</td> <td>-</td> </tr> </table>	A.2	-	A.2.5	-

Photo: Hedge No. 14, looking east. Photo: Hedge No. 14, looking west. This hedge line contains the following trees.			
A.2	-	A.2.5	-											
0413 – 0415 (3 trees)	Aspen <i>Populus tremuloides</i>	A.13	A.340	A.N5 S3 E4	2	Early Mature	Fair / Good	Fair A group of three trees close planted and growing up together to form a combined	These trees may be outside the management control of this site. They	10-20	C1

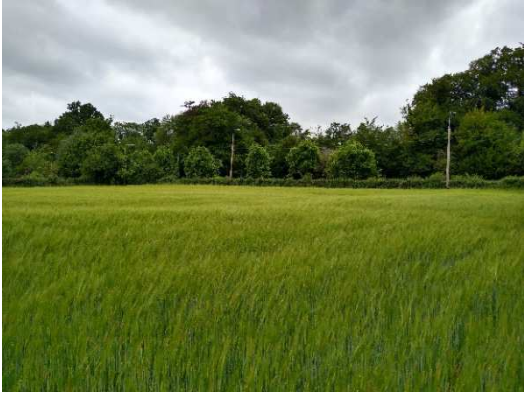
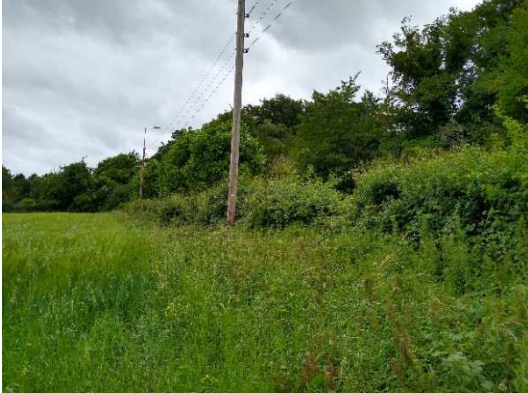
Tree No.	Tree Species	Ht. (m)	Stem Dia. (mm)	Branch Spread (m)	C-Ht. (m)	Age Class	Phys. Con.	Structural Condition Other Comments	Preliminary Recommendation	Remain Contribute in years	Cat. Grade						
								N-north S-south E-east W- west Phys.-physiological.	A- average

<p>Photo: Hedge No. 16. Photo: Hedge No. 16, looking west.</p>											
Tree Line No. 6 (5 trees)	Plane <i>Platanus acerifolia.</i>	A.10	A.220	A.N3 S3 E3 W3	A.2	Early Mature	Fair / Good	Fair This tree line is located to the north of Hedge No. on the roadside grass margin and they have been heavily pruned in the past to clear the adjacent overhead line and contain size. They provide screening along this boundary.	Management of these trees is outside the control of this site.	20+	C2						
Hedge No. 17	Ash <i>Fraxinus excelsior</i> Cherry <i>Prunus sp.</i> Holly <i>Ilex aquifolium</i> Rugosa Rose <i>Rosa rugosa</i> Bramble <i>Rubus fruticosus</i>	<p>This hedge extends at 90 degrees from Hedge No. 16 in a broadly north to south direction and forms the boundary with the adjacent commercial property to the west.</p> <p>It is of a mature age class in fair condition physiologically and fair / poor condition structurally. It is a low hedge consisting mostly of dog rose. There are a few trees beginning to develop above the general hedge height. It has been cut to present height and spread in the past.</p> <table border="1" data-bbox="472 1289 1032 1353"> <tr> <td>A.2</td> <td>-</td> <td>A.2.5</td> <td>-</td> </tr> </table>										A.2	-	A.2.5	-	Carry out general tidy up and cut back to shape.	C2
A.2	-	A.2.5	-

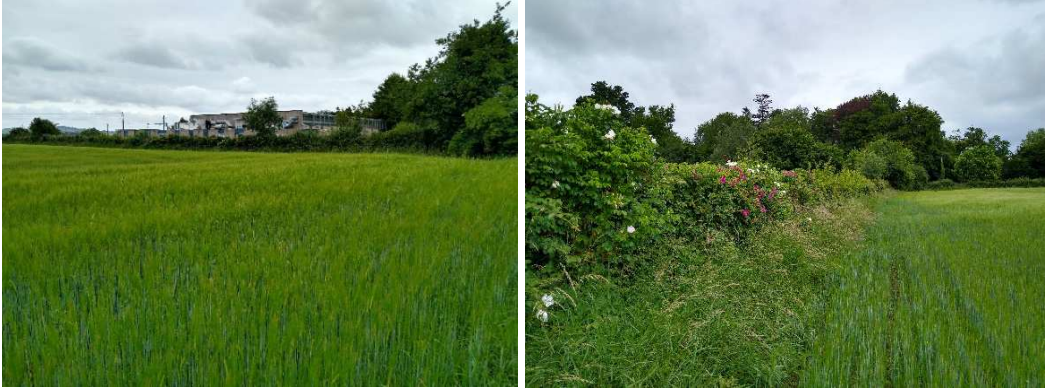
<p>Photo: Hedge No. 17. Photo: Hedge No. 17, looking north</p> <p>This hedge contains the following tree.</p>											
Tree No. 2	Cherry <i>Prunus sp.</i>	8	280	N3 S3 E3 W3	2	Mature	Fair	Fair It is growing just off the site boundary on the adjoining property. The crown is being heavily suppressed by Ivy growth.	Management of this tree is outside the control of this site.	10-20	C1				
Hedge No. 18A	Bramble <i>Rubus fruticosus</i>	<p>This hedge extends at 90 degrees from the southern end of Hedge No. 17 in a broadly east to west direction. It forms the boundary with the adjacent commercial property to the north.</p> <p>It is of a mature age class in poor condition physiologically and structurally. The original hedge plants have been lost and Bramble has colonised and dominated.</p> <table border="1" style="width: 100%; border-collapse: collapse;"> <tr> <td style="width: 25%;">A.2</td> <td style="width: 25%;">-</td> <td style="width: 25%;">A.3</td> <td style="width: 25%;">-</td> </tr> </table>		A.2	-	A.3	-						This hedge could be rejuvenated by the planting of hedge plants and general tidying works.		C2
A.2	-	A.3	-

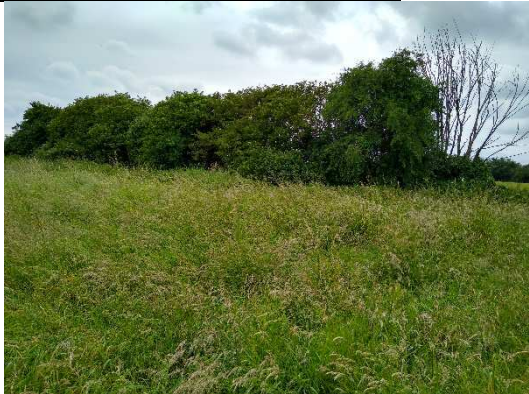
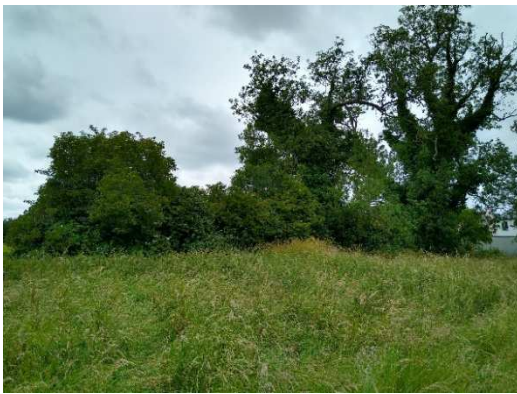
Tree No.	Tree Species	Ht. (m)	Stem Dia. (mm)	Branch Spread (m)	C-Ht. (m)	Age Class	Phys. Con.	Structural Condition Other Comments	Preliminary Recommendation	Remain Contribute in years	Cat. Grade			
								N-north S-south E-east W- west Phys.-physiological.	A- average					
Hedge No. 20	Hawthorn <i>Crataegus monogyna</i> Elder <i>Sambucus nigra</i>	<p>This hedge extends from the cemetery wall in a broadly east to west direction to the site boundary to the west and forms an internal boundary between two fields within the site area.</p> <p>It is of a mature age class in fair condition physiologically and structurally. It has been allowed to grow up while the sides have been managed, mainly on the southern side and this has helped to maintain its stock-proof quality. There is a field entrance located part way along the line with a dead Elm tree located adjacent to the gap. There are two very large trees located towards the western end.</p> <table border="1"> <tr> <td>A.5</td> <td>-</td> <td>A.4</td> <td>-</td> </tr> </table> <div style="display: flex; justify-content: space-around;">

</div> <p>Photo: Hedge No. 20, looking east Photo: Hedge No. 20, looking west</p> <p>This hedge contains the following trees.</p>						A.5	-	A.4	-	Remove dead tree beside the field gap.		C2
A.5	-	A.4	-											
0423	Ash <i>Fraxinus excelsior</i>	20	1000	N10 S7 E7 W8	2	Mature	Fair/ Poor	Fair/ Poor A very large tree growing on the hedgerow bank. It divides at c.3-3.5m into a multi-stem tree with a heavy scaffold limb to the south. Very heavy Ivy growth extends high into the crown. The crown contains deadwood and is	Make safe large dead/ unstable growth and prune remaining crown to shape balance. Cut Ivy at ground level. Move ploughing away from	10+	C1

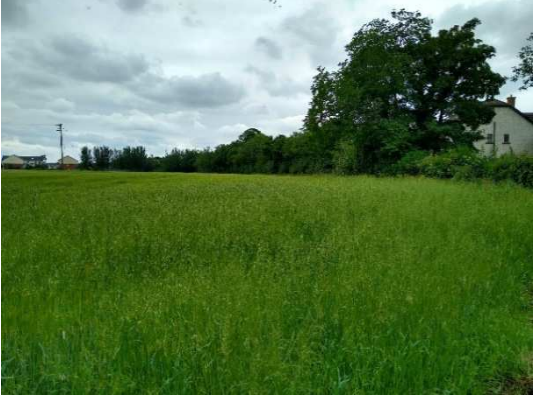
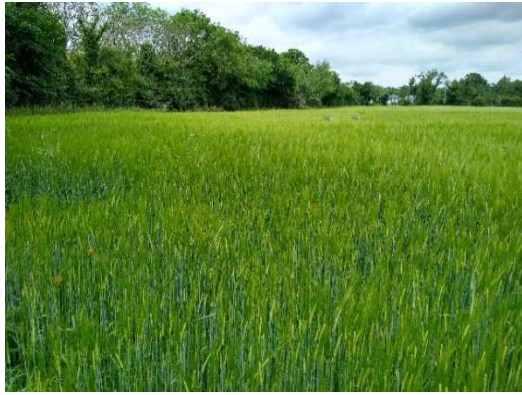
Tree No.	Tree Species	Ht. (m)	Stem Dia. (mm)	Branch Spread (m)	C-Ht. (m)	Age Class	Phys. Con.	Structural Condition Other Comments	Preliminary Recommendation	Remain Contribute in years	Cat. Grade	
								N-north S-south E-east W- west Phys.-physiological.	A- average			
	Hawthorn <i>Crataegus monogyna</i> Blackthorn <i>Prunus spinosa</i> Privet <i>Ligustrum vulgare</i>	area and the adjoining developed areas.										
		A.2	-	A.3	-

Photo: Hedge No. 21, looking south		Photo: Hedge No. 21, looking north								
		This hedge contains the following trees.										
0425	Sycamore <i>Acer pseudo-platanus</i>	11	300	N3 S5 E4 W3	1	Early Mature	Fair	Fair A single stem tree growing on the bank of the stream with heavy Ivy growth extending high into the crown.	Cut Ivy at ground level. Tidy up around base to allow for a more detailed assessment.	10-20	C1	
Tree Group No. 2	Sycamore <i>Acer pseudo-platanus</i> Elm <i>Ulmus glabra.</i>	A.18	A.500	A.N5 S5 E5 W5	A.3	Early Mature / Mature	Fair / Good	Fair It consists of a group of three trees which have grown up together, on both sides of the stream to form a combined canopy. There is a Sycamore growing on both sides of the stream. Heavy Ivy extends	Cut Ivy at ground level. Access is required to carry out a more detailed assessment of these trees.	20+	B2

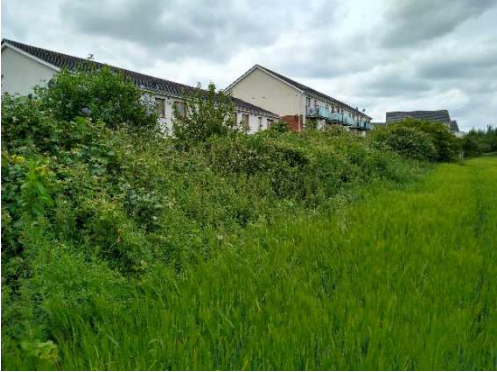
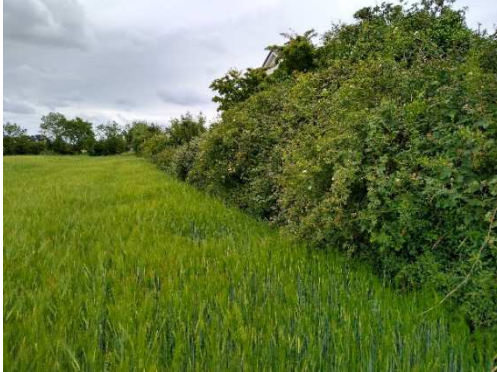
Photo: Hedge No. 22, looking west.		Photo: Hedge No. 22, looking east								
Notes:

Tree No.	Tree Species	Ht. (m)	Stem Dia. (mm)	Branch Spread (m)	C-Ht. (m)	Age Class	Phys. Con.	Structural Condition Other Comments	Preliminary Recommendation	Remain Contribute in years	Cat. Grade	
								N-north S-south E-east W- west Phys.-physiological.	A- average			
	<i>Sambucus nigra</i> Bramble <i>Rubus fruticosus</i> Dog Rose <i>Rosa canina</i>	encroaching out in places. Bramble and Dog Rose are colonising sections along its length. There are sapling Ash trees developing at the east end.										
		A.6	-	A.4	-
