Jacob's Island Strategic Housing
Development, Co. Cork

Quality Audit

Document Ref:	P22-071-UQA-GEN-RP-001
----------------------	-------------------------------

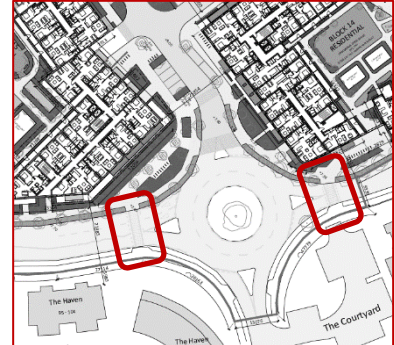
4.3.1 Problem

Summary: Existing crossings on Longshore Avenue may be unable to accommodate the increased volume of pedestrians and cyclists.

The new Strategic Housing Development may increase the volume of pedestrians wishing to cross Longshore Avenue, particularly during AM and PM peak periods. There may also be an increase in the volume of cyclists crossing Longshore Avenue. It is unclear if the existing Zebra Crossings will be capable of meeting additional crossing demand following the construction of the SHD site. Should the crossings be inadequate, there may be a risk of unsafe pedestrian and cyclist crossing movements, particularly where young children or mobility impaired pedestrians are using the crossing.

Ensure that the existing Zebra Crossings can support the expected pedestrian and cycle volumes likely to cross Longshore Avenue.

If Zebra Crossings are found to be adequate, significant maintenance/repair will be required to ensure the two existing Zebra Crossings are fully operational.

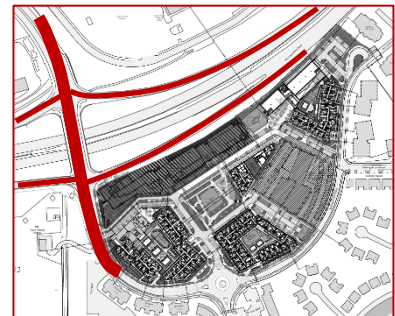
4.3.2 Problem

Summary: Congestion at junction 10 of the N40 may increase the risk of vehicle/pedestrian and vehicle/cyclist collisions.

The RSA Team understand that Junction 10 of the N40 is currently at, or above, capacity. The addition of the SHD site, which shall see an increase in the volume of cars, pedestrians and cyclists using the junction, may exacerbate peak hour queuing, and increase the likelihood of pedestrians and cyclists weaving through congested traffic. This may lead to vehicle/pedestrian and vehicle/cyclist collisions, particularly during winter months where road users will be passing through the junction in darkness.

Undertake a detailed assessment of the junction's performance with the SHD site, including future year assessments (i.e. +5 and +15 years). Ensure robust measures are in place, or will be put in place, to accommodate the increased vehicle, pedestrian and cyclist volumes generated by the SHD site.

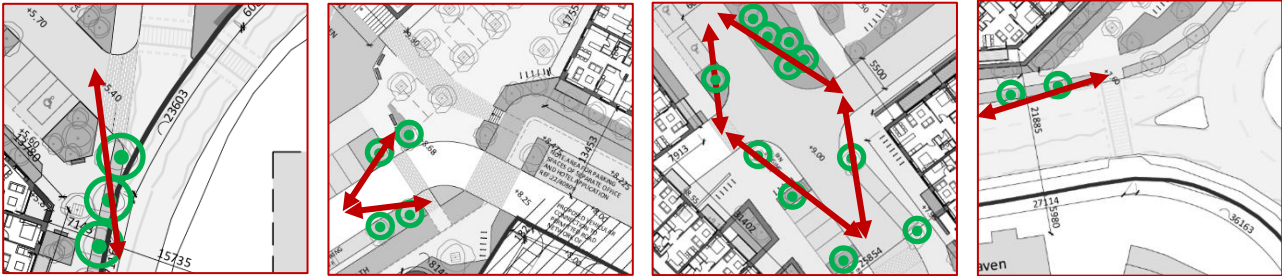
4.3.3 Problem

Summary: The location of trees may reduce intervisibility between road users.

The location of trees at side road junctions, pedestrian crossing points, perpendicular parking spaces, and the Zebra crossings on Longshore Avenue, may reduce intervisibility between drivers, and between drivers and pedestrians/cyclists. Reduced intervisibility may increase the risk of side-on collisions and vehicle/pedestrian and vehicle/cyclist collisions.

Ensure trees are located outside visibility splays.

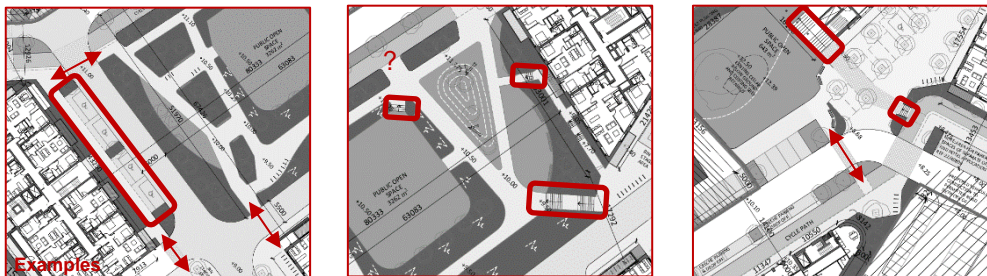
4.3.4 Problem

Summary: Absence of Dropped Kerb and Tactile Paving may lead to slips, trips, falls and possible vehicle/pedestrian collisions.

Mobility impaired parking spaces have been indicated within the development, however dropped kerbs and tactile paving have not been indicated adjacent these spaces. If a level difference exists between the footpath and carriageway/parking spaces the absence of dropped kerbs could lead to difficulties for mobility impaired pedestrians in accessing the footpath once they leave their vehicle, while a failure to provide tactile paving at dropped kerbs may lead to visually impaired pedestrians inadvertently entering the carriageway where there is an increased risk of being struck by a vehicle.

Additionally, the absence of tactile paving at uncontrolled pedestrian crossings, at the top and bottom of steps, and at the interface between the internal cycle track and adjoining footways may increase the risk of visually impaired pedestrians being insufficiently aware that they are approaching a hazard. This may increase the risk of visually impaired pedestrians entering a live carriageway without due care and attention, falling from height, or entering cycle tracks where there is a risk of pedestrian-cyclist collisions.

Dropped kerbs and tactile paving should be provided within the development.

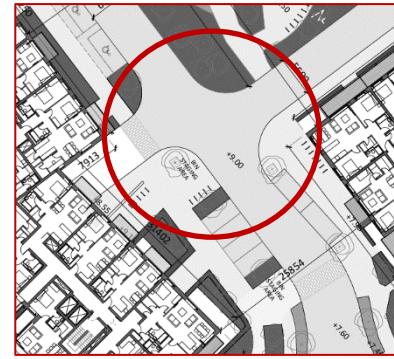
4.3.5 Problem

Summary: Junction control, and priority, has not been indicated at the crossroad junction.

The junction control (stop, yield etc.), and thus priority, at the development's internal crossroad junction has not been indicated. The absence of adequate road markings and signage may lead to driver confusion and hesitation resulting in drivers misinterpreting priority at the junction and entering the junction at the same time as opposing vehicles where there is an increased risk of side-swipe or side-on collisions.

Ensure the junction control, and priority, at the proposed crossroad junction is clear via signage and road markings.

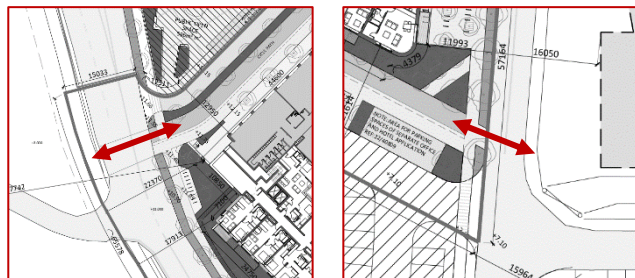
4.3.6 Problem

Summary: It is unclear how cyclists will safely cross Longshore Avenue at the extremities of the internal cycle track.

An internal cycle track is provided within the SHD site. The cycle facility connects with Longshore Avenue to the east and west of the development, however, no crossings have been indicated within the plan. It is therefore unclear how cyclists will safely access the opposite side of the road, where they can continue their journey. The absence of a crossing facility may lead to cyclists mounting a full height kerb to access the facility, which can increase the risk of falls and personal injuries, or cycling straight into the carriageway in front of a vehicle, leading to vehicle/cyclist collisions.

Additional facilities should be provided where the internal cycle track interfaces with Longshore Road, ensuring cyclists can safely access the cycle track from Longshore Avenue, or cross to the opposite side of Longshore Avenue when wishing to continue their journey toward Mahon in the north, or the amenities south of Longshore Drive.

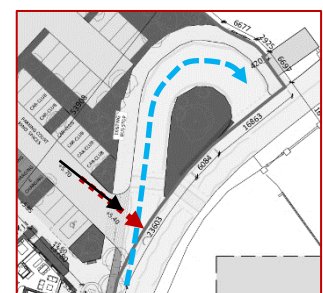
4.3.7 Problem

Summary: Junction layout may increase the risk of side-on collisions.

Access to the proposed Office (Block 12) and Residential Area (Block 11) carpark at the eastern extents of the scheme is provided via a new junction that is offset from the existing bus turnaround entry. The proposed layout is

complicated by the location of trees to the south of the access, and trees within the bus turnaround island, as well as the location of the access which is offset from Longshore Avenue/The Sanctuary. This may lead to drivers exiting the carpark with limited visibility to vehicles on Longshore Avenue/The Sanctuary, and to buses which may carry high speeds into the 'Bus Only' turnaround area. It may also lead to drivers exiting the carpark junction and abruptly stopping within the bus turnaround access before entering Longshore Avenue, increasing the risk of rear-end-shunt and side-on collisions.

The layout may also lead to drivers continuing through the junction without due care and attention, believing the edge of Longshore Avenue to be the stop/yield line, further increasing the risk of side-on collisions.

The access arrangement should be modified to ensure the junction interface is with Longshore Avenue/The Sanctuary, not the internal edge of the bus turnaround.

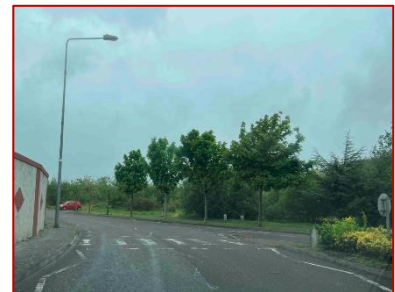
4.3.8 Problem

Summary: Existing pedestrian crossing may lead to confusion and possible vehicle/pedestrian collisions.

The existing layout near the bus turnaround includes black and white road markings, but no Belisha Beacons or red tactile paving. Pedestrians, particularly children, may believe this is a Zebra crossing, and enter the road in front of a driver, leading to vehicle/pedestrian collisions.

Additionally, the crossing extends across the bus turnaround access, approximately on the same line. Pedestrians may continue straight across the second crossing without due care and attention, increasing the risk of vehicle/pedestrian collisions.

A controlled pedestrian crossing (e.g. Zebra, Toucan, etc.) should be provided in this location.

Additionally, the crossings on Longshore Avenue/The Sanctuary and the Bus Turnaround should be staggered.

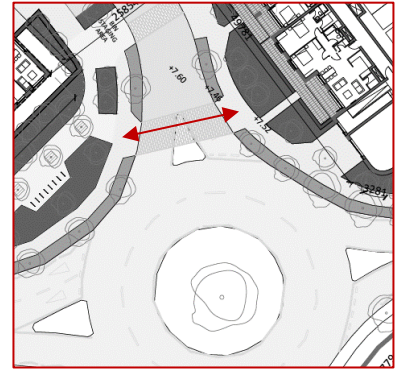
4.3.10 Problem

Summary: Possible slips, trips, and falls.

The proposed layout indicates an uncontrolled pedestrian crossing of the primary development access at the northern arm of the Longshore Avenue roundabout. However, the crossing appears to be on a ramp gradient, which may increase the risk of pedestrians crossing on a surface that is not level, leading to slips, trips, and falls.

Ensure the uncontrolled pedestrian crossing is located on a flat, level, surface, and that provision for the crossing is made within the splitter island. Tactile paving and dropped kerbs should be provided at the crossing.

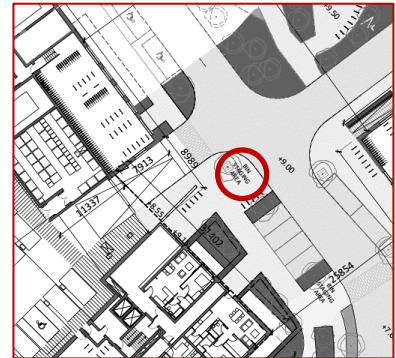
4.3.11 Problem

Summary: Bins storage areas may obstruct visibility for drivers when located at accesses or side roads.

Bin Staging areas are located within the development. However, some areas are located near side road junctions or vehicle accesses, which may reduce visibility for drivers using the development. This may lead to drivers entering the road when it is unsafe to do so, leading to side-on or vehicle/cyclist collisions.

Ensure bin storage areas do not reduce or block visibility.

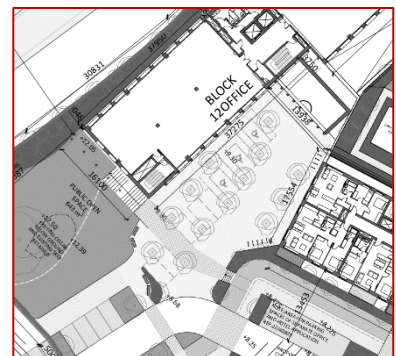
4.3.12 Problem

Summary: Planter boxes may obstruct the safe entry and exit of vehicles in the Office Block 12 carpark.

Several planter boxes have been located near mobility parking spaces within the Office Block 12 carpark. It is unclear if these planter boxes will obstruct safe entry/exit movements for drivers using the carpark. Should the planter boxes restrict vehicle movement, there is an increased risk of material damage collisions.

Ensure planter boxes near Mobility Parking spaces do not interfere with a vehicle's swept path near Block 12.

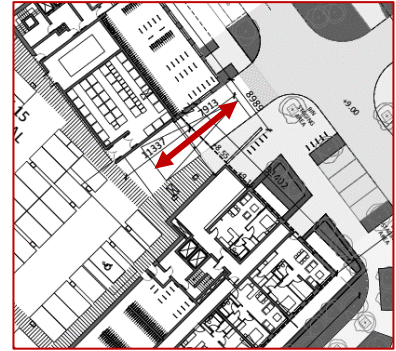
4.3.13 Problem

Summary: Possible loss of control collisions for cyclists using the basement ramps.

The gradient of the proposed basement carpark access ramp has not been indicated. If the ramp is too steep, it may lead to possible loss of control collisions for cyclists, who may use the ramp to access the basement carpark.

Ensure the gradient of the ramp is sufficient for all types of vehicles that will require access to the carpark without experiencing difficulties when ascending/descending the ramp.

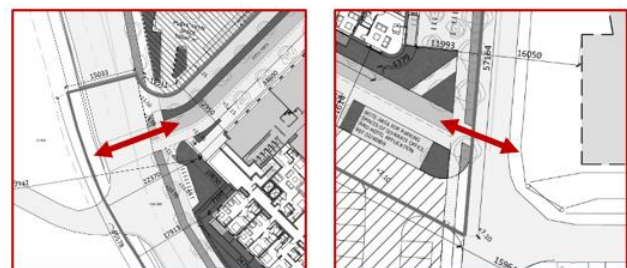
6.1.1 Issue

The proposed cycle track within the SHD site connects externally with Longshore Avenue to the east and west of the development, however, no crossings have been indicated within the plan. It is therefore unclear how cyclists will safely access the opposite side of the road, where they can continue their journey. This may discourage cyclists from travelling to and from the development.

Additional facilities should be provided where the internal cycle track interfaces with Longshore Road.
