Arborist Associates Ltd.

An Arboricultural Assessment of the Tree Vegetation on the Site Area at 'Jacob's Island', Cork, Co. Cork.

Prepared for: Hibernia Star Limited.

Date: 17th May 2022

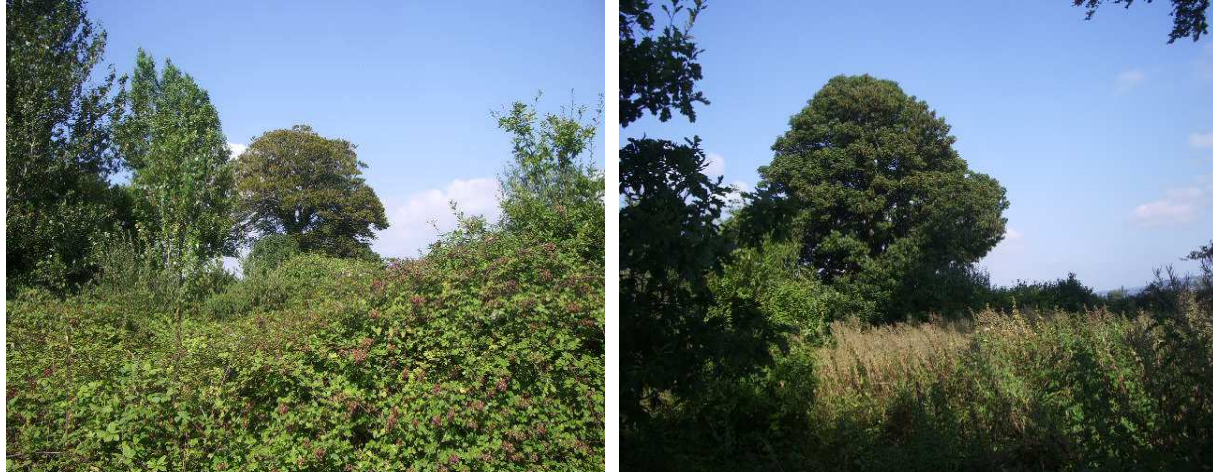
Tree Nos. 0495 & 0497 are the two large prominent trees on this site area.

0495	Beech <i>Fagus sylvatica</i>	19	1200	7	10	10	9	0	Late Mature	Fair/ Poor	Poor It is a large, prominent, visual tree within this site area and it stands out within the locality. Extensive basal decay is present and it is also infected at numerous points by the fungus 'Ganoderma Sp.' This decay will eventually impact on its stability and its safety is of concern. Heavy Ivy cover on the main trunk is extending up into its crown. Its upper crown is showing signs of stress/ decline with deadwood throughout its crown.	It will either need to be removed or allowed to fall naturally within this site area.	<10	U

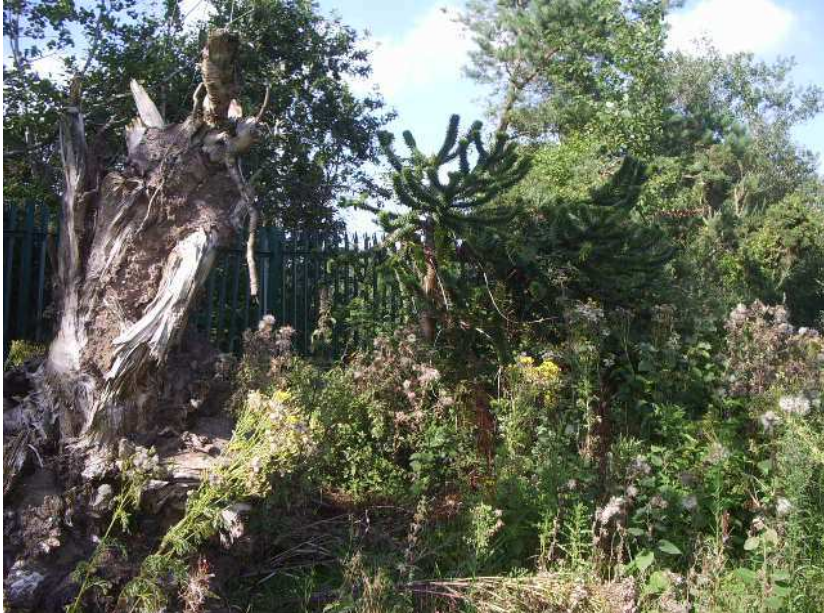
The following Monkey Puzzle was once also a large prominent tree within the treescape of this area before it fell.

0498	Monkey Puzzle <i>Araucaria araucana</i>	3	110	2	2	2	1	0.5	Mature	Fair/ Poor	Poor I suspect that it is a sucker growing from the original stump left of the tree that fell or was removed. Scrub is growing up through its crown and its top would appear to have suffered branch breakage in the past.	Carry out some formative pruning to address structure. It would benefit from general tidying works and the clearing back of the scrub vegetation to allow its more space to develop.	20+	C1
0499	Crack Willow <i>Salix fragilis</i>	11	250/ 160/	4	4	4	4	0	Early Mature	Fair	Fair/ Poor Multiple-stemmed from base and is growing up through the chain link fence	Requires no work at the present time.	10-20	C1

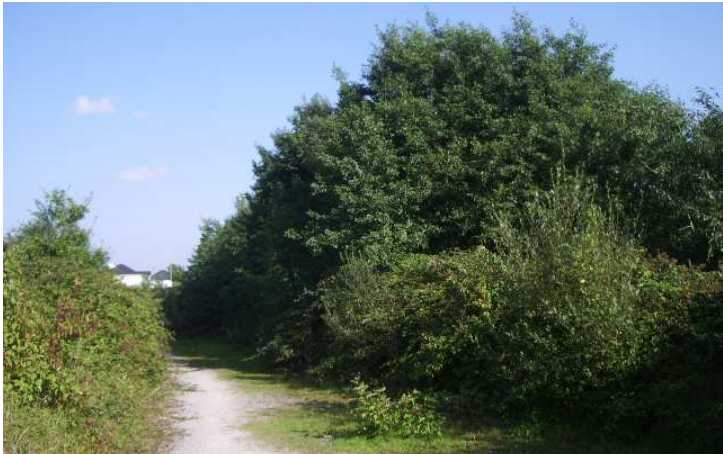
Tree No.	Tree Species	Ht. (m)	Stem Dia. (mm)	Branch Spread (m)				C-Ht. (m)	Age Class	Phys. Con.	Structural Condition Other Comments	Preliminary Recommendation	Remain Contribute in years	Cat. Grade
				N	S	E	W							
				N	S	E	W				N-north S-south E-east W- west Cat.- category Phys.-physiological	A- average Dia- diameter C-Ht.- crown height		
0500	Grey Poplar <i>Populus x canescens</i>	10	540	6	7	6	6	2	Early Mature	Poor	Poor It is located beside an old E.S.B substation and is growing up through the chain link fence on the edge of the surfaced area and the chain link fencing is causing some damage to this tree. Fire damage has been caused to the lower trunk with dieback evident throughout its crown. This tree has limited future potential.	I would recommend its removal as the most appropriate management option.	<10	U

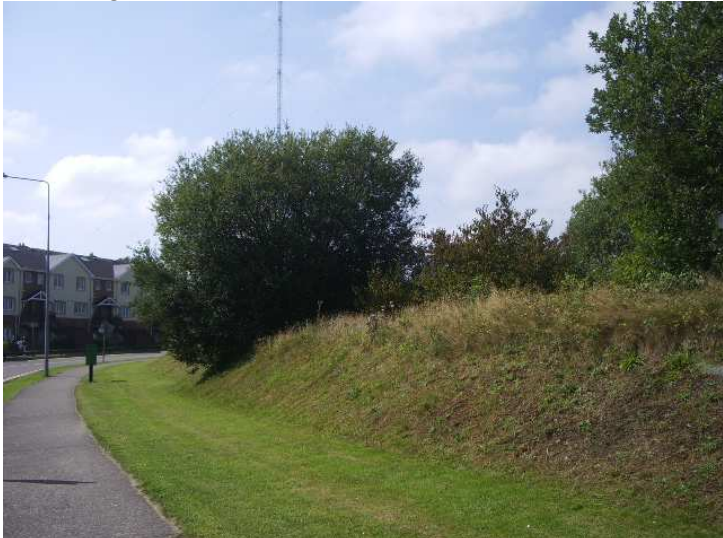
0501	Goat Willow <i>Salix caprea</i>	7	100 (10 stems)	4	4	4	5	0	Early Mature	Fair/ Good	Fair Multiple-stemmed from base and is self-seeded into this area. Bramble is growing up through its lower crown. It forms part of the higher bulking within this scrub woodland and protrudes up over the height of the main scrub/ woodland area.	Tidy up the undergrowth at the present time.	20+	C1
0502	Goat Willow <i>Salix caprea</i>	7	100 (10 stems)	4	4	4	5	0	Early Mature	Fair/ Good	Fair It is growing on top of the soil bank and is most likely self-seeded into this area. Scrub and Bramble are growing up through its lower crown. It protrudes up	Tidy up the undergrowth at the present time.	20+	C2

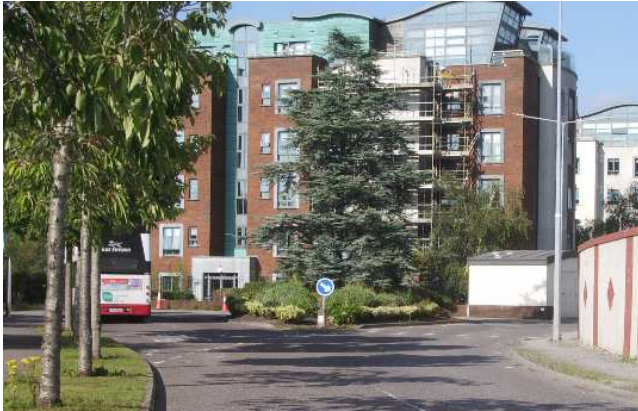
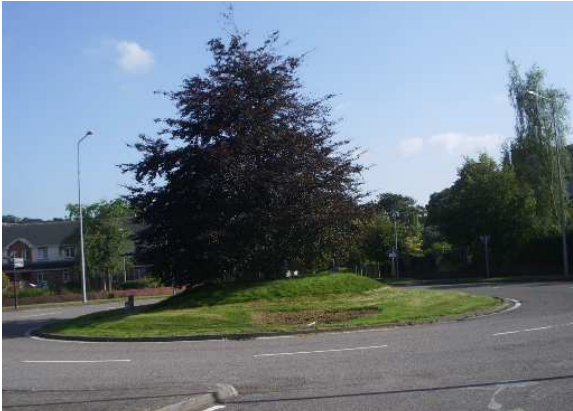
</div>														
Tree No. 1	Blue Cedar <i>Cedrus atlantica</i> 'Glauca'	11	350	4	4	4	4	0	Semi Mature	Fair/ Good	Fair/ Good It is located on the roundabout as a feature tree and is establishing well. I suspect that it was planted as a large size tree and it is of prominence within this area. The stay wires are still attached to this tree.	The stay wires will need to be checked/ repositioned to ensure that they are not causing damage to this tree and if no longer required, they should be removed.	40+	A1

Tree No. 2	Copper Beech <i>Fagus sylvatica</i>	10	360	4.5	4.5	4	4	0	Semi Mature	Good	Good It is located on the traffic island / roundabout on a raised soil mound. It is establishing well and would appear to be of good quality. I suspect that it was planted as a large size tree (semi mature). It is a focal point on this road.	Requires no work at the present time.	40+	A1
Notes:
