APPENDIX 14.1 CONSTRUCTION & DEMOLITION WASTE MANAGEMENT PLAN

**CONSTRUCTION &
DEMOLITION WASTE
MANAGEMENT PLAN FOR
A PROPOSED RESIDENTIAL
DEVELOPMENT**

**MASTERPLAN, SITE 3, SITE 4
AND SITE 5.**

CB/20/11784WWMR01

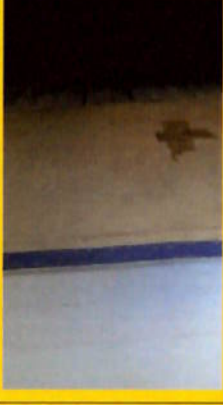
38	10-11 Moore Lane	4 storey Building 3 rd floor WC		VFT and adhesive		No visible asbestos containing materials identified.

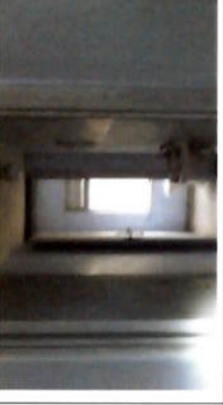
39	10-11 Moore Lane	4 storey Building 3 rd floor WC		Concrete floor		No visible asbestos containing materials identified.

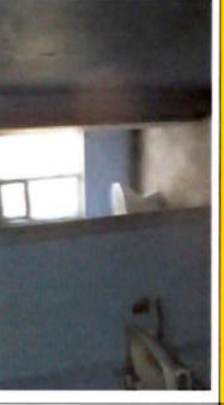
40	10-11 Moore Lane	4 storey Building 3 rd floor Roof	2027336	AC single skin corrugated roof sheeting, ridge tiles and flashings	400 SM approx	Crocidolite and chrysotile	1	1	1	1	4	Removal and disposal as asbestos waste by a competent contractor prior to work likely to cause disturbance

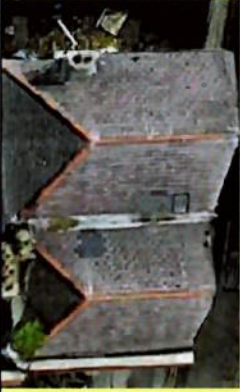
2	No.s 10-12 Moore Street	Roofs to No. 11 and 12		Felts to all flat		Presumed asbestos						Investigation by a competent contractor prior to work likely to cause disturbance.

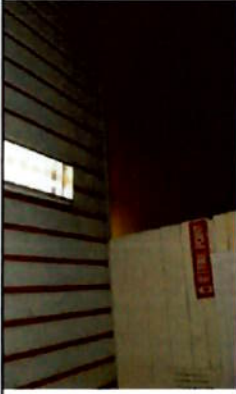
10	No. 24/25 Moore Street	1 st floor Canteen				No visible asbestos containing materials identified.

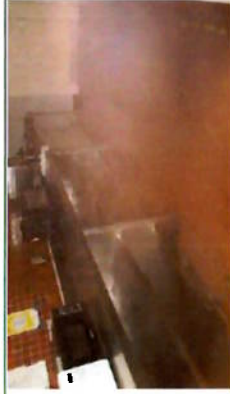
12	No. 24/25 Moore Street	1 st floor Office				No visible asbestos containing materials identified.
