ARBORICULTURAL ASSESSMENT & IMPACT REPORT

BAILEY GIBSON 2 SHD

Project No.	Project name	Date	Revision
TBAI001	Bailey Gibson SHD 2	08/06/22	A

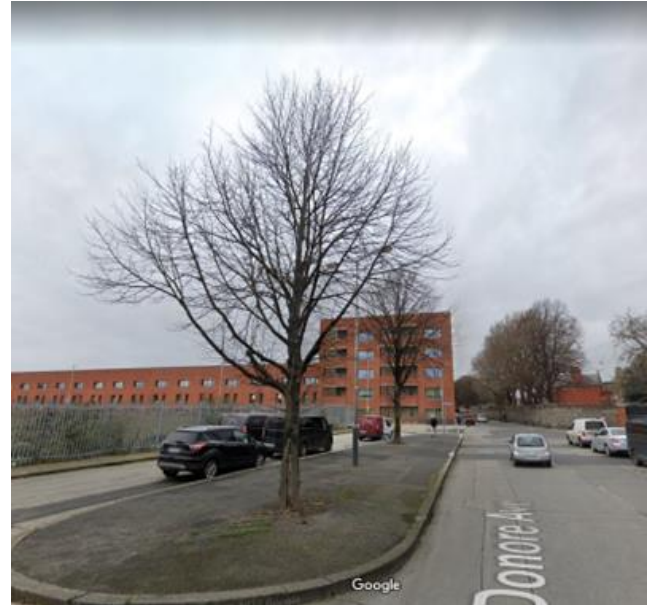
The better-quality trees are arguably the small leaved lime cultivars (*Tilia cordata* cv) on Donore Avenue which have established well and provide a softening of the streetscape in this area (image 2).

Image 2. Lime cultivars on Donore Avenue
©Google

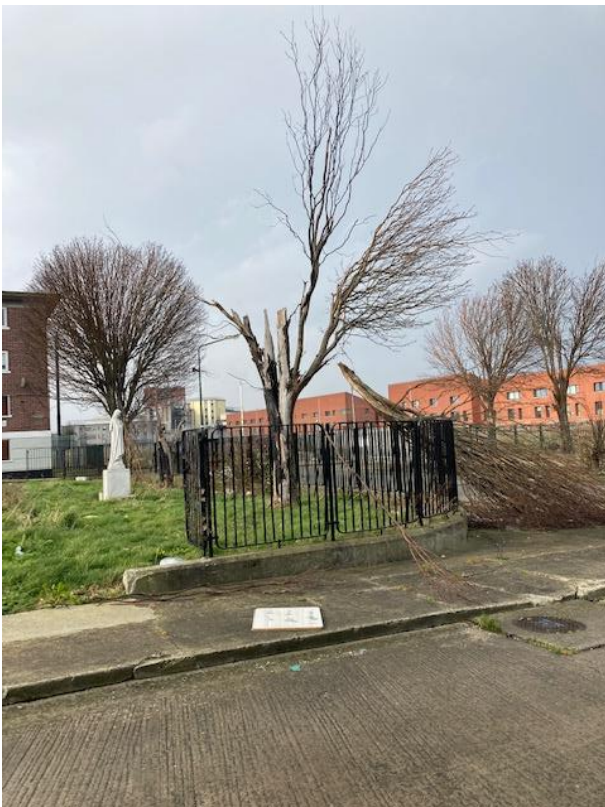
The trees within the more central area of St Teresa's Gardens have been blighted by vandalism with storm damage also a factor (image 3). The main species planted was Swedish whitebeam (*Sorbus aria*) which though having the potential to develop into good quality trees often contain structural issues such as included bark which renders them prone to storm damage.

Image 3. Storm damage to Swedish whitebeam within St Teresa's gardens

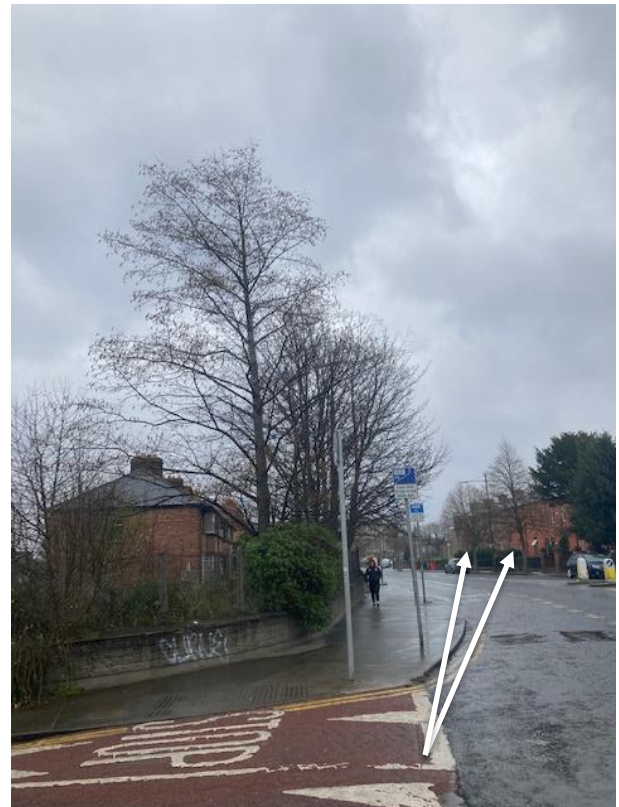
The street trees on South Circular Road within the applicant's landholding are Turkish hazel (*Corylus colurna*) which are of mixed age and quality. Like small leaved lime cultivars this species has been used extensively by local authorities as a street tree. It is a robust species and like lime responds well to pruning allowing it to be shaped to avoid high sided vehicles etc. Some of the trees assessed for this report appear to have established more readily than other with poor planting conditions most likely responsible for the less successful plantings. A disused allotment within the applicant's landholding contains a number of trees which appear to be both self-seeded and planted (image 4). They form an effective screen to this area and though crowded together are generally well developed. The close proximity of some of the trees to a low boundary wall reduces their long-term potential.

Image 4. Trees screening the allotment area on South Circular Road with street trees within site boundary arrowed.
