**B&G Salvage Site ,
Dolphins Barn,
Dublin 8.**

Pre-Refurbishment & Demolition Survey
(Building Fabric Only)

Report type:	Pre- Refurbishment & Demolition Survey
Report Date:	08th February 2022
Survey Date(s): Review Date:	22nd May 2019 19th January 2022
Surveyor:	Johann Flynn
Issue:	Draft Issue to Client

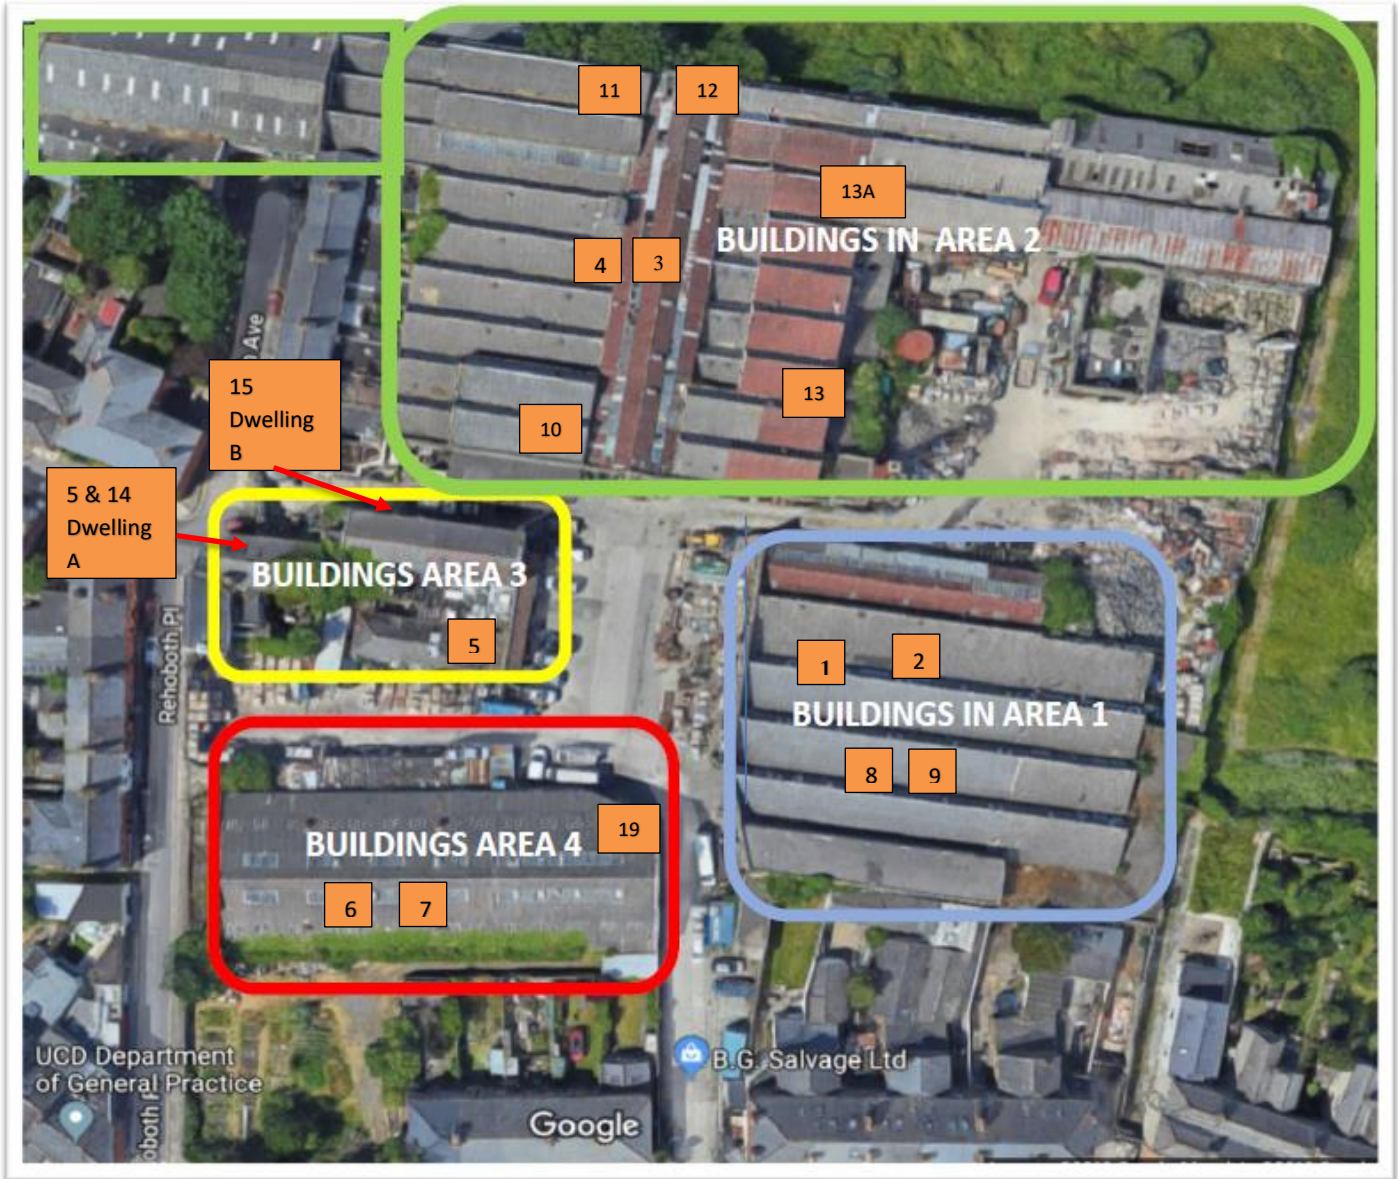
Confirmed ACM's Reference No. & Outline Locations

12	Building Area 2 – First Floor Male/Female WC Asbestos Cement Sheeting 100sq./m.
13	Building Area 2 – Ground Floor to Front of Lean-to Asbestos Cement Wall Sheeting 40sq./m. approx.
13A	Building Area 2 – Approx 4/5 1Tonne Asbestos IBC Bags Observed throughout area.
14	Building Area 3 – Dwelling A Ground Floor Lino Flooring 20sq./m. approx.
15	Building Area 3 – Dwelling B Staircase to First Floor Stair Thread nosing < 10 Linear/m.
19	Building Area 4 - Staircase to First Floor Red- Stair Nosing 10 Linear/m.
<p>*Reference No. Locations are identified on outline drawing below.</p>

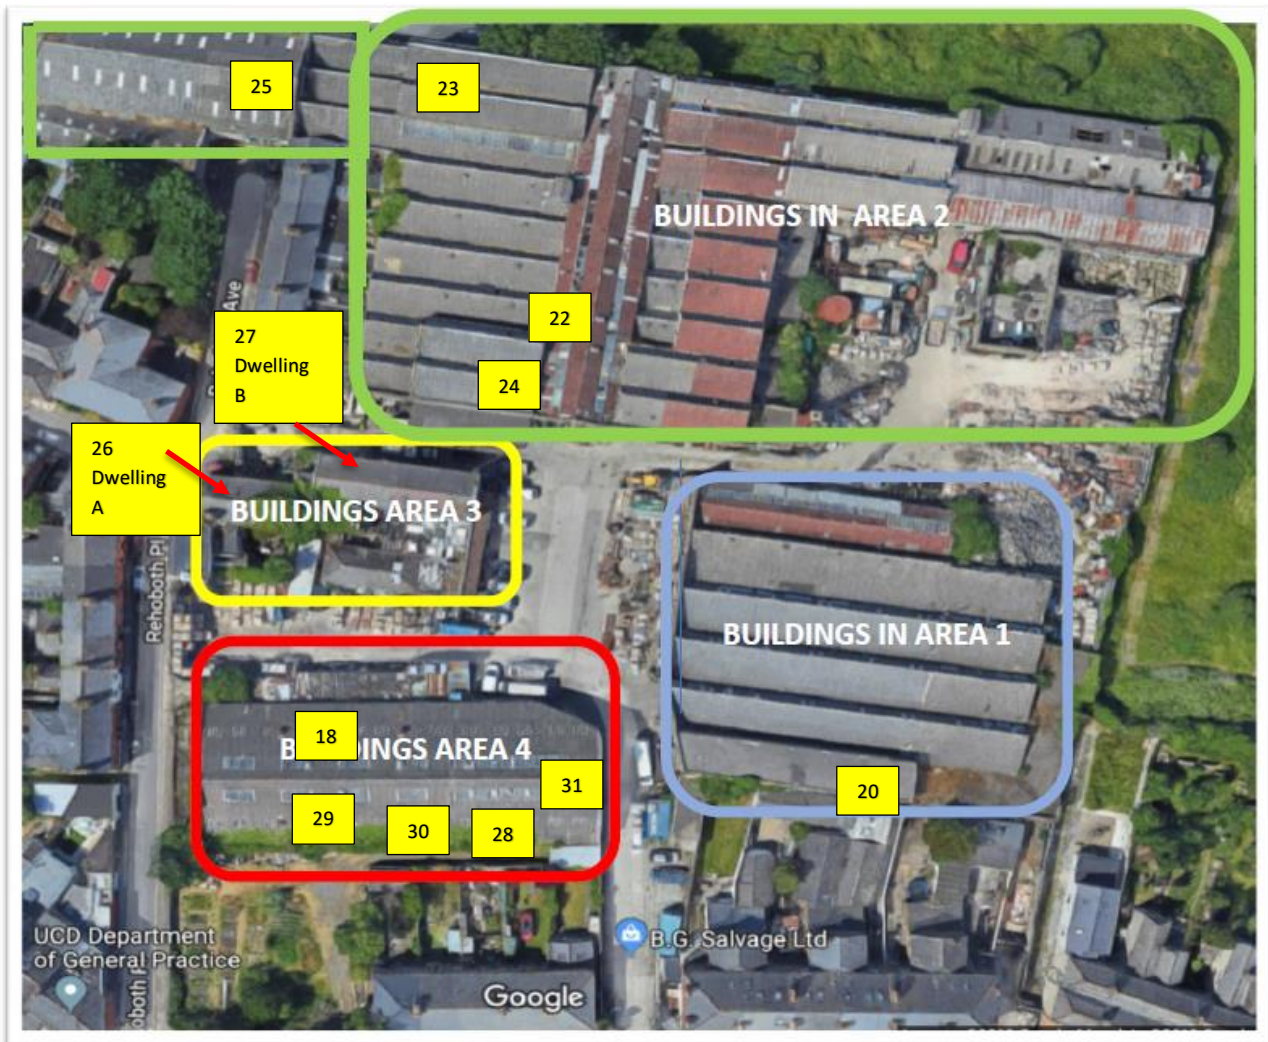
Presumed ACM's Reference No. & Outline Locations

Appendix B Ref. No	STRONGLY PRESUMED/PRESUMED ASBESTOS
18	Building Area 4 – Thermal Insulation to High Level Pipes returning through wall mid- section of Showroom 20 Linear/m.
20	Building Area 1 - Flat Roof Material amount TBD.
21	All Buildings onsite with “North Facing Windows” presumed Rope Seals amount TBD.
22	Building Area 2 – Ground Floor Quarantine Area AC Water Tank.
23	Building Area 2- First Floor No Access Lift Area, Shaft, Carriage & Motor presumed ACM’s
24	Building Area 2 – First Floor Fire Door top of stairs First Floor presumed ACM components.
25	Building Area 2 – First Floor High Level no access presumed AC Sheeting.
26	Building Area 3 – Dwelling A Ground Floor & First Floor Areas not accessible due to structural collapse in area.
27	Building Area 3 – Dwelling B First Floor Areas not accessible due no floors in area.
28	Building Area 4 – First Floor Presumed Concealed Thermal Insulation to concealed pipework.

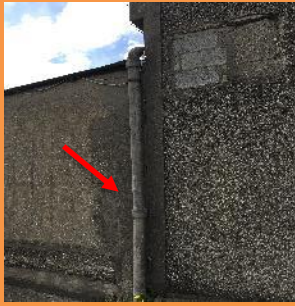
7	Old B&G Salvage Site , Dolphins Barn, Dublin 8.	Building Area 4 Asbestos Cement Gutters & down pipes.	N/A	AC Cement Rainware	200 linear meters approx	Strongly Presumed Chrysotile	1	2	1	1	5	n/a	n/a	n/a	n/a	n/a	5	L	Removal by competent Contractor prior to any Refurbishment &/or Demolition Works. Disposal as Hazardous Waste.

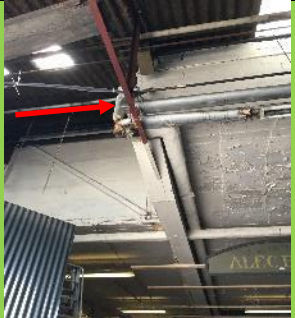
16	Old B&G Salvage Site , Dolphins Barn, Dublin 8.	Building Area 4 Ground Floor Inside Main Entrance	1914523	High Level Thermal Insulation to old redundant pipes.	40 linear metres approx	Amosite	3	3	2	2	10	n/a	n/a	n/a	n/a	n/a	10	H	Removed by Specialist Contractor under controlled cond.

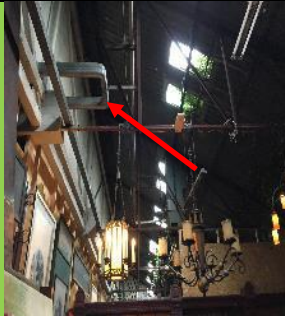
18	Old B&G Salvage Site , Dolphins Barn, Dublin 8.	Building Area 4 Ground Floor Rear of Building	N/A	High Level Thermal Insulation to old redundant pipes- no access pipe returns through wall.	20 linear metres approx	Strongly Presumed Amosite	3	3	2	2	10	n/a	n/a	n/a	n/a	n/a	10	H	Removed by Specialist Contractor under controlled cond.
