## **APPENDIX 13-2**

**QUALITY AUDIT**

Title: **QUALITY AUDIT**  
**For;**  
**Proposed Moygaddy Castle SHD**

Report reference: **1577R01**

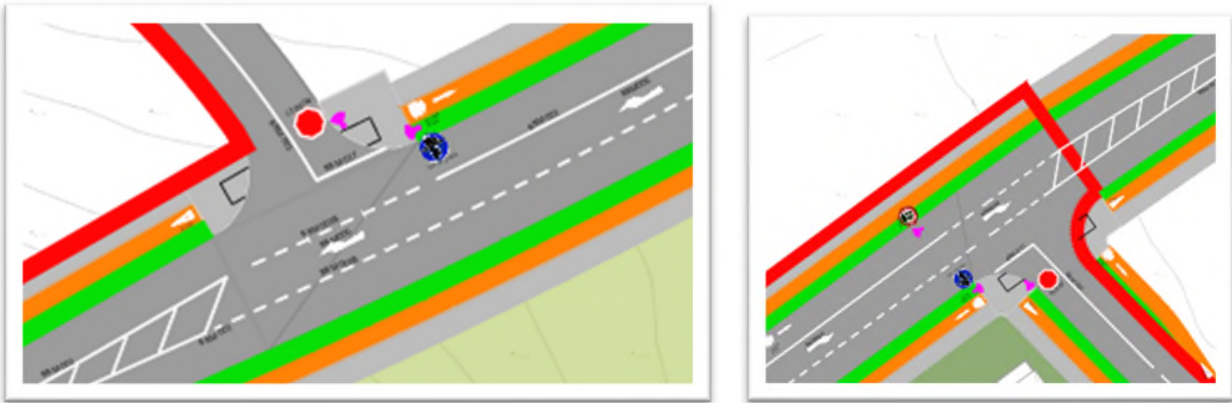
Drawing S665-OCSC-1C-MH-DR-C-0111 S4 P04, MOOR

Both junctions on the MOOR extension are simple priority junctions. There are no facilities for pedestrians or cyclists to cross from one side to the other.

It is recommended that crossing facilities be provided for vulnerable road users.

3.1	Yes	Yes	Toucan Crossing to be added with Detailed design on the MOOR north of the junction with the L6219 (Eastern)	Yes
3.2	Yes	No	The red line has been adjusted to take account of verge requirements for forward visibility. Pedestrian and cyclist infrastructure will be provided along this road as part of the future development of this part of the masterplan lands.	Yes

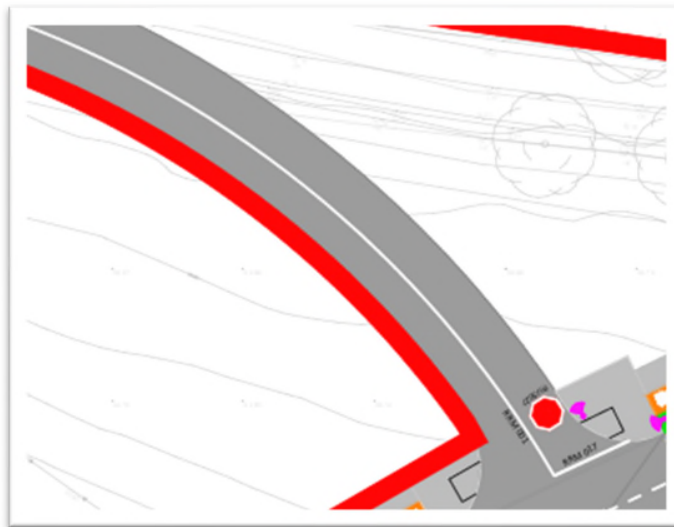
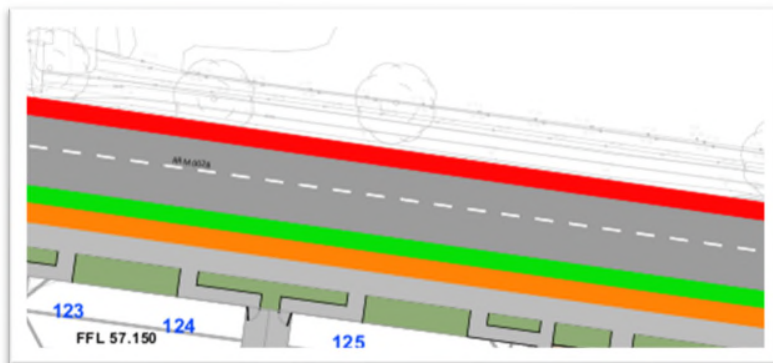
Drawing S665-OCSC-1C-MH-DR-C-0111 S4 P04, MOOR

The tie-in with the existing L2214-3 and the realigned L2214-3 is shown to be constructed tight to the land boundary. This may leave no room for refuge in a verge or footpath for pedestrians. This could lead to collisions with vehicular traffic,

It is recommended that that a suitable verge width be provided.

It is also recommended that the footpaths be returned around the sideroad of the junction of the western tie-in as far as a suitable transition point for transfer to on-road pedestrians.

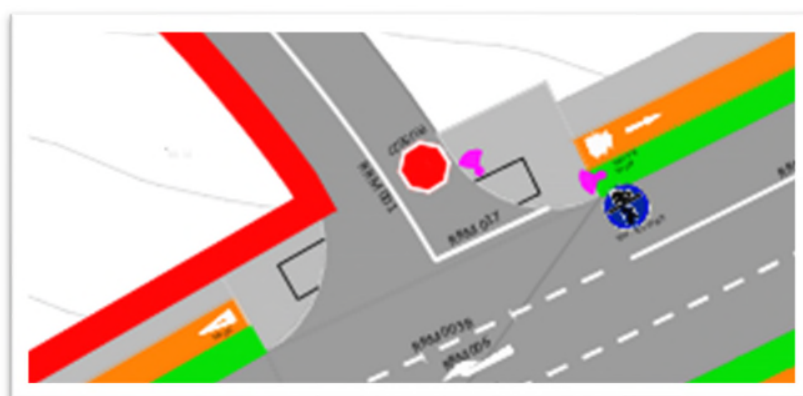
S665-OCSC-1C-MH-DR-C-0111 S4 P04, MOOR & L2214-3

At both junctions on the extended MOOR and on the junctions along the improved L2214-3 cyclists have to yield to sideroad traffic. This could make the cycle facilities unattractive to cyclists due to journey time delays. Cyclists may opt to remain on the carriageway where they would have a higher likelihood of being struck by passing or turning vehicles.

It is recommended that the cycle tracks be transitioned to an on-road facility at the junctions and be clearly highlighted to alert drivers of their presence.

3.3	Yes	No	OCSC notes that there are several suitable solutions that will not affect the extent of works. OCSC will agree a suitable solution in consultation with MCC for this and similar locations at detailed design stage.	Yes

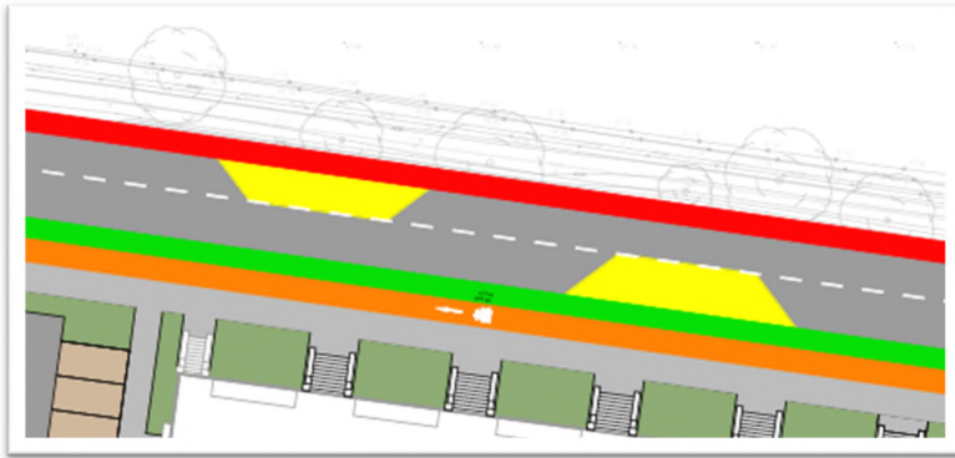
S665-OCSC-1C-MH-DR-C-0112 S4 P04, L2214-3

It is proposed to provide two chicanes on the L4413 as a means of providing traffic calming. It is anticipated that this will be a relatively heavily trafficked link/arterial road and this type of traffic calming may not be appropriate as approach speeds may be too high and this could lead to head on collisions.

It is recommended that more appropriate traffic calming measures be provided to suit the nature of the road.

3.4	No	No	The chicanes will not be installed until the MOOR is complete, and the purpose is to deter through vehicles from using the L6219 in favour of the MOOR.	Yes

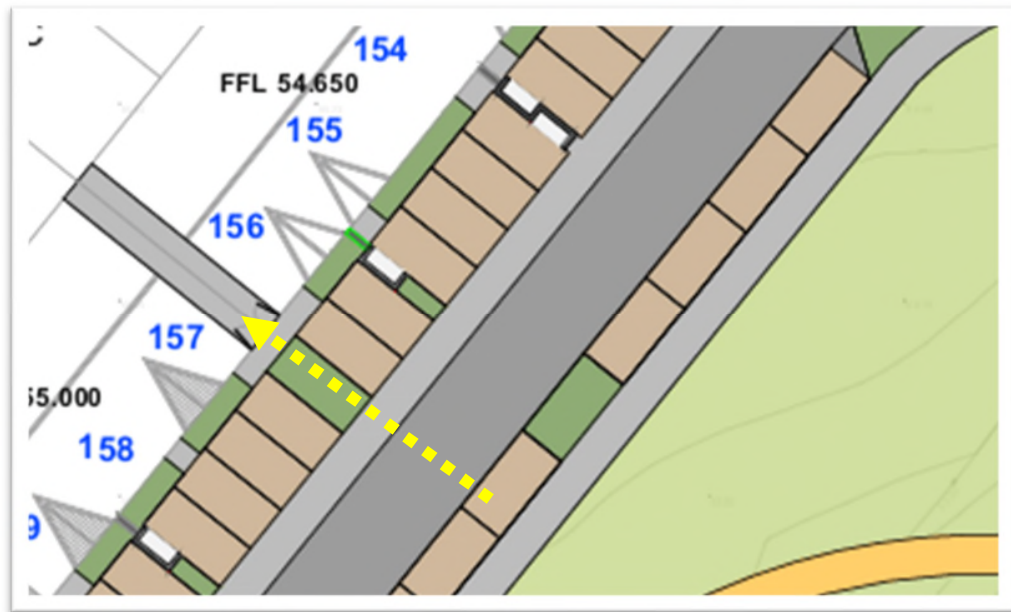
Throughout the development.

It is unclear if access to some residential units will be feasible for visitors if all the parking spaces are occupied. It appears that there are landscaped areas between parking spaces and along the front of the units.

It is recommended that access routes for pedestrians be provided assuming that all parking spaces are occupied.

3.5	Yes	Yes	The current driveway positions are wider than the required minimum as part of Part M. 1.2m access routes will be provided to all front doors as part of the Detailed Design stage of this development.	Yes

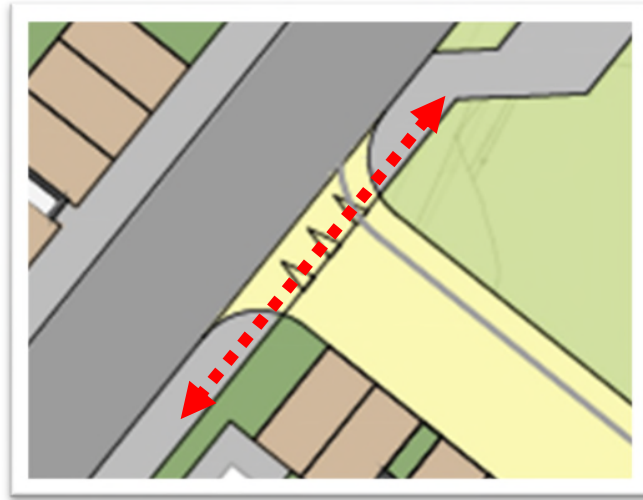
Throughout the development, Shared streets.

Shared streets are generally proposed to be raised to distinguish them from other streets. The tapers at some of the shared streets however coincide with the crossing area for pedestrians on the footpath. The steep gradients of the tapers could lead to instability for the mobility impaired and lead to falls.

It is recommended that the cross fall on the tapers be acceptable for all pedestrians users.

3.6	Yes	Yes	Taper length to be adjust as part of detailed design stage to be acceptable for pedestrians.	Yes

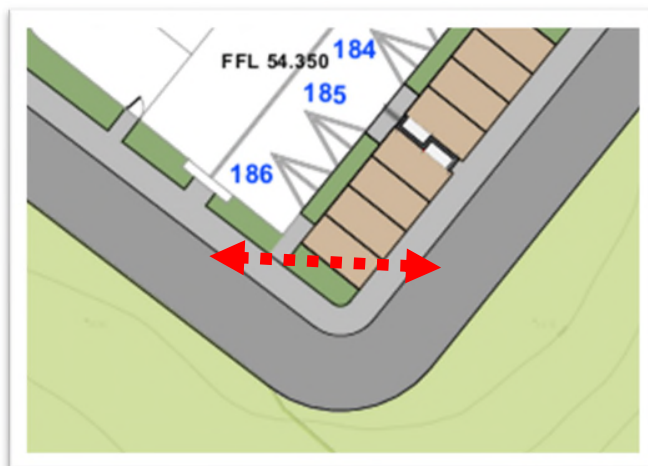
Drawing S665-OCSC-1C-MH-DR-C-0113 S4 P04.

There is a 90 degree bend at unit 186 in the south west corner of the development. It is unclear if suitable stopping sight distance will be provided due to landscaping and perpendicular car parking. A lack of visibility could lead to collisions with oncoming vehicles or hazards on the carriageway.

Ensure suitable stopping sight distance is available at this and other tight radii bends.

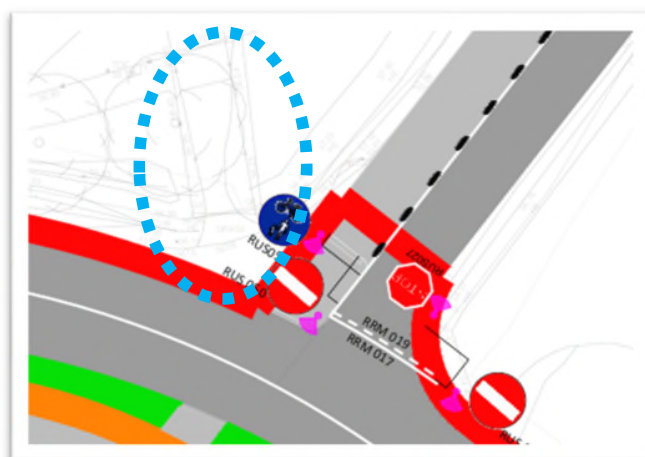
Drawing S665-OCSC-1C-MH-DR-C-0114 S4 P04. L2214 Junction.

There is an agricultural access at the L2214 junction which has limited visibility. It is unclear if vehicles will be able to enter/exit this access safely given the proposed works.

Ensure the access is accommodated for and that suitable visibility is provided.
