An Arboricultural Assessment of the Tree Vegetation on Lands at 'Baltrasna and Milltown, Ashbourne, Co. Meath.

Prepared for: Arnub Ltd. & Aspect Homes (ADC) Ltd.

**Prepared by: Felim Sheridan F. Arbor. A, RFS Dip, Nat. Dip & NCH in
Arboriculture**

Date: 26th August 2022

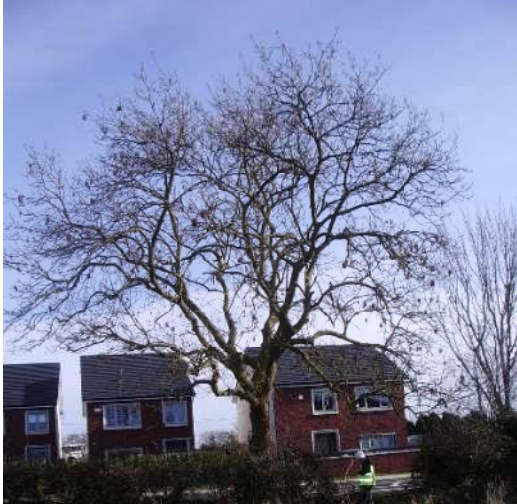
0401	Sycamore <i>Acer pseudoplatanus</i>	13	560	1	3	5	5	2	Mature	Fair	Fair It forms part of the group canopy formation with Tree No. 0402 with an asymmetrical crown as a result. Heavy Ivy cover on the main trunk is beginning to	Cut Ivy at ground level and tidy up the area around its base to allow a more detailed assessment of its	20+	B2

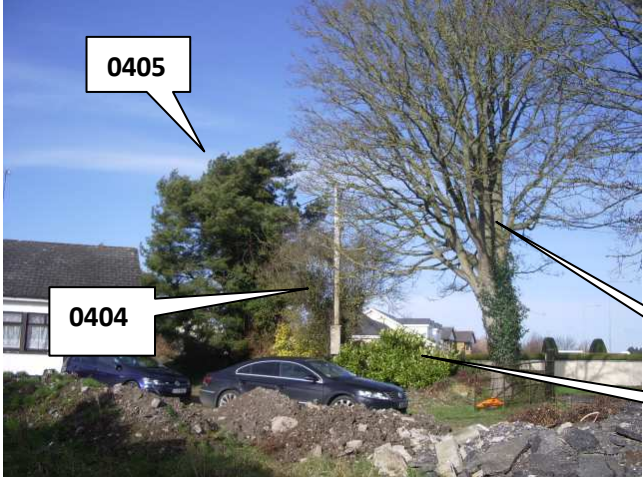
<p>The following trees are located within Hedge No.3.</p>												
0403	Sycamore <i>Acer pseudoplatanus</i>	15	820	4	5	7	4	2	Mature	Fair	Fair It is located to the right of the entrance to this private property and it may have been impacted upon during the previous upgrade works carried out on the entrance and the road in the past. It is a prominent visual tree within this area. There is Ivy cover on the main trunk.	Remove dead/ unstable growth from within its crown.	20+	B1

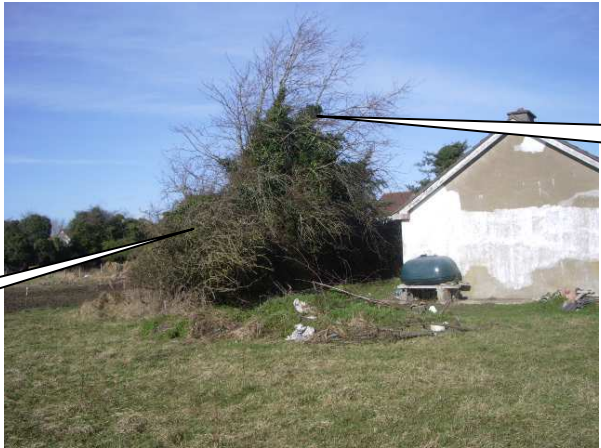
<p>The following trees are located within Hedge No. 7.</p>														
0417	Flowering Cherry <i>Prunus avium</i>	9	240/ 280/ 280/ 300	4	4	5	4	2	Mature	Fair	Fair It is being suppressed by Ivy and is towering over the height of the hedge. It forms a multiple-stemmed tree from low down with an acute union formation between stems.	Cut Ivy at ground level and tidy up the undergrowth.	10-20	C1
0418	Flowering Cherry <i>Prunus avium</i>	5	300	3	1	4	3	2	Mature	Fair	Fair/ Poor It has an asymmetrical crown due to its group growing environment and is being overcrowded by Tree No. 0417. It is beginning to be suppressed by Ivy.	Cut Ivy at ground level and tidy up the undergrowth.	10-20	C1

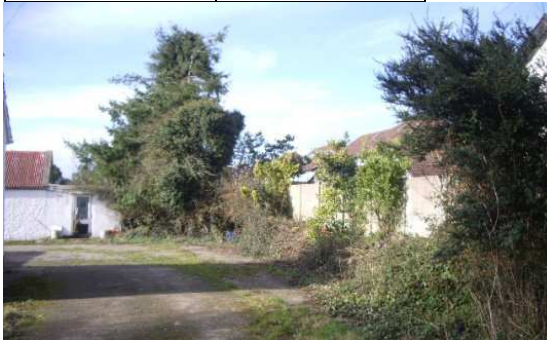
The following trees are growing within, or just in front of Hedge No.8.												
0419	Apple <i>Malus domestica</i>	6	280	1	3	2	2	2	Mature	Fair	Fair/ Poor It is being heavily suppressed by lvy and may be prone to storm damage as a result.	Tidy up the area around its base and cut lvy at ground level in order to improve the windsail of its crown.	10-20	C1

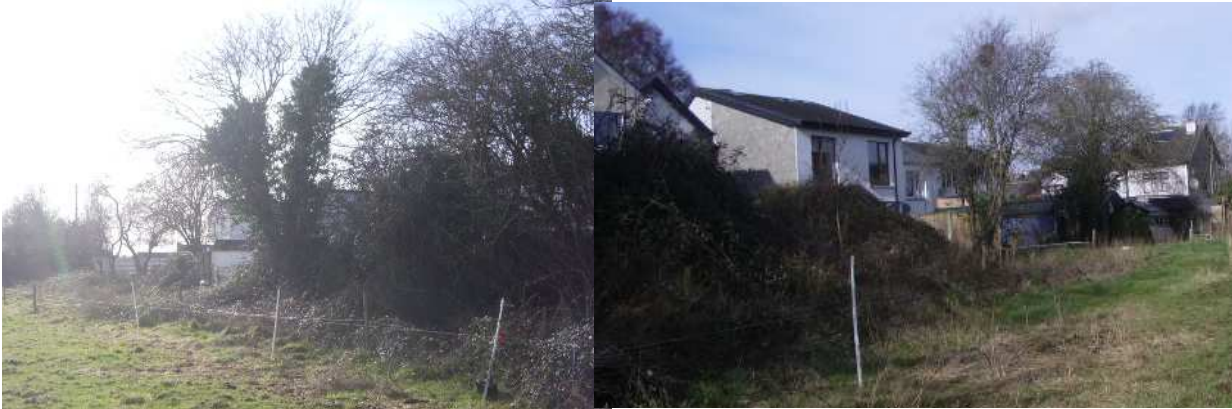
Average Height	Average Width																		
3m	4m																		
		The following trees are located within Hedge No. 11.																	
0432	Ash <i>Fraxinus excelsior</i>	14	320/ 300/ 340/ 350	3	6	6	7	2	Mature	Fair	Fair It is a large, multiple-stemmed tree from base and it is growing on the hedge line. It is beginning to be suppressed by Ivy. The assessment has been limited due to dense undergrowth and its position.	It would benefit from general tidying works. Cut Ivy at ground level and tidy up the area around its base to allow a more detailed assessment of its base and lower trunk.	10-20	C2

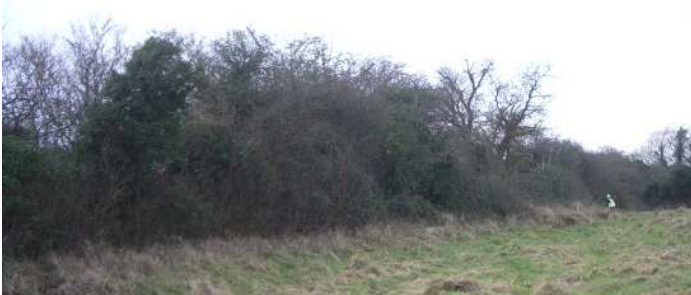
The following trees are located within Hedge No. 14.															
0448	Ash <i>Fraxinus excelsior</i>	11	380/ 380/ 380	2	7	4	8	0	Mature	Fair/ Poor	Poor It is multiple-stemmed from base and one stem has broken out in recent winds. There are areas of decay and dead bark present and its crown is in declining	I would recommend its removal as the most appropriate management option.	<10	U

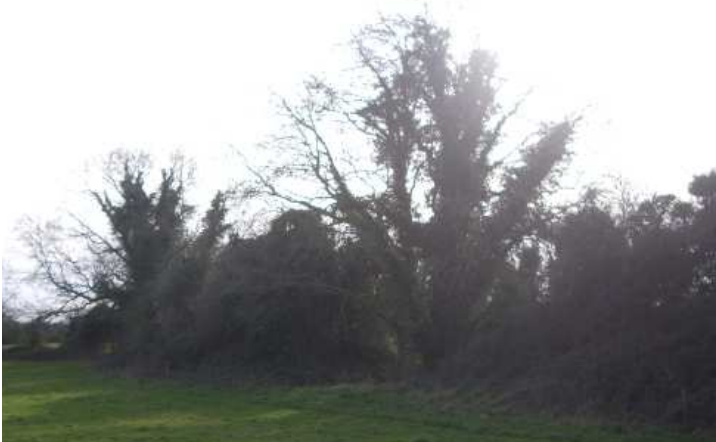
<p>The following trees are located within Hedge No. 24B.</p>												
0528	Ash <i>Fraxinus excelsior</i>	17	580/ 400/ 560	8	7	7	8	3	Mature	Fair	Fair / Poor It is a large size tree with a broad spreading crown formation. It forms a multiple-stemmed tree from base with an acute union formation between some stems. There is fungal activity present on its lower trunk / base; I suspect the fungus ' <i>Daldinia concentrica</i> '. Heavy lvy cover on the main trunk is extending up into its crown and is increasing its crowns windsail.	Remove dead/ unstable growth. It would benefit from remedial works in order to address structural issues due to weak union formations between stems.	10-20	C2

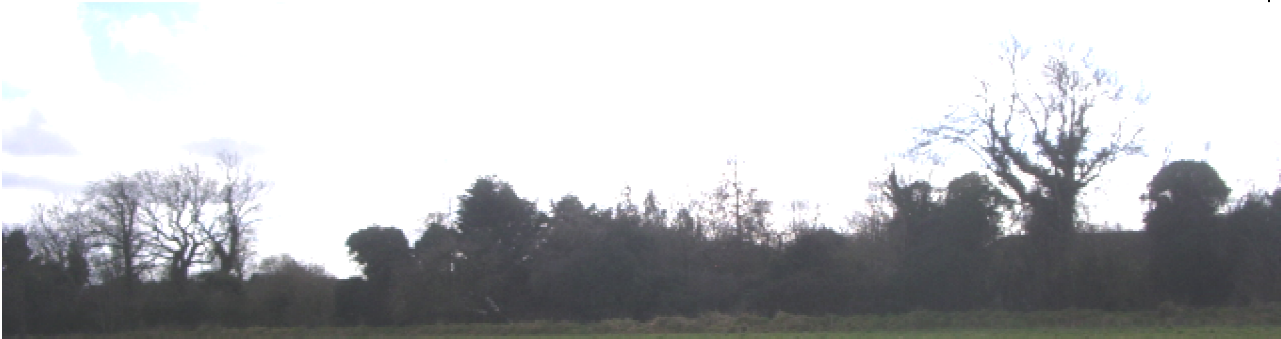
0539	Ash <i>Fraxinus excelsior</i>	10	200 (5 stems)	3	3	7	5	3	Mature	Fair	Fair/ Poor It is multiple-stemmed from base, most likely due to being cut/ coppiced into the hedge during past management. It forms part of the higher hedge bulking and is being heavily suppressed by Ivy.	Make safe large size dead/ unstable growth. Cut Ivy at ground level.	10-20	C1

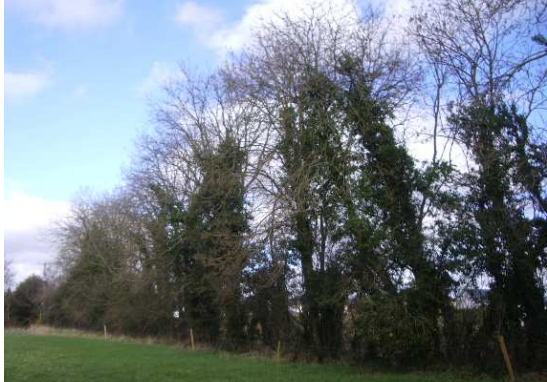
<p>The following trees are located within Hedge No. 28. From Tree Nos. 0558-0573 a drainage ditch has been dug on the site side (west side) within c.4m of these trees and this is likely to have caused some soil and root damage within this area; however, this is not apparent within the health of these trees at the present time.</p>				
0558-0573 Tag No. 0572 is missing	Ash <i>Fraxinus excelsior</i> Flowering Cherry <i>Prunus avium</i>	15	360	3	4	4	3	7	Mature	Fair	Fair It consists predominately of Ash with some small size Cherry stems mixed throughout. They are growing up through the hedge line. Most of them are multiple-stemmed from base with Ivy cover on some stems becoming heavy. They are growing up forming a combined canopy formation and they provide support/shelter to one another.	Make safe large pieces of dead/ unstable growth. Cut Ivy at ground level where it is heavy on the stems and extending up into their crowns.	20+	B2

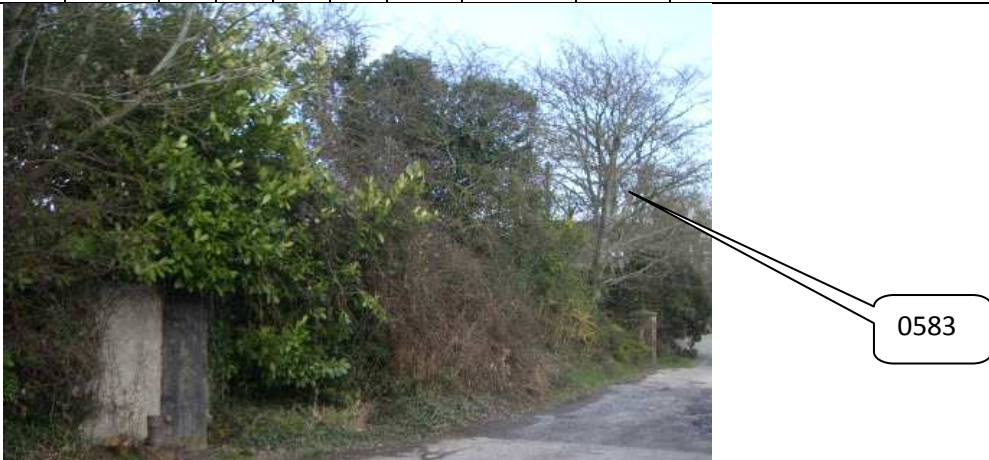
<p>The following tree is located within Hedge No. 33.</p>												
0583	Beech <i>Fagus sylvatica</i>	9	340	4	4	4	4	1	Semi Mature	Fair/ Good	Fair It is located to the right of the entrance and the lower branches have been pruned in order to raise up its crown over the entrance.	Prune stubs back to proper pruning points. It may require further pruning of lower branches in order to improve clearance.	20-40	B1
Notes:
