**Gortyrahilly, Inchamore and
Cummeennabuddoge (CMBG) Wind Farms**

Civil & Structural Due Diligence Report

October 2020

Document Number: Project No. 201164-R0

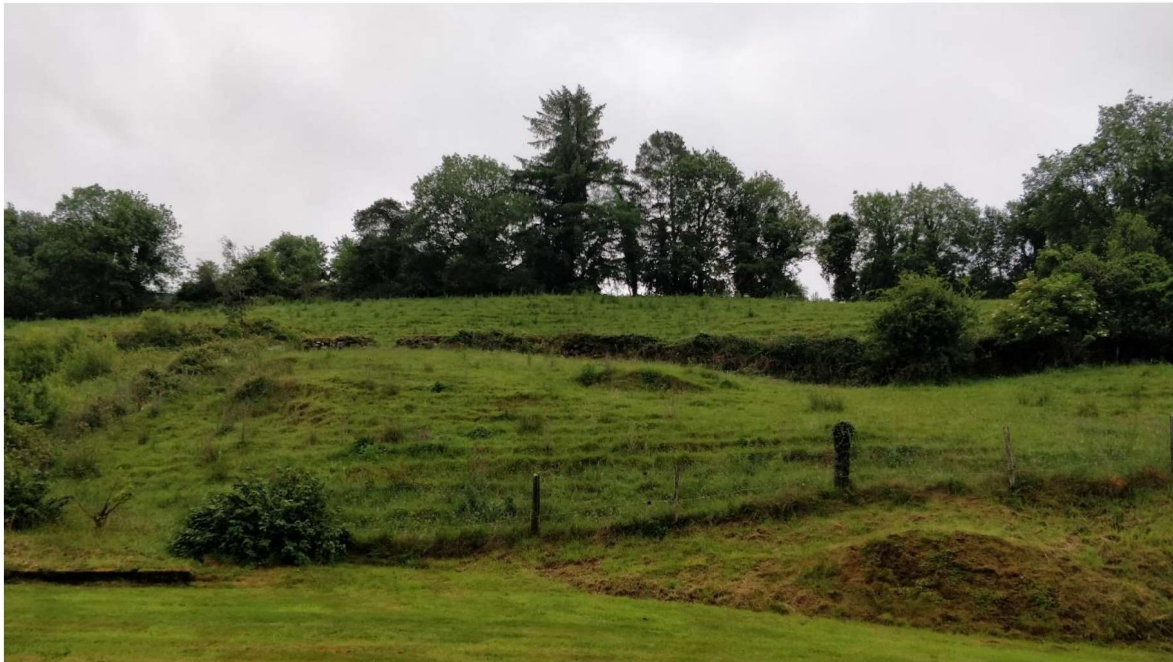
Figure 6-2: Evidence of overburden slope scarping along route A

The existing topography to the south of Baile Bhuirne includes steep slopes (greater than 30°) sloping east to west/southeast to northwest (waypoints B-C). Some scarping of the steep slopes was noted on site as shown in Figure 6-2, although rock outcrops were noted in adjacent slopes and ditches, suggesting rock is likely shallow in the area. The vertical gradient of the road south of Baile Bhuirne (waypoints A-B-C) was observed to be generally acceptable. The cross slopes along the route to the north of Baile Bhuirne (waypoints C-D-E) are typically lesser than those to the south, however, the vertical gradients are typically greater in this section. The existing boreens have historically been levelled by constructing embankments along the cross slopes between waypoints C, D and E.

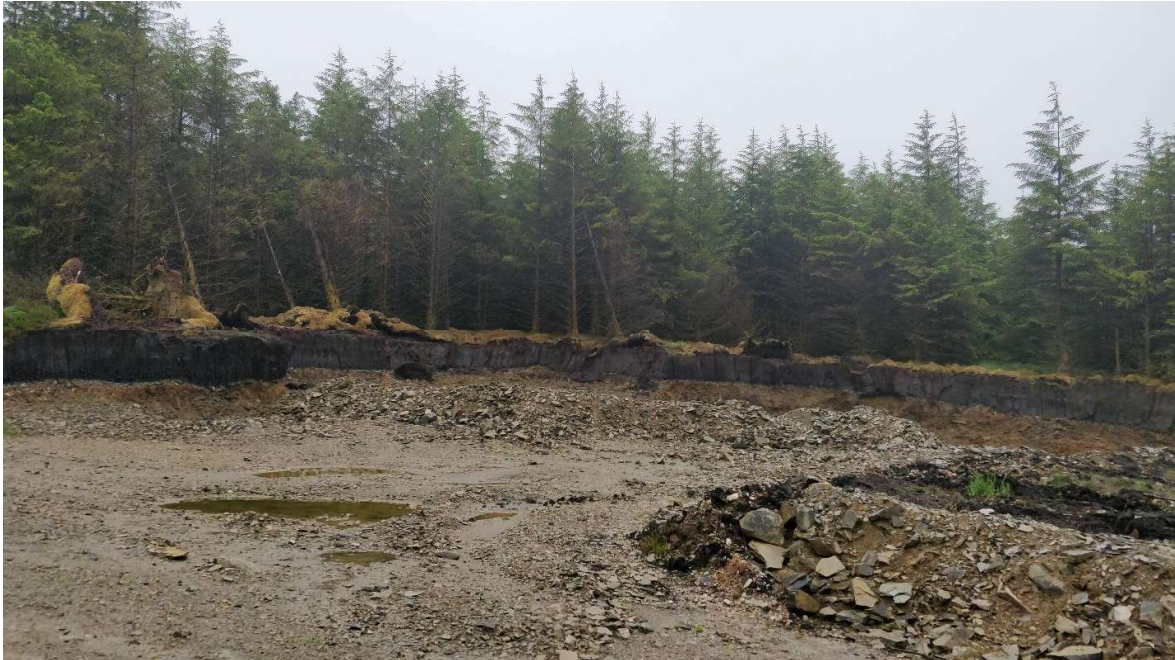
Figure 6-3: Ground conditions observed along route C

Route C runs between Inchamore Windfarm and Cummeennabuddoge (CMBG) Windfarm (waypoints F-G-J-K). Route C is typically proposed to be installed along existing forestry tracks with some alternative routes through Coillte forestry and privately owned farmland in the northern sections of this route. The forest tracks were typically cut into the existing topography, although some embankments were also noted. The ground conditions observed in the cuttings (Figure 6-3) included 1.0m to 1.5m of peat overlying till and/or weathered rock, with some rock outcrops also observed.

In areas of peat either a geotextile membrane should be incorporated into the floor of the trench to support the ducts or the peat should be excavated down to the top of the till/weathered rock stratum. No special measures are anticipated for areas of till, weathered rock or road hardcore, which should be excavatable. In areas where rock is present along the edge of the road the trench excavation process may be hindered by this rock.

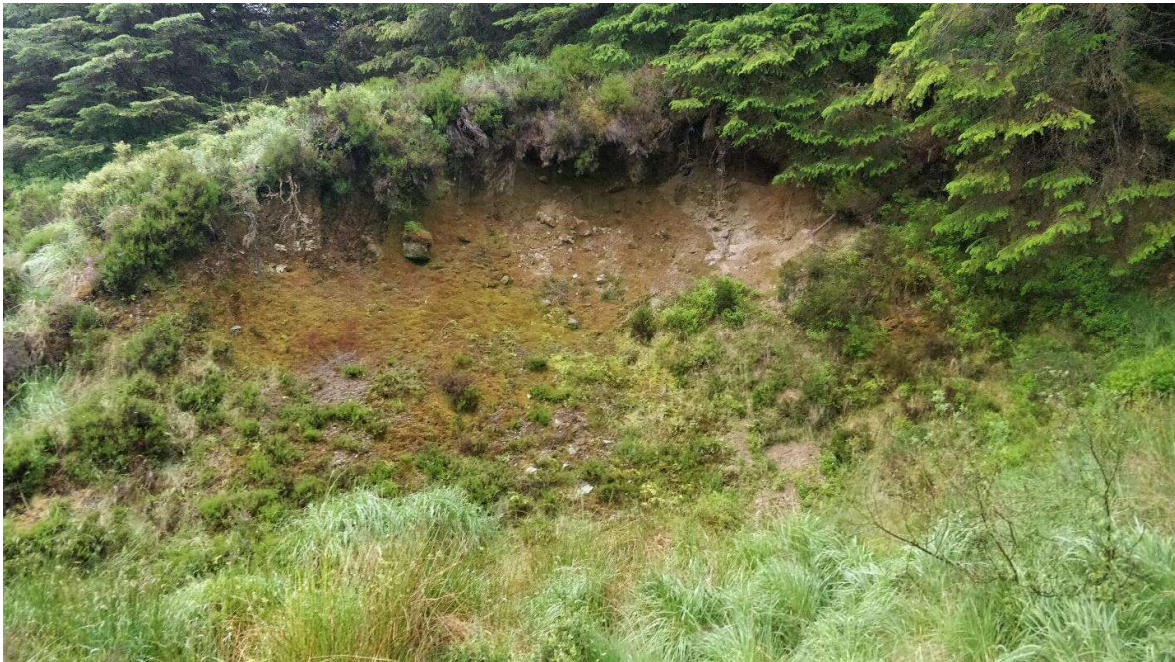
Figure 6-4: Exposed overburden cut with evidence of erosion/shallow slips (ITM 515852E,582740N)

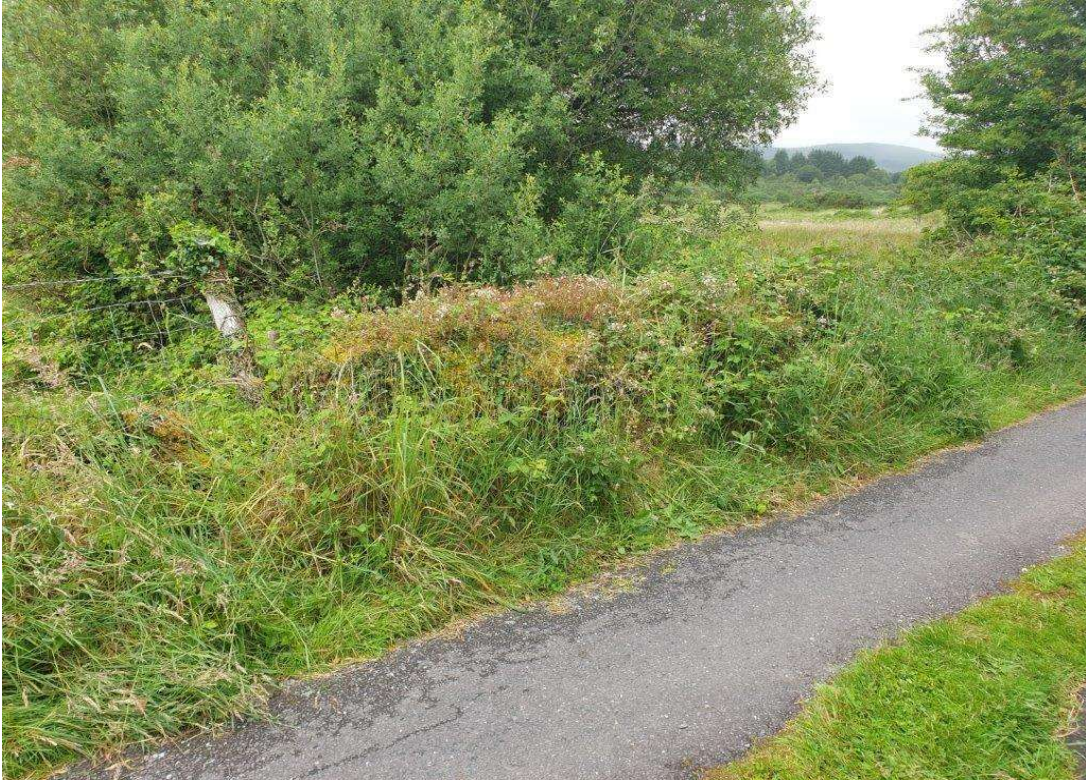
Stone masonry wall on the D/S side of the bridge in poor condition and very overgrown with vegetation. Masonry block wall on the U/S side of the bridge as seen in previous image,

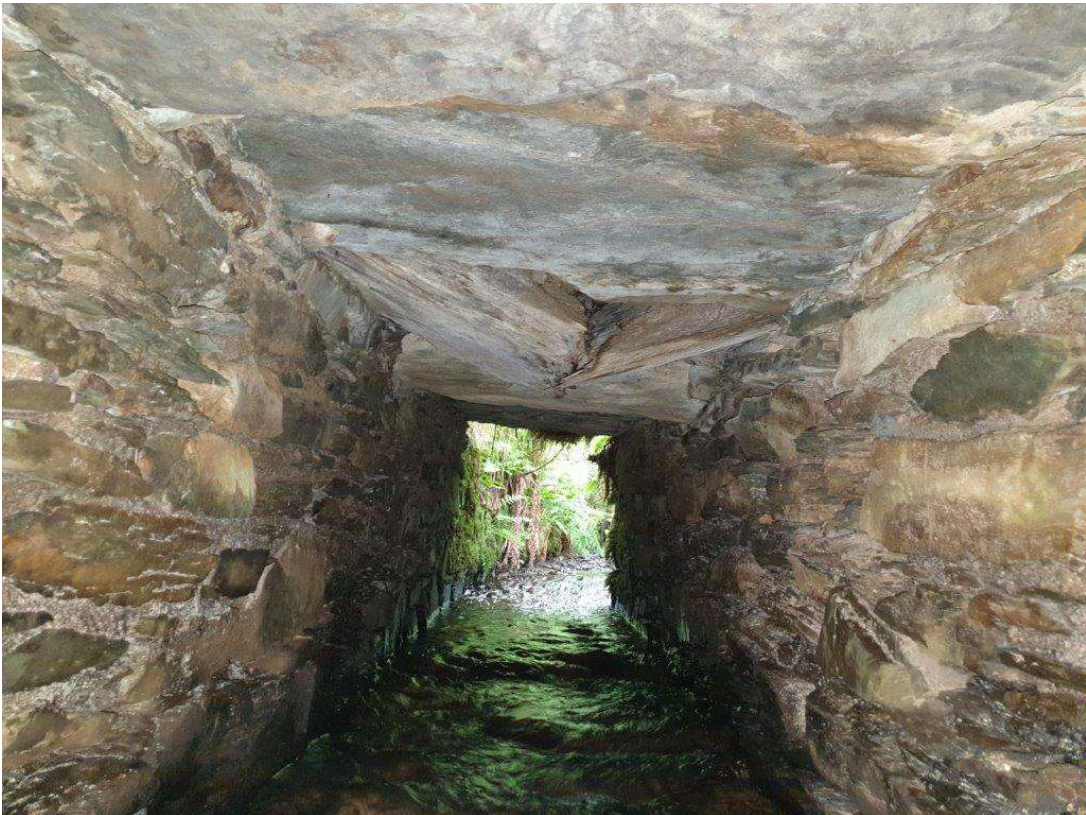
Soffit of bridge deck/box stone culvert. Flag stone is damaged and has collapsed as seen viewed from U/S (north span).

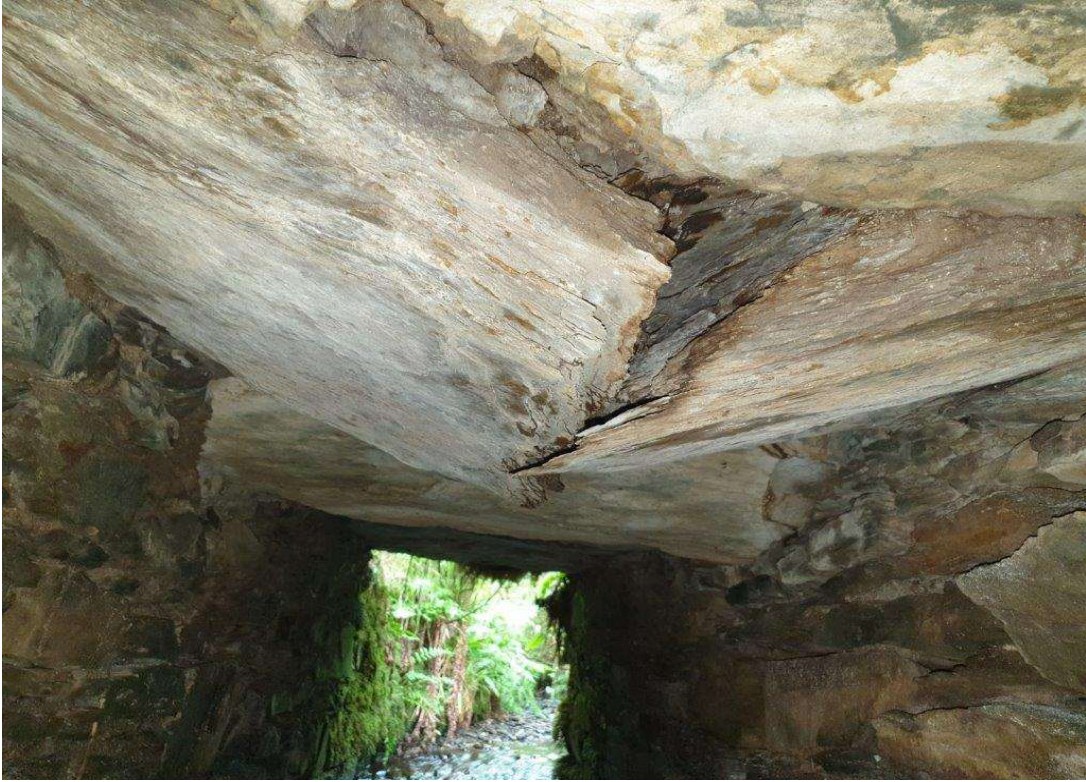
Soffit of bridge deck - viewed from D/S. Collapsed Flagstone (north span)

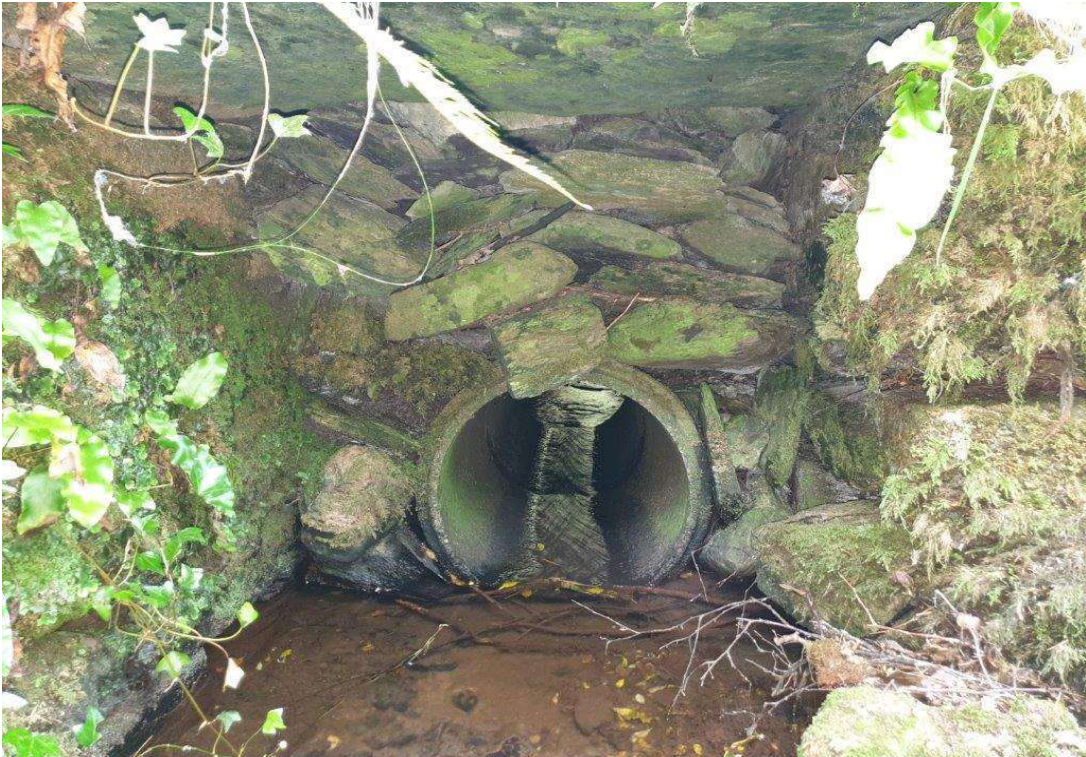
Repair to existing culvert with a 450mm concrete drainage pipe (south span).

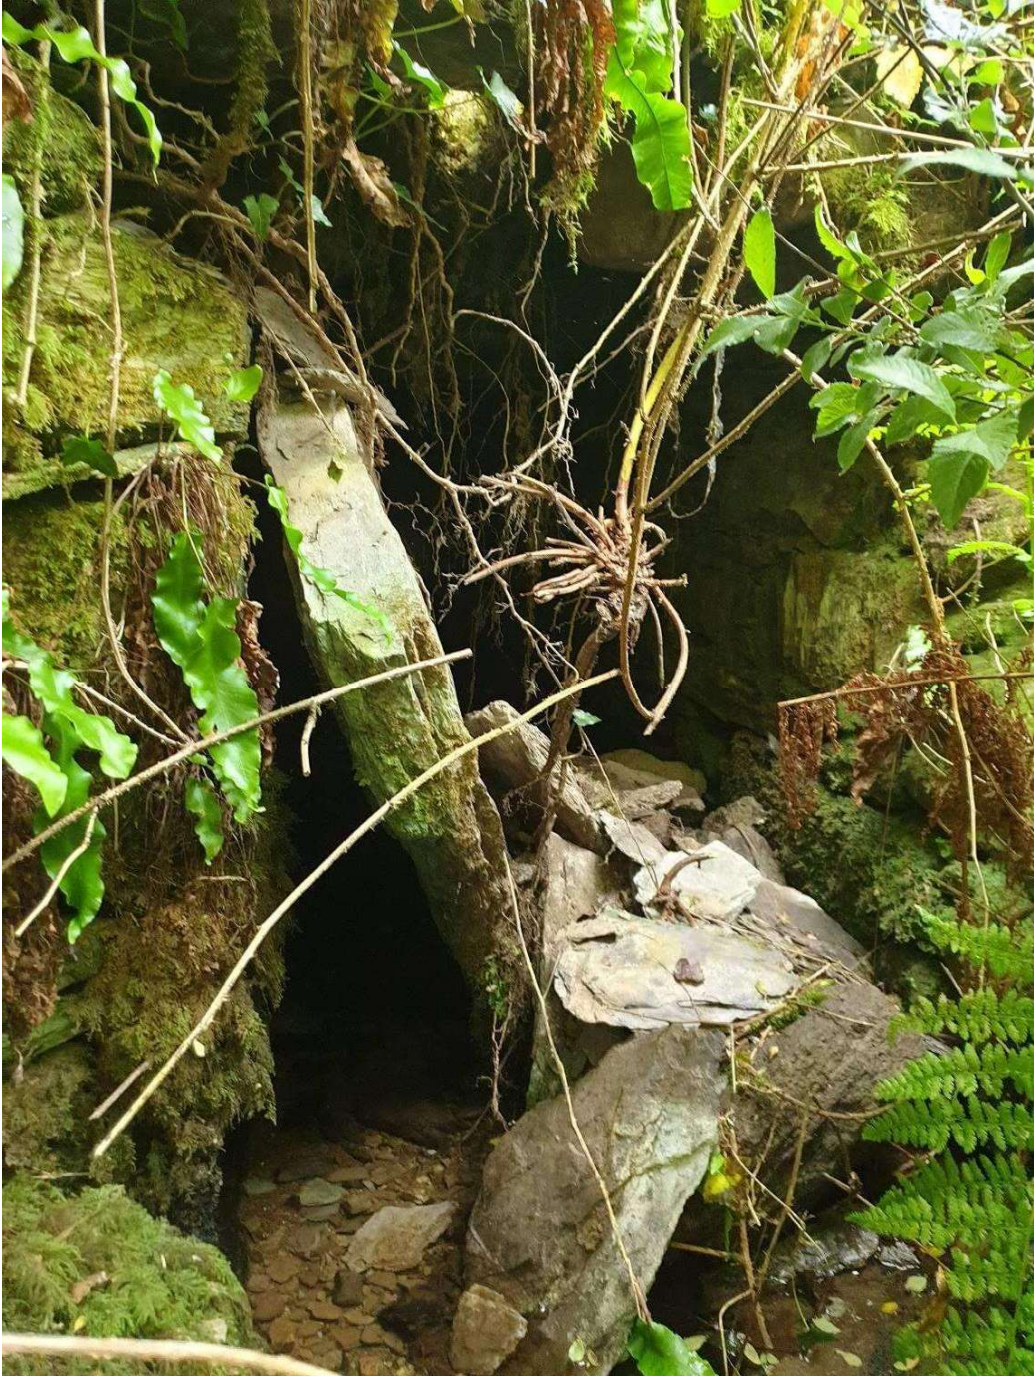
Collapsed stones at the west end of the south span

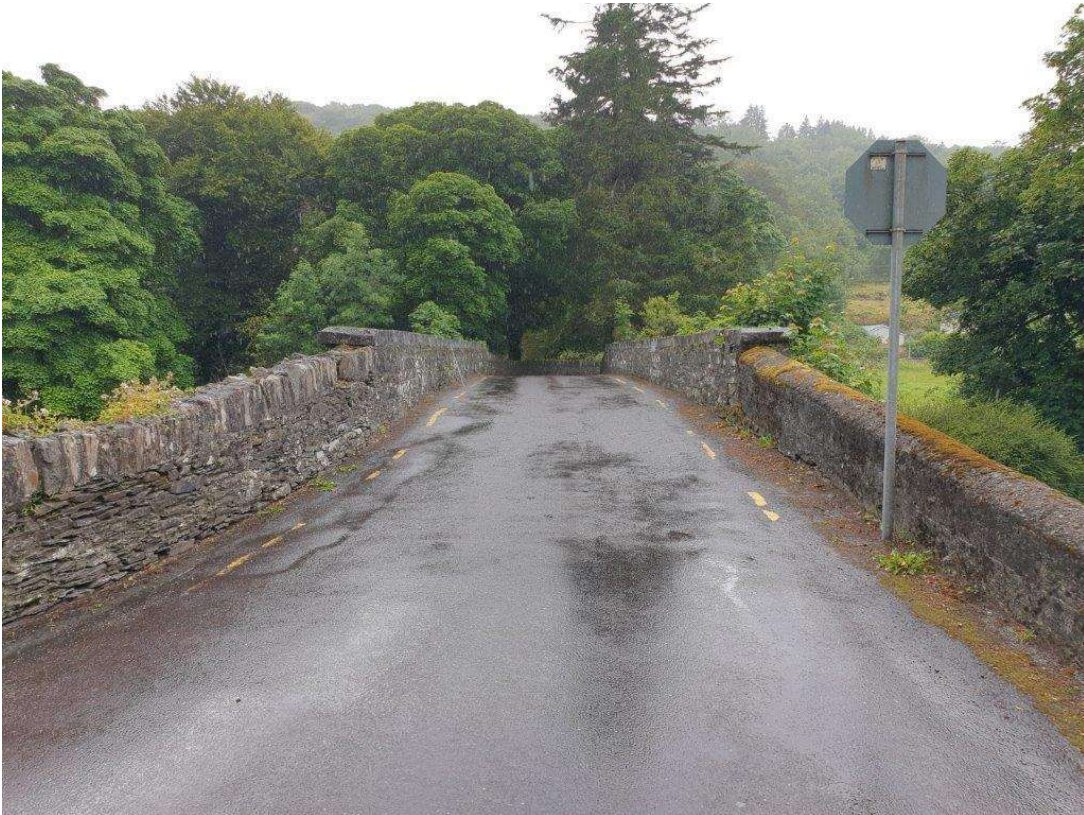
Road surface showing wear, abrasion and some rutting

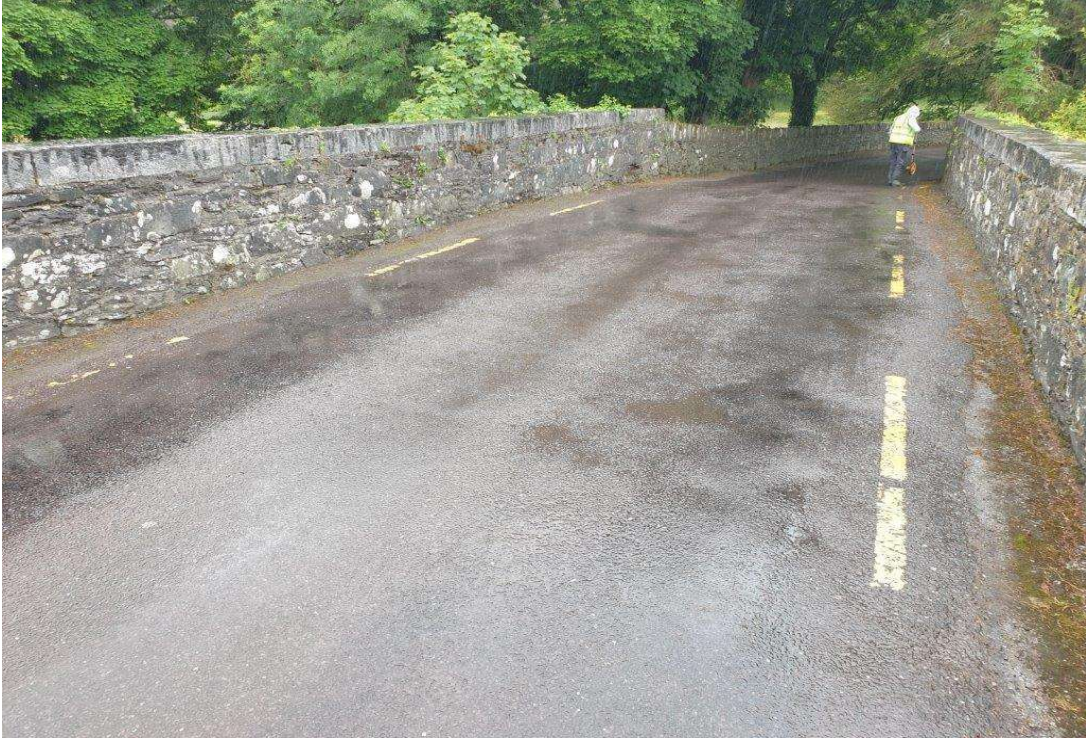
Road surface showing wear, abrasion and some rutting

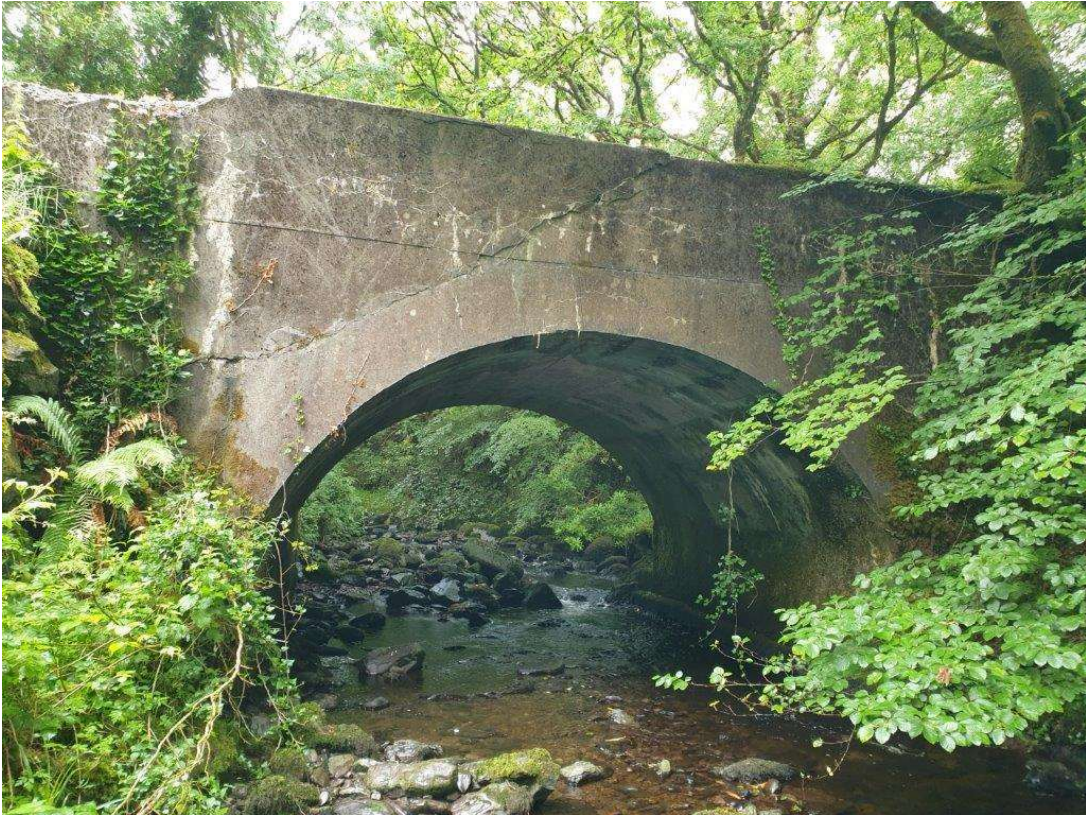
General view of the south elevation, note damage to parapet and west spandrel

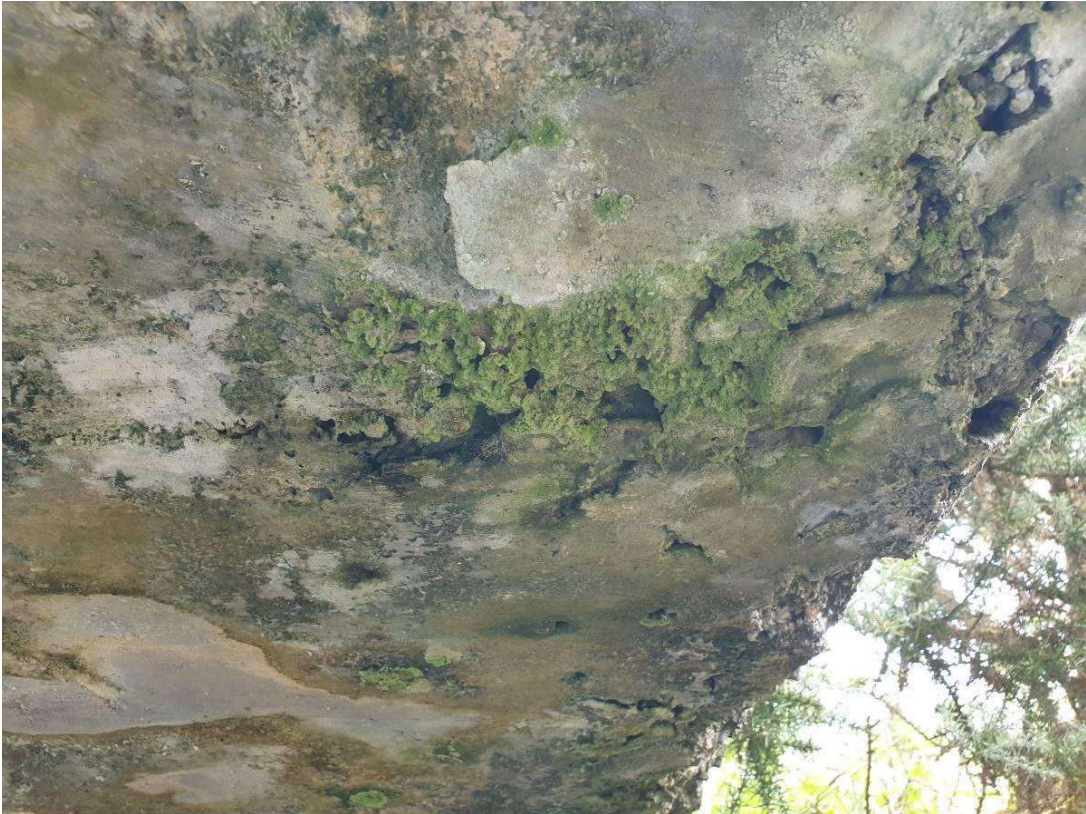
Local scaling of the soffit of the bridge deck

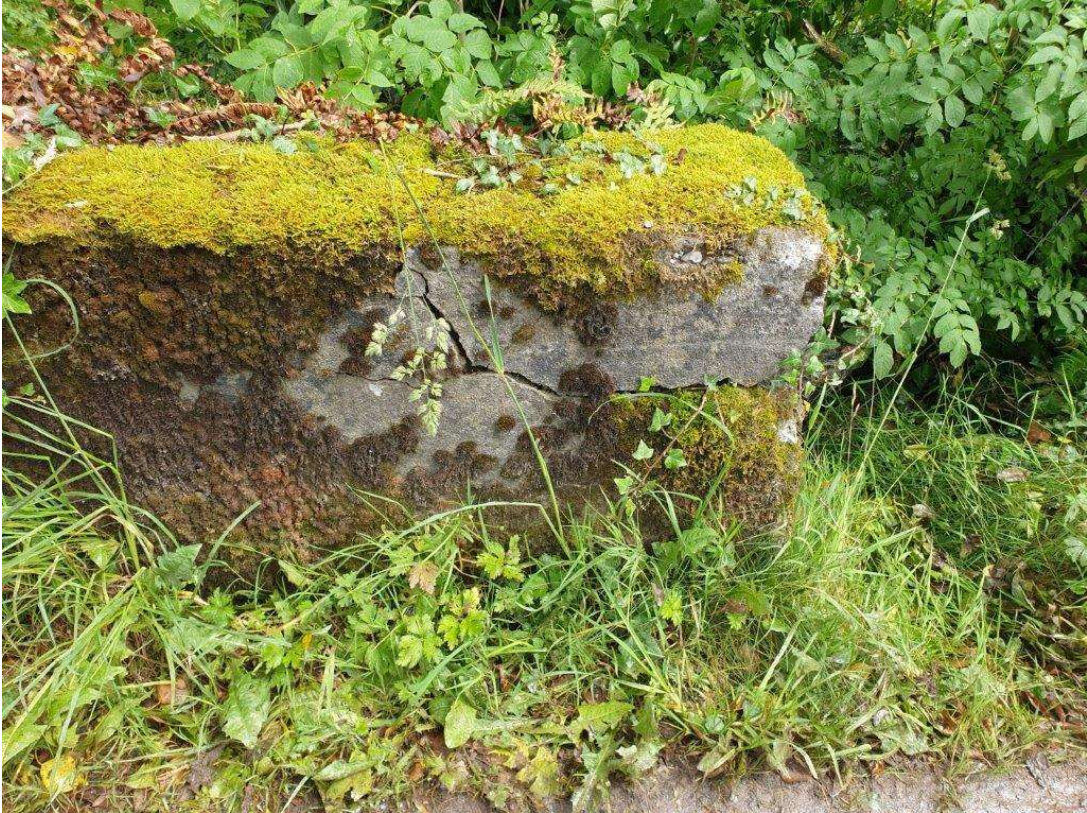
Local damage to the west parapet

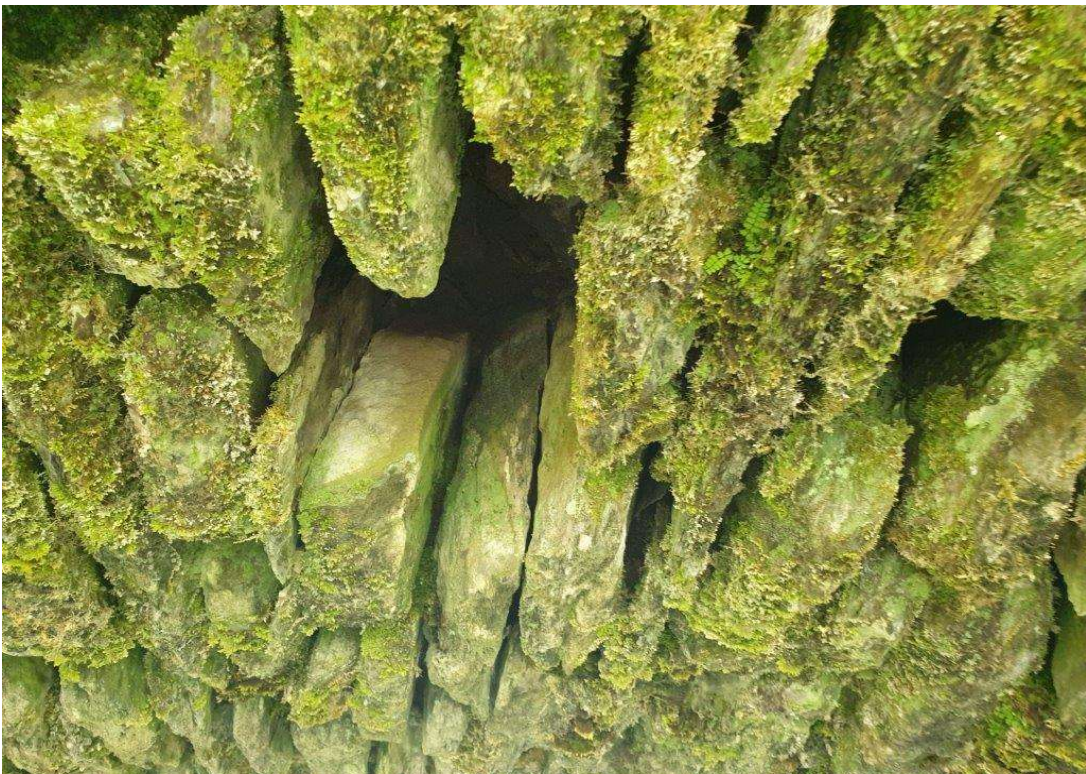
Dropped / missing stones in the arch barrel towards the north face of the bridge

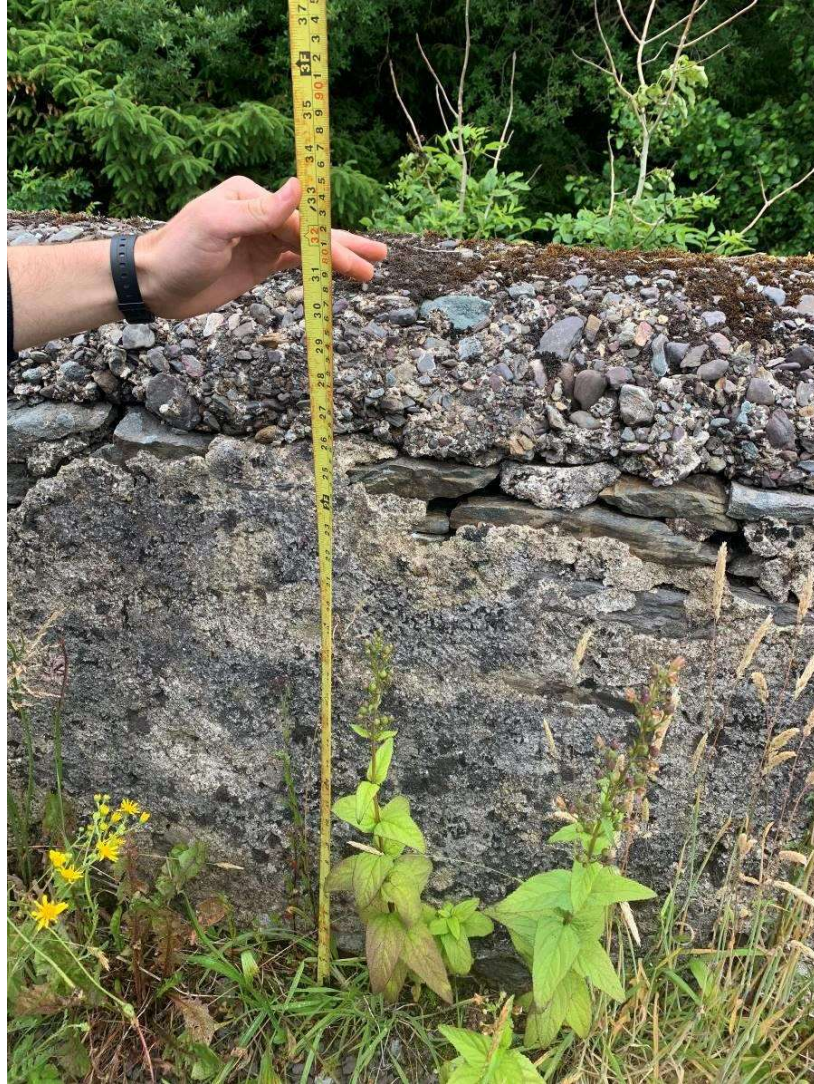
Parapet with concrete coping and repairs, open joints in exposed masonry

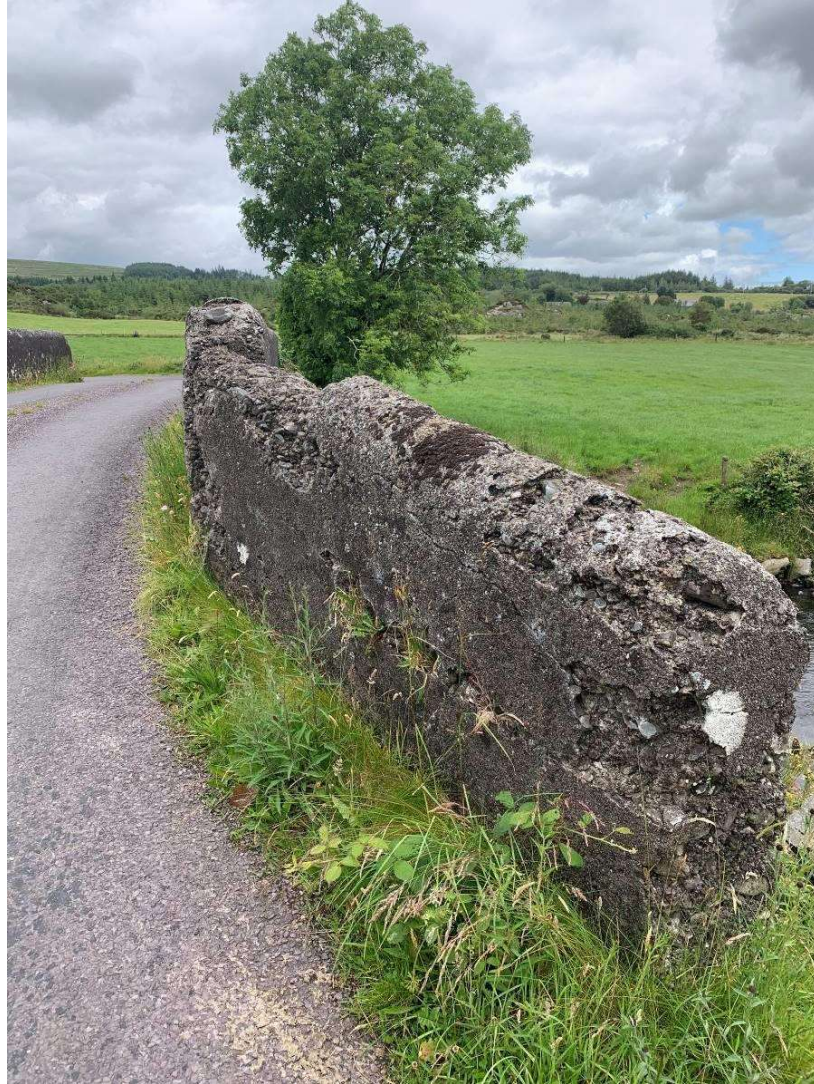
Close up of parapet showing concrete damage

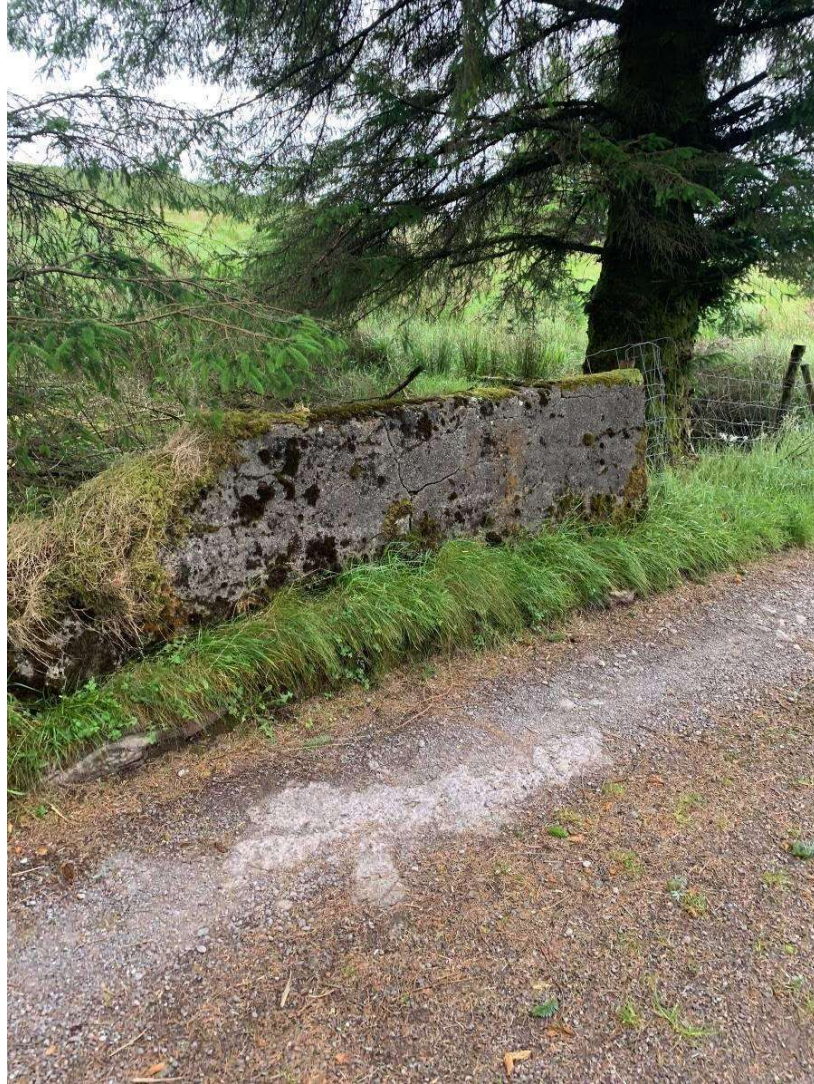
Upstream parapet with knocked section and structural cracking

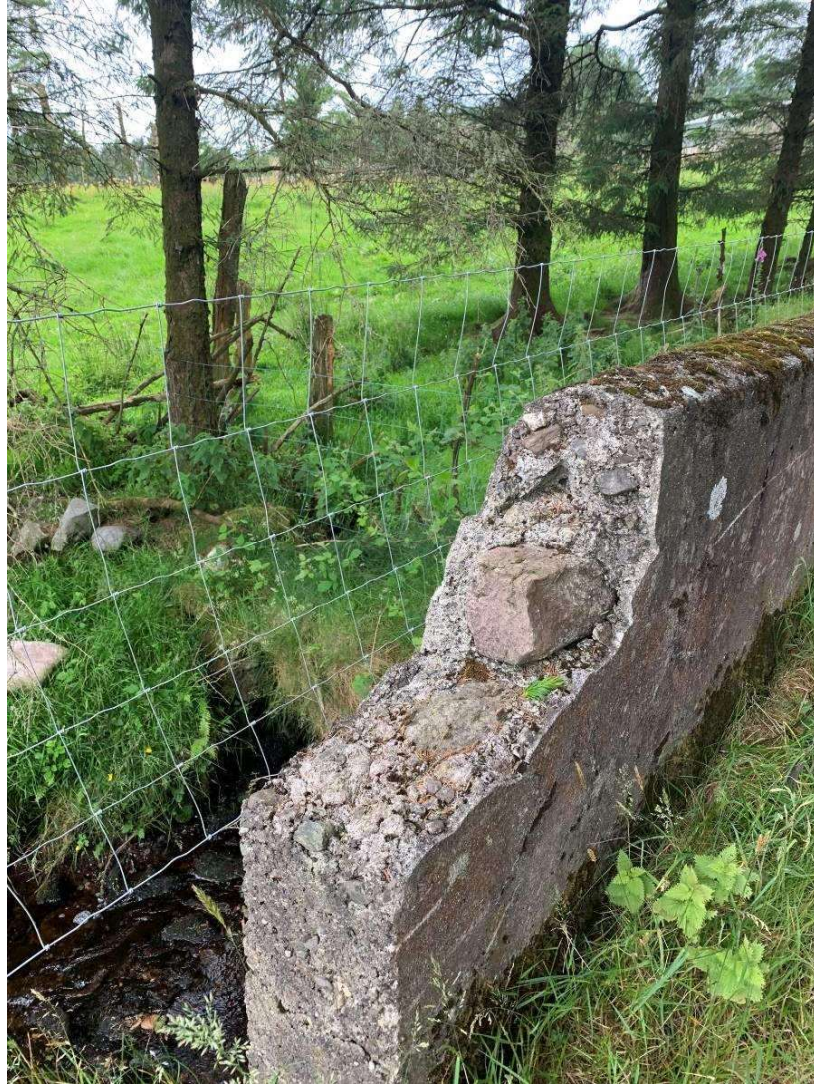
Knocked section of the downstream parapet
