Primary Route Assessment - Gortyrähilly Wind Farm, County Cork

Tuesday, 25 February 2020

Prepared For Coillte

21 Locations Assessed

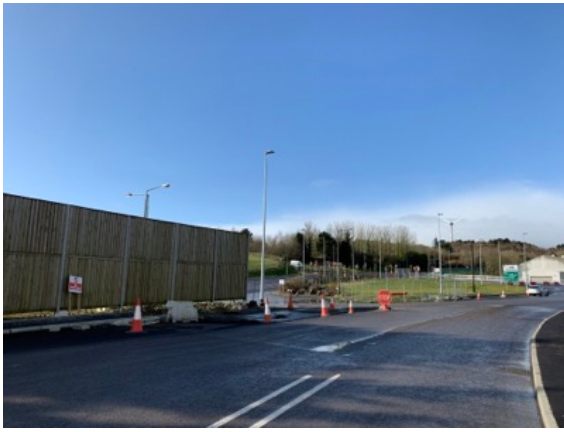
Location 1 - Exit 1 At Ringaskiddy Port Onto N28
Direction Turn Right At Junction
Visual inspection indicates that road widening is required on offside of junction up to the anchor platform.

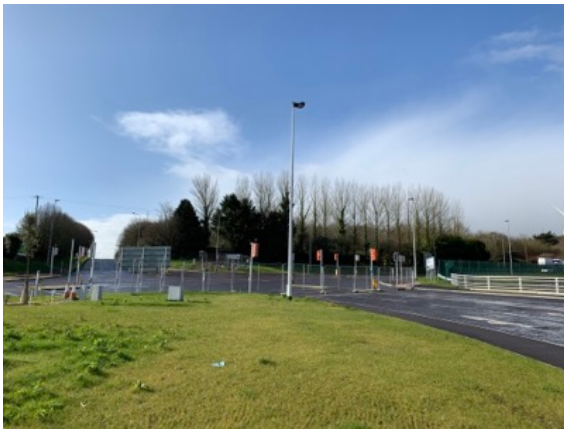
Location 2 - Exit 2 At Ringaskiddy Port Onto N28
Direction Turn Right At Junction
Visual inspection indicates that traffic lights on junction will be required to be removed.

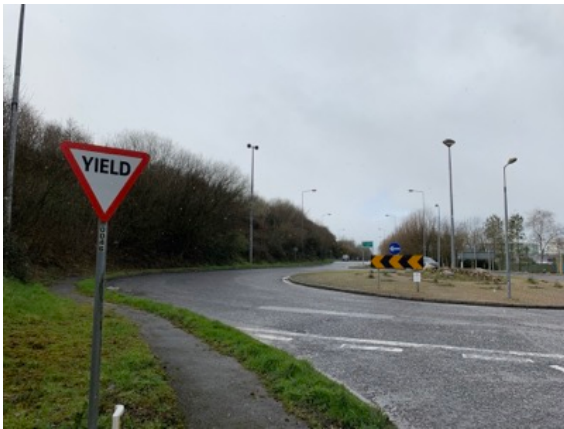
Location 3 - N28/Unclassified Road Roundabout
Direction Take 1st Exit At The Roundabout
Visual inspection indicates that road widening on central island is required.

Road sign on central island and exit splitter island to be removed.

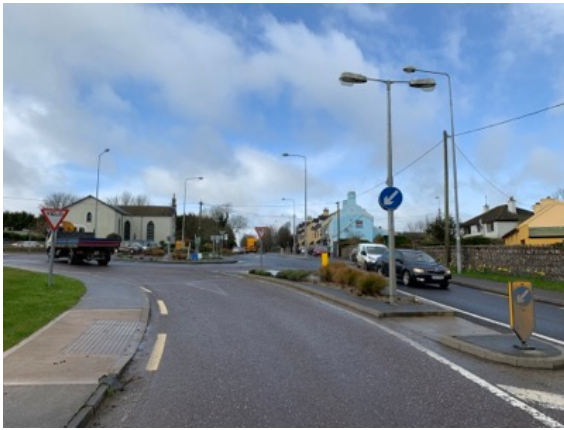
Location 4 - N28/Marian Terrace/L2492

Visual inspection indicates that road widening is required on entry splitter island.

Splitter island after roundabout to be removed.

Road sign on entry splitter island to be removed.

Loaded blade component is required to contraflow the roundabout to reduce modifications.

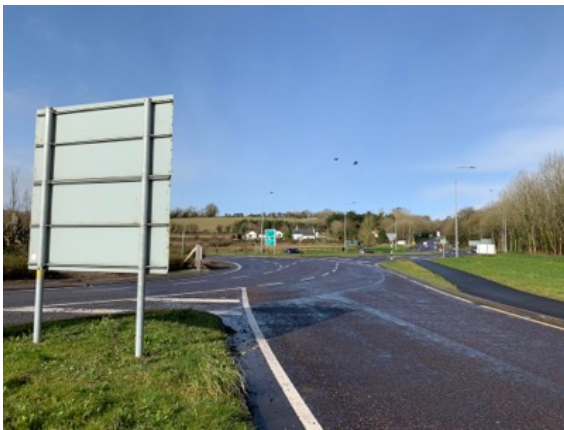
Location 5 - N28/R611 Roundabout

Visual inspection indicates that road sign on offside is to be removed.

Loaded blade component is required to contraflow the roundabout to reduce modifications.

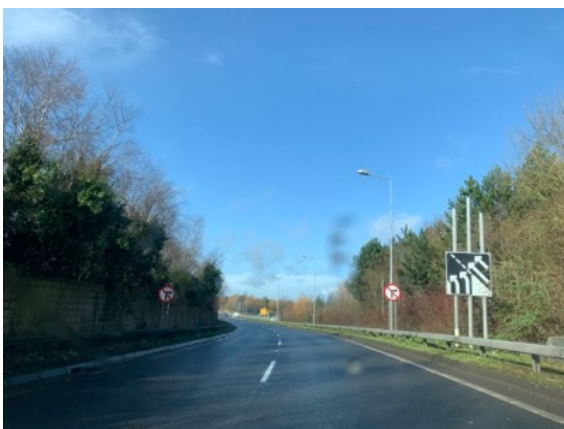
Location 6 - N28/N40 Slip Road

Visual inspection indicates that loaded blade will navigate this junction without issue.

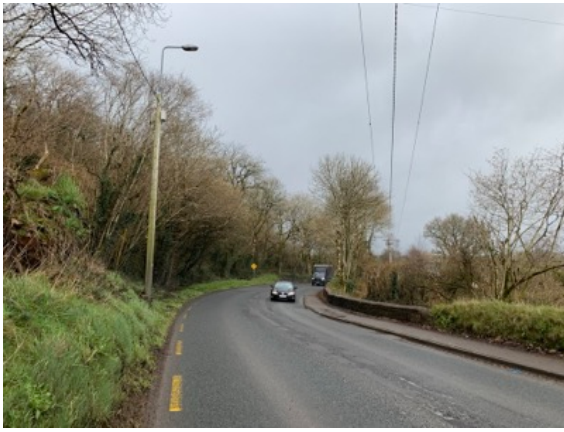
Location 7 - Right Hand Bend Prior To R618

Visual inspection indicates that manual steering is required.

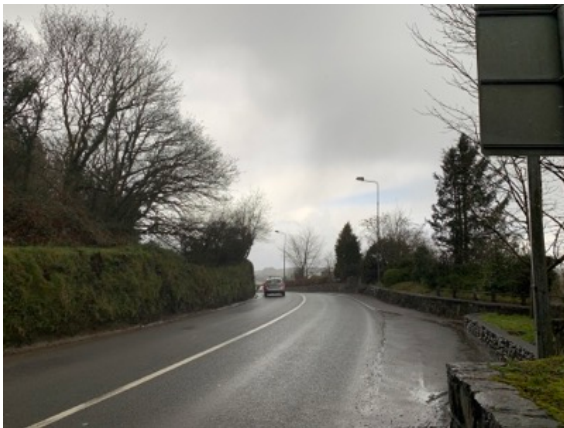
Location 8 - Left Hand Bend After R618

Visual inspection indicates that manual steering is required.

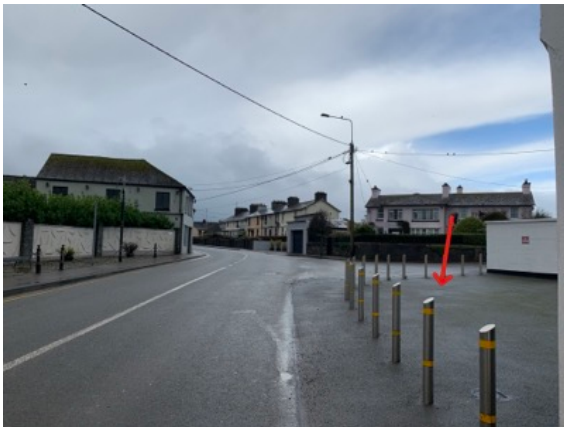
Location 9 - Left Bend On N22 After Oakwood In Macroom

Visual inspection indicates that further investigation is required at this location.

Swept Path Analysis is recommended on topographical survey data to determine whether the blade component can navigate.

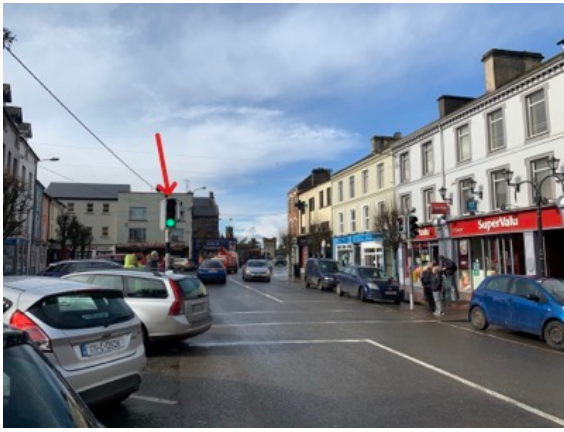
Location 10 - Right Hand Bend In Macroom At Drapery Store

Visual inspection indicates that further investigation is required at this location.

Swept Path Analysis is recommended on topographical survey data to determine whether the blade component can navigate.

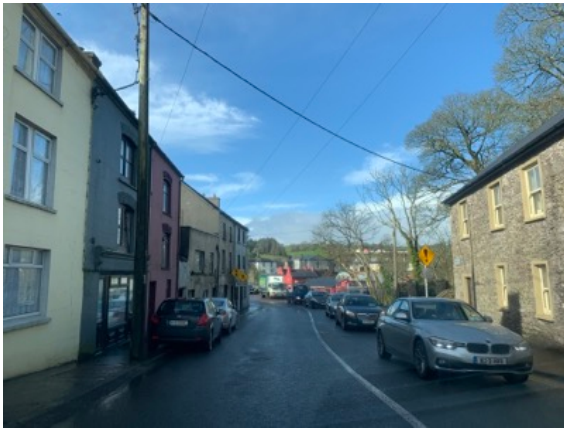
Location 11 - Left Bend On N22 Before Bridge In Macroom

Visual inspection indicates that further investigation is required at this location.

Swept Path Analysis is recommended on topographical survey data to determine whether the blade component can navigate.

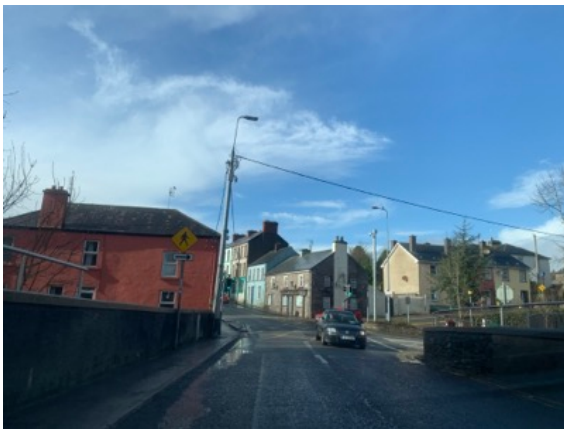
Location 12 - Left Hand Bend Exiting The Bridge In Macroom

Visual inspection indicates that further investigation is required at this location.

Swept Path Analysis is recommended on topographical survey data to determine whether the blade component can navigate.

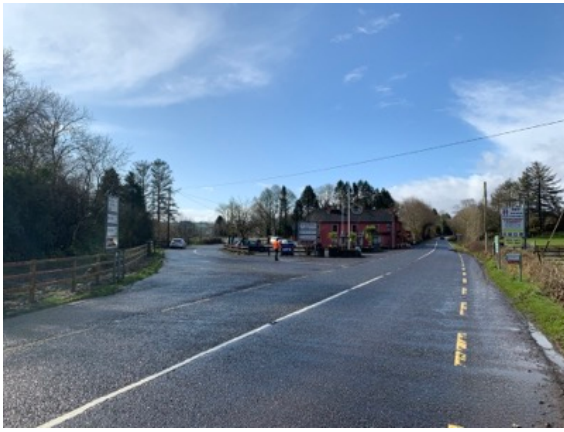
Location 13 - N22/L3402 Junction

Visual inspection indicates that loaded blade will oversail third party land.

Fence and road sign on nearside to be removed.

Swept Path Analysis recommended.

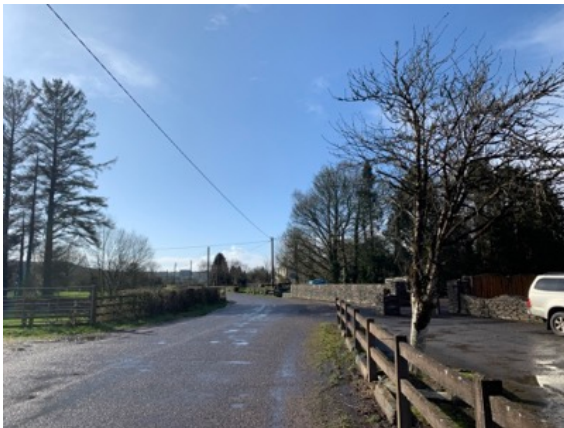
Location 14 - Left Hand Bend On L3402

Visual inspection indicates that rear projection of blade will oversail third party land on offside to avoid telegraph pole on nearside.

Trees in third party land to be removed.

Swept Path Analysis recommended.

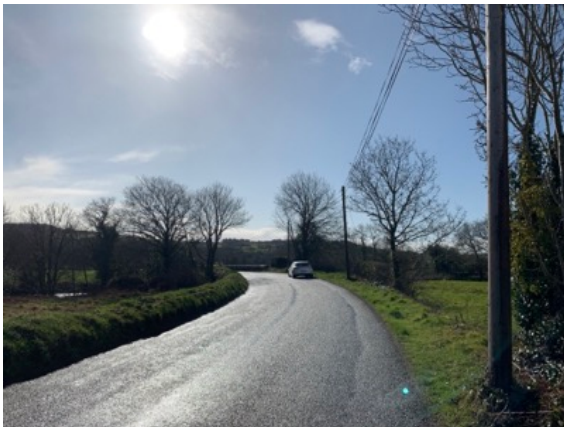
Location 15 - Left Hand Bend Prior To Bridge On L3402

Visual inspection indicates that trailer body will oversail third party land on nearside.

Trailer may be required to be raised to avoid colliding with bridge parapet on nearside.

Manual steering will be required to exit the bridge.

Swept Path Analysis recommended.

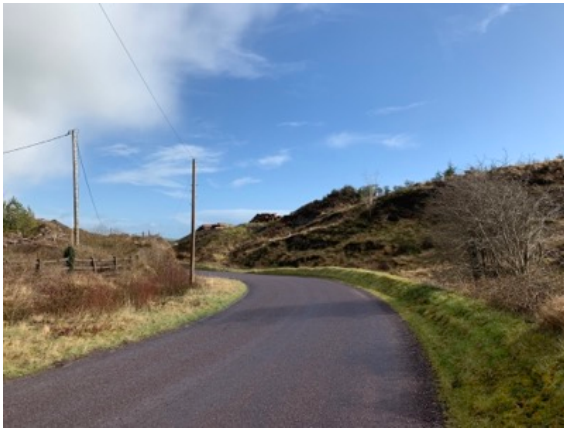
Location 16 - Right Hand Bend Of S Bend On L3402

Visual inspection indicates that telegraph pole on offside will be required to be removed.

Swept Path Analysis recommended.

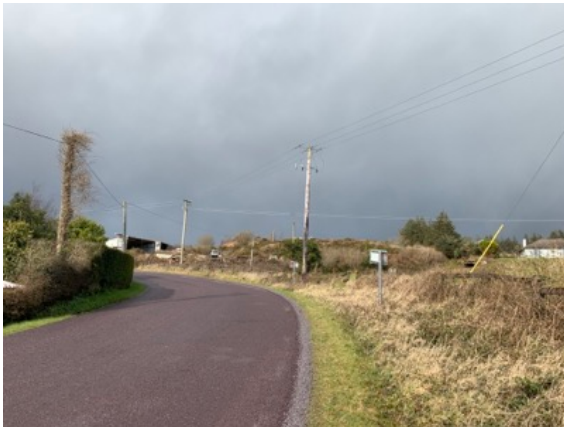
Location 17 - Left Hand Bend Of S Bend On L3402

Visual inspection indicates that road widening is required on offside to avoid third party land on the nearside.

Rear projection of blade to oversail third party land on offside.

Swept path analysis is required at this location on topographical data.

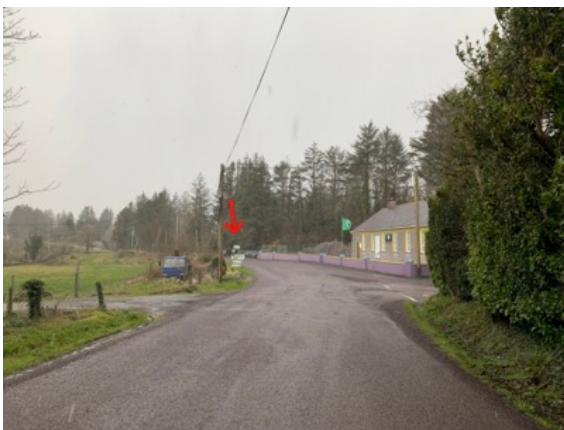
Location 18 - Left Hand Bend At School On L3402

Visual inspection indicates that road sign on nearside to be removed.

Manual steering will be required.

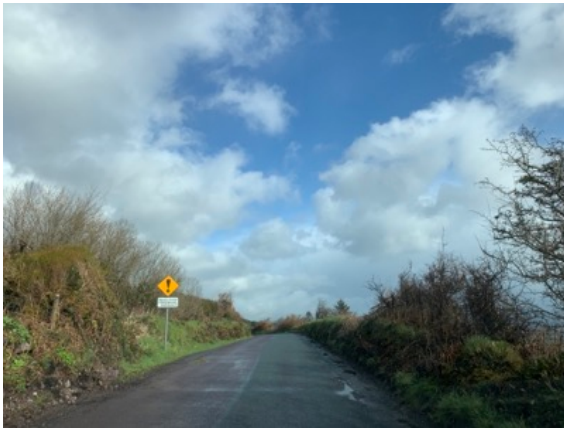
Location 20 - Right Hand Bend On L3402

Visual inspection indicates that manual steering will be required.
