## Primary Route Assessment - Port Of Foynes / Gortyrahilly

343154

Wednesday, 23 September 2020

Prepared For Coillte

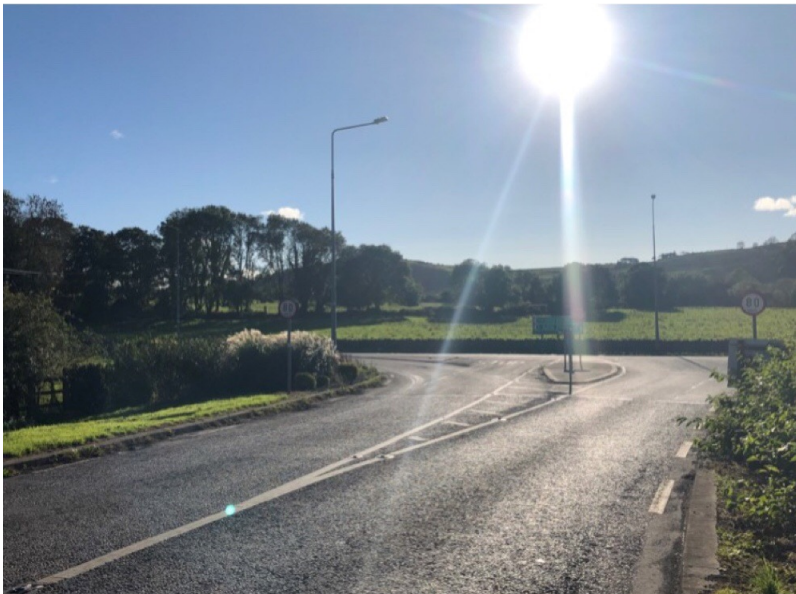
#### Location 1 - Port Exit

Visual inspection indicates that the Loaded blade is required to Contraflow the security gate house.

Swept path analysis recommended to confirm.

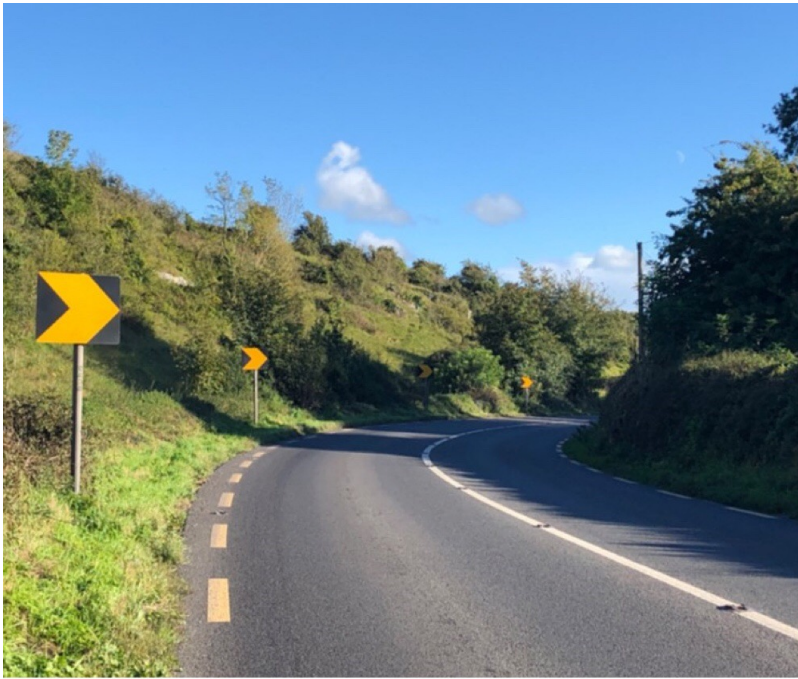
#### Location 2 - Exit From Port Of Foynes/N16 Junction

Visual inspection indicates that third party land will be required on the nearside.

Modifications to street furniture will be required

Walls and hedges to be removed.

Swept path analysis recommended to confirm.

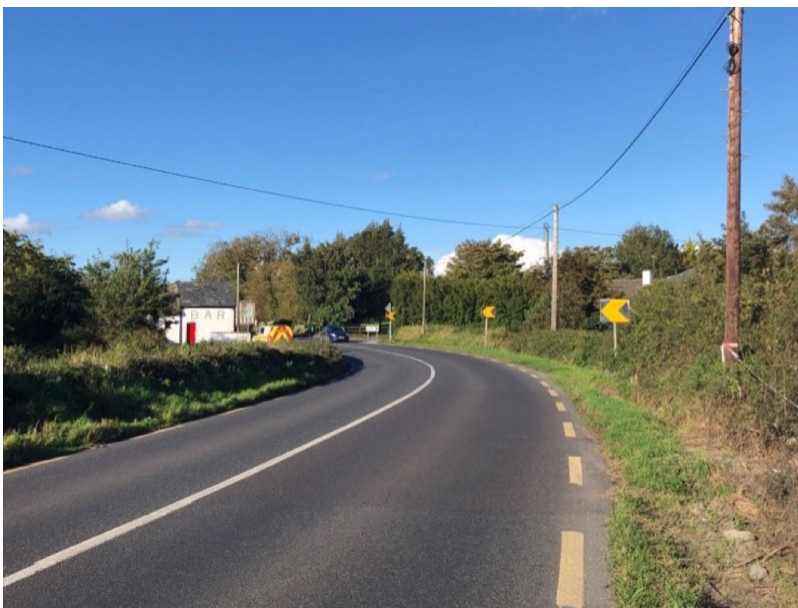
Location 3- S Bend At Whitehouse  
On N69

Visual inspection indicates manual steering is required to avoid modifications.

Swept path analysis  
recommended to confirm

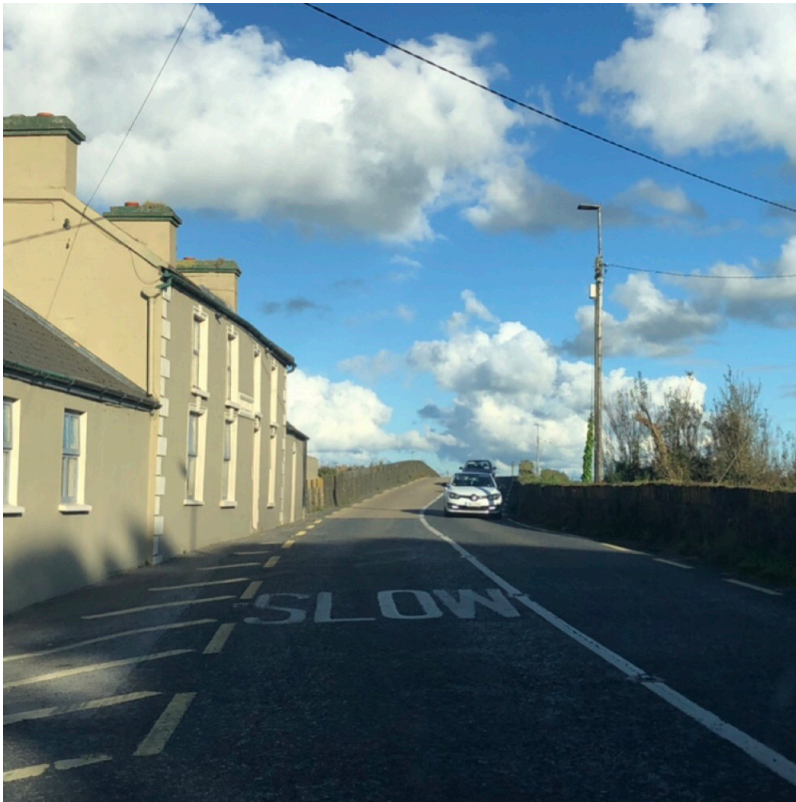
Location 4 - Left Bend On N69 At  
Junction With L6062

Option 1- Visual inspection indicates loaded blade will oversail third party land on nearside. Wall on nearside may be required to be removed.

Option 2 - Road signs, hedges and possible telegraph pole required to be removed offside to allow rear projection of blade to oversail.

Swept path analysis  
recommended to confirm

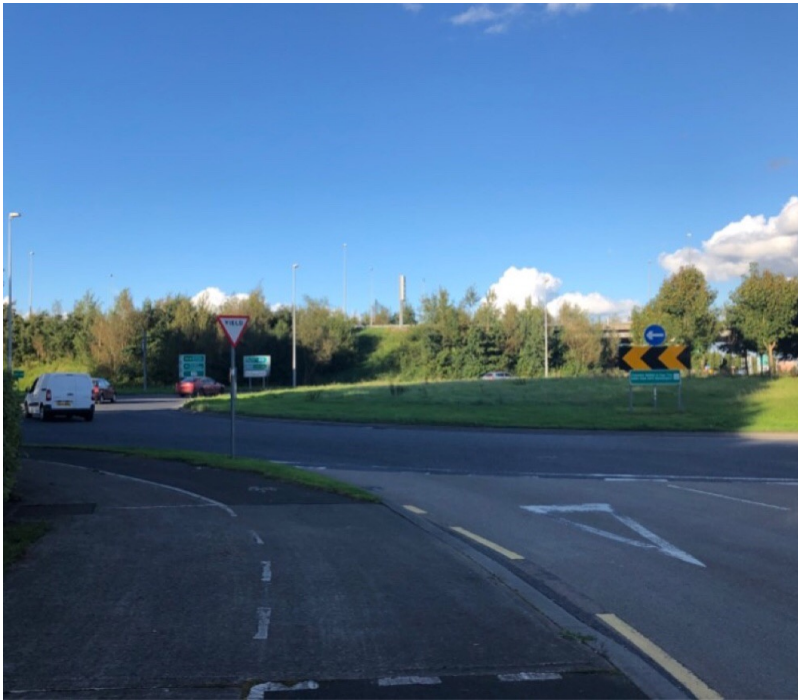
#### Location 6 - N69 Roundabout At Clarina

Visual inspection indicates that widening is required on the on central island of roundabout and street furniture to be removed at this location. This is to avoid third party land.

Swept path analysis recommended to confirm modifications

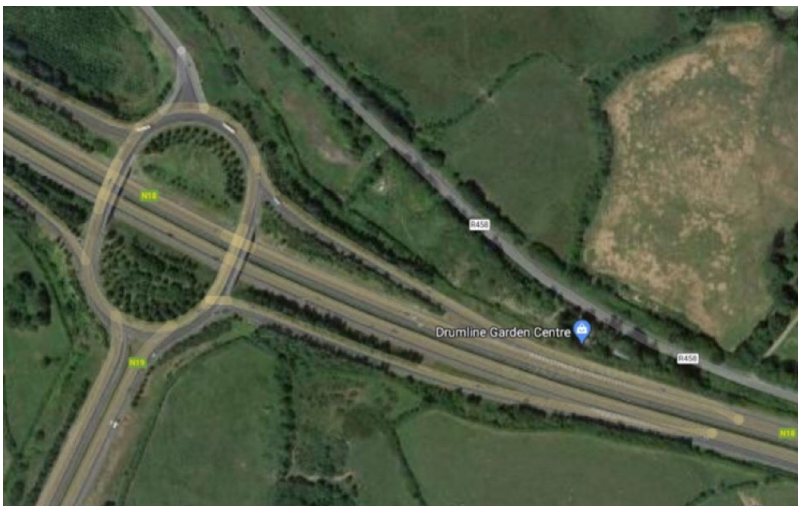
#### Location 7 - N69/N18 Roundabout

Visual inspection indicates that road widening on central island is required.

Road signs on central island also to be removed

Swept path analysis recommended to confirm

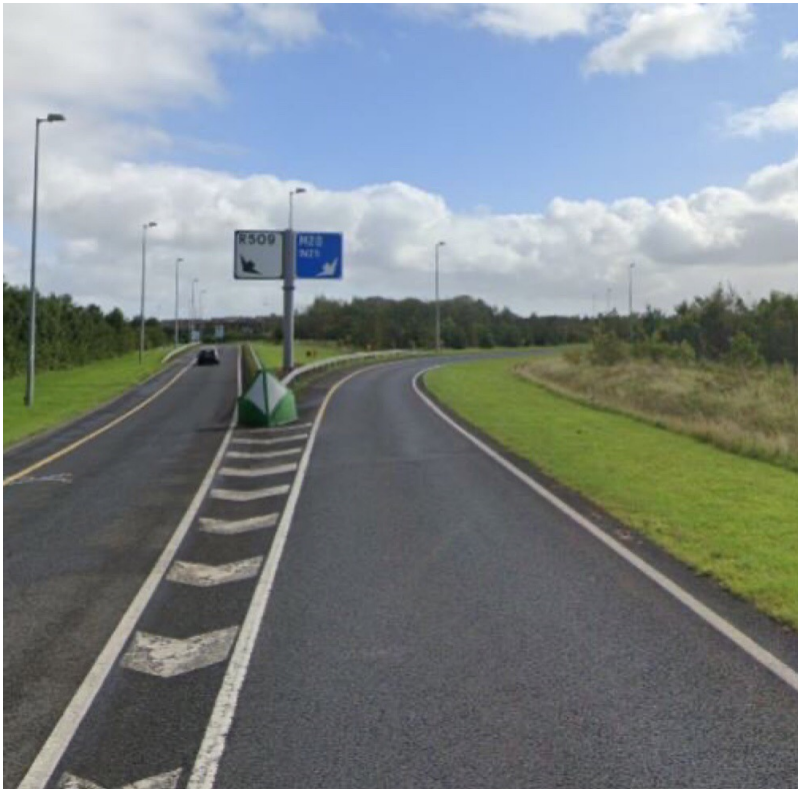
#### Location 8 - N18/N19 Roundabout

Visual inspection indicates modifications to street furniture will be required.

Swept path analysis required to determine the extend of the modifications

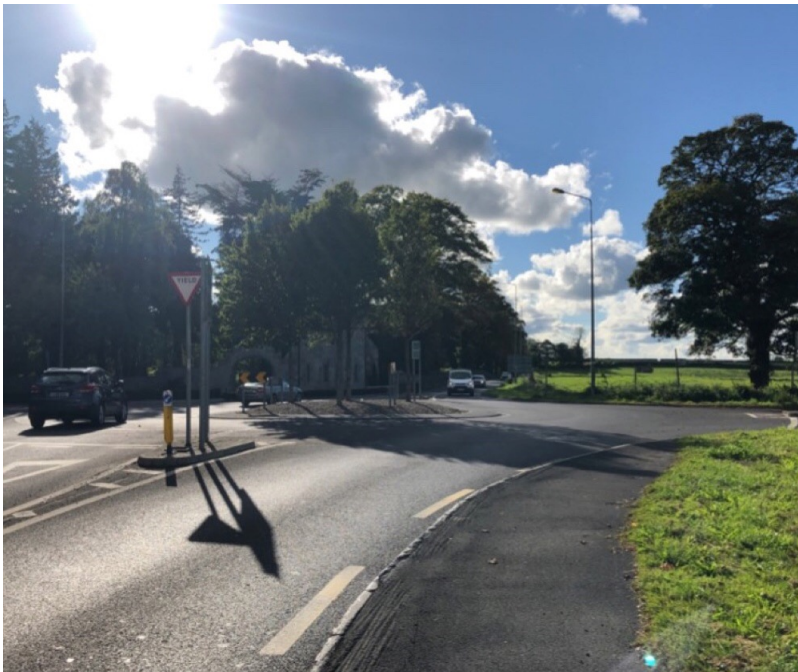
Location 9 - N18/M20 Junction  
 Direction Turn Right Onto M20  
 Visual inspection indicates that  
 loaded blade component will  
 navigate with no issue

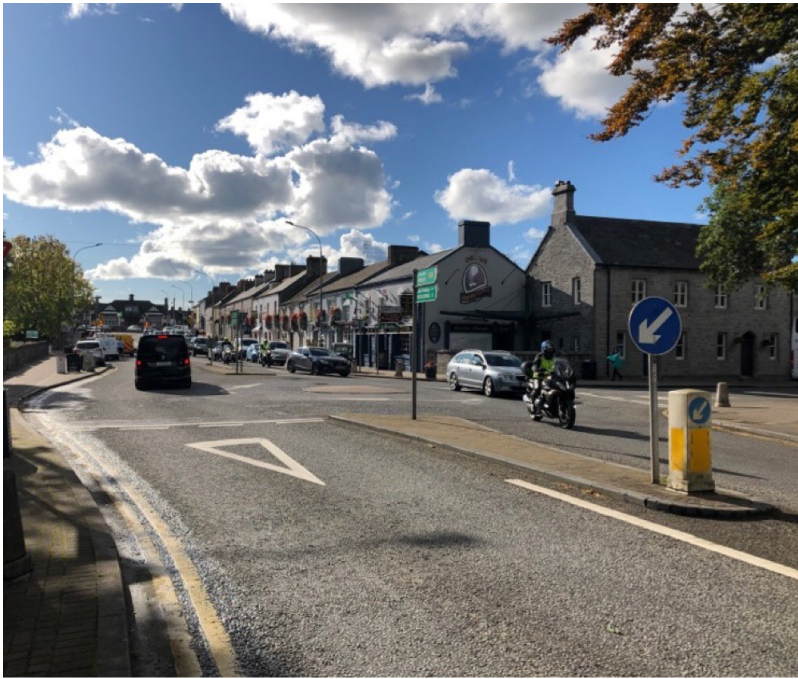
Location 10 - N21 L1420 L1424  
 Roundabout  
 Direction Continue Straight On  
 N21  
 Visual inspection indicates Road  
 widening required on offside of  
 entering and exit of the  
 roundabout  
 Swept path analysis  
 recommended to confirm this

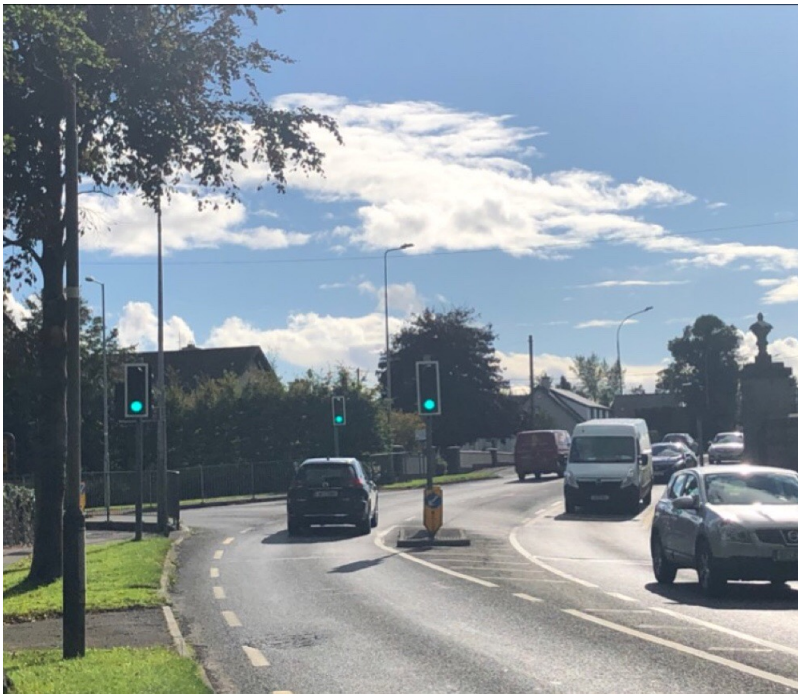
Location 13 - Left Bend On N21 At  
Junction With L1422 In Adare  
Direction Continue On N21

Parking restrictions on both side of  
the road  
Lamp posts and road signs  
required to be removed  
Topographical survey is required  
throughout Adare to ascertain  
accurate mapping data

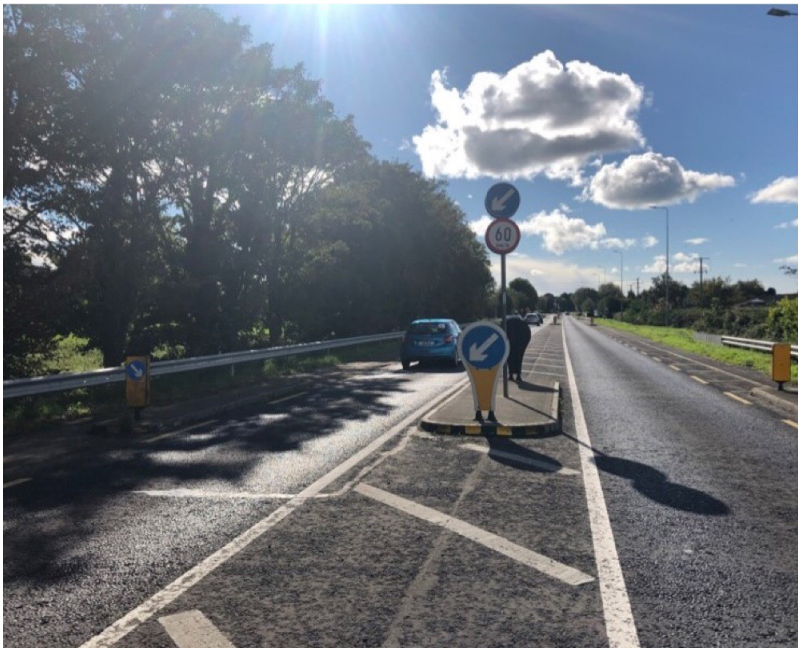
Location 15 - N21 Splitter Island At Entrance To Croagh

Visual inspection indicates there being no issues at this location

Nearside kerb road sign on splitter - 4.7m

Bollard to bollard - 5.0m

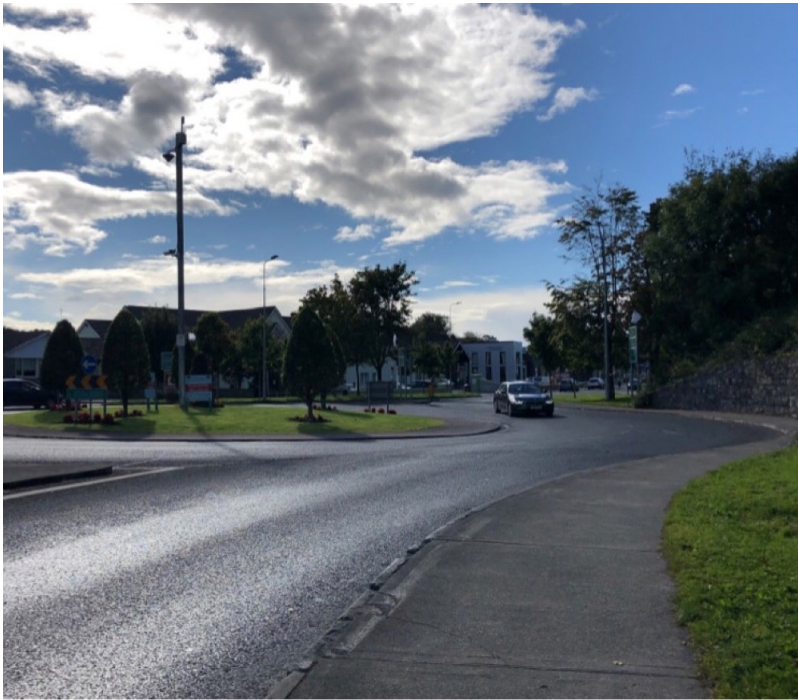
Location 18 - N21 Splitter Island At Entry To Newcastle West

Visual inspection indicates that the removable road sign may be required to be removed.

4.1m from nearside Splitter Kerb to road signs on lamppost. 4.5m to lamppost

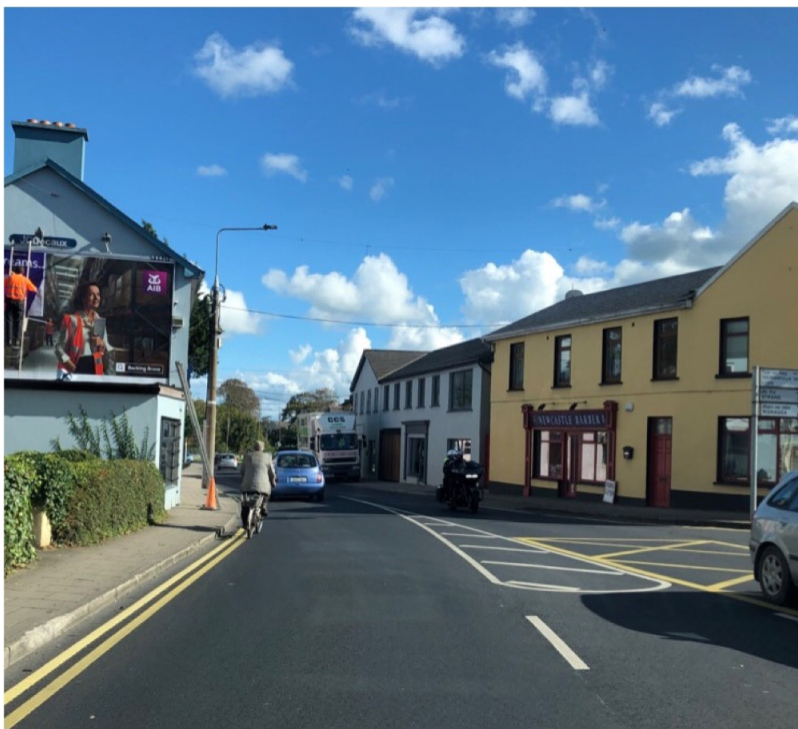
Location 19 - N21/R522

Visual inspection indicates that a  
contraflow manoeuvre is required  
at this location

Loaded vehicle to run on hard  
standing area of roundabout

Tree and road sign on offside of  
exit are to be removed

Swept path analysis required to  
determine extend of modifications

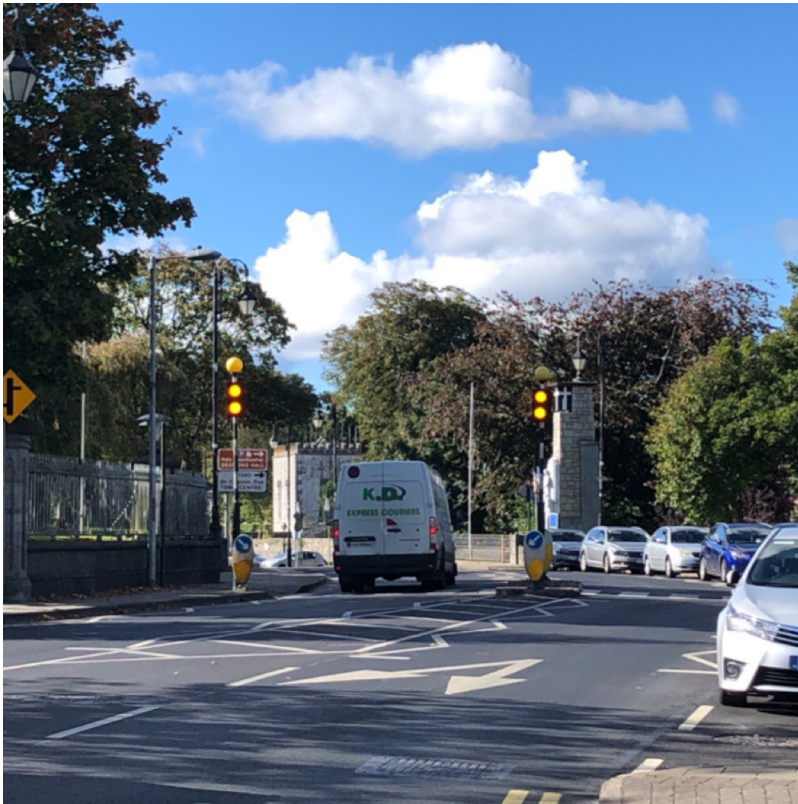
Location 20 - Newcastle West

Topographical survey is required  
throughout Newcastle west to  
ascertain accurate mapping data

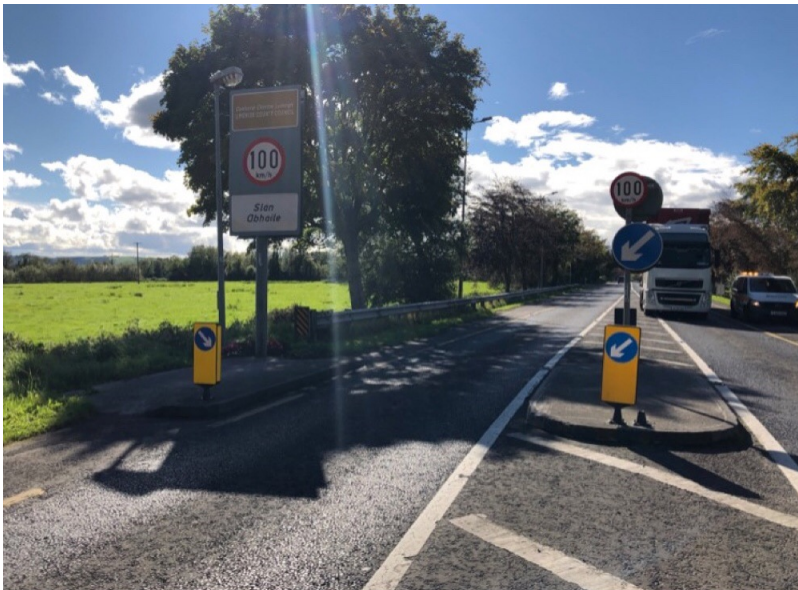
Location 21- Splitter islands On  
Left Bend In Newcastle West  
Direction Continue On N21  
Visual inspection indicates that  
street furniture on splitter island as  
well as the next to be removed  
due to blade and trailer oversail  
Swept path analysis  
recommended to determine the  
extent to the modifications.

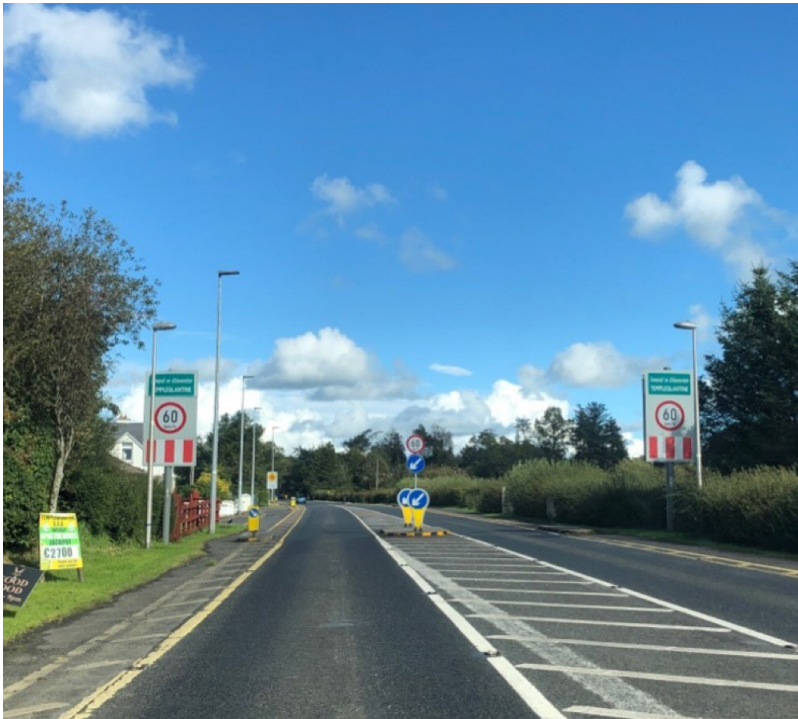
Location 24 - 4x Splitter Island On  
N21 At Templeglantine

Visual inspection indicates that loaded vehicle to contraflow splitter islands 1-3 to avoid modifications.

Splitter island 4 poses no issues

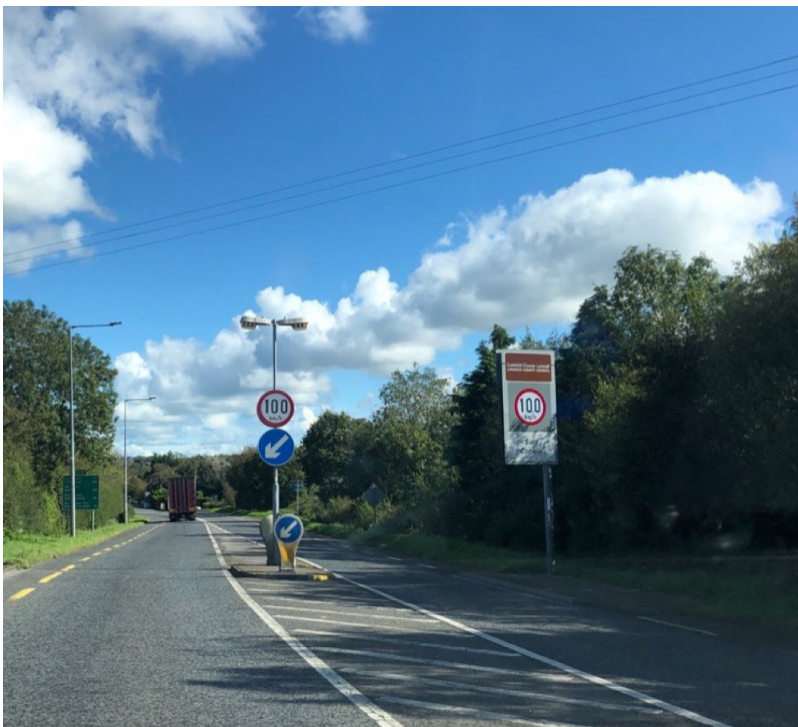
Location 25 - N21 Splitter Island At Exit From Templeglantine

Visual inspection indicates that road signs to be removed on splitter island due to blade chord. Road sign is removable - once a manufacturer has been chosen this should be re visited

Width measured at 4.1m from nearside kerb to road sign on splitter island.

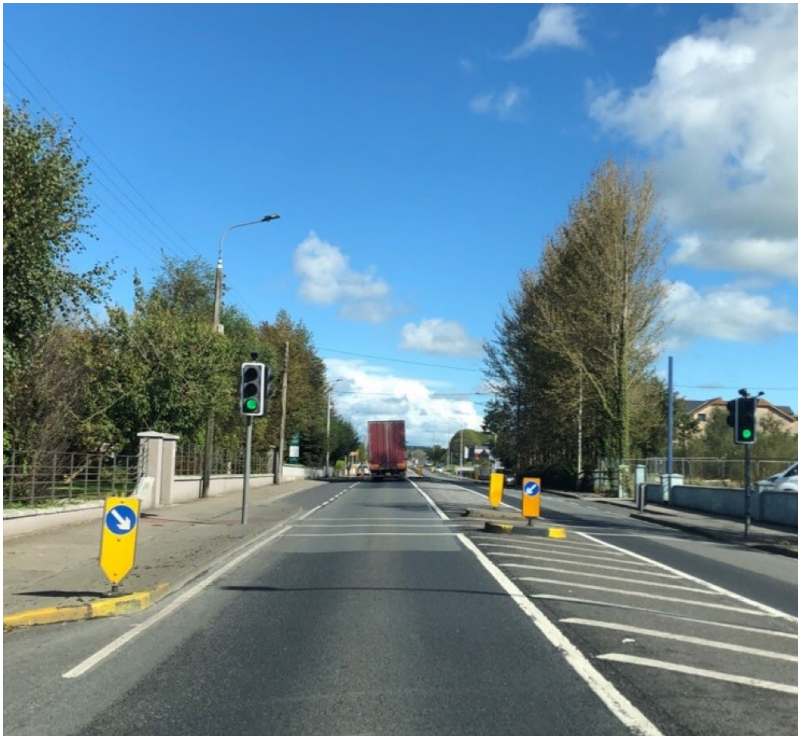
Location 26 - N21 Splitter Island At Entry To Abbeyfeale

Visual inspection indicates that there are no issues at this location

Width measured at 4.4m from nearside Kerb to road sign

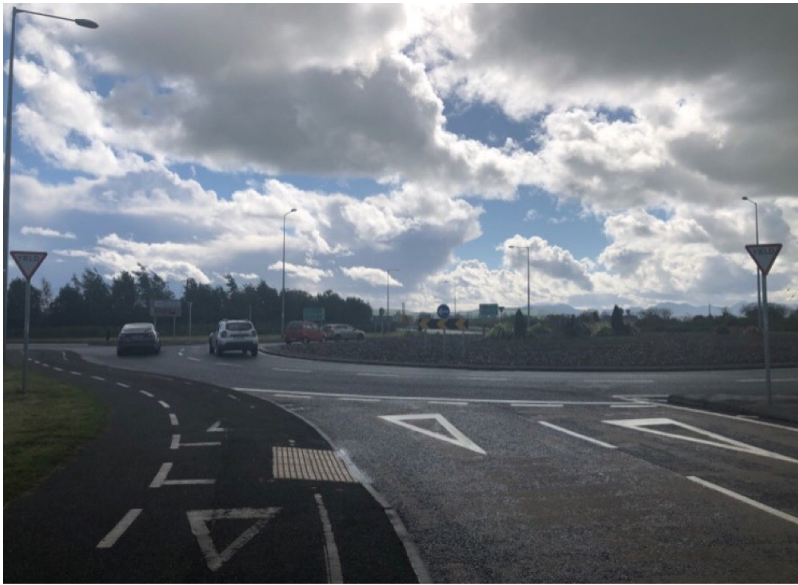
Location 30 - N21/L2041  
Roundabout

Visual inspection indicates that  
widening and street furniture  
removal is required on central  
island.

Swept path analysis  
recommended to confirm  
modifications

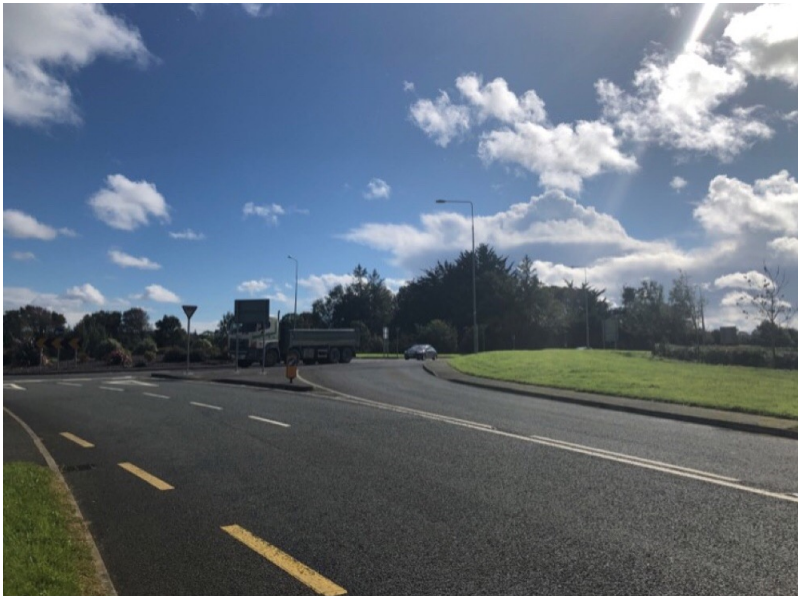
Location 31 - N21 R577 N23

Visual inspection indicates that widening and street furniture removal is required on central island.

Swept path analysis recommended to determine the extent of the modifications

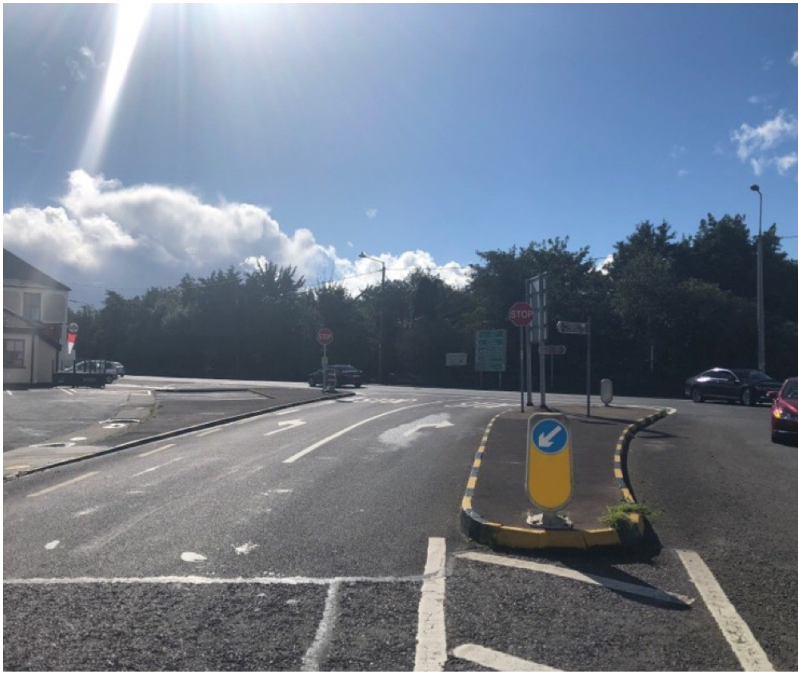
Location 32 - N23/L2040

Visual inspection indicates that road widening and lamp post removal is required on the offside of the roundabout.

Loaded blade is required to contraflow this roundabout.

Swept path analysis recommended to confirm

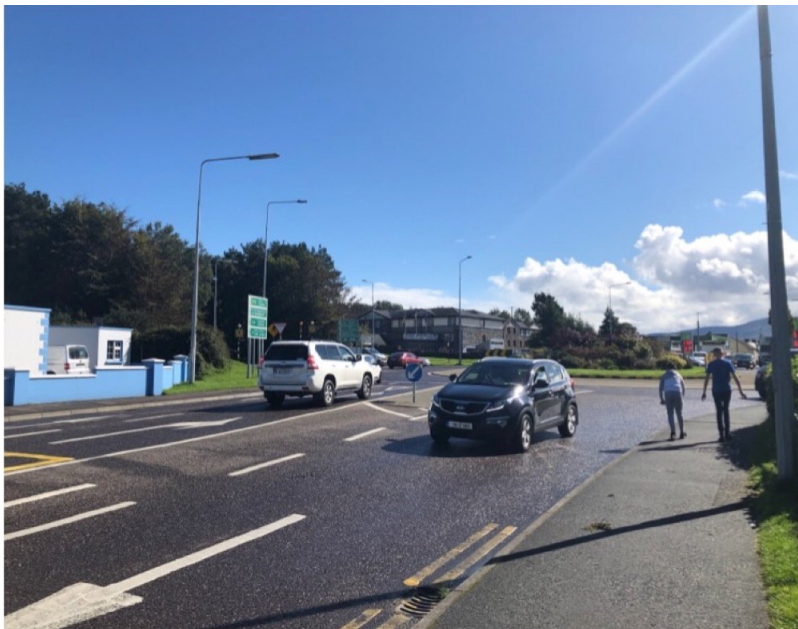
### Location 33 - N23 / N22 Junction

Visual inspection indicates that third party land is required on the nearside of the junction.

Stop sign on nearside to be removed

Swept path analysis recommended to confirm modifications

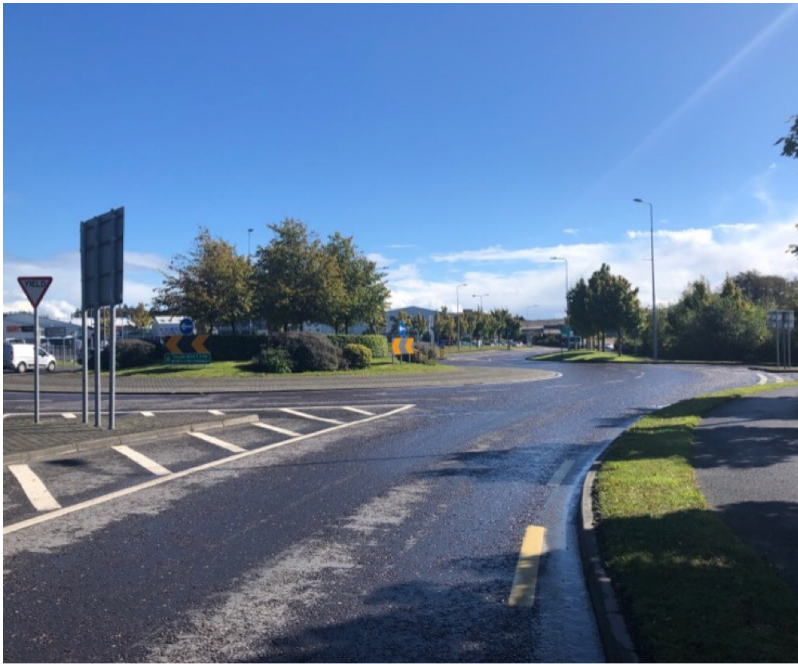
### Location 34 - N22/N71 Cleeny Roundabout

Visual inspection indicates that widening and lamp posts, traffic lights and road sign removal is required. Street furniture on both the entry and exit splitter islands is to be cleared to allow blade and trailer to oversail.

Rear projection of blade will oversail 3rd party land on offside of entrance to roundabout  
Swept path analysis recommended to confirm this.

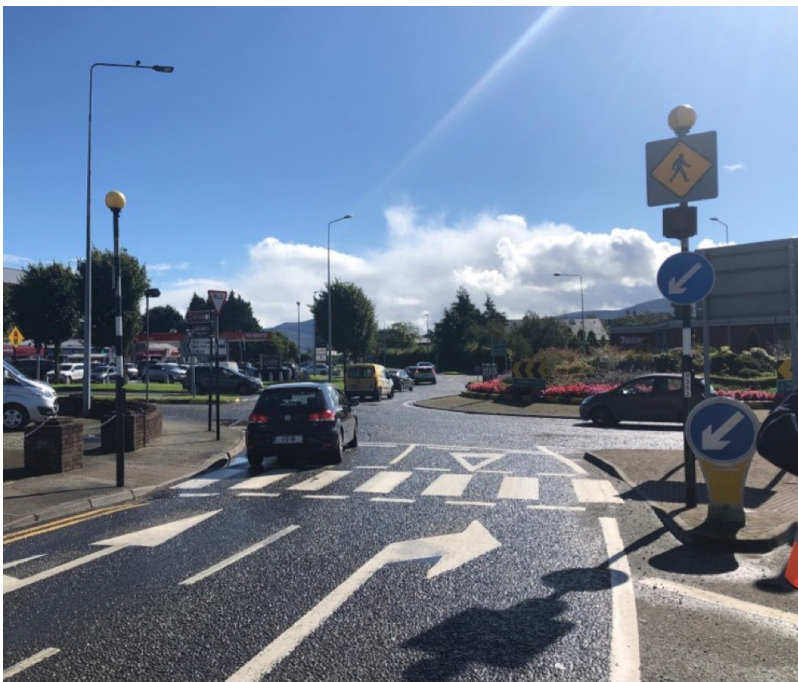
Location 35 - Micheal D'Oshea Roundabout

Visual inspection indicates that a contraflow manoeuvre is required at this roundabout.

Blade vehicles to run on central island hard standing

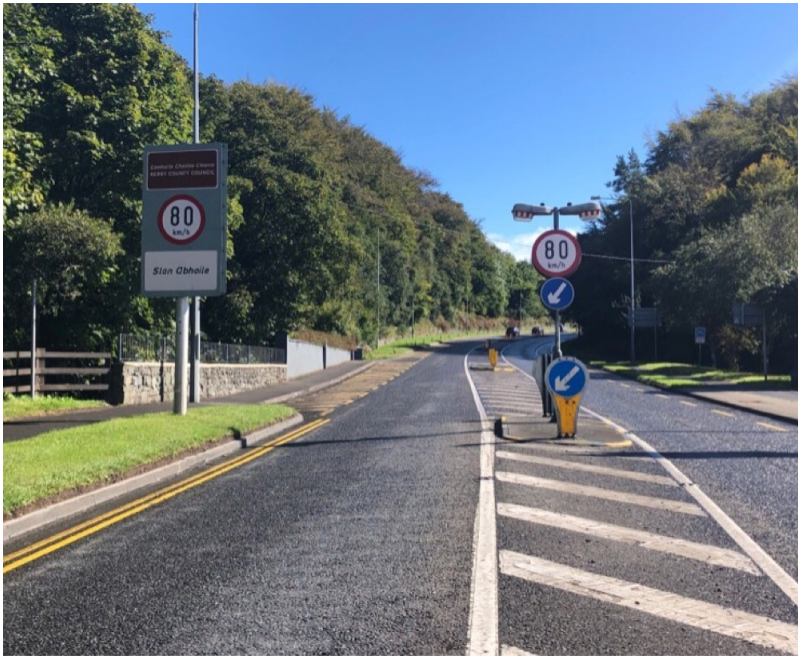
Location 36 - N22/L3010 Park Roundabout

Manual steering required- No issues at this location

Swept path analysis recommended to confirm

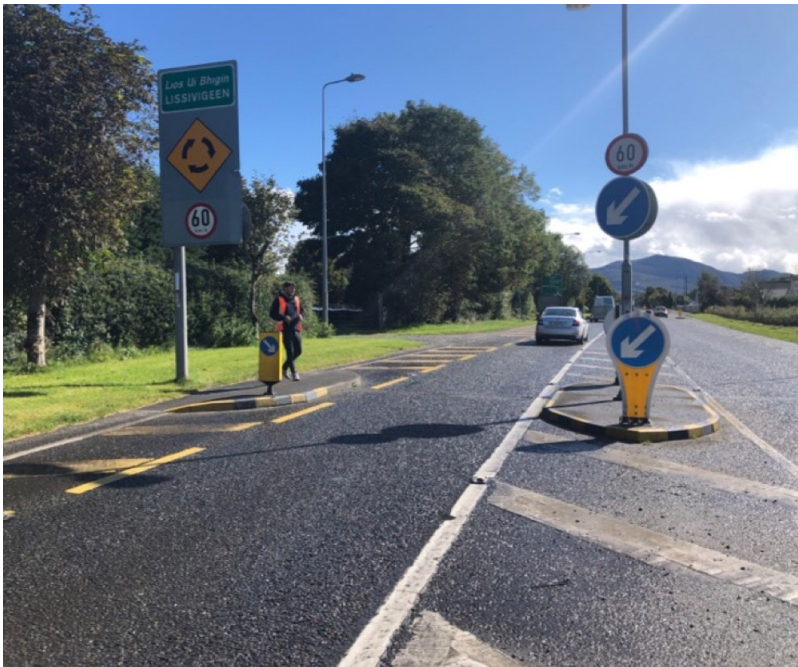
Location 37 - Splitter Island  
 Numerous After Roundabout  
 Direction Continue On N22  
 Visual inspection indicates that  
 loaded blade will navigate this  
 spiller island without issue  
 \*Note\*  
 Road width - 4.5

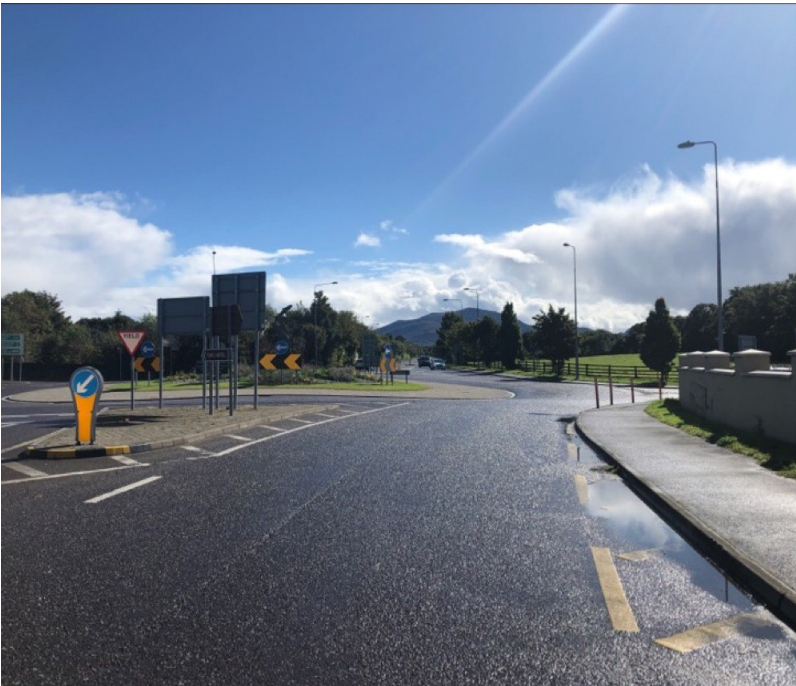
Location 39 - N22 Splitter Island In Lissivigeen

Visual inspection indicates that loaded blade will navigate through with no issues.

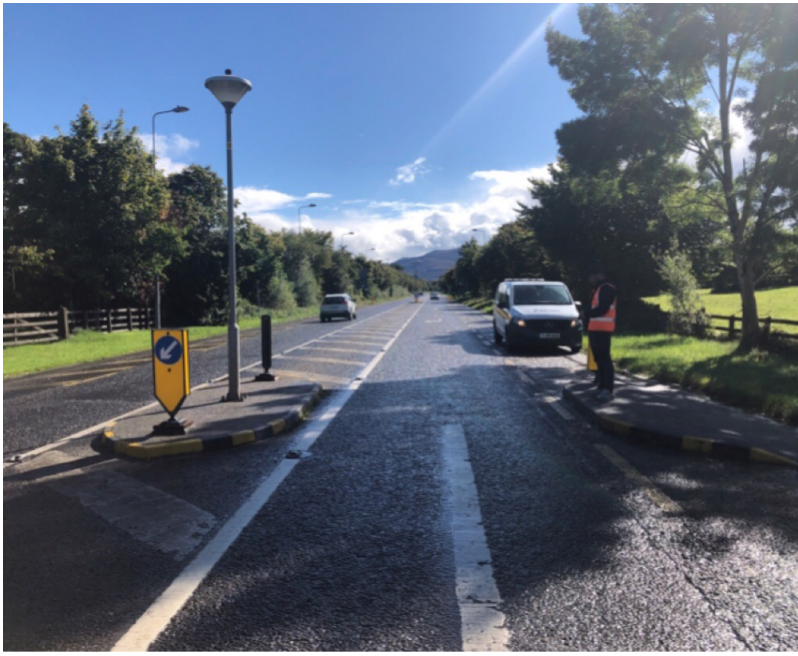
Location 40 - N22/N72

Visual inspection indicates that a Contraflow manoeuvre is required to allow navigation  
Swept path analysis recommended to confirm

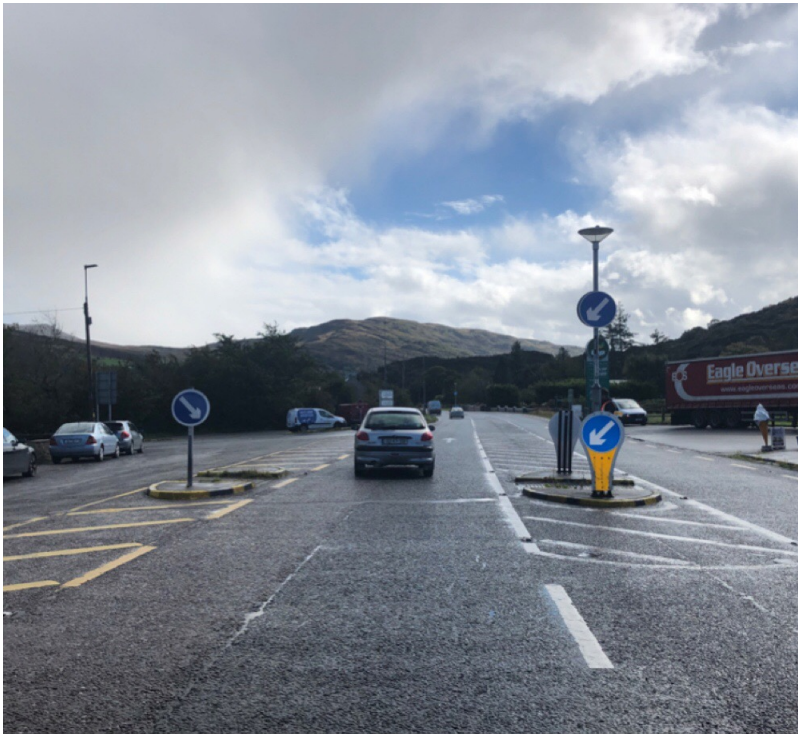
Location 42 - Lissivigeen Splitter Island Exit

Visual inspection indicates that loaded blade component will navigate through with no issues.

Road width - 5.0m

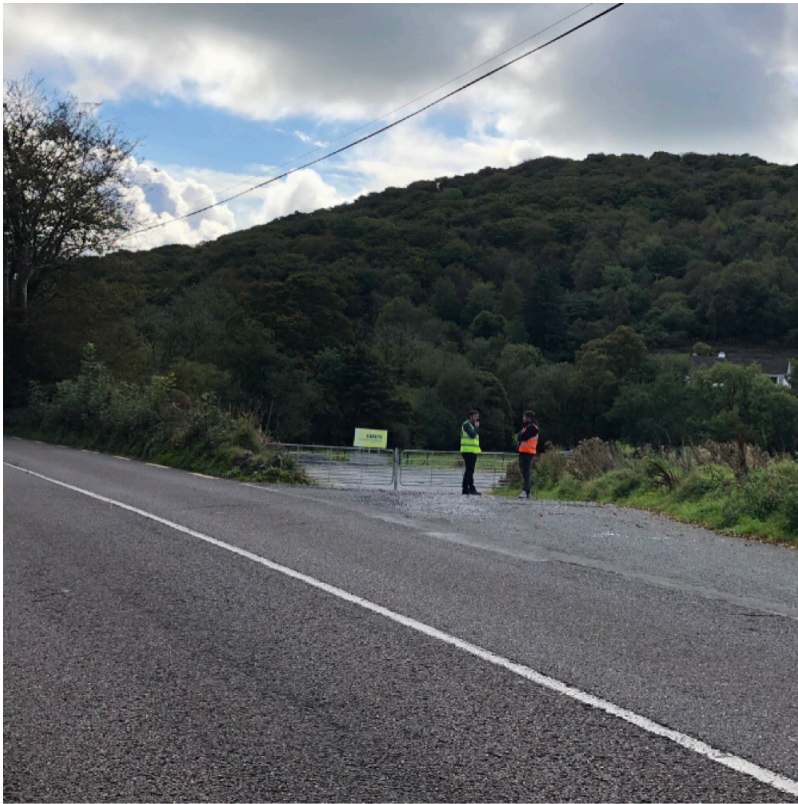
Location 44 - Glenflesk Exit Splitter  
Island

Visual inspection indicates that  
loaded blade will navigate with no  
issues at this location

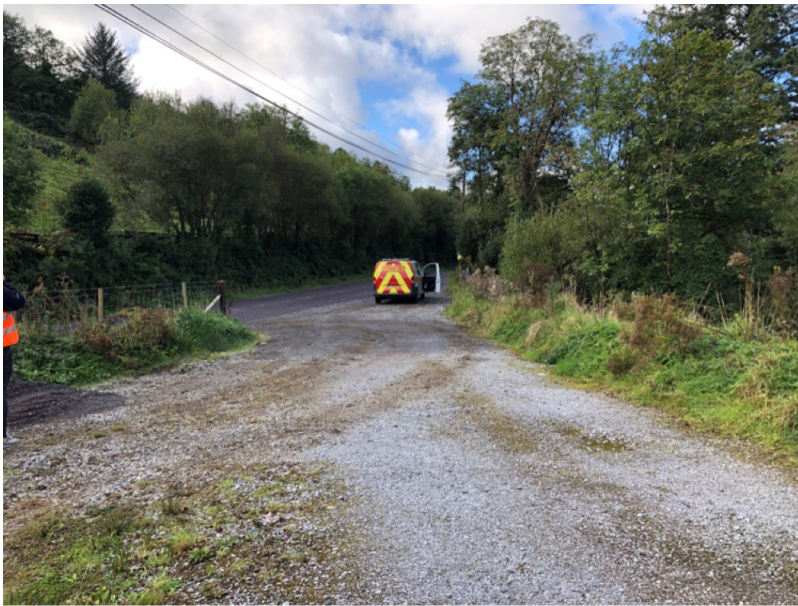
### Location 45 - Entrance Of Constructed Bridge

Visual inspection indicates that further road widening will be required on the track prior to the bridge.

Swept path analysis recommended to confirm

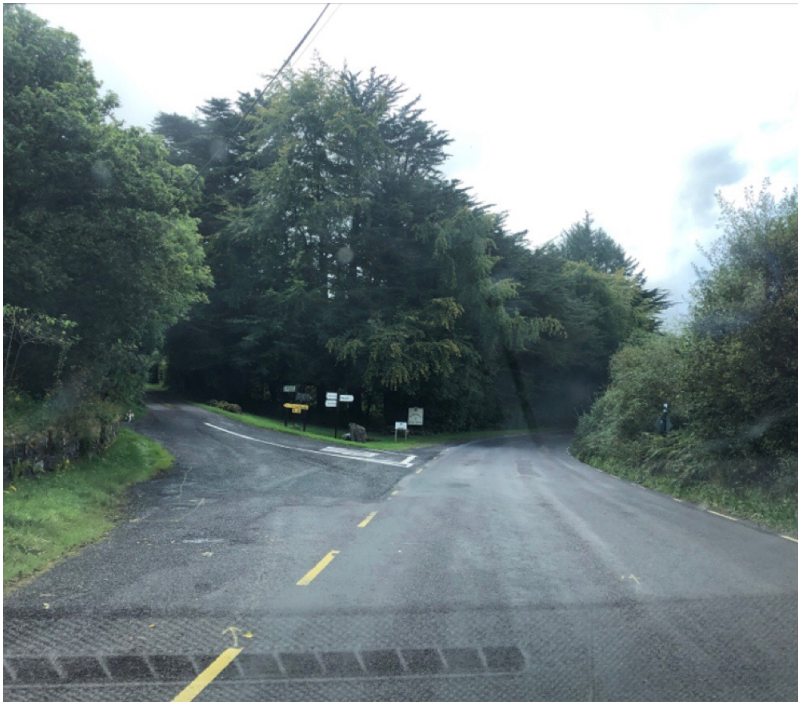
### Location 46 - Exit Of Constructed Bridge

Visual inspection indicates that loaded blade component should navigate through gate with no issues.

Swept path analysis recommended to confirm this.

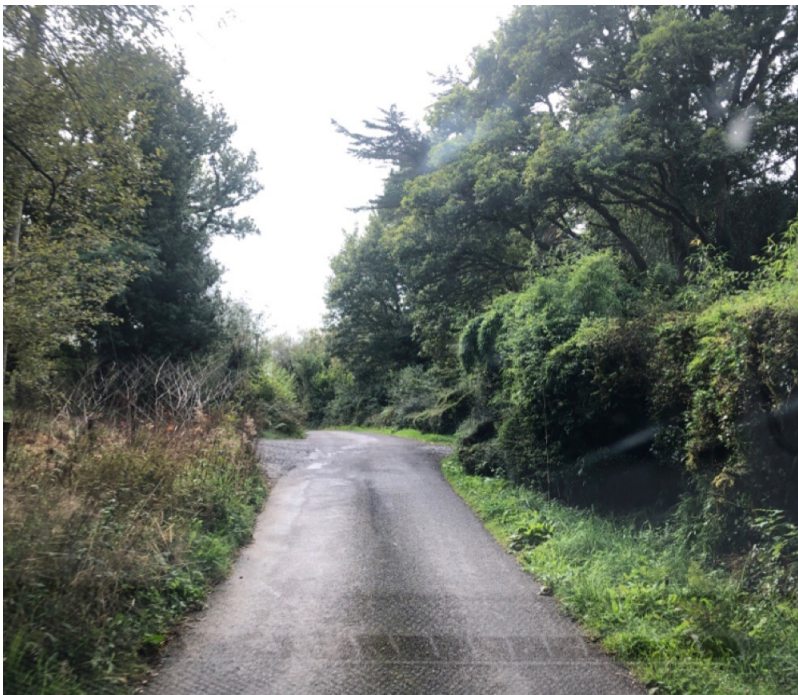
Location 47 - Left Turn On

Visual Inspection indicates third party land and the removal of signs on the offside will be required at this junction

Swept path analysis  
recommended to confirm this

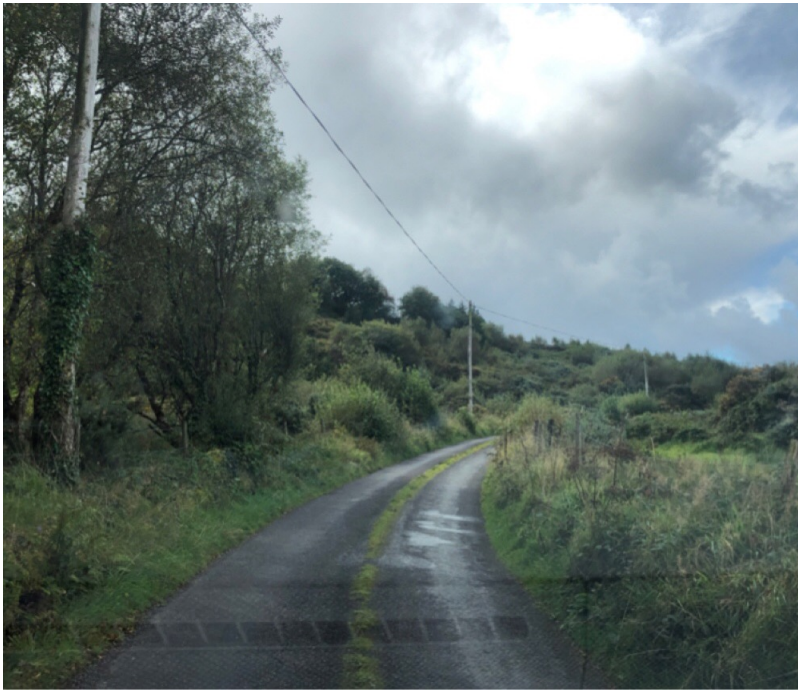
Location 48 - Narrow Section On  
Unnamed Road

Visual inspection indicates road widening, tree removal and telegraph pole removal will be required throughout this section of unclassified road, this may involve third party land.

Approx 4.10km

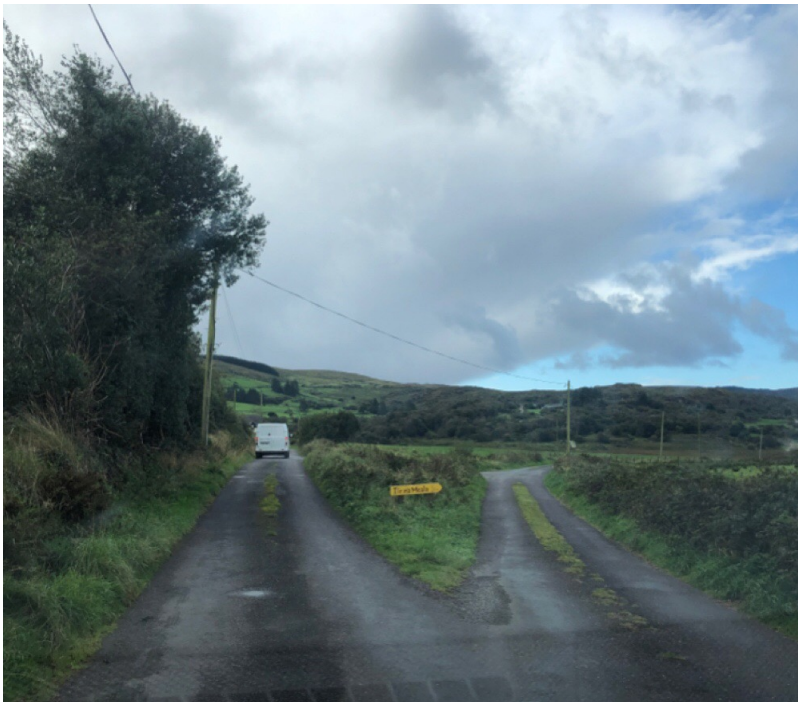
Location 49 - Right Bend On  
Unnamed Road Towards Site  
Direction Continue On Unnamed  
Road

Visual inspection indicates that third party land will be required. Tree removal will be required on nearside due to the rear projection of the blade component and the over sailing of the trailer body on the offside. Swept path analysis recommended to confirm. modifications

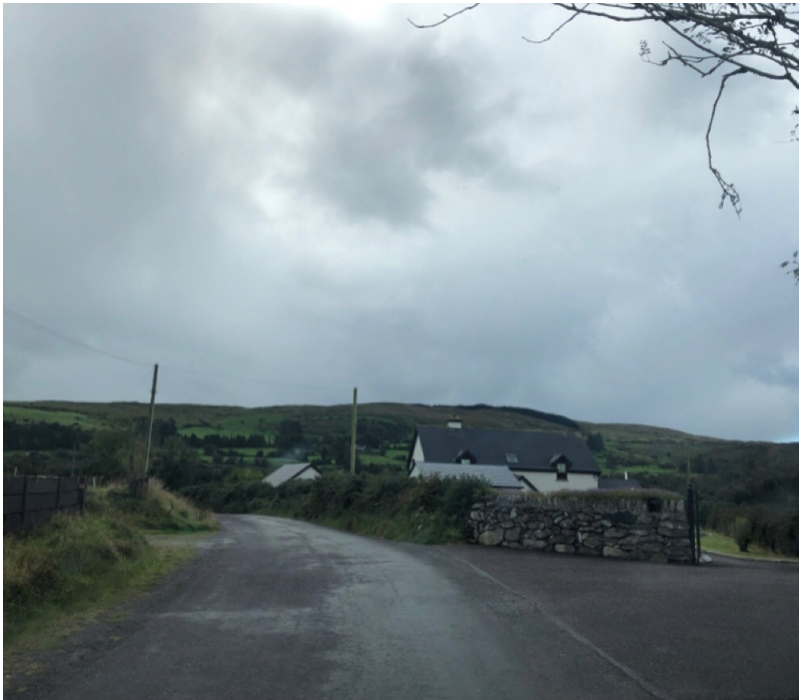
Location 50 - Fork In Unclassified  
Road  
Direction Stay Left At The Fork In  
The Road

Visual inspection indicates that road widening is required along the section of unclassified road. Swept path analysis recommended to confirm this

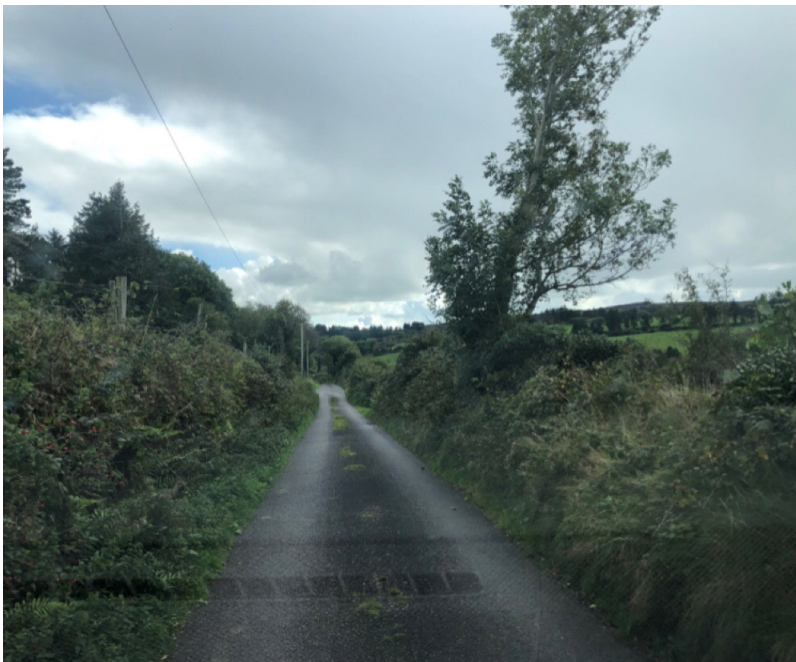
Location 51 - Left Bend At Houses  
Direction Continue On Unnamed  
Road To Proposed Site

Visual inspection indicates that road widening and third party land may be required to allow loaded blade component to navigate. Swept path analysis recommended

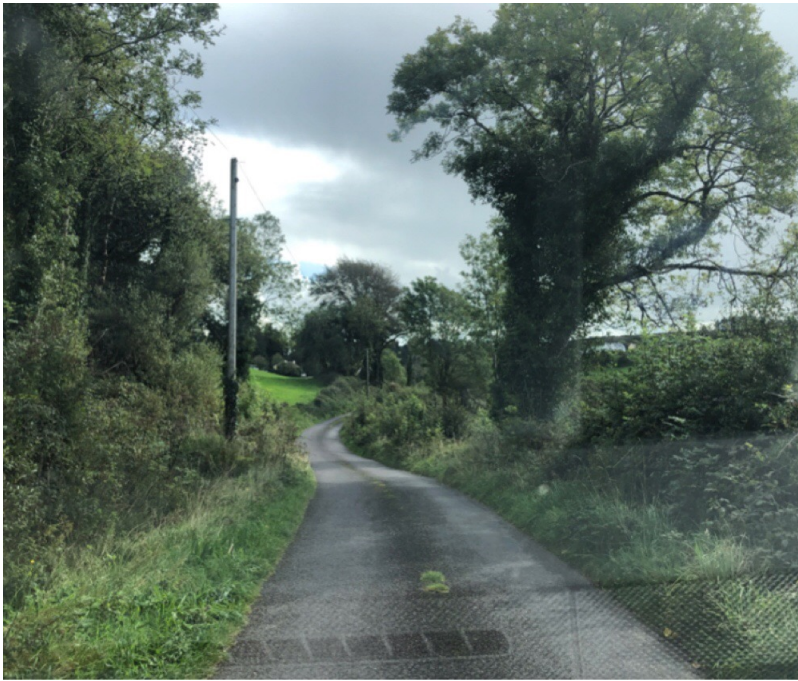
Location 52 - Narrow Section Of  
Unclassified Road

Direction Continue On The  
Unmakes Road To Proposed Site  
Visual inspection indicates road widening will still be required along the section of unclassified road as well as possible third party land required. Swept path analysis recommended to confirm this
