## Primary Route Assessment - Port Of Foynes / Gortyrahilly

343154

Wednesday, 23 September 2020

Prepared For Coillte

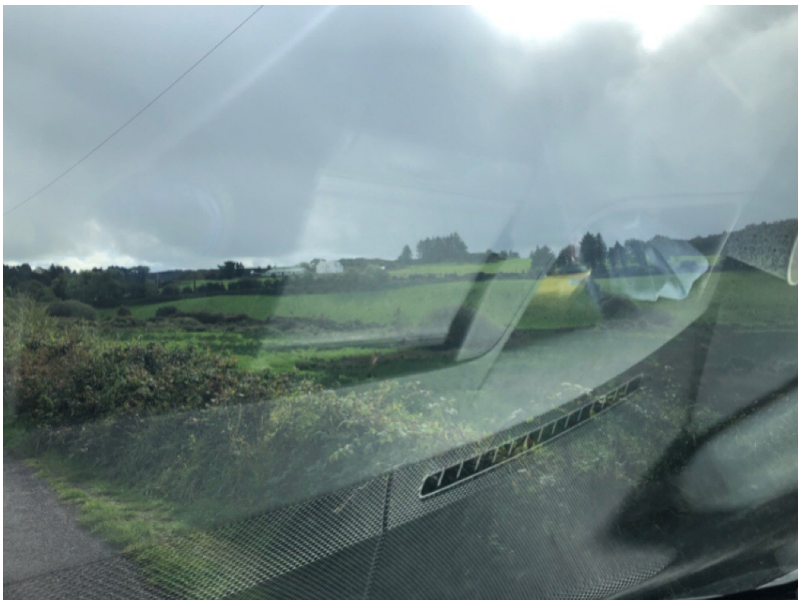
#### Location 53 - Chicane On

Visual inspection indicates that third party land may be required. Road widening is required in order to counteract the chicane. Swept path analysis recommended to confirm modifications

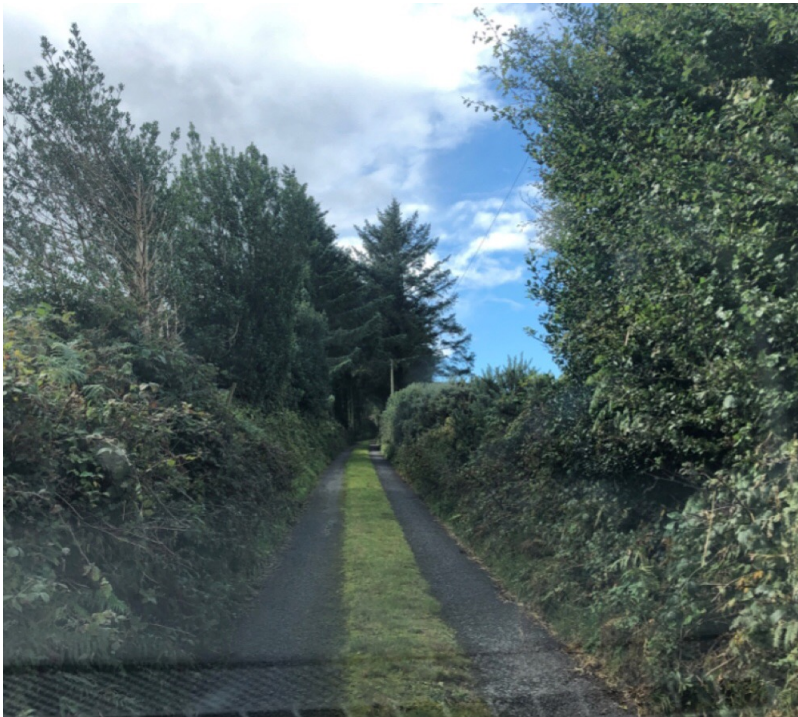
#### Location 54 - CUT THROUGH

Visual inspection indicates that third party land will be required along the full length of the proposed road. Swept path analysis and vertical analysis recommended to confirm any modifications

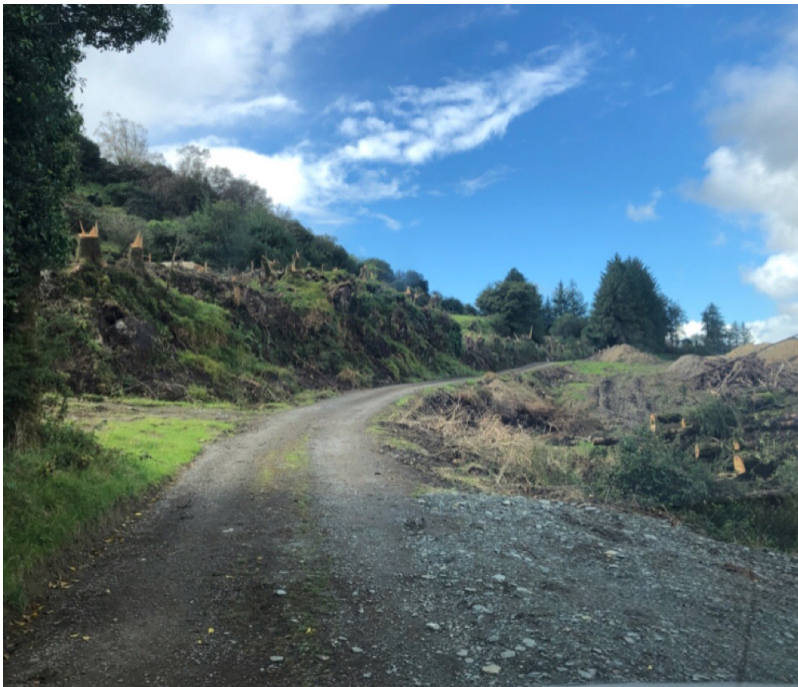
### Location 55 - Narrow Section On Second Unclassified Road

Visual inspection indicates that road widening will be required along the section of unclassified road. This may also involve the use of third party land on offside and nearside.

Swept path analysis recommended to confirm this

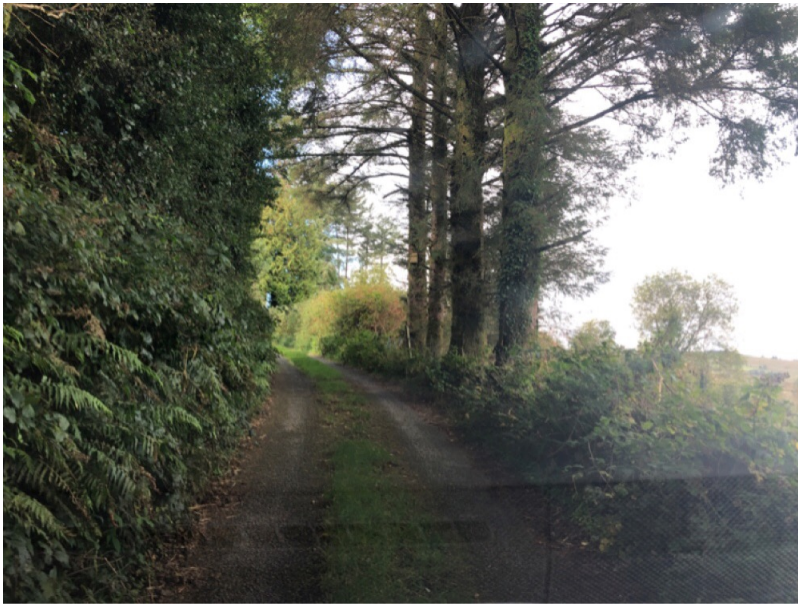
### Location 56 - Right Hand Bend At Farm

Visual inspection indicates that road widening is required to allow loaded blade to navigate, this road widening may involve third party land.

Swept path analysis recommended to confirm this.

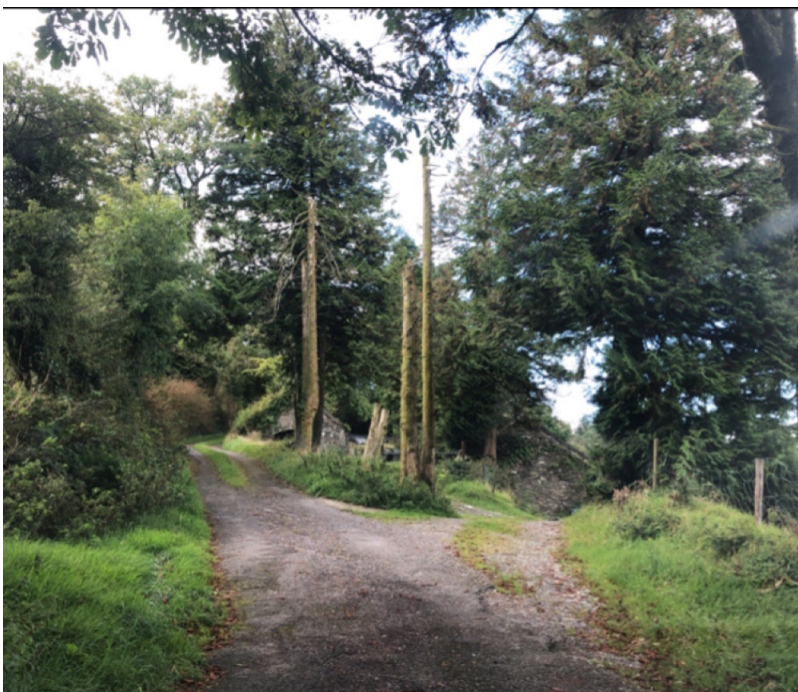
Location 57 - Left Hand Bend On  
Unclassified Road Route  
Direction Continue On Unnamed  
Road

Visual inspection indicates that road widening will be required along this full section of unclassified road, this may involve third party land.

Tree removal will also be required along this section of road to allow blade component to navigate.

Swept path analysis recommended to confirm this
