Primary Route Assessment - Gortrahilly Wind Farm, County Cork

343154

Wednesday, 20 October 2021

52 Locations Assessed

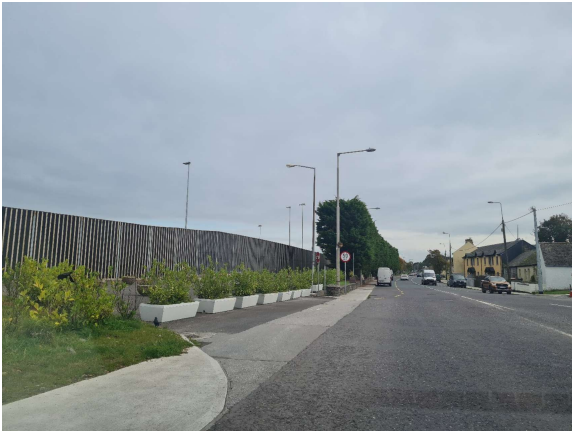
Location 1 - Exit From Ringaskiddy Port

Visual inspection indicates that the fencing and flower pits are to be removed to allow access from the port.

Manual steering required to assist navigation.

Swept Path Analysis recommended to ensure no further modifications are required.

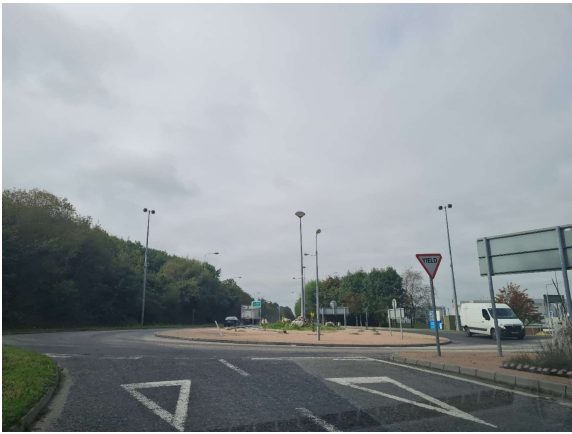
Location 2 - N28 Roundabout

Visual inspection indicates that the loaded blade vehicle is to run on hardstanding central island of the roundabout and the exit Splitter Island.

Street furniture in these locations to be removed.

Swept Path Analysis recommended to confirm modifications.

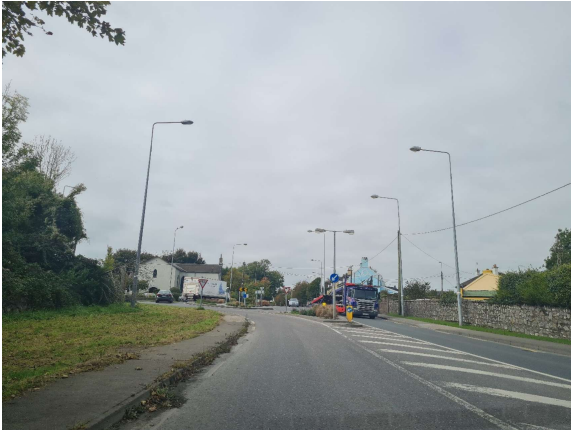
Location 5 - N28 Roundabout

Visual inspection indicates that a contraflow manoeuvre is required at this roundabout.

Loaded vehicle is required to run on hardstanding area in front of the shop on the offside of the roundabout.

Street furniture in this area to be removed.

Manual steering required to assist navigation.

Swept Path Analysis recommended to confirm modifications.

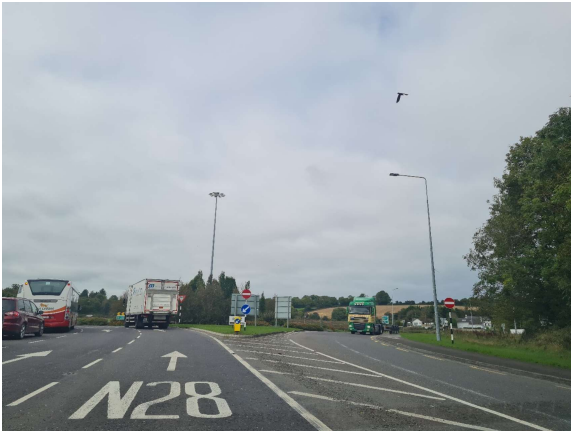
Location 13 - N28/R611 Roundabout

Visual inspection indicates that a contraflow manoeuvre is required to navigate this roundabout.

Street furniture on the entry Splitter Island to be removed due to rear projection of the blade components.

Manual steering required to assist navigation.

Swept Path Analysis recommended to confirm modifications.

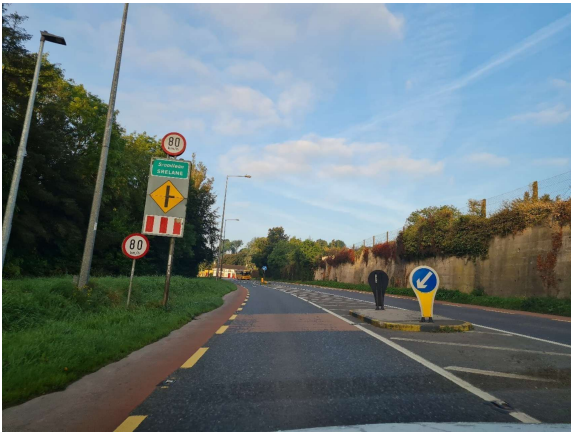
Location 17 - Splitter Island On N22

Visual inspection indicates that flexi bollards to be flattened to allow loaded vehicle to navigate.

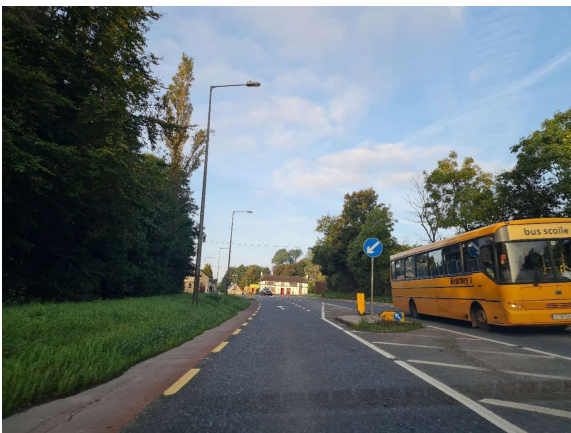
Location 18 - Splitter Island On N22

Visual inspection indicates that flexi bollards on the nearside to be flattened to allow loaded vehicle to navigate and avoid Splitter Island.

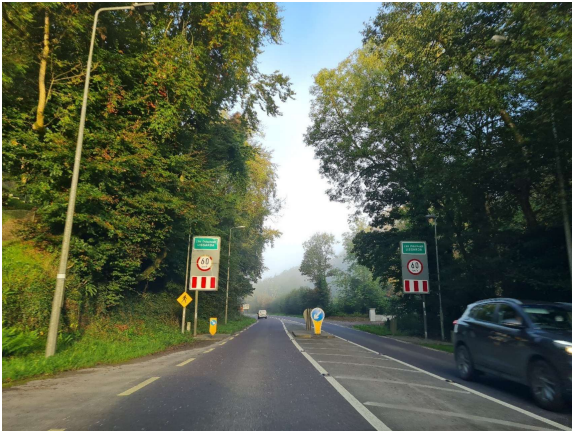
Location 28 - Splitter Island On N22

Visual inspection indicates that the flexi bollards to be flattened to allow loaded vehicle to navigate.

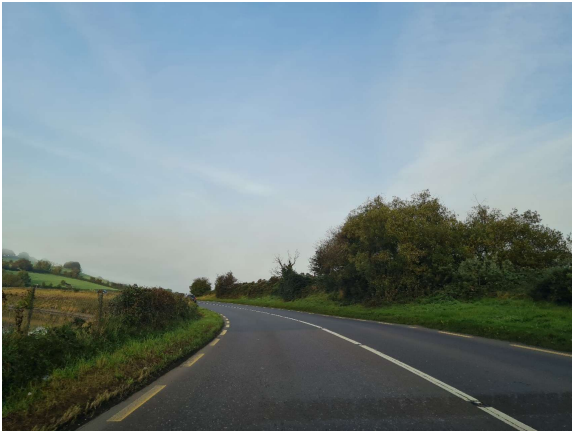
Location 34 - Left Bend On N22

Visual inspection indicates that the loaded vehicle will navigate this location utilising manual steering.

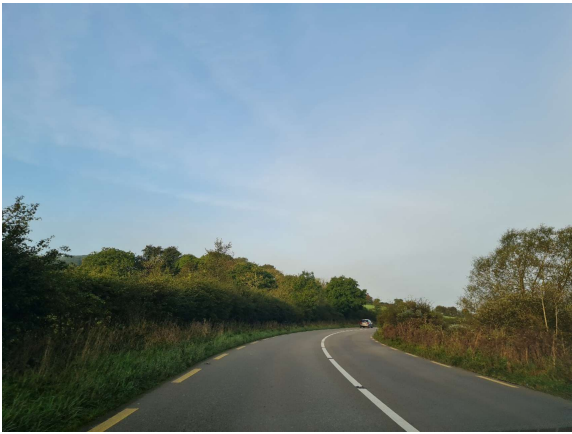
Location 35 - Right Bend On N22

Visual inspection indicates that the loaded vehicle will navigate this location utilising manual steering.

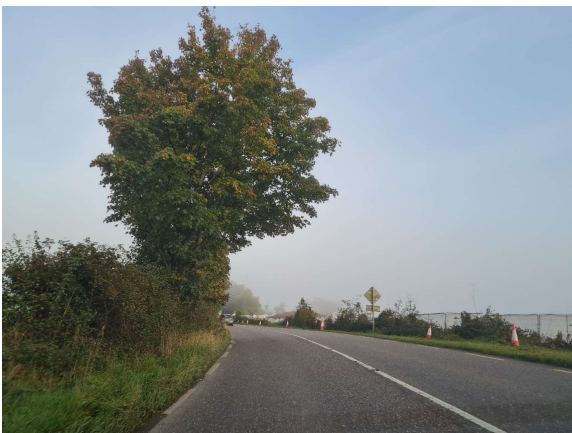
Location 36 - Macroom Bypass Interchange

Loaded vehicles are to use the new Bypass, to navigate to Ballyvourney, which is currently under construction to avoid the town of Macroom.

Once constructed the Bypass is to be assessed to ensure route suitability.

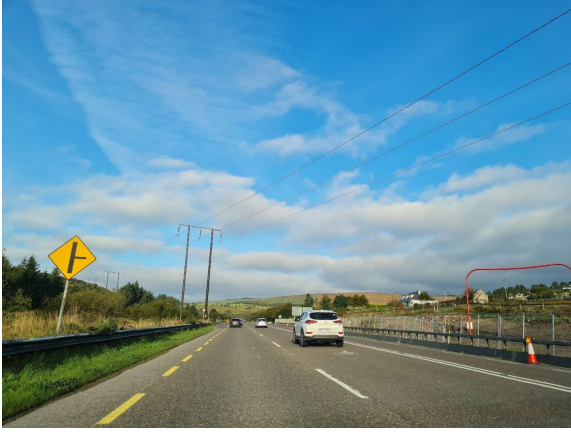
Location 37 - N22 / Macroom Bypass Interchange At Ballyvourney

Loaded vehicles are to use the new Bypass, to navigate to Ballyvourney, which is currently under construction to avoid the town of Macroom.

Once constructed the Bypass is to be assessed to ensure route suitability.

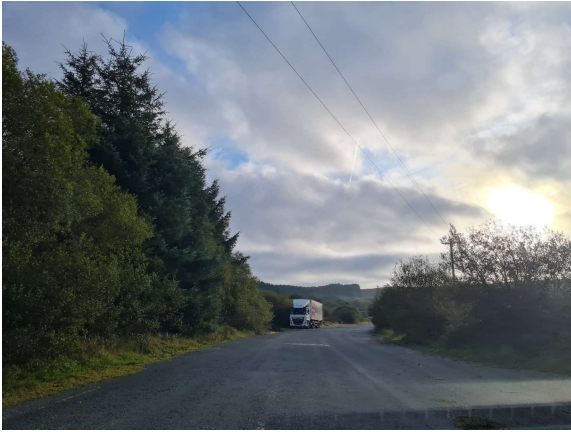
Location 38 - N22 Turning Area At County Boundary

The loaded vehicle are to enter the lay by and use the proposed site access to CMBG Wind Farm to turn the vehicles around.

Access to the lay by is to be opened up as it is current blocked with an soil banking.

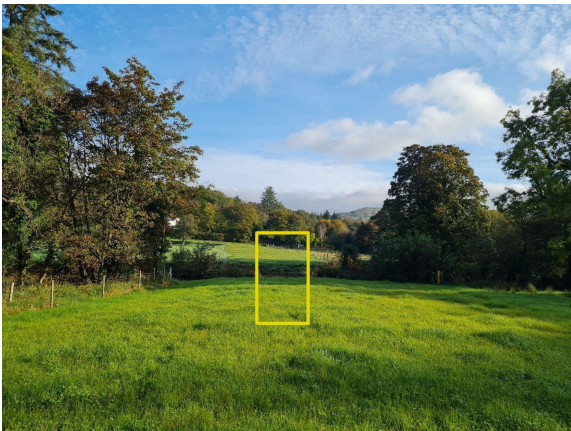
Location 39 - Bridge Crossing River Sullane

Previously installed bridge and works for Grousemount Wind Farm to be reinstated to allow access onto the L3400.

Swept path analysis recommended to confirm suitability.

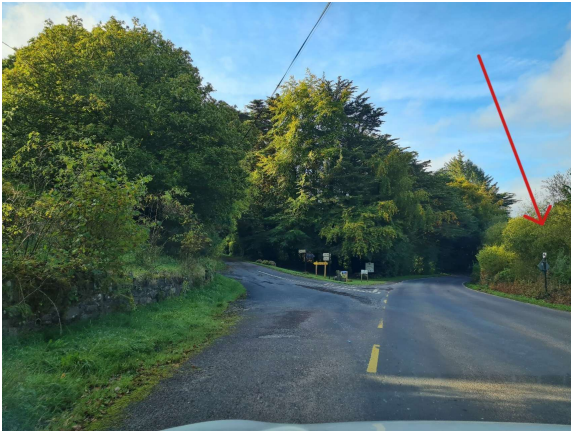
Location 40 - Tir Na Meala Junction

Visual inspection indicates that third party land and tree removal will be required on the offside of the unnamed Road to navigation.

Street furniture on the offside to be removed.

Swept Path Analysis recommended to confirm modifications.

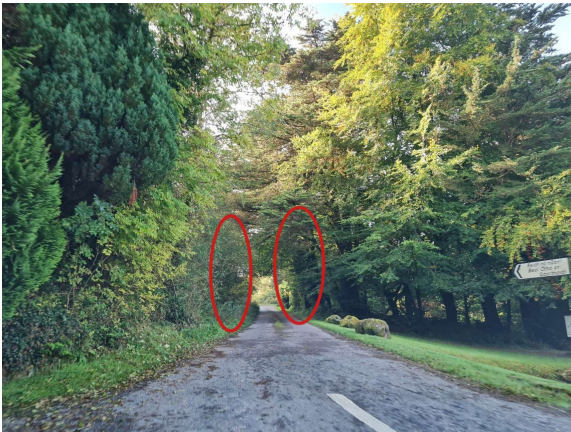
Location 41 - L-3405-0

Visual inspection indicates that the Unnamed Road will require upgrading to the turbine manufacturers specification.

Road widening and tree Pruning will be required along this section of route.

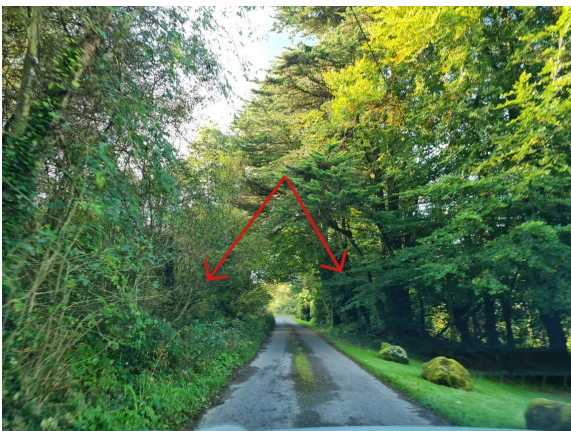
Location 42 - L-3405-0

Visual inspection indicates that the section of Road is required to be upgraded. Trees are required to be pruned back to the trunks and fence line on both sides of the road.

Road width - 2.90m

Telegraph Pole to fence - 5.60m

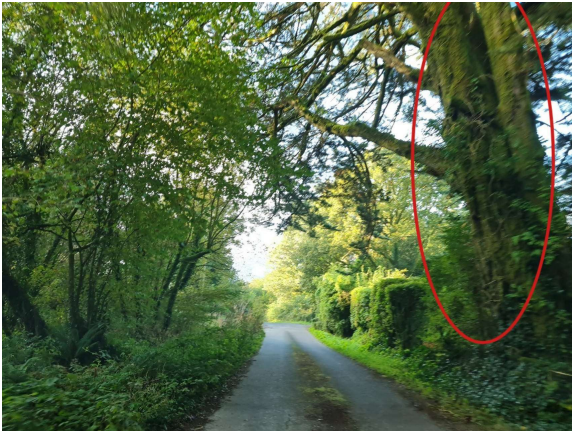
Location 43 - L-3405-0

Visual inspection indicates that the tree on the offside is required to be removed to avoid collision with loaded components.

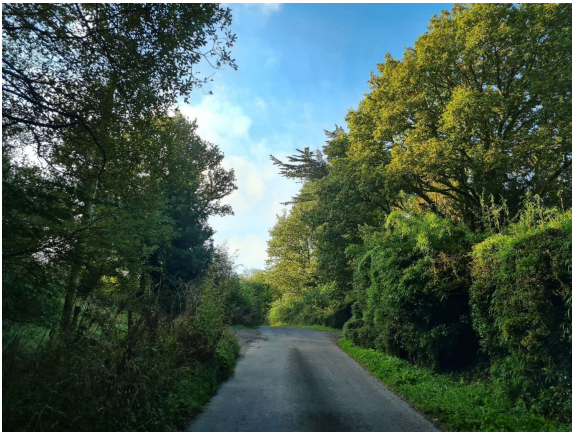
Location 44 - L-3405-0

Visual inspection indicates that there are no issues at this location.

Telegraph Pole to road edge - 5.05m.

Road widening and Pruning required on both sides of the road.

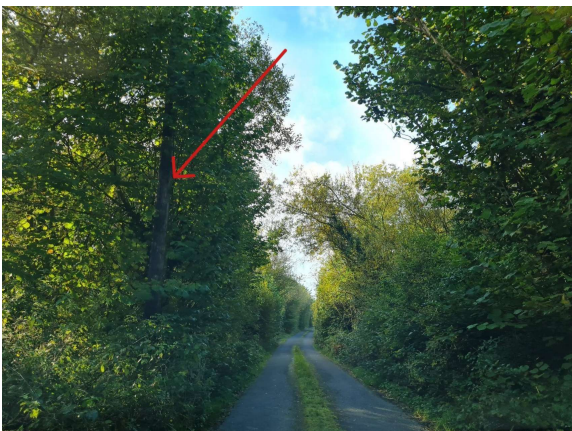
Location 45 - L-3405-0

Visual inspection indicates that the telegraph Pole is required to be removed on the nearside.

Road widening and pruning will be required on both sides of the road.

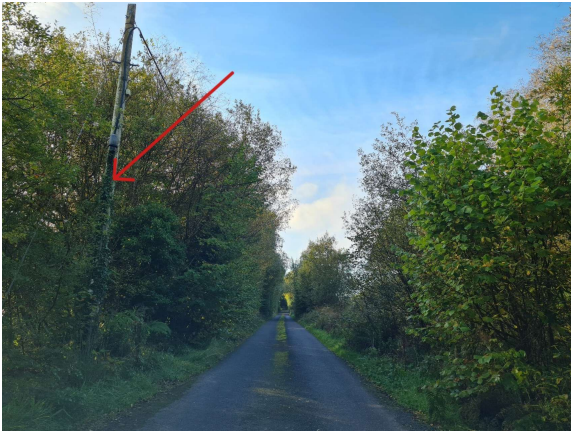
Location 46 - L-3405-0

Visual inspection indicates that the telegraph pole is required to be removed on the nearside.

Fence to fence - 5.40m

Telegraph Pole to fence 4.80m

Road widening and Pruning required on both sides of the road.

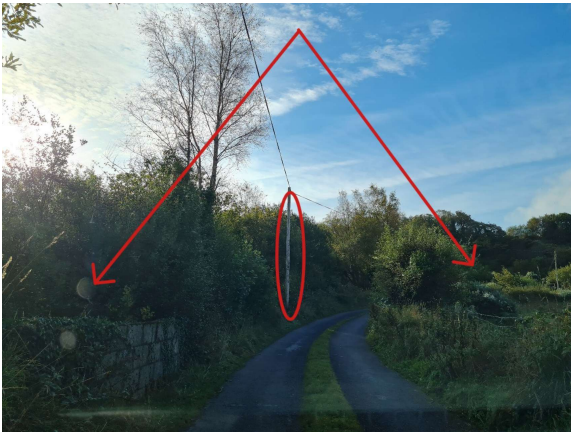
Location 47 - L-3405-0

Visual inspection indicates that third party land on both sides of the road is required.

Telegraph Pole on nearside requires removal to allow rear projection to oversail.

Swept Path Analysis recommended to confirm modifications

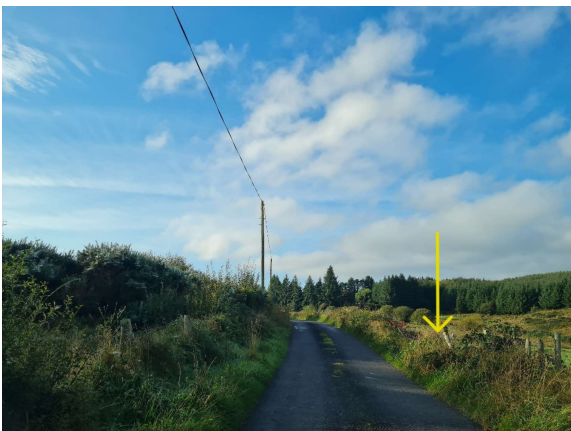
Location 48 - L-3405-0

Visual inspection indicates that third party land is required on the offside.

Inspection has shown that the Nearside is approximately 1.50m higher than the offside.

Road widening required on the offside.

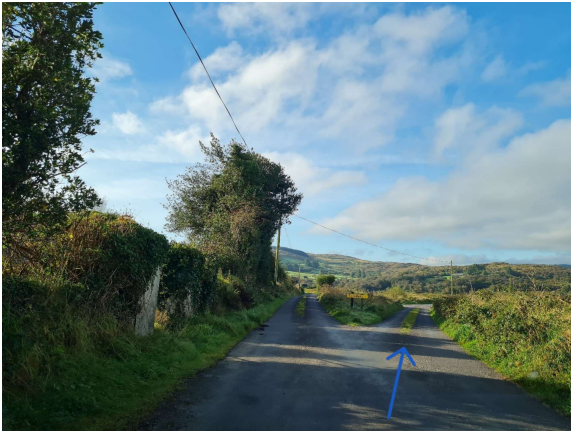
Location 49 - Fork In L-3405-0

Visual inspection indicates that third party land will be required at this location.

Road to be upgraded to the turbine manufacturers specification.

Swept Path Analysis recommended to confirm modifications.

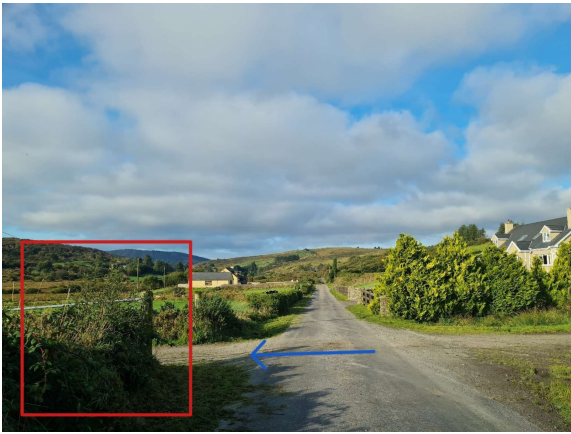
Location 50 – L-7405 / Unnamed Track Junction

Visual inspection indicates that third party land is required on the nearside in order to allow access on the Unnamed Track.

Swept Path Analysis recommended to confirm modifications.

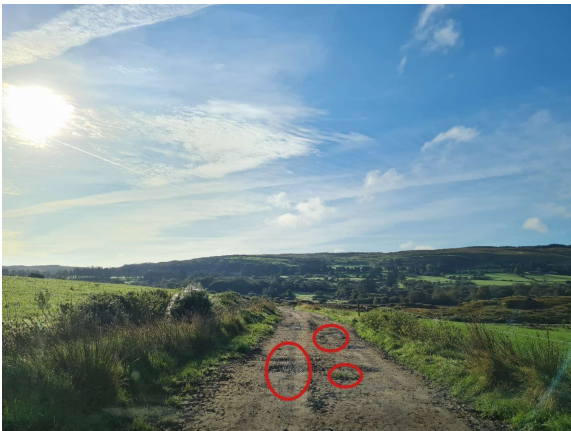
Location 51 - Unnamed Track

Visual inspection indicates that this section of road is to be upgraded to the turbine manufacturers specification to allow loaded vehicles to navigate.

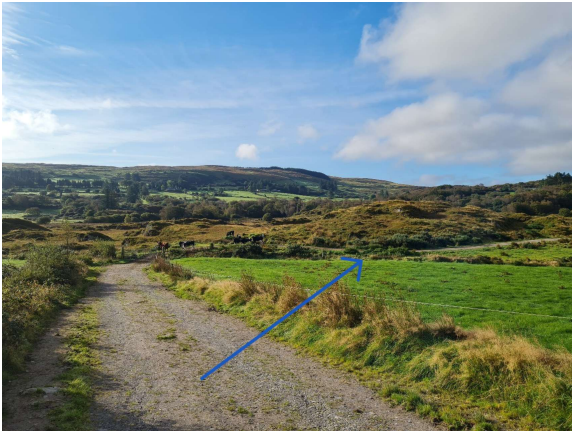
Location 52 - Unnamed Track - New Access

Visual inspection indicates that a New access Road is to be constructed to allow loaded vehicle to navigate to the proposed site entrance.
