Appendix D1
Arboricultural Impact
Assessment Report -
Ballymun to City
Centre

Arboricultural Assessment, Report

Scheme 03:
Ballymun To
City Centre

Project No.	TBAL001	Date	24/08/22
Project Name	BUSCONNECTS Core Bus Corridors. Emerging Preferred Routes / Public Consultation	Revision	-

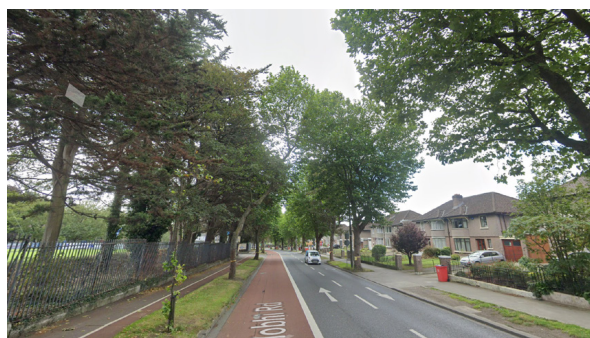
Image 3. Saint Mobhi Road with mature London plane and Norway maple.

Saint Mobhi Road (image 3) with it's many mature London plane (*Platanus × acerifolia*) and Norway maple (*Acer platanoides*) hold the densest concentration of higher value trees (85% are category B&A). These trees hold high landscape and amenity value for local residents. With some noted practical drawbacks associated with abundant leaf fall and shading over properties.

Where the largest concentration of higher quality trees are located within Saint Mobhi Road, increased measures of care are recommended to reduce construction impact on roots (also detailed within Appendix A).

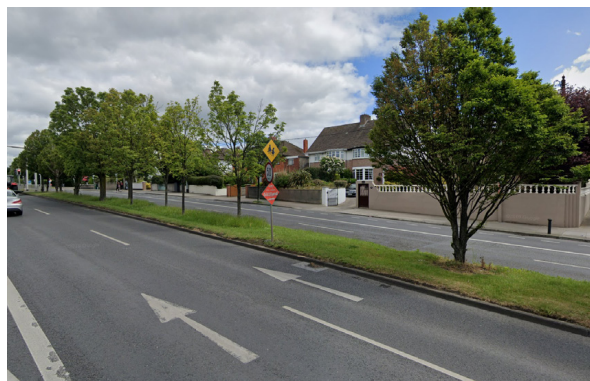
Image 5. Trees of mixed vigor located in the median areas between Our Lady of Victories Catholic Church and Griffith Avenue.

Conversely, the largest concentration of less vigorous trees are found in the median areas between Our Lady of Victories Catholic Church and Griffith Avenue (images 4&5). With many trees in this area being of a younger age profile and suffering poor drainage.
